Annual Audit Compliance Report Form

Licence number:	L6498/1995/11	Licence file number:	2012/006868-1
Licence holder name:	Northern Star Resources Ltd		
Trading as:	Northern Star Resources Ltd		
ACN:	092832892		
Registered business address:	Level 4, 500 Hay Street Subiaco		
Reporting period:	01 / 01 / 2023 to 31 / 12 / 2023

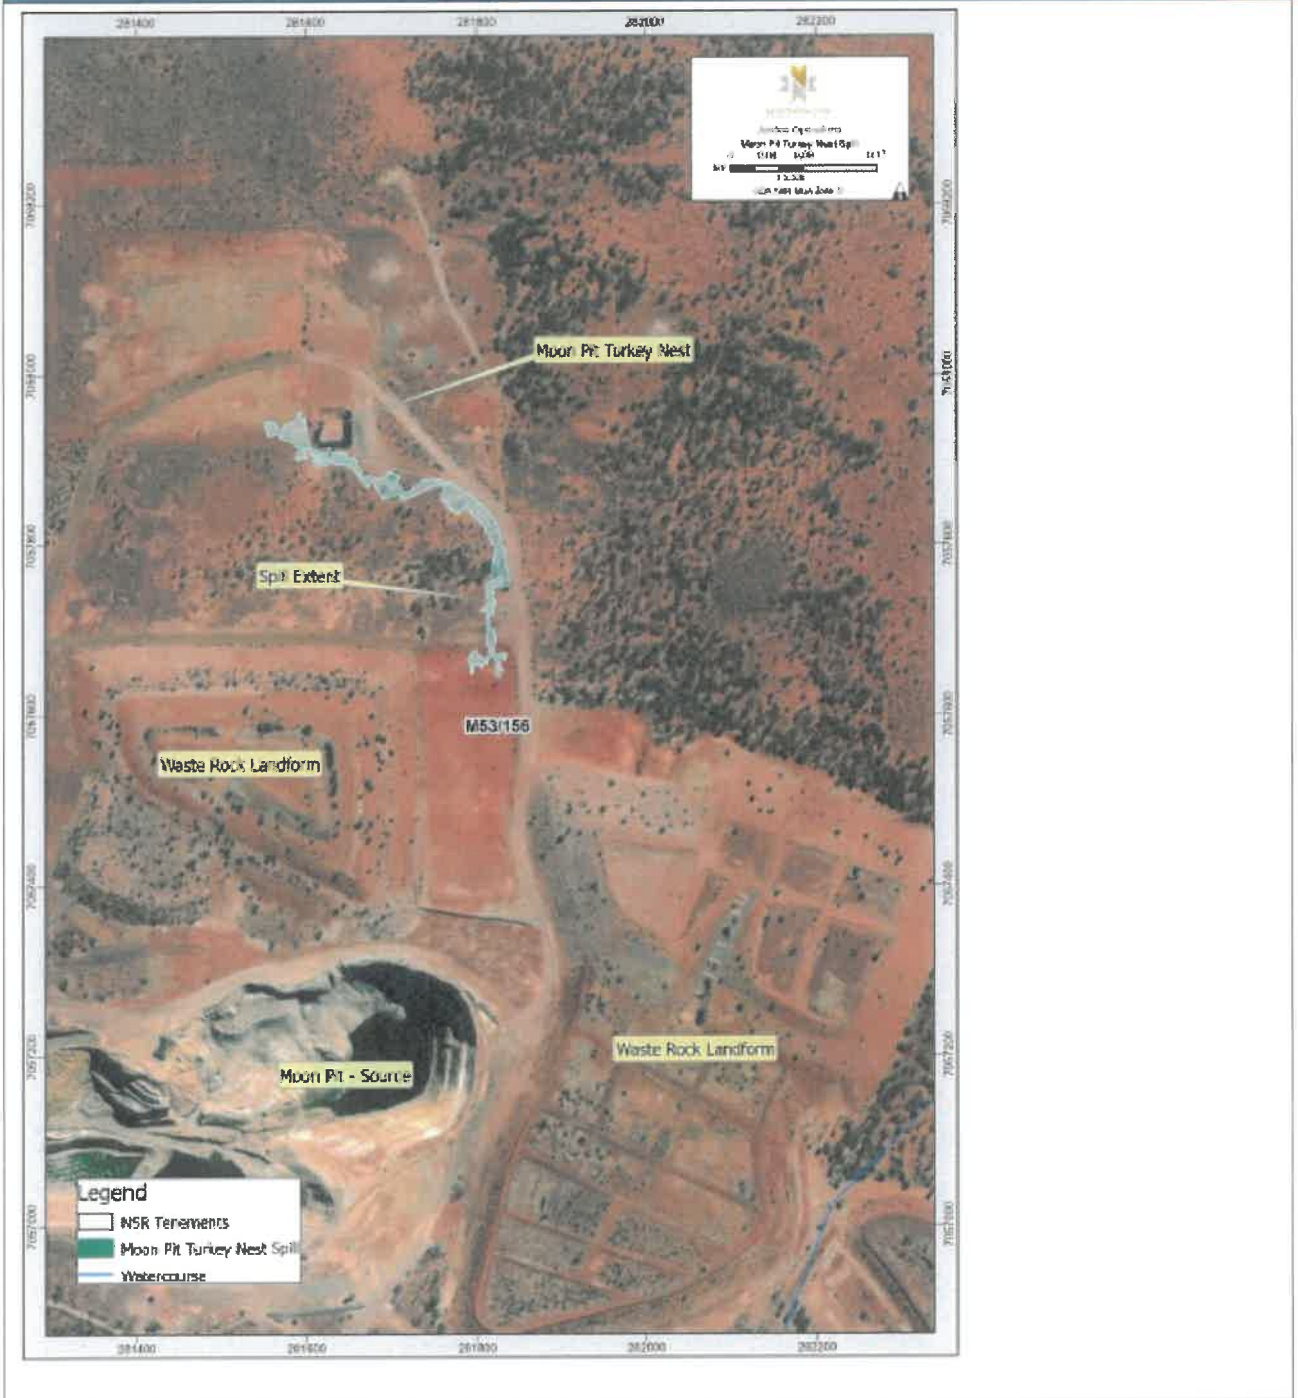
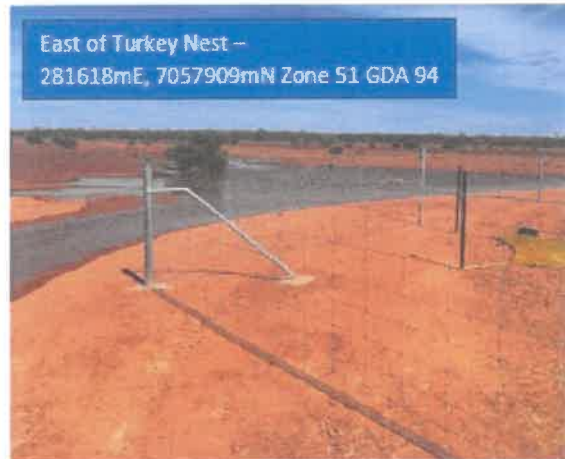
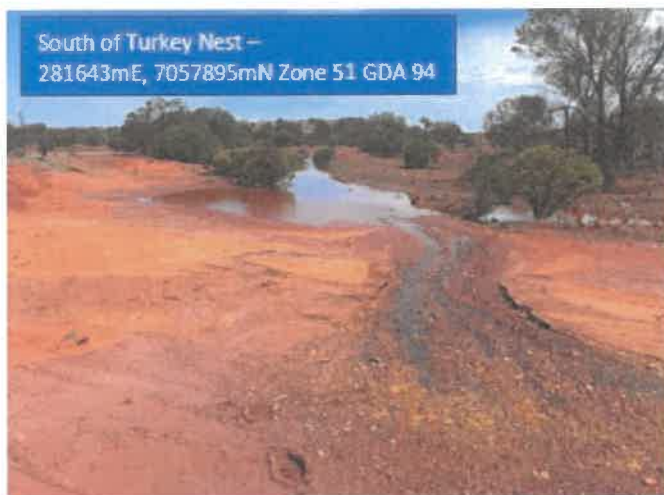
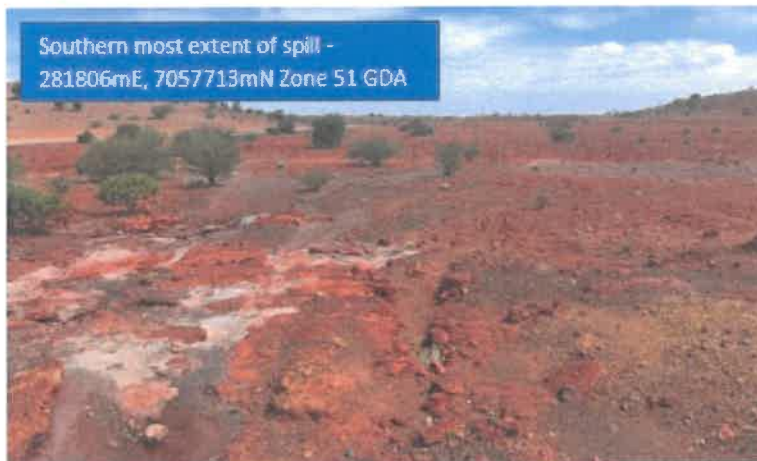
Section E – Details of non-compliance with licence condition			
Please use a separate page for each condition with which the licence holder was non-compliant at a time during the reporting period.			
Condition no:	1.2.4 Maintaining freeboard	Date(s) of non-compliance:	2 January 2023
Details of non-compliance:			
<p>Moon Pit Turkeys Nest Dam Overflow</p> <p>On 2 January 2023, approximately 40kL of saline water from the Moon Pit Turkey Nest (on tenement M53/156) was released into the surrounding disturbed and rehabilitated areas and native vegetation. The affected area covered a footprint of 0.65ha of which 60% was previously disturbed.</p>			
<p>What was the actual (or suspected) environmental impact of the non-compliance?</p> <p>NOTE – please attach maps or diagrams to provide insight into the precise location of where the non-compliance took place.</p>			
<p>The event was expected to have negligible environmental impact with no impact to vegetation has been observed.</p>

The Turkey Nest was in the process of commissioning. The Turkey Nest was being filled for the first time. The float level switch, used to shut the pump off, was not set correctly, allowing water to continue to flow into the turkey nest.

Upon being aware of the event, operation of Moon Pit Pump and Turkey Nest ceased. The float level switch was adjusted accordingly.

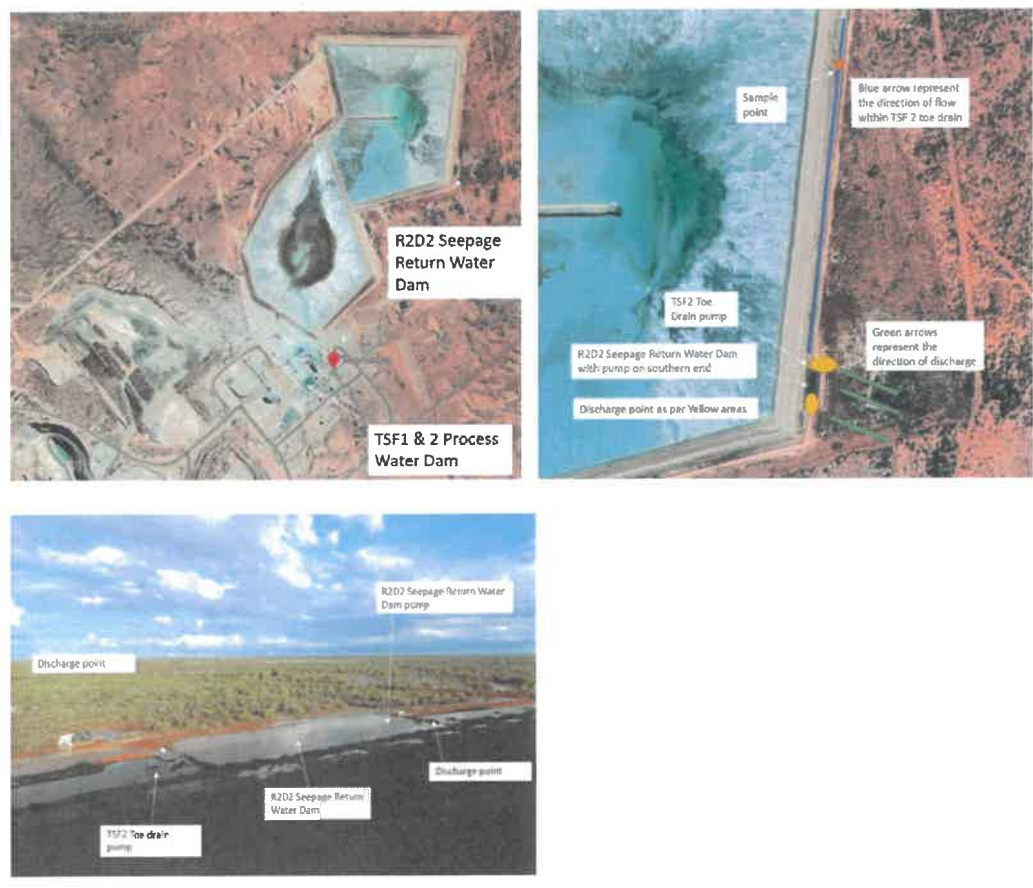
High rainfall between 26 March and 2 April 2023 resulted in significant site water runoff, with the TSF2 North/East Seepage interception trench becoming full of water. Due to the ongoing inclement weather, ground conditions and lightning, additional pumps could not be deployed to reduce water levels in the trench. Subsequently, the trench overflowed into the R2D2 seepage return water dam, and significantly diluted water from the R2D2 dam overflowed into the surrounding area. During to the incident, NSR continued to run pumps to stop the emission and ensure water levels returned to normal in the toe drains and at the R2D2 Seepage Return Water Dam.

The event was expected to have negligible environmental impact – due to the volume of rain entering the toe drain and dam, the water was heavily diluted and essentially fresh rainfall.

Flow in toe drain exceeded pumping capacity.

Section E – Details of non-compliance with licence condition	
Action taken to mitigate any adverse effects of non-compliance and prevent recurrence of the non-compliance:	
<ul style="list-style-type: none"> • Continued to run existing pumps to stop emissions. • Repair of damaged sections of the TSF toe-drain embankment. • Vegetation monitoring was undertaken for a three-month period and determined no visible impact from the event. Soil sampling was also undertaken, with samples compared against analogue soil samples. The results indicate an increase in conductivity with negligible change with other parameters. • The Jundee Tailings Operational Manual, Jundee Tailings Management Plan and Jundee Extreme Weather Management Plan were reviewed, and revised. 	
Was this non-compliance previously reported to DWER?	
<input type="checkbox"/> Yes, and	
<input type="checkbox"/> Reported to DWER verbally	Date: / /

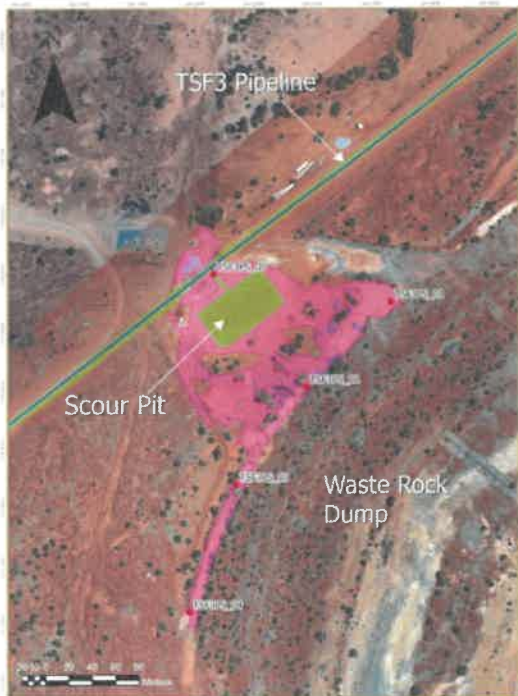
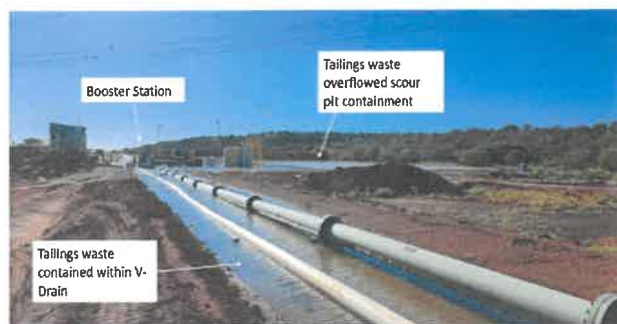
Figure 3: Photo of TSF3 Pipeline Staff looking west along pipeline 2022 scour pit

On 18 July 2023, a second visual integrity check of the tailings pipeline was not completed during the dayshift, as specified in Table 1.2.3 of the Licence (i.e., twice every 12 hours). This coincided with a failure of the pipeline and resulted in that failure not being detected. The cause of the spillage was a burst disc rupture, causing tailings to overflow into the secondary containment area as designed. Discharge was identified during the first night shift inspection, 15 hours after the initial burst disc rupture. The scour pit was designed to capture 6 hours of spill and as a result the spill overflowed to adjacent, previously disturbed areas.

Licence conditions require inspections be performed twice every 12 hours. This equates to 4 inspections per day, two by day shift and another two by night shift. An inspection was not performed allowing the spill to go unnoticed for a full 15 hours.

Following identification of the failure, the tailings pipeline to TSF3 was isolated and tailings were temporarily diverted to TSF2. Several vacuum trucks were used to remove tailings slurry from the scour pit and surrounding areas, with the material discharged to Fisher In-pit TSF.

- Changing the leak detection alarm in the control room from ‘warning’ to ‘critical’ for the burst disc rupture.
- Reviewed the logic on the leak detection within the control room to ensure it provides leak detection alarms that are required to be acted on immediately.
- Installed cameras on the switch room to monitor the booster station area from the mill control room. Cameras are monitored continuously throughout each shift.
- Reviewed the TSF3 checklist and updated appropriately, including a travel map of the pipeline inspection points to ensure the pipeline is completely checked.
- Ensured the TSF inspections are conducted on a frequency of two inspections per shift, with inspection forms now recorded in a book and checked each shift by the supervisor.

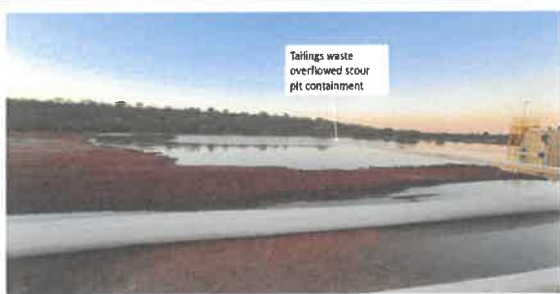
Figure 4. Photo of TSF2 pipeline spill showing waste overflowing scour pit

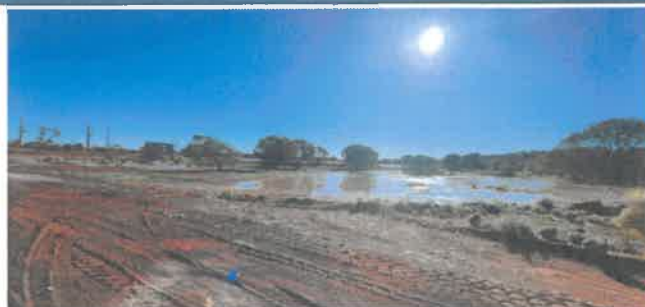
Figure 5. TSF3 pipeline spill showing car across the spill at night containment and scour pit in the background

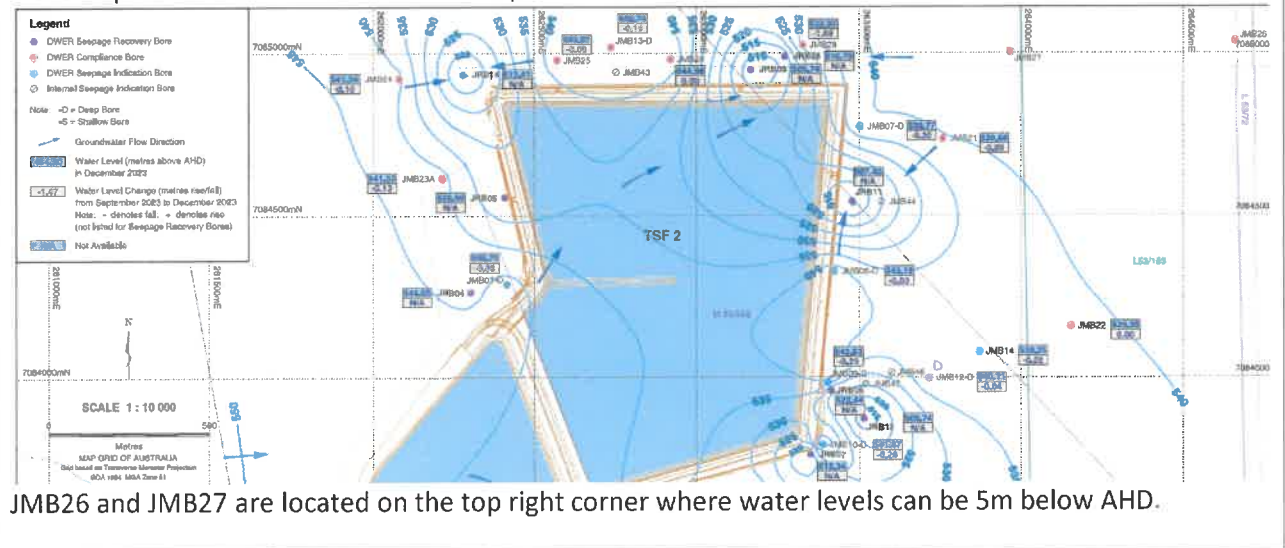
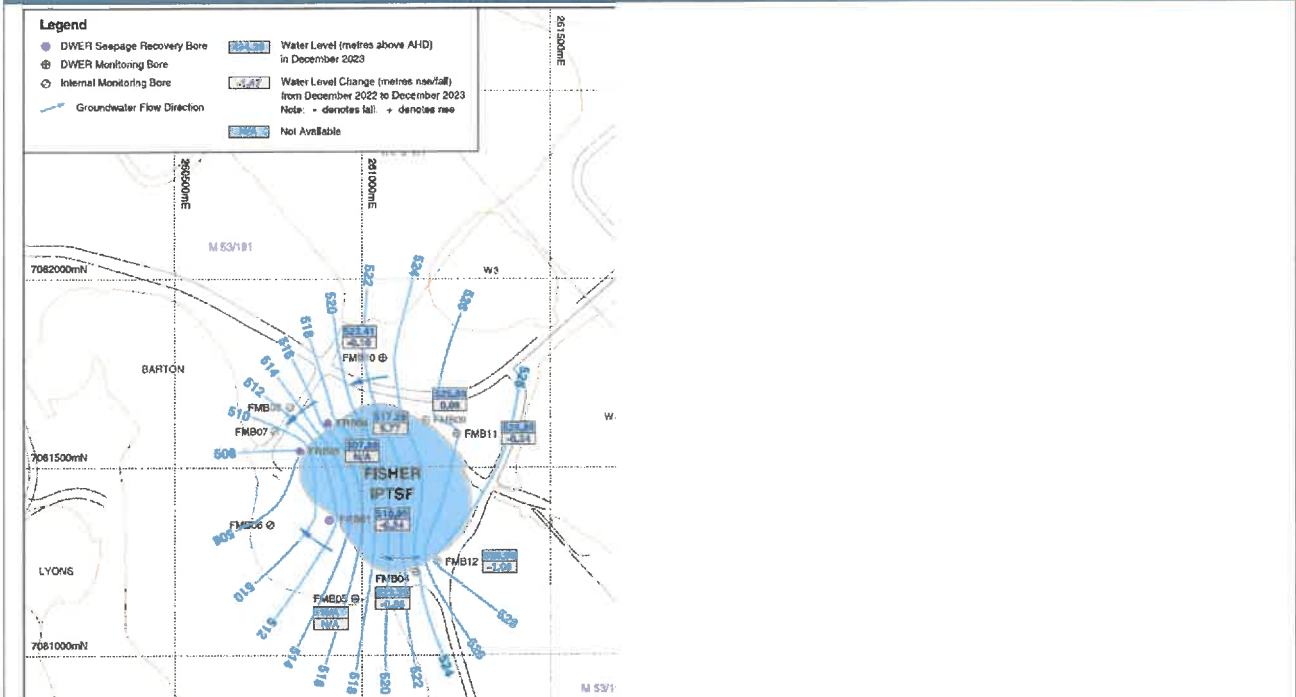
The Licence specifies a minimum 90% of all bores to be sampled during any quarterly period. Between 83.2%, 83.2% and 84.9% of measurements were undertaken in quarters 1, 2 and 3 respectively.

FMB05 is located in the southern side of Fisher Pit. Multiple bore collapses have been reported and detailed in Annual Tailings Audit Report.

Monitoring bores JMB26, JMB27 and FMB05 have been expected to be dry for an extended period, and these locations account for approximately 13% of all required measurements

Northern Star is in the process of engaging a specialist consultant to assess the bores to determine if they are blocked or dry. Results from this assessment will be used to determine a way forward to ensure we are adequately monitoring ambient groundwater and achieving compliance requirements.
