Annual Audit Compliance Report Form

Environmental Protection Act 1986, Part V Division 3

Section A – Licence details			
Licence number:	L8578/2011/1	Licence file number:	2011/003002
Licence holder name:	Regis Resources Limited		
Trading as:	Regis Resources Limited		
ACN:	009 174 761		
Registered business address:	Level 2 516 Hay Street Subiaco WA 6008		
Reporting period:	01/01/2021 to 31 /12/2021

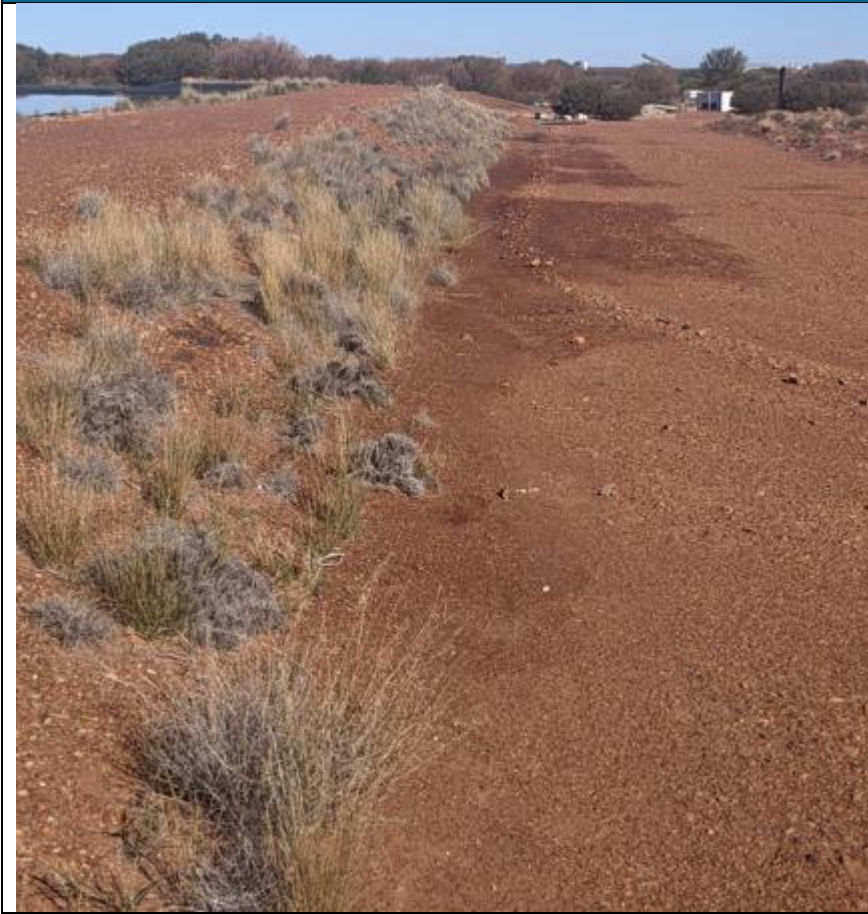
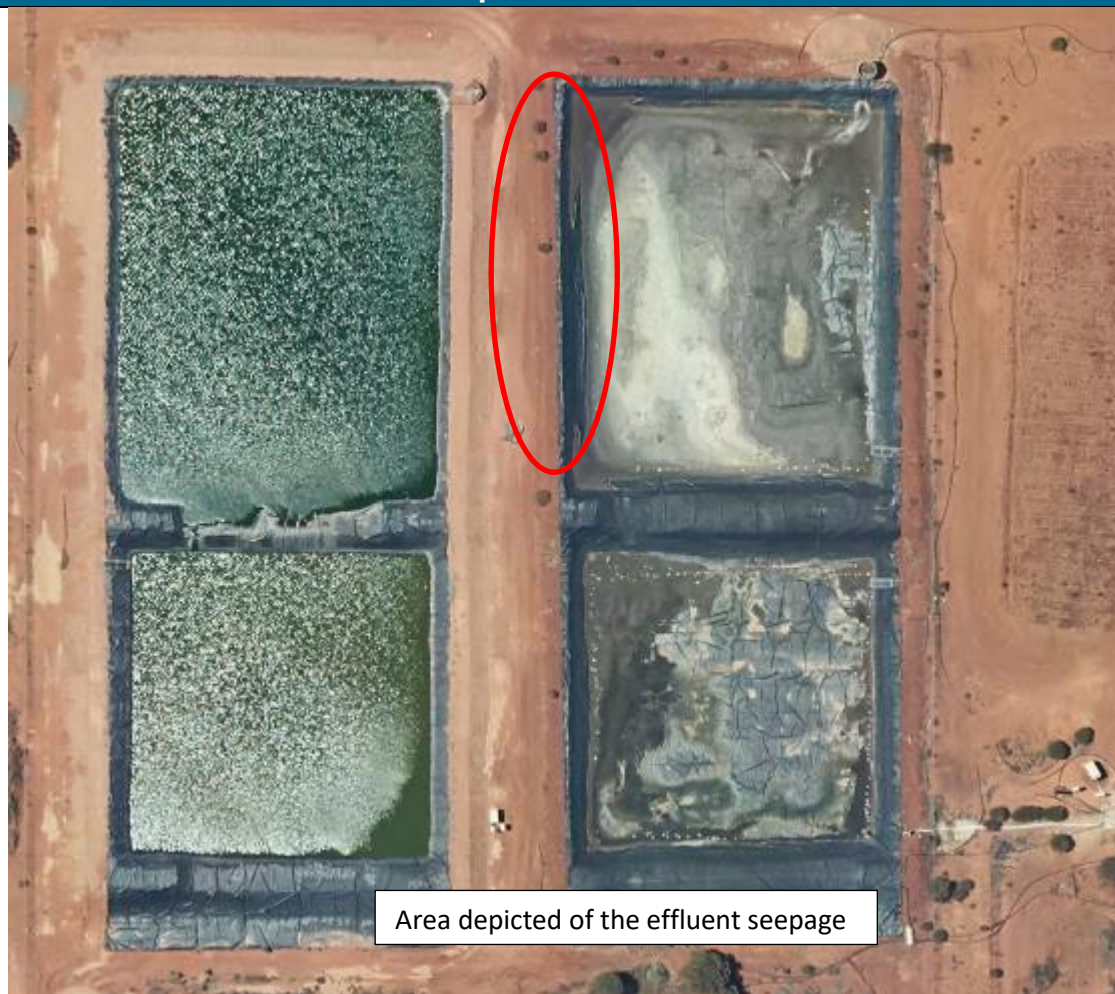
Section E – Details of non-compliance with licence condition			
Please use a separate page for each condition with which the Licence holder was non-compliant at a time during the reporting period.			
Condition no:	1.2.6	Date(s) of non-compliance:	25/06/2022
Details of non-compliance:			
While commissioning the GW WWTP inlet pond (L2) on 25/06/2021, a leak was identified by the environmental advisor on-site. The effluent material was contained and removed.			
What was the actual (or suspected) environmental impact of the non-compliance? NOTE – please attach maps or diagrams to provide insight into the precise location of where the non-compliance took place.			
The effluent caused minor pooling outside of the containment structure. The environmental impact was minimal.

The integrity of the containment structure was not confirmed before the inflow of effluent commenced.

Waste water inflow immediately ceased and directed back to the operational pond.
 An earth berm was established around the spill to contain surface flow.
 A pump was installed in the inlet pond to transfer water to the irrigation pond.
 The incident was communicated on INX.

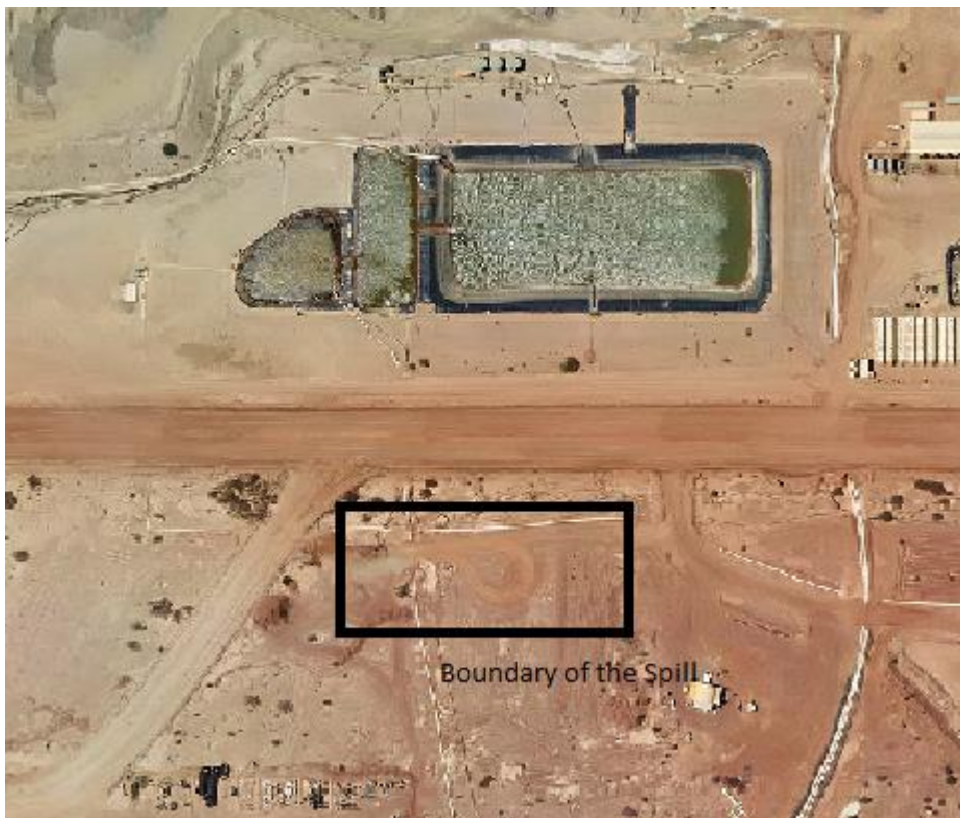
On 09/06/2021 an IT operator clipped the tailings return line whilst conducting roadworks at the Barminco office complex.

A volume discharged from the return water line is estimated to be 40 8m³. The area impacted was 1066m² of existing disturbance. WAD cyanide results of return water on 27/05/2021 were 0.033 mg/L.

Section E – Details of non-compliance with licence condition	
Cause (or suspected cause) of non-compliance:	
Operator error.	
Action taken to mitigate any adverse effects of non-compliance and prevent recurrence of the non-compliance:	
Return water immediately shut off. An earth berm was established around the spill to contain surface flow. The incident was communicated on INX. Operators instructed to conduct risk assessments prior to commencing work.	
Was this non-compliance previously reported to DWER?	
<input checked="" type="checkbox"/> No,	
<input type="checkbox"/> Reported to DWER verbally	Date: / /
<input type="checkbox"/> Reported to DWER in writing	Date: / /

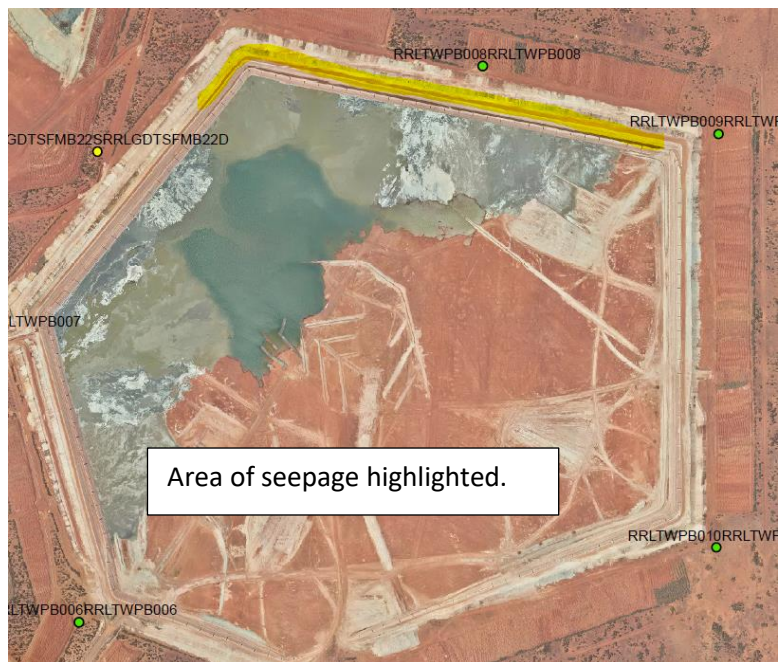
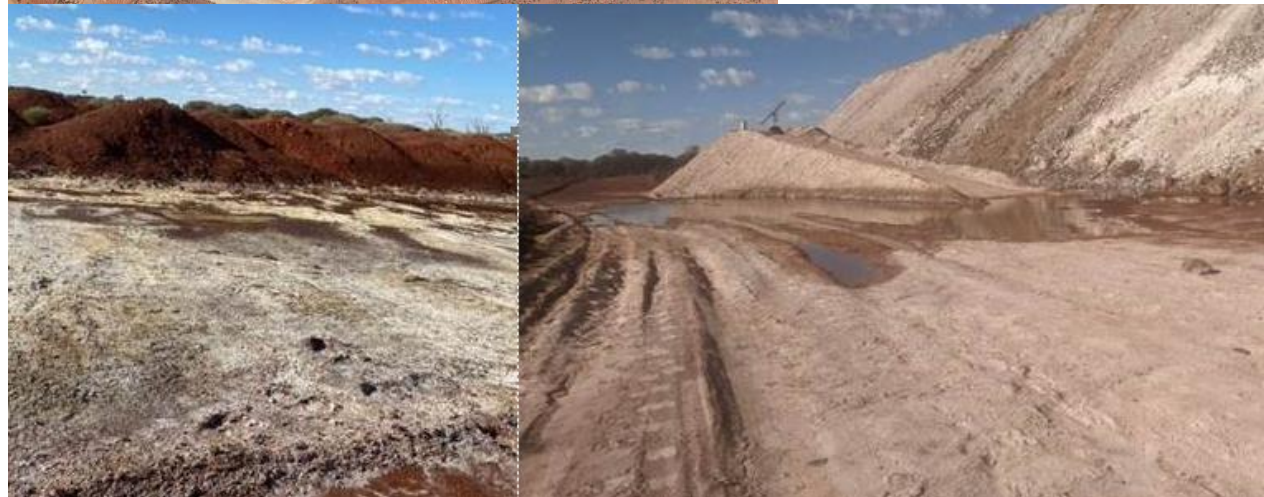
Section E – Details of non-compliance with licence condition			
Please use a separate page for each condition with which the licence holder was non-compliant at a time during the reporting period.			
Condition no:	1.2.12 & 1.2.14	Date(s) of non-compliance:	22/08/2021
Details of non-compliance:			
Seepage of TSF3 was identified and reported accordingly.

Minor seepage from the TSF impacted the running track and topsoil stockpile around the eastern and northern walls of the TSF.

The seepage collection system drainage pipes were not functioning while tailings water was discharged into the decant. re

Seepage collection system drainage pipes were reconnected. Pumps for the seepage collection system were upgraded. Seepage recovery recorded as per condition 1.2.13. V-drain established to contain and control water. Weekly environmental monitoring. A monthly meeting is held with numerous departments to communicate updates regarding TSF3.
