Annual Audit Compliance Report Form

Environmental Protection Act 1986, Part V Division 3

Licence number:	L8578/2011/1	Licence file number:	2011/003002-1	
Licence holder name:	Regis Resources Limited			
Trading as:	Regis Resources Limited			
ACN:	009 174 761			
Registered business address:	Level 2 516 Hay Street SUBIACO WA 6008			
Reporting period:	1/01/2022 to	31/12 /2022

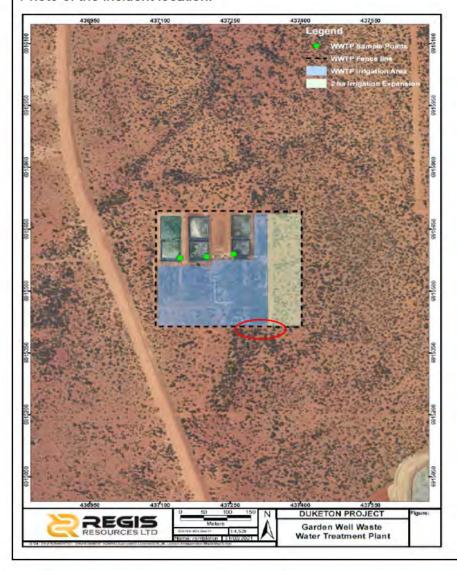
Photo of the incident location:

On 2/05/2022 pooling of Garden Well WWTP irrigation was noted just outside the defined irrigation area. An internal investigation determined that the irrigation pump was started by unauthorized personnel and left running. This increased the volume irrigated and caused saturation of the irrigation field. As a result, minor pooling was noted outside of the defined irrigation area.

There was minor pooling outside of the defined irrigation area. The environmental impact was minimal.

Section E – Details of non-compliance with licence condition			
Cause (or suspected cause) of non-compliance:			
Unauthorized personnel operated the WWTP irrigation genset.			
Action taken to mitigate any adverse effects of non-compliance and prevent recurrence of the non-compliance:			
A lock out system was installed to prevent unauthorised personnel from operating the pump/genset. An automatic cut out system was installed to control the run time.			
Was this non-compliance previously reported to DWER?			
⊠ No,			
☐ Reported to DWER verbally	Date: / /		
Reported to DWER in writing

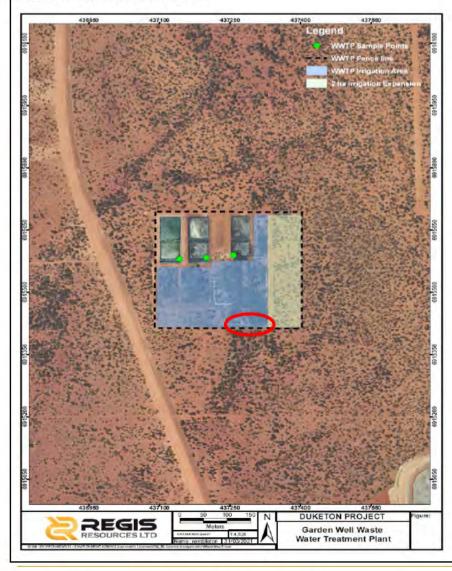
Photo of the incident location:

On 11/5/2022 pooling at the Garden Well WWTP irrigation was noted just outside of the defined irrigation area. The incident investigation determined that the irrigation field was saturated due to the incident on the 2/5/2022. Subsequent irrigation caused minor pooling outside of the defined irrigation area.

The effluent caused minor pooling outside of the defined irrigation area. The environmental impact was minimal.

Section E – Details of non-compliance with licence condition			
Cause (or suspected cause) of non-compliance:			
The genset was turned on to ensure a freeboard of 300mm, however the ground was saturated due to the incident on the 2/05/2022.			
Action taken to mitigate any adverse effects of non-compliance and prevent recurrence of the non-compliance:			
Re-lining of the two settling ponds was actioned to increase evaporative loss and holding capacity.			
Was this non-compliance previously reported to DWER?			
⊠ No,			
☐ Reported to DWER verbally	Date: / /		
Reported to DWER in writing Date:

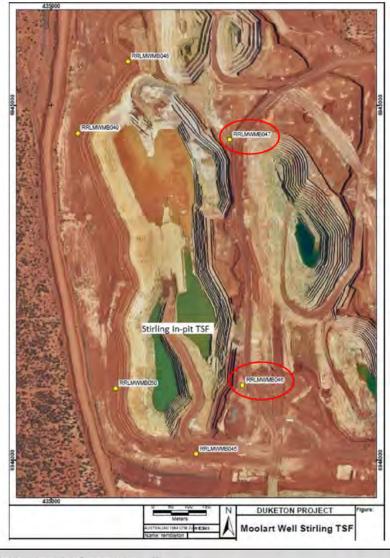
During May (Q2) 2022, no water quality parameters were sampled for RRLMWTSFMB046 and RRLMWTSFMB047. This was due to inaccessibility of the sampling area. The missed sample was not noted in the monitoring plan and the sampling of RRLMWTSFMB046 and RRLMWTSFMB047 was not rescheduled. The non-compliance was noted in the Quarter 3, on compilation of monitoring results.

There was no environmental impact from the non-compliance. Monitoring was conducted for the remainder of the year with no significant fluctuation or upward trends in the results, as detailed in Table 40,41 and Graph 8,9. The accompanying map outlines the bores location around Stirling Inpit TSF.

Section E – Details of non-compliance with licence condition			
The missed sample was not noted in the monitoring plan and the sampling of RRLMWTSFMB046 and RRLMWTSFMB047 was not rescheduled.			
Action taken to mitigate any adverse effects of non-compliance and prevent recurrence of the non-compliance:			
Improvements to the scheduled monitoring plan were made, including the introduction of a notification procedure for missed samples. ESdat, an environmental data management system was implemented in November 2022 to manage the monitoring requirements, data and deliverable timeframes.			
Was this non-compliance previously reported to DWER?			
⊠ No,			
☐ Reported to DWER verbally	Date: / /		
Reported to DWER in writing Date:

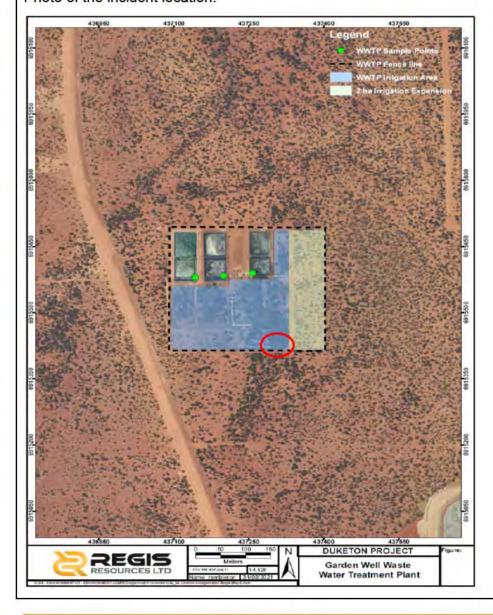
Photo of the incident location:

On 08/07/2022 pooling of the Garden Well WWTP irrigation was noted just outside of the defined irrigation area. The incident investigation determined that the irrigation field was saturated due to the incident on the 2/5/2022, and winter weather contributing to reduced evaporative loss. Subsequent irrigation caused minor pooling outside of the defined irrigation area.

The effluent caused minor pooling outside of the defined irrigation area. The environmental impact was minimal.

The genset was turned on to ensure a freeboard of 300mm, however the irrigation field was saturated due to the prior incident on 2/05/2022 and recent environmental conditions present at the time.

Re-lining of the two settling ponds was actioned to increase evaporative loss and holding capacity. Clearing over-grown vegetation was planned for the summer months to increase evaporative loss in the irrigation field.

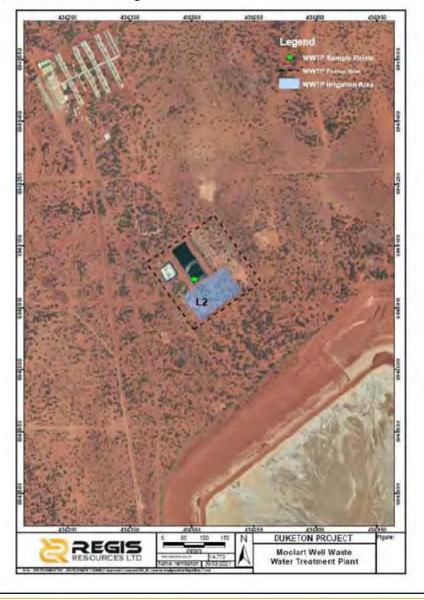
Photo of the Moolart Well WWTP irrigation area:

Annual emission to land for Total Nitrogen and Total Phosphorus were above the licensed limits at the Moolart Well Waste Water Treatment Pond. Total Nitrogen was 516.7kg/ha/year and Total Phosphorus was 124.4 kg/ha/year.

Weed species did not increase during the reporting period, however the irrigation field was monitored and weeds managed as required. There are no surrounding water ways or aquatic environments and irrigation remained within the permitted boundary.

Section E – Details of non-compliance with licence condition			
Cause (or suspected cause) of non-compliance:			
Low oxygen levels in the ponds are causing low levels of biological activity and limiting the removal of nitrogen and phosphorus from the effluent.			
Action taken to mitigate any adverse effects of no compliance:	n-compliance and prevent recurrence of the non-		
A wastewater engineer has been engaged to audit the WWTP system and monitoring results. Quotes have been provided for the provision and installation of an aeration systems.			
Was this non-compliance previously reported to DWER?			
⊠ No,			
Reported to DWER verbally	Date: / /		
Reported to DWER in writing Date:

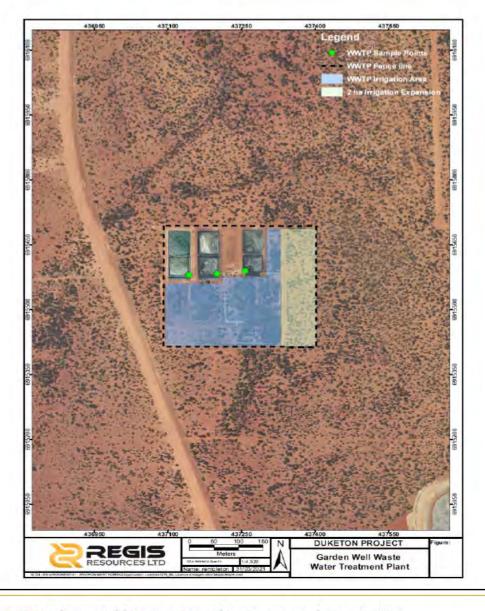
Photo of the Garden Well WWTP irrigation area:

Annual emission to land for Total Nitrogen were above the licensed limits at the Garden Well Waste Water Treatment Pond. Total Nitrogen at the Garden Well WWTP was 561.2kg/ha/year.

The environmental impact was moderate. Weed coverage increased within the irrigation boundary during the reporting period. During scheduled maitance in November 2022 all weeds were removed. There was no impact to the surrounding area, water ways or aquatic environments.

Section E – Details of non-compliance with licence condition			
Cause (or suspected cause) of non-compliance:			
Low oxygen levels in the ponds are causing low levels of biological activity and limiting the removal of nitrogen and phosphorus from the effluent.			
Action taken to mitigate any adverse effects of non-compliance and prevent recurrence of the non-compliance:			
A wastewater engineer has been engaged to audit the WWTP system and monitoring results. Quotes have been provided for the provision and installation of an aeration systems.			
Was this non-compliance previously reported to DWER?			
⊠ No,			
Reported to DWER verbally	Date: / /		
Reported to DWER in writing Date:			
<u> </u>
