Annual Audit Compliance Report for

- L8578/2011/1

Annual Audit Compliance Report Form

Section A – Licence details			
Licence number:	L8578/2011/1	Licence file number:	2011/003002-1
Licence holder name:	Regis Resources Limited		
Trading as:	Regis Resources Limited		
ACN:	009 174 761		
Registered business address:	Level 2 516 Hay Street SUBIACO WA 6008		
Reporting period:	1/01/2023 to 31/12 /2023

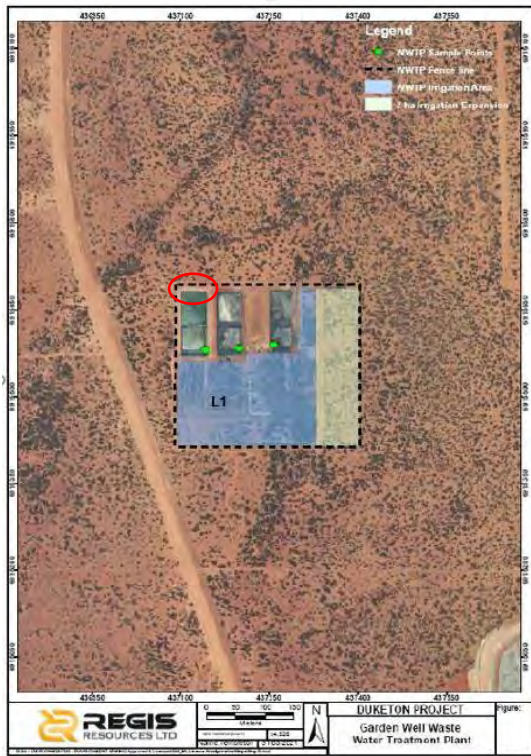
Section E – Details of non-compliance with licence condition			
Please use a separate page for each condition with which the licence holder was non-compliant at a time during the reporting period.			
Condition no:	1.2.6 (A)	Date(s) of non-compliance:	9/05/2023
Details of non-compliance:			
On May 9th, 2023, waste water was observed just outside of the designated irrigation area at the GW WWTP. Following an internal investigation, it was determined that a welded joint on the influent line had weakened, causing a slow leak.			
What was the actual (or suspected) environmental impact of the non-compliance?			
NOTE – please attach maps or diagrams to provide insight into the precise location of where the non-compliance took place.			
Although there was some minor pooling observed outside the designated irrigation area, the effluent remained contained within the operational boundaries of the WWTP. As a result, there was negligible impact to the receiving environment. Photo of the incident location:

Cause (or suspected cause) of non-compliance:

The integrity of the influent pipe was compromised.

The damaged influent pipe was replaced and pipelines inspected.

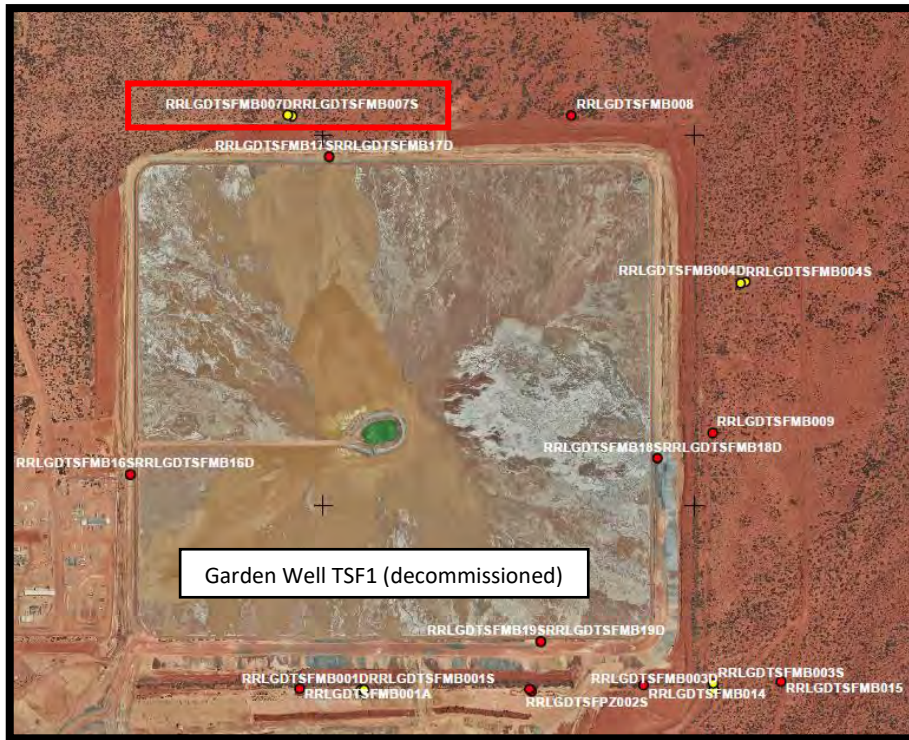
During June 2023 (Q2), chemical analyses for Garden Well Monitoring Bore RRLGWMB07D (including HCO₃, CO₃, Cl, NO₃, and SO₄) was not conducted. This occurred because the sample bottle was lost during packaging. Rescheduling of the sampling for RRLGWMB07D did not occur.

The non-compliance did not result in any environmental impact. Sampling was successfully conducted in the shallow bore (RRLGWMB07S). Monitoring continued for the remainder of the year without any notable fluctuations or upward trends in results. It is noted tailings deposition into GDW TSF1 has not occurred since 2019. Photo of the incident location:

The missed data was not noted and resampling of RRLGWMB07D did not occur.

The internal environmental report monitoring has been improved to ensure missed parameters are noted and sampling can be rescheduled.

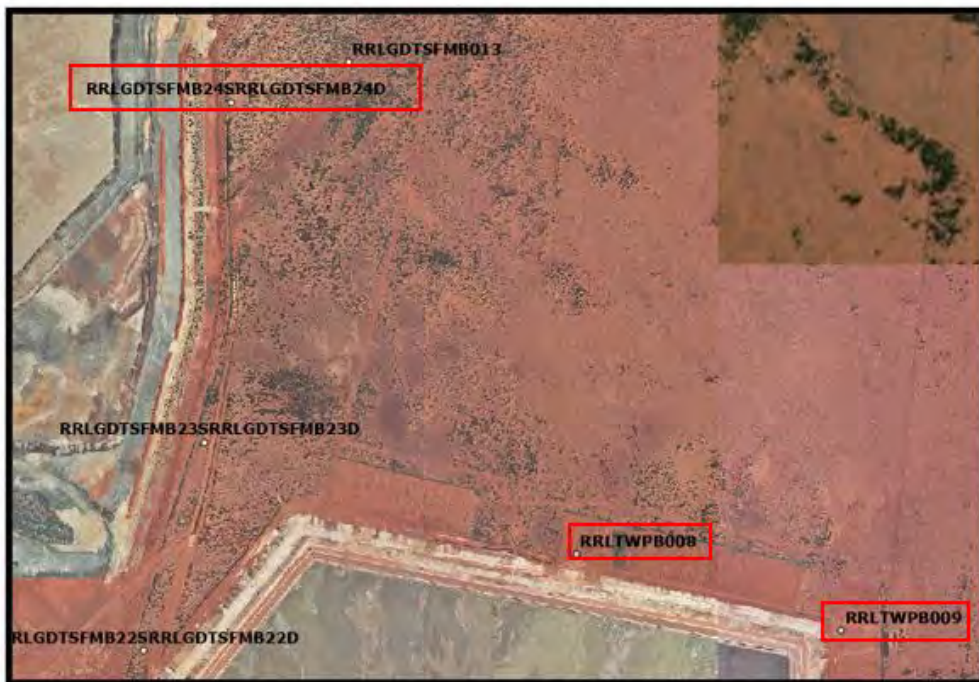
In June 2023 (Q2), water quality parameters were not sampled for Garden Well monitoring bores RRLGWMB24D, RRLTWPB08, and RRLTWPB09. RRLTWPB08 and RRLTWPB09 were inaccessible during the sampling period, while the sampling bottles for RRLGWMB24D were misplaced during packaging. rescheduling of the sampling of these locations did not occur.

The non-compliance did not result in any environmental impact. Monitoring was carried out for the remainder of the year, revealing no significant fluctuations or upward trends in results. Sampling for the shallow bore RRLGWMB24D was completed. The accompanying map outlines the bore locations. Photo of the incident location:

Resampling of bores RRLGWMB24D, RRLTWPB08 and RRLTWPB09 did not occur.

The internal environmental report monitoring has been improved to ensure missed parameters are noted and sampling can be rescheduled.

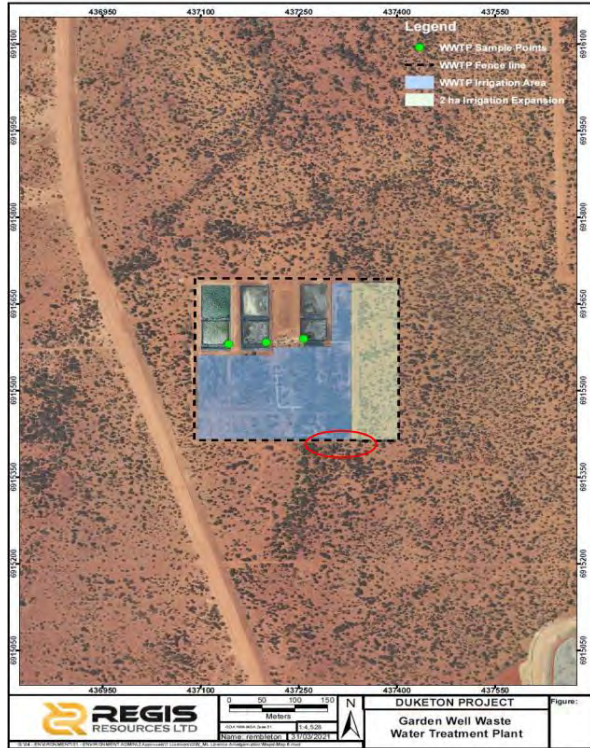
On 15th June 2023 pooling of Garden Well WWTP irrigation was noted just outside the defined irrigation area. The incident investigation determined that the irrigation field had become saturated due to winter weather conditions, low evaporative loss and increased inflow volumes from the Reverses Osmosis (RO) Plants. Subsequent irrigation caused minor pooling outside of the defined irrigation area.

There was minor pooling outside of the defined irrigation area. The environmental impact was negligible. Photo of the incident location:

The RO backwash programs had been incorrectly set, temporarily increasing the inflow volume to the WWTP. Winter weather had contributed to lower evaporative loss and increased saturation of the irrigation field.

The backwash programs were reset and the inflow volume was reduced. Bunding over the southern part of the irrigation boundary was improved.

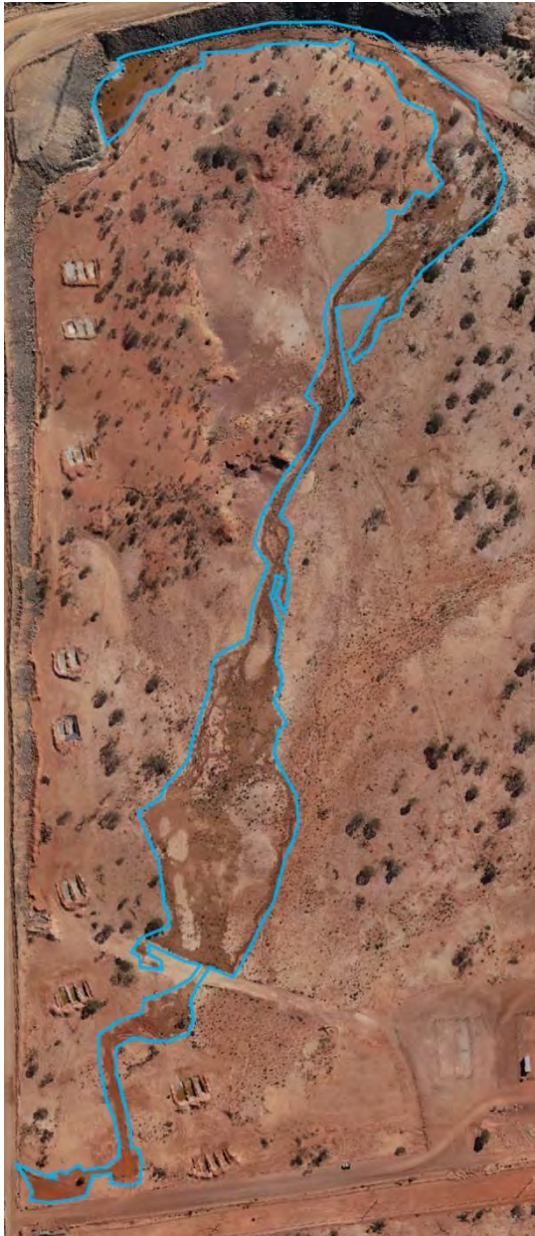
On July 8th, 2023, the Rosemont Pit raw water pipeline experienced a decoupling at a plassion joint, causing 180,000 L of raw water to spill into 2.3 hectares of native vegetation. The pipeline was not contained by bunding measures at the time of the spill. Water quality analysis revealed the following: pH: 7.75, TDS: 30,587 mg/L

Environmental monitoring was set up to track impact to vegetation. The last 8 months have monitoring have not noted any impact to vegetation in the area and no visible salt crust was observed.
 Photo of incident location:

The area was not bunded and the plasson joint decoupled due to a combination of factors, including an inadequate coupling, expansion and contraction of the pipe (weather conditions) and an increase in pipe pressure.

The joint was repaired and poly-welded, bunding was installed and monthly vegetation monitor was established.

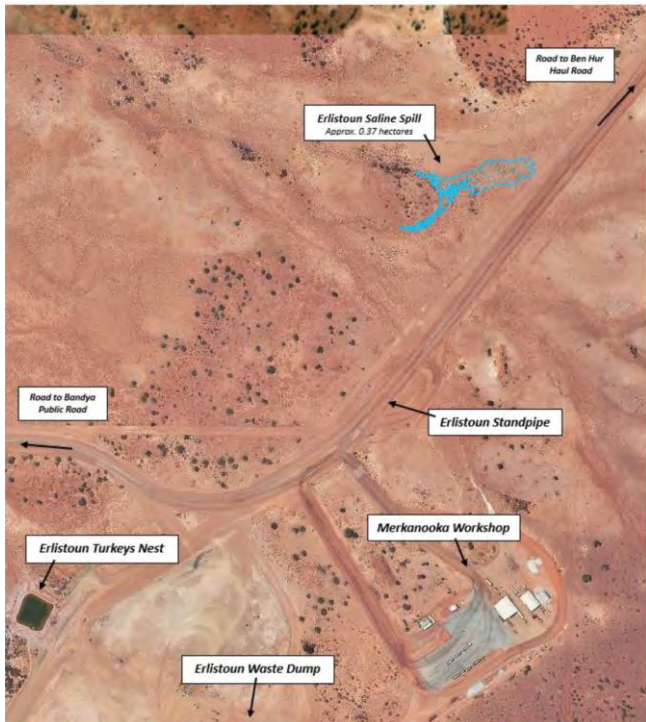
On 11th November 2023, a water pipeline spill occurred near Eristoun, resulting in the release of 18,000L of raw water onto 0.37 hectares of native vegetation. Despite initial containment efforts, the spillage exceeded the capacity of the bunding. Following the incident, water quality tests revealed a pH level of 7.9 and a total dissolved solids concentration of 36,458 mg/L

The incident impacted approximately 0.37 hectares of native vegetation, no priority flora or fauna was impacted, and subsequent monitoring has not noted an impact to vegetation.
 Photo of the incident location:

Cause (or suspected cause) of non-compliance:
An internal investigation found that the pipe had split at a weld and breached containment infrastructure.

Action taken to mitigate any adverse effects of non-compliance and prevent recurrence of the non-compliance:
The pipeline was repaired and bunding reinstated. The impacted area was flushed with fresh water. The line has been tagged out of service for this section to be replaced prior to recommissioning.
