## Annual Audit Compliance Report Form

| Licence number: | L7851/2002/6 | Licence file number: | DER2013/000925 |
| Licence holder: | BHP Billiton Iron Ore Pty Ltd | | |
| Reporting period: | 01/07/2019 to 30/06/2020 | | |

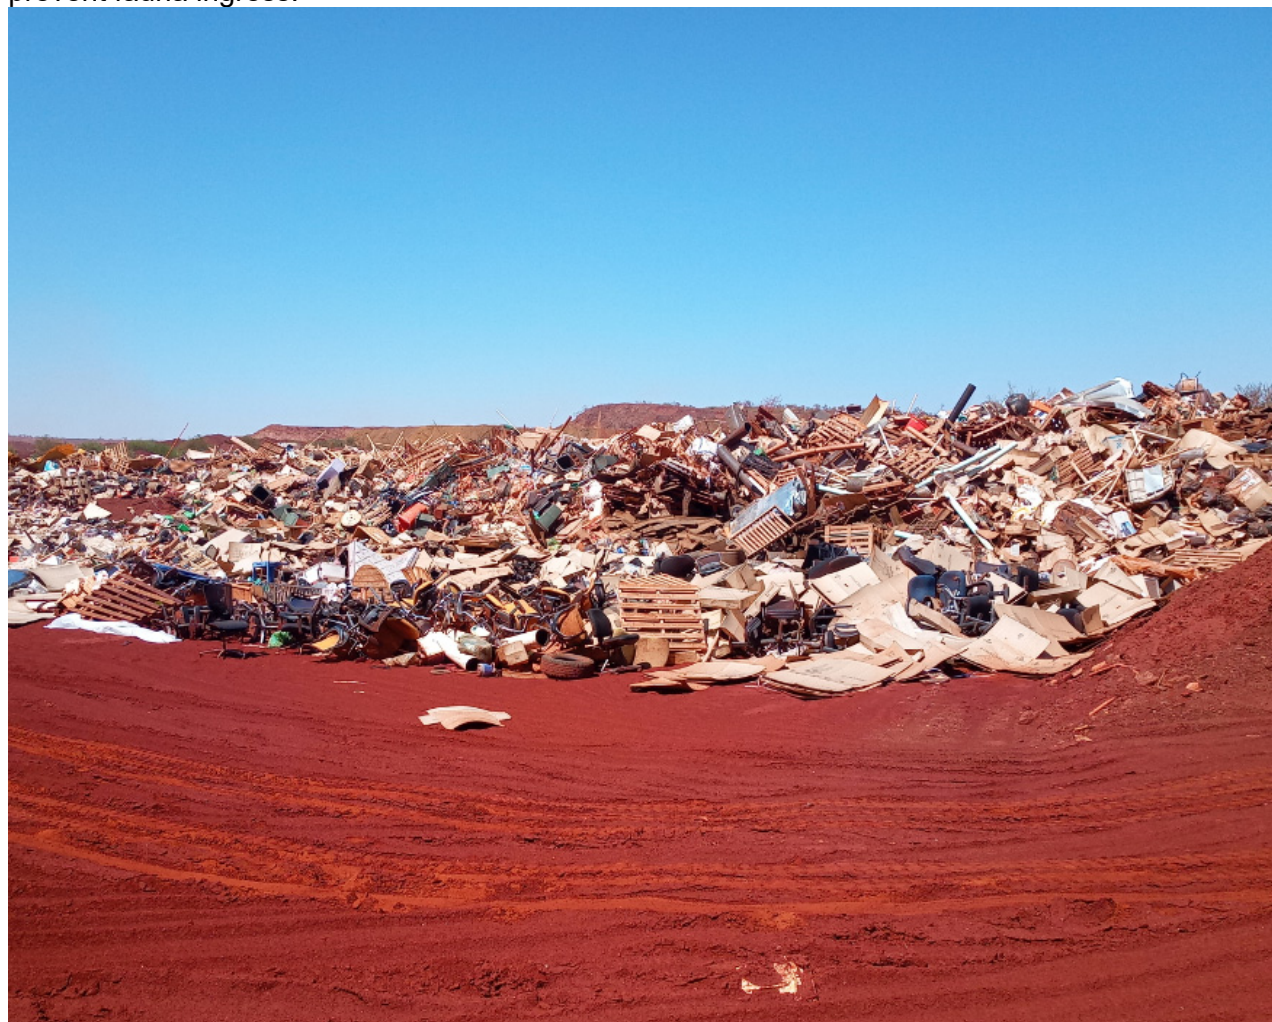
Approximately 500 t of putrescible waste including wooden pallets, cardboard, office furniture and general waste were disposed of at the Packsaddle Inert Landfill between September and November 2019. Small volumes of banded hydrocarbons were disposed of in the inert landfill, however they were removed immediately upon identification.

No known actual or suspected environmental impacts based on weekly covering of waste to prevent fauna ingress.

Misunderstanding of landfill management requirements by landfill users led to incorrect waste types being delivered to the inert landfill.

| <p>DWER was notified immediately when the potential non-compliance became known. The material was covered in line with putrescible management practices as advised by DWER. All hydrocarbons were recovered, disposed of correctly and no spills were identified. An amendment to L7851/2002/6 was also sought to reclassify the inert landfill to a putrescible landfill. A project has been initiated to install fencing, CCTV and boom gates to prevent incorrect waste disposal and control access to the landfill. It is expected that these upgrades will be completed in FY2021.</p> | |

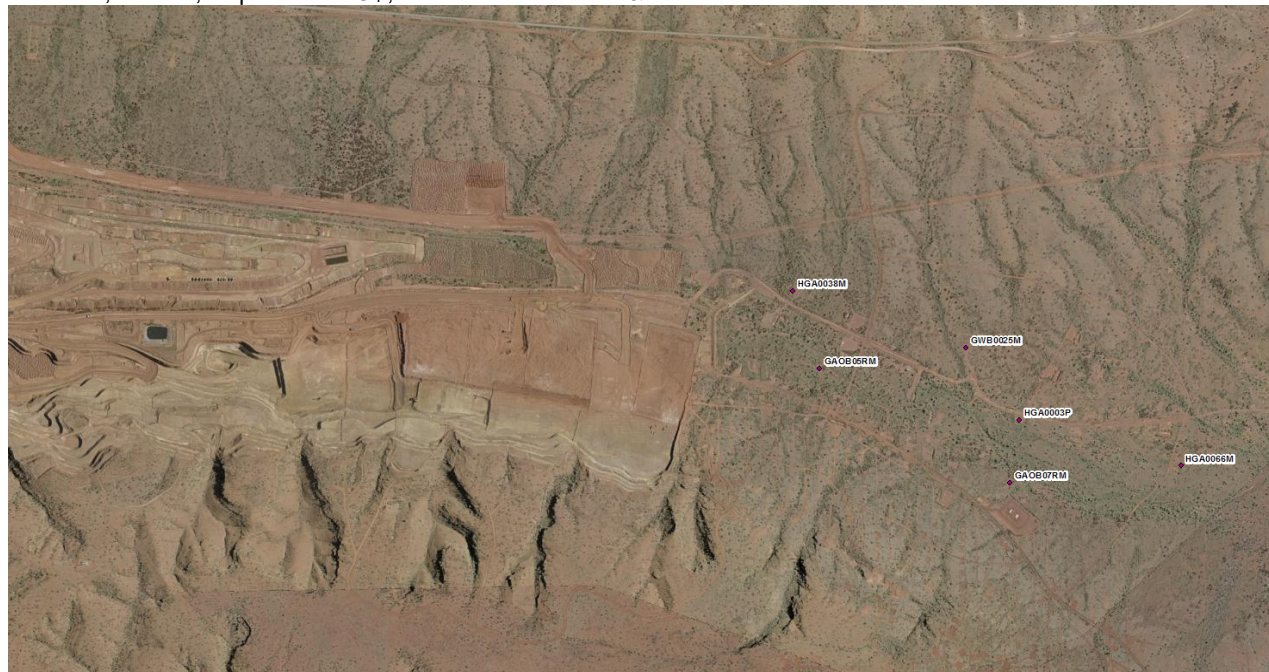
Amendment Notice 3 of Environmental Licence L7851/2002/6 removed the A Deposit MAR scheme as the facility had been decommissioned. However, an administrative error resulted in Tables 2.3.1, 2.3.2 and 3.3.1 still containing references these bores (HGA0001P, HGA0002P, HGA0040P and HGA0041P) and Tables 3.5.2 and 3.5.3 containing references to the associated monitoring bores GAOB07RM, HGA0003P and HGA0066M. GAOB05RM was destroyed during mine construction, and was removed from the Licence in November 2019.

BHP is reporting missed analysis as technical non-compliances for Q2, Q3 and Q4.

There was no known actual or suspected environmental impact as a result of the missed samples as the A Deposit MAR is decommissioned

Amendment Notice 3 of Environmental Licence L7851/2002/6 removed the A Deposit MAR scheme as the facility had been decommissioned. However, an administrative error resulted in Tables 2.3.1, 2.3.2 and 3.3.1 still containing references these bores (HGA0001P, HGA0002P, HGA0040P and HGA0041P) and Tables 3.5.2 and 3.5.3 containing references to the associated monitoring bores GAOB07RM, HGA0003P and HGA0066M.

| A request to update the tables correctly was included in the May 2020 L7851/2002/6 amendment. | |
