## Annual Audit Compliance Report Form

Licence number:	L4503/1975/14	Licence file number:	DER2013/000901
Licence holder name:	BHP Iron Ore Pty Ltd		
Trading as:	BHP Iron Ore Pty Ltd		
ACN:	008 700 981		
Registered business address:	Level 1, City Square Brookfield Place 125 St Georges Terrace PERTH WA 6000		
Reporting period:	01/07/2024 to 30/06/2025

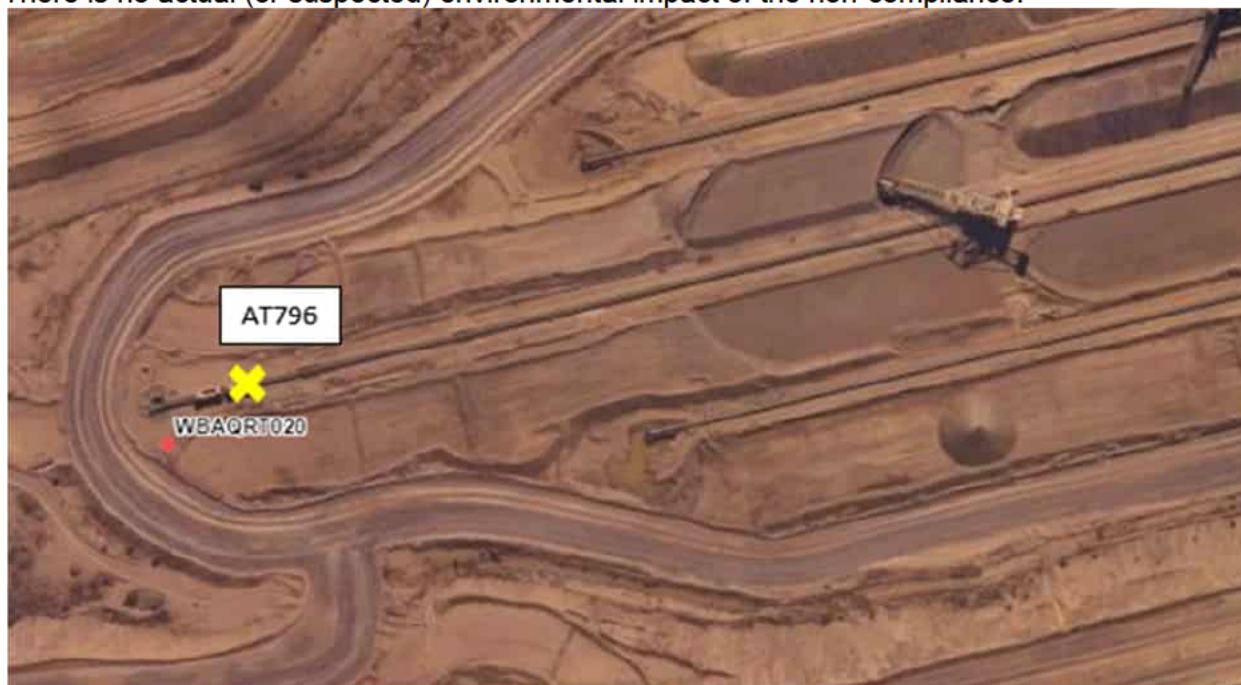
Data collection of required parameters stipulated in the Licence at monitoring the stockyard weather sensor (AT796) at a frequency defined for an annual period as 'continuous' was not achieved for the FY2025 reporting period as required under Condition 12, Table 3 of the Licence.

There is no actual (or suspected) environmental impact of the non-compliance.

The equipment associated with the sensor is faulty and unable to collect the data required under Condition 12. This is a repeat non-compliance from the previous reporting period (FY2024).

Installation of a new weather sensor is being done concurrently to this report and will be completed within the FY2026 reporting period.

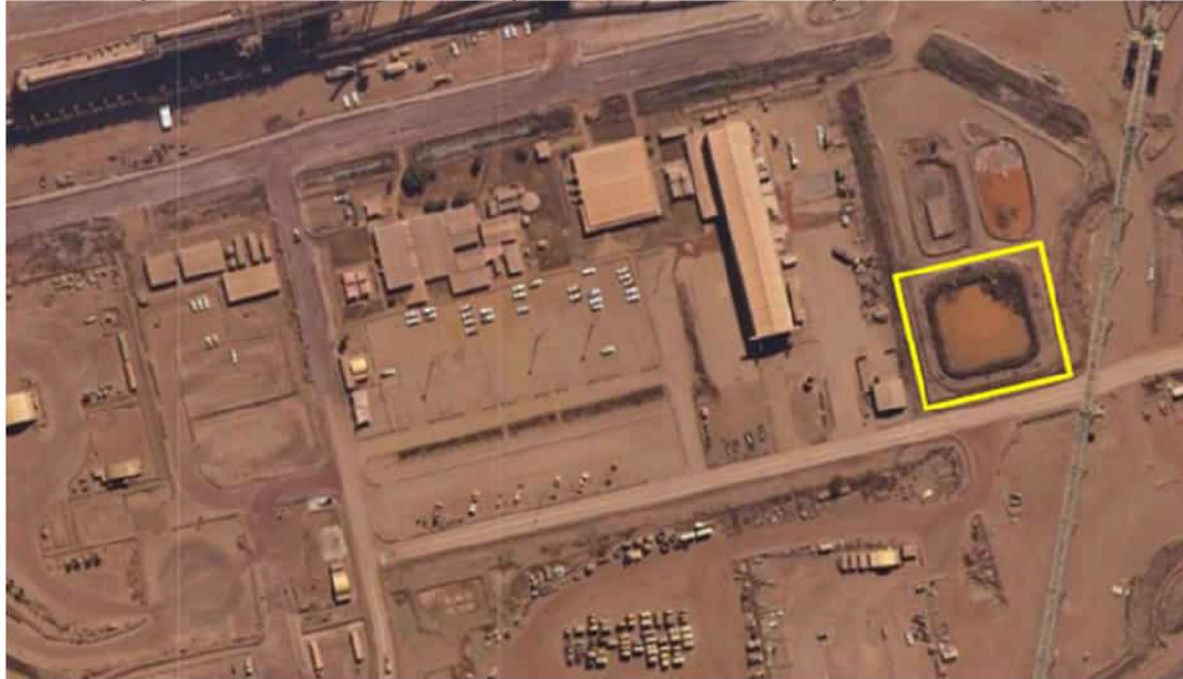
Condition 32 stipulates that emissions to land are required to be monitored through water sampling in accordance with Table 8 of the Licence. The Hub Turkeys Nest (L3) monitoring point location is required to be sampled for Total Dissolved Solids (TDS) at each discharge event. During March 2025, there was a discharge event where a spot sample was not taken for TDS at the time of discharge.

The non-compliance has no known or suspected environmental impact.

A spot sample for TDS during the March 2025 discharge event was not collected due to access restrictions in the area resulting from construction and operational movements. Once access was granted, insufficient water was present to enable a sample to be taken.

The access restrictions have been rectified and construction in the area has been completed, April 2025 sample was collected in accordance with the Licence.

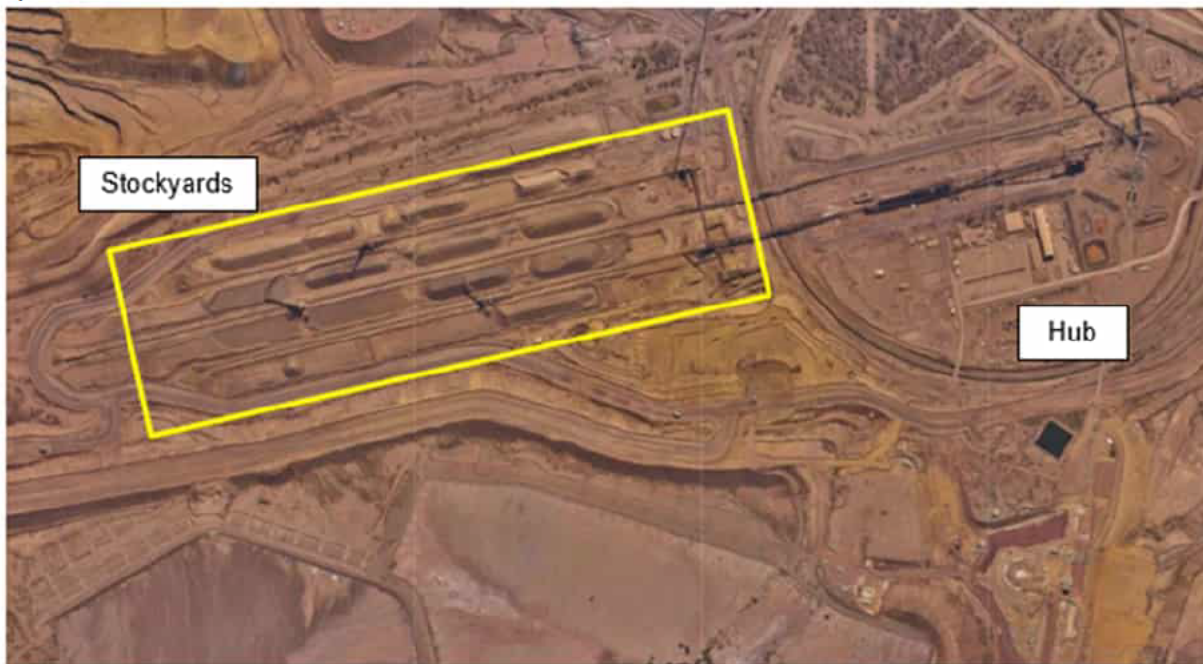
During August 2024 and November 2024, the Stockyard Water Canons recorded a below average Monthly Performance (time in Auto Mode) of 57.98% and 85.77% respectively. The Licence stipulates that *'the average monthly performance must accurately measure and achieve a rate of 90% or more'*.

There was no actual or suspected environmental impact of the non-compliance, the stockyard canons were still operating as required, however the Monthly Performance was below Licence requirements.

The non-compliance resulted from incorrect mode selection by the remote operations team, which misclassified equipment usage as maintenance mode rather than operational, despite the equipment operating as intended.

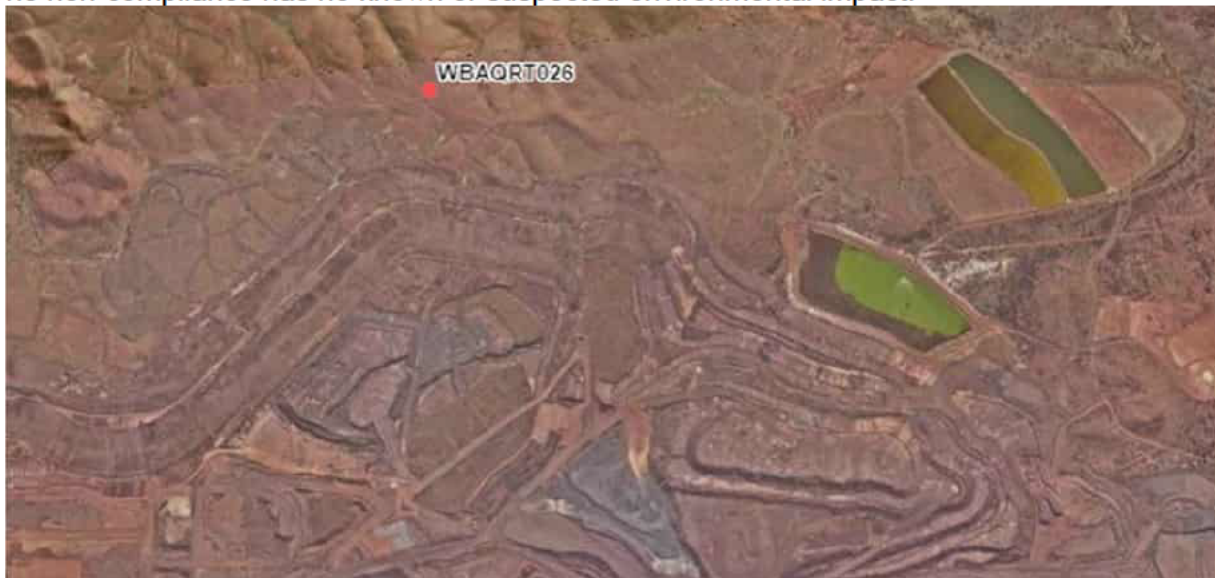
Data collection of required parameters stipulated in the Licence at monitoring station W39 North (WBAQRT026) at a frequency defined for an annual period as 'continuous' was not achieved for the FY2025 reporting period as required under Condition 12, Table 3 of the Licence.

The non-compliance has no known or suspected environmental impact.

There was a fault with the equipment, which was attended to in attempt to fix, however it was unable to be fixed and resulted in data unable to be collected from 14 April to 9 May 2025, which is below the 'continuous' frequency required under the Licence (determined to be <90% annual performance).

The equipment was replaced on 9 May 2025 and operational for the remainder of the FY2025 reporting period.

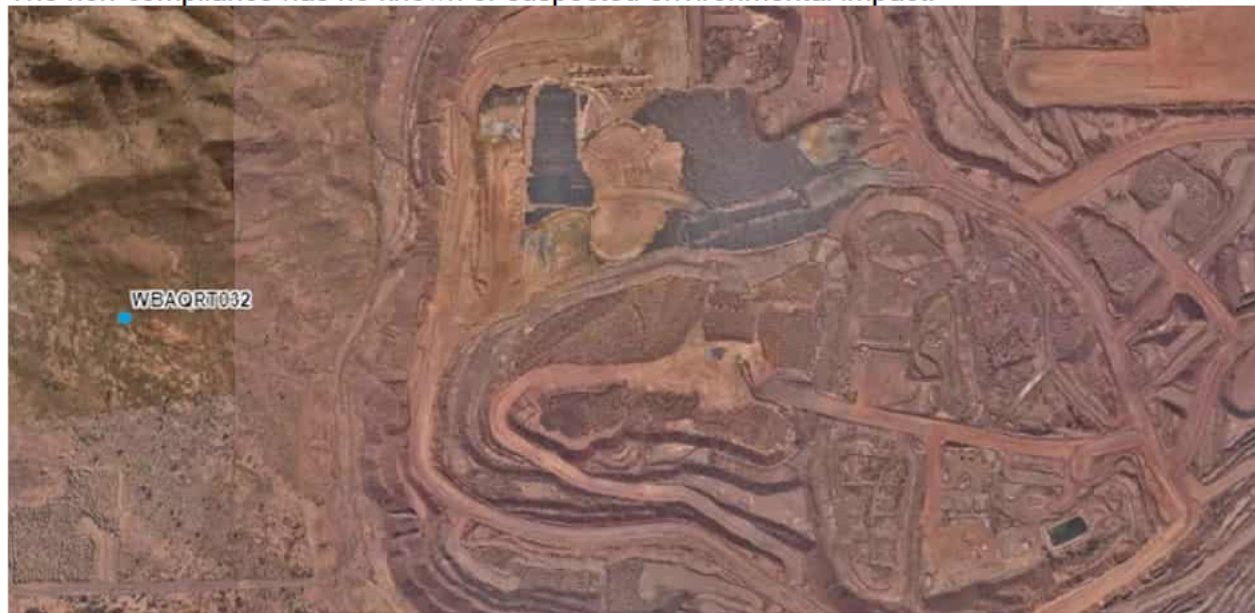
Data collection of required parameters stipulated in the Licence at monitoring station Background 4 West (WBAQRT032) at a frequency defined for an annual period as 'continuous' was not achieved for the FY2025 reporting period as required under Condition 12, Table 3 of the Licence.

The non-compliance has no known or suspected environmental impact.

The cause of the non-compliance was due to the annual data collection not captured as 'continuous' due to faults with the equipment recorded in September and December 2024 and January 2025. Additionally, due to localised flooding, access to attend the fault was restricted and the fault was unable to be rectified, and equipment replaced until March 2025.

Access to the Background 4 West monitor was rectified and a technician was sent to fix the fault as soon as the road became accessible after the localised flooding, where the ES642 sensor for measurement of PM<sub>10</sub> was replaced.

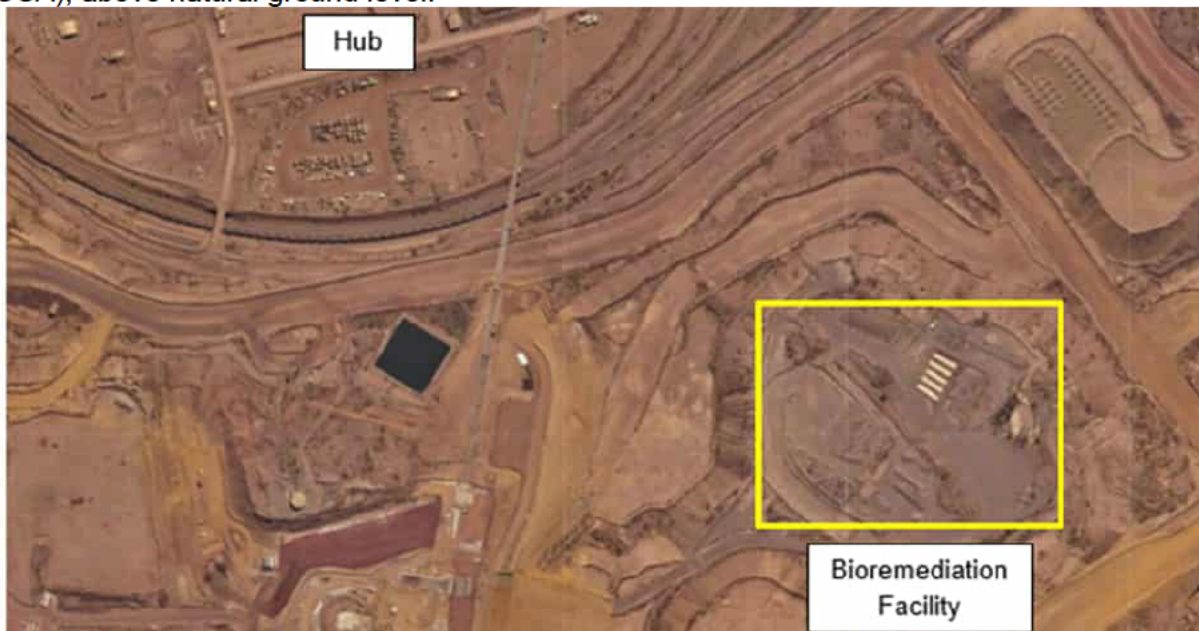
There is no known or suspected environmental impact of the non-compliance, the bioremediation facility is located within OB29 and is on top of an Overburden Stockpile Area (OSA), above natural ground level.

The bioremediation facility was not constructed to the specified requirements stipulated in the Licence, with a facility cell liner permeability of  $\leq 10^{-9}$  m/s.

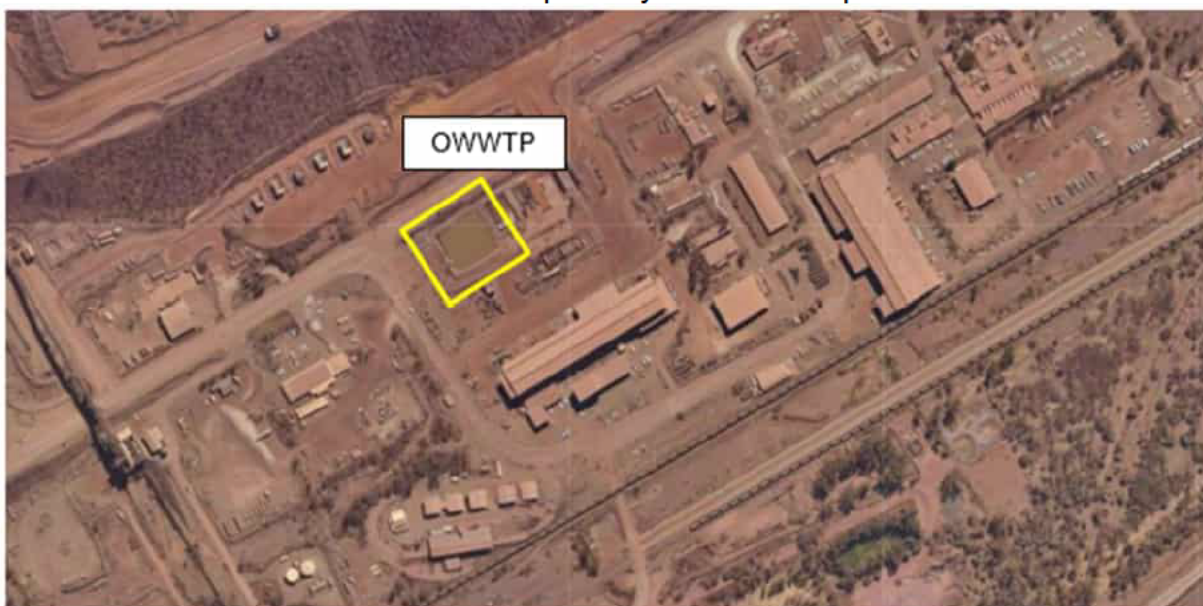
Condition 2 states that the premises infrastructure and equipment listed in Table 16, located at the corresponding infrastructure location is maintained and operated in accordance with the corresponding operational requirement set out in Table 16 (item number 2). During November 2024, the OWWTP Evaporation Pond (P2) exceeded the 300 mm minimum vertical freeboard due to a high rainfall event and overtopped containment.

There was no actual or suspected environmental impact of the non-compliance. The unauthorised discharge that resulted from the OWWTP Evaporation pond overtopping was contained to the sealed area and did not impact any sensitive receptors.

Following a high rainfall event, it was identified that the OWWTP Evaporation Pond (P2) had exceeded the 300 mm minimum vertical freeboard and had overtopped.

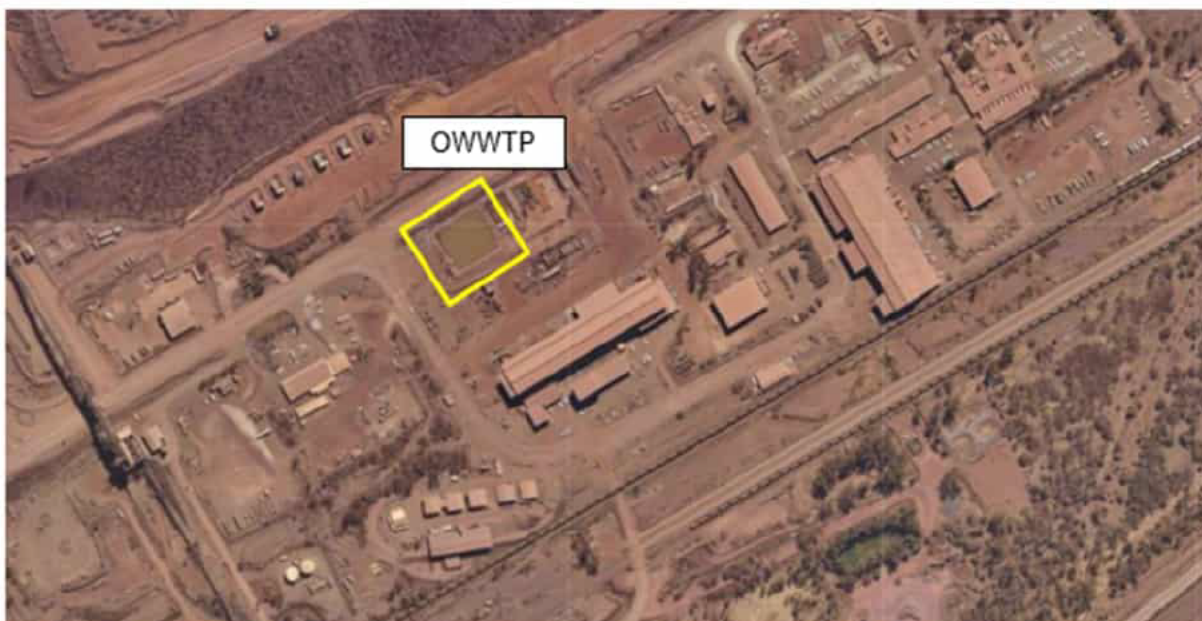
Condition 32 stipulates that emissions to land are required to be monitored through water sampling in accordance with Table 8 of the Licence. The OWWTP Evaporation Pond (P2) is required to be sampled for pH, Total Dissolved Solids (TDS) and Total Recoverable Hydrocarbons (TRH) at each discharge event. During November 2024, following a high rainfall event (see AACR above) there was a controlled discharge event to reinstate the 300 mm freeboard of the Evaporation Pond where a spot sample was not taken for the required parameters at the time of discharge.

There was no actual or suspected environmental impact of the non-compliance.

The water sample was not taken during the November 2024 discharge event from the OWWTP Evaporation Pond (P2).

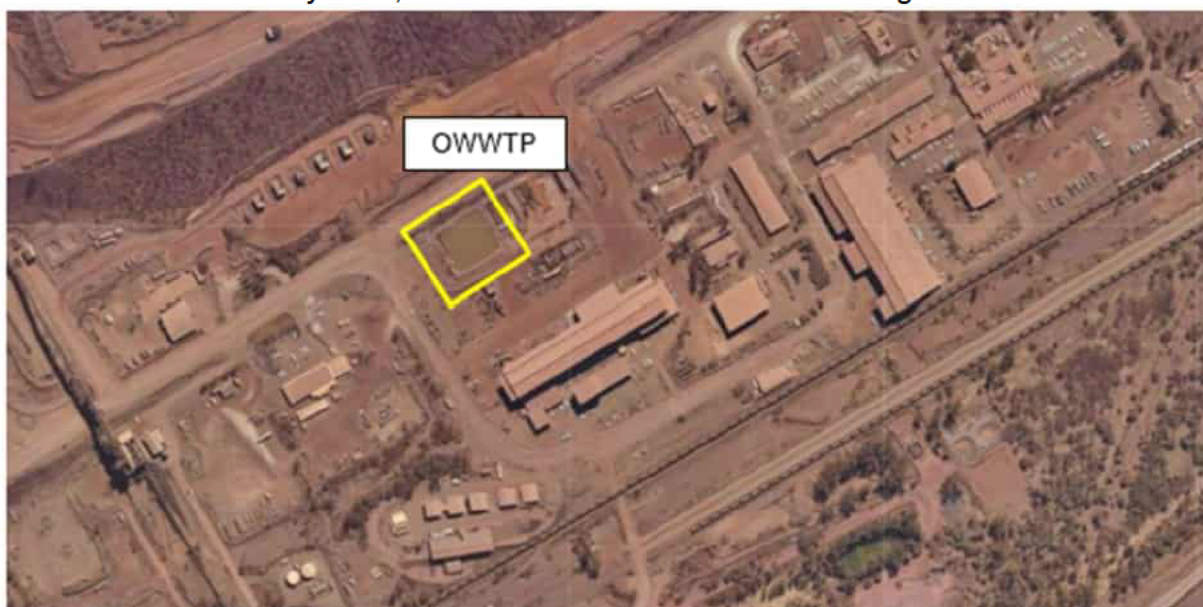
During a contingency discharge event authorised under the Licence from the OWWTP Evaporation Pond (P2) when the water level approaches 300 mm freeboard (licensed limit), a water sample was taken in accordance with Condition 32 (Table 8). The sample returned a Total Recoverable Hydrocarbon (TRH) result of 24.0 mg/L, exceeding the licence limit of 15.0 mg/L.

There was no actual or suspected environmental impact of the non-compliance, further sampling was conducted in January 2025, which recorded a TRH result of 0.6 mg/L.

An exceedance (24.0 mg/L) of the 15 mg/L TRH limit in the December 2024 water sample during the discharge event, as stipulated in the Licence.

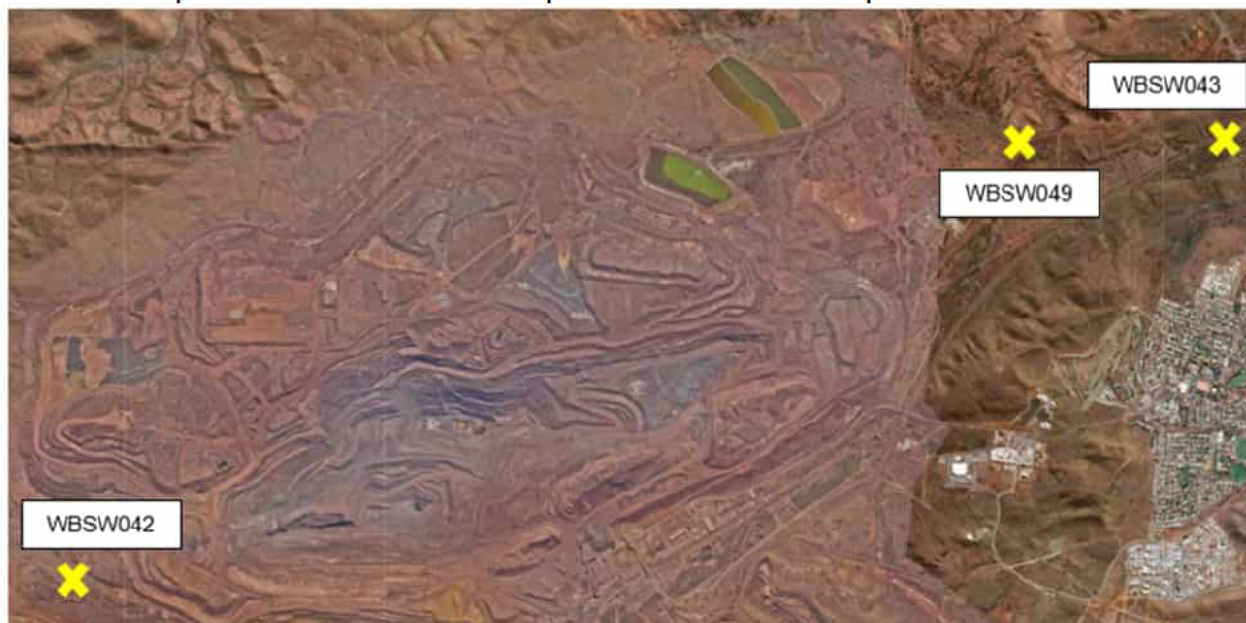
Surface water monitoring is required under Condition 36 of the Licence, there are three monitoring point locations Whaleback Creek Upstream (WBSW042), Whaleback Creek Downstream (WBSW043) and Power Station Creek Downstream (WBSW049), which are required to be sampled quarterly when flowing. Following a high rainfall event in December 2024, the three surface water monitoring sites equipment was destroyed.

The non-compliance has no known or suspected environmental impact.

The cause of the non-compliance was due to the surface water monitoring stations being damaged in December 2024 following the high rainfall event (which recorded flow conditions) resulting in water samples unable to be taken.

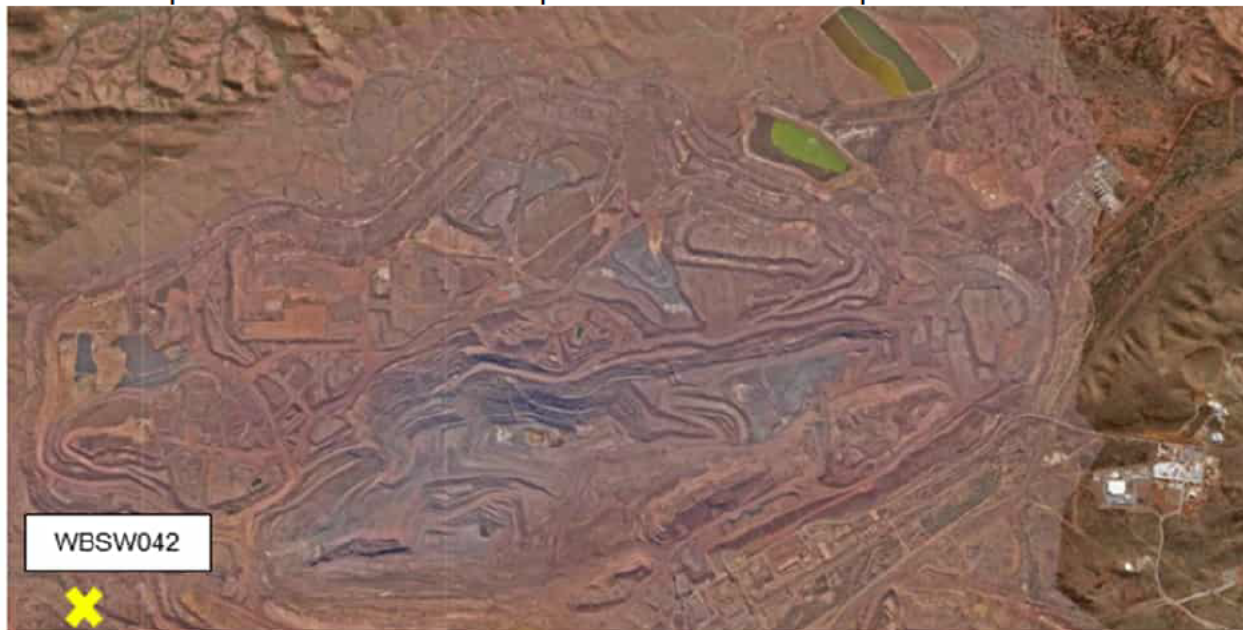
Surface water monitoring is required under Condition 36 of the Licence. Whaleback Creek Upstream (WBSW042) monitoring point location is required to be sampled quarterly when flowing. During Quarter 3 of the FY2025 reporting period, Whaleback Creek Upstream (WBSW042) was unable to be sampled due to insufficient volume, following late installation of equipment, however, flow was recorded for the quarter and samples were able to be collected for the two other monitoring point locations.

The non-compliance has no known or suspected environmental impact.

Following a high rainfall event in December 2024, the three surface water monitoring locations were destroyed. These were replaced in March 2025, however, WBSW042 was installed late, and insufficient water was available for a sample to be obtained.

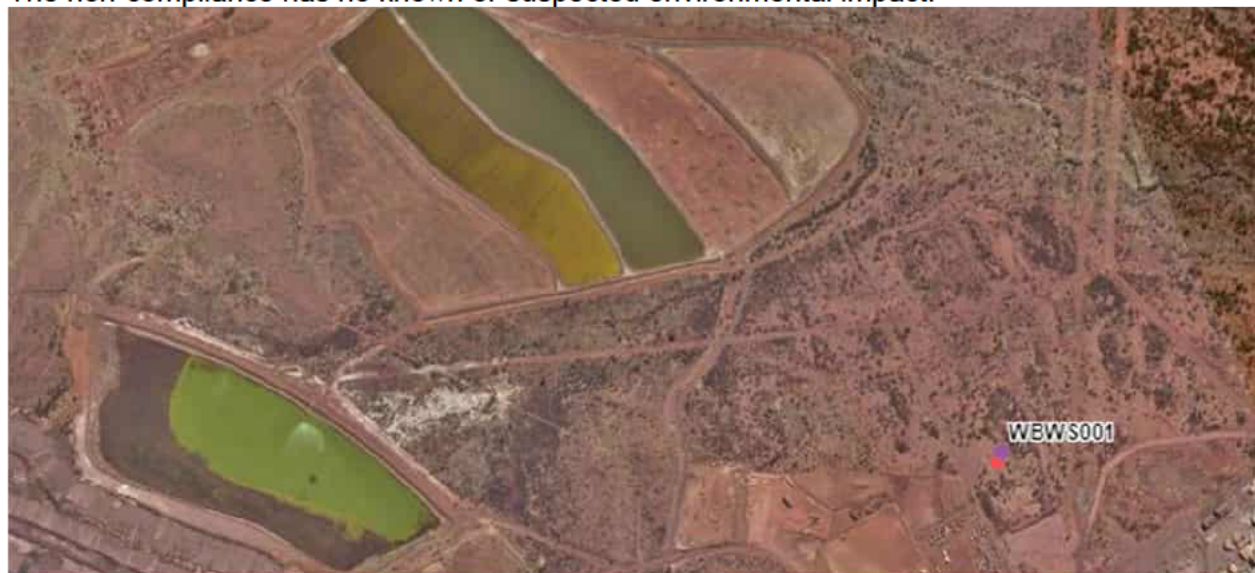
Air quality monitoring is required under Condition 10 (Table 3) at the meteorological station Whaleback AWS (WBWS001) for temperature, rainfall, relative humidity, wind speed and direction. The annual data collection did not achieve the ‘continuous’ requirement stipulated in the Licence due to a lightning strike in February 2025, which damaged the station equipment.

The non-compliance has no known or suspected environmental impact.

The meteorological station (WBSWS001) was struck by lightning on 25 January 2025 which destroyed all sensors and caused structural damage to the slab and tower. No further data was able to be generated from the date of the lightning strike.

A Licence Amendment was completed in April 2025, which removed the damaged meteorological station and included a new meteorological station to be installed by 30 September 2025, as stipulated under Condition 6 (Table 1). The Licence states that monitoring of this monitor is only required following installation in accordance with Table 6.

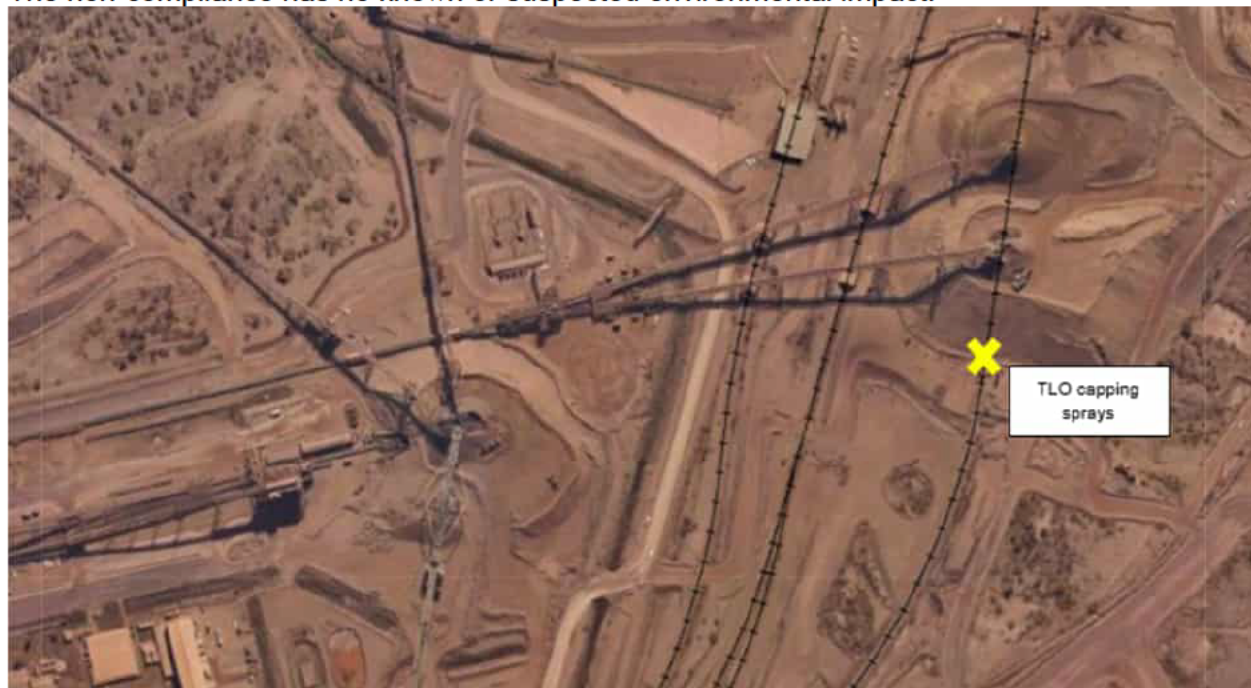
Condition 6 of the Licence requires infrastructure/equipment to be designed and constructed/installed in accordance with the requirements specified in Table 1 by the required completion date. The Train Load-Out infrastructure required ore conditioning sprays (item number 3) to be installed by 30 August 2024. The ore conditioning sprays were installed on 18 September 2024; however, compliance could not be measured until 9 October 2024.

The non-compliance has no known or suspected environmental impact.

The cause of the non-compliance was that the ore conditioning sprays were not installed by the required completion date (30 August 2024). Installation and measurement of compliance of capping sprays was not completed by the required date of 30 August 2024.

The ore conditioning sprays have been installed and are operational, in line with the Licence requirements.

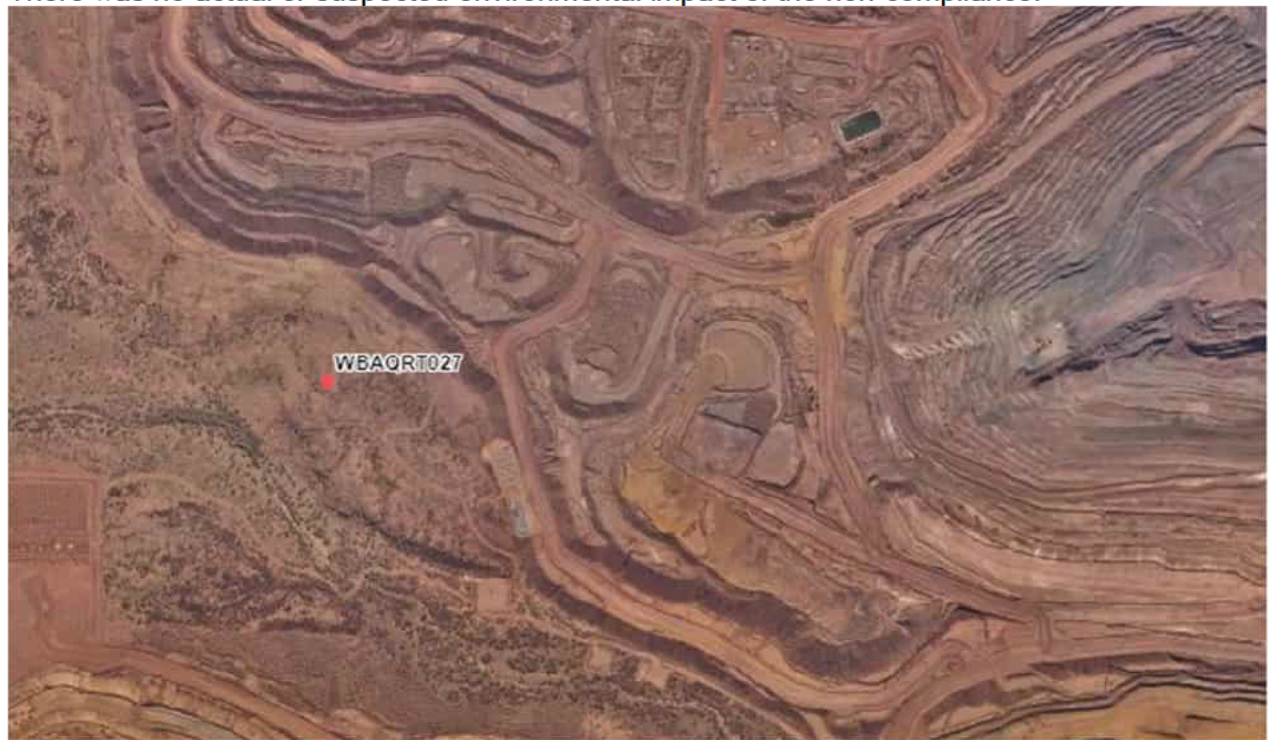
The data collection of required parameters stipulated in the Licence at monitoring station Western Ridge Boundary (WBAQRT027) at a frequency defined for an annual period as 'continuous' was not achieved for the FY2025 reporting period as required under Condition 12, Table 3 of the Licence.

There was no actual or suspected environmental impact of the non-compliance.

The non-compliance was caused due to a fault within the equipment that could not be attended to in the required timeframe due to access restrictions within the autonomous operational area.

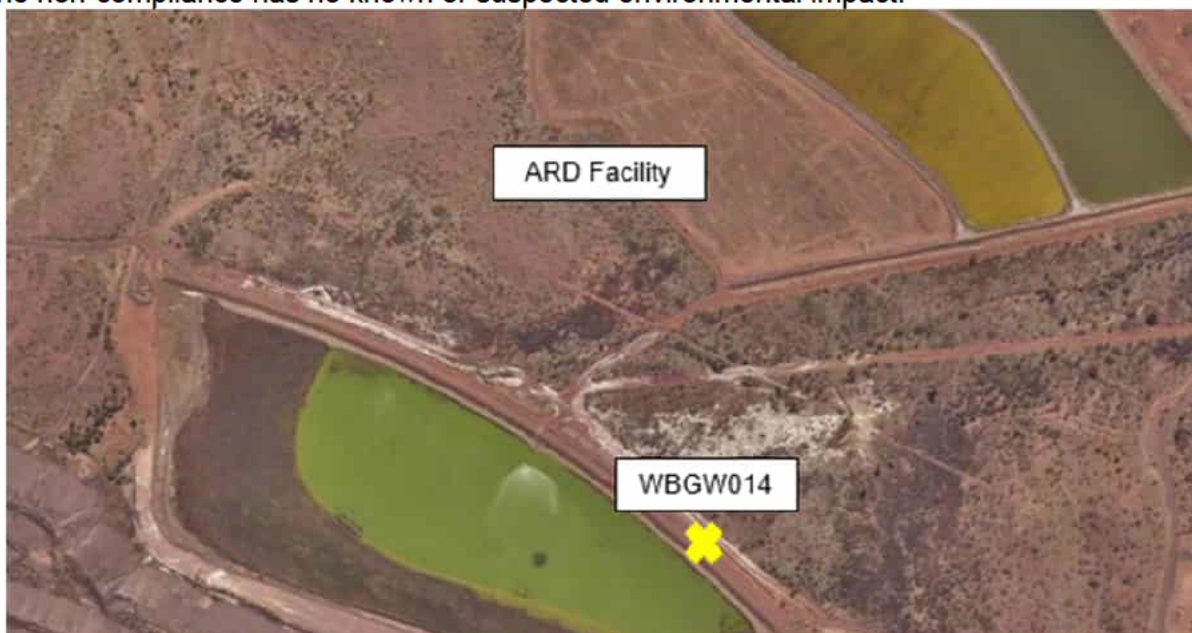
Condition 32 (Table 9) of the Licence requires groundwater sampling downstream of the ARD Facility at monitoring point location WBGW014 for hydrochemistry parameters on a quarterly basis. During the FY2024 reporting period, the groundwater bore was damaged and buried as reported in the AER. During the FY2025 reporting period, a quarterly sample could not be taken for Quarter 1, Quarter 2 and Quarter 3.

The non-compliance has no known or suspected environmental impact.

The cause of the non-compliance was damage to the groundwater monitoring bore casing and bore head, the required groundwater sample was unable to be taken from the monitoring bore for the FY2025 reporting period.

The April 2025 Licence Amendment removed WBGW014 from Table 9. Condition 38 (Table 11) of the amended licence required a replacement bore (WBGW014) to be drilled next to the destroyed bore. Works are underway to drill the replacement bore.

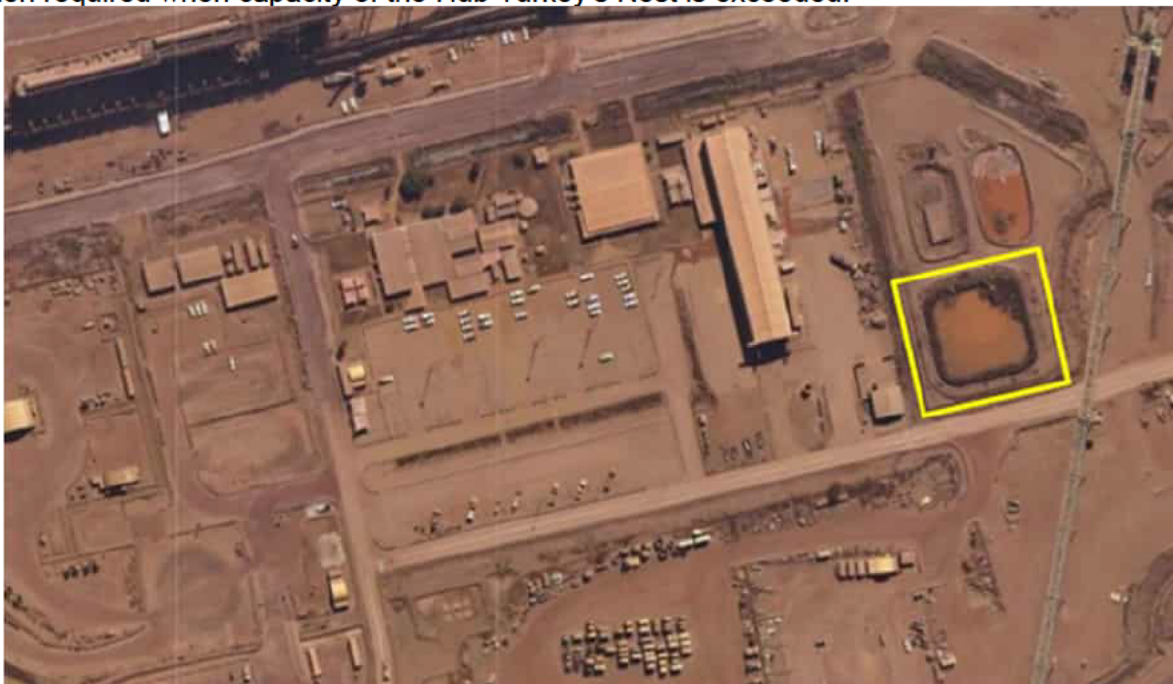
Condition 32 stipulates that emissions to land are required to be monitored through water sampling in accordance with Table 8 of the Licence. The Hub Turkey's Nest (L3) monitoring point location is required to record volumetric flow rate (cumulative) annually. The flow meter was damaged in July 2024 and was unable to record volumetric flow rate (cumulative) until October 2024.

The non-compliance has no known or suspected environmental impact, this monitoring point is for the Hub Turkey's Nest when the storage has been exhausted, therefore only discharged when required when capacity of the Hub Turkey's Nest is exceeded.

The flow meter was damaged in July 2024 and was unable to record volumetric flow rate (cumulative) until it was replaced in October 2024.

The flow meter was replaced and confirmed operational in October 2024; volumetric flow rate (cumulative) has been recorded for the remainder of the FY2025 reporting period.
