Annual Audit Compliance Report Form

Section A – Licence details			
Licence number:	4611/1987/11	Licence file number:	2012/006836-1
Licence holder name:	Agnew Gold Mining Company Pty Ltd		
Trading as:	Agnew Gold Mining Company Pty Ltd		
ACN:	098 385 883		
Registered business address:	Level 4, 235 St Georges Terrace PERTH WA 6000		
Reporting period:	01 / 01 / 2025 to 31 / 12 / 2025

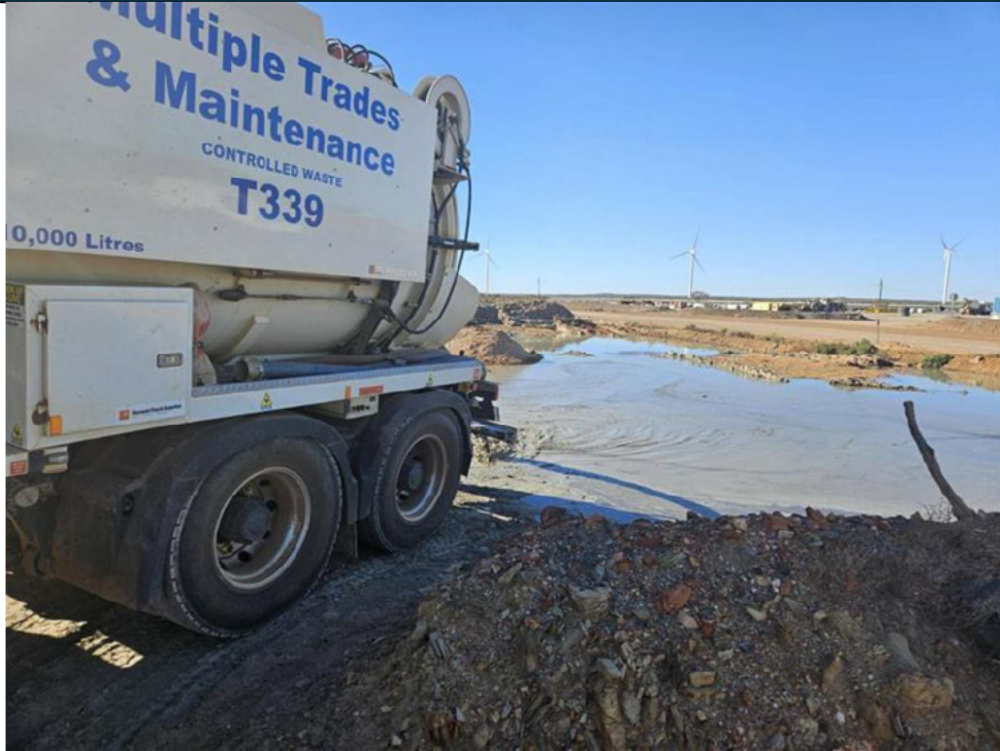
<p>What was the actual (or suspected) environmental impact of the non-compliance?</p> <p>NOTE – please attach maps or diagrams to provide insight into the precise location of where the non-compliance took place.</p>			
<p><u>Oily Water Separator Discharge</u> There was negligible actual environmental impact imposed by this non-compliance, with the entirety of hydrocarbon contaminated water and sediment contained to the bounds of the Waroonga Bioremediation Pad, and the materials were largely sourced from water/sediment runoff from a nearby washdown bay. The Waroonga Bioremediation Pad has since been rehabilitated (14 February 2026) as the containment infrastructure had reached operational capacity. See below for relevant photos of the non-compliance, and associated rehabilitation.</p>

Figure1 – Oily Water Separator discharge to Waroonga Bioremediation Pad.

The licensed waste management contractor was directed by site personnel to discharge hydrocarbon contaminated liquid to the Waroonga Bioremediation Pad. This was a result of misunderstanding by site personnel on the intent, and associated licence conditions, relating to this containment infrastructure. The sump muds from the washdown bay have been previously accepted at the Waroonga Bioremediation Pad, however the volume discharged was largely liquid, also discharging hydrocarbon contaminated water. The Environment Department observed discharge in-situ and immediately directed the waste management contractor to cease discharging and coordinated additional removal of material.

- All hydrocarbon contaminated water was removed from Waroonga Bioremediation Pad.
- Educational waste management presentations completed across all operations, including correct management of bioremediation pads and hydrocarbon contaminated materials.
- Complete rehabilitation of the Waroonga Bioremediation Pads, the location of non-

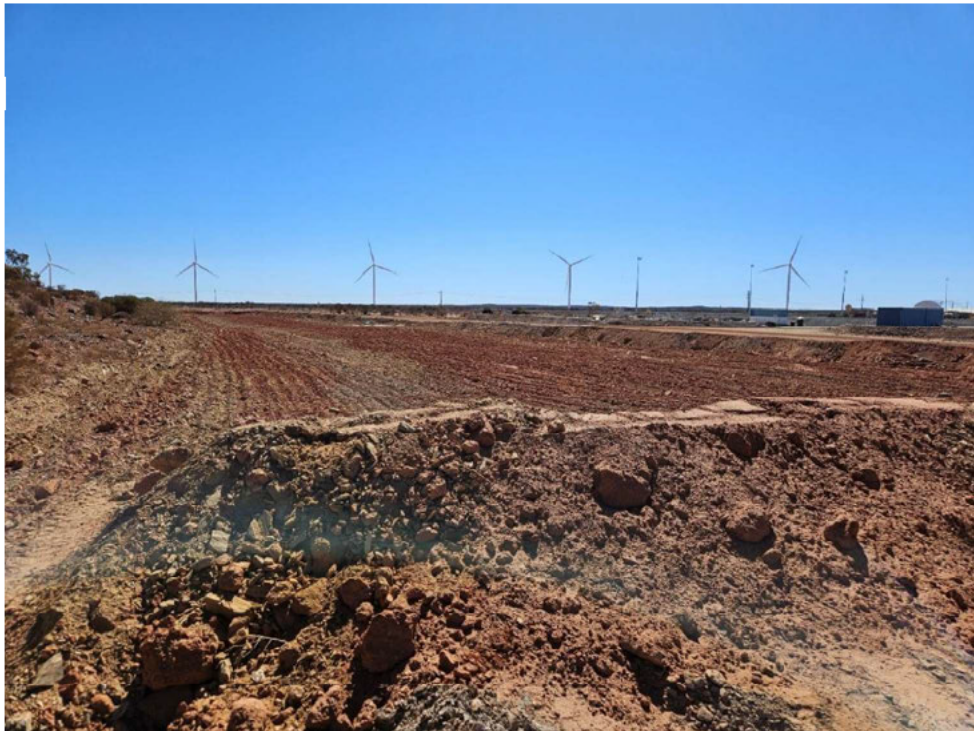
Figure 2 – Rehabilitated Waroonga Bioremediation Pad

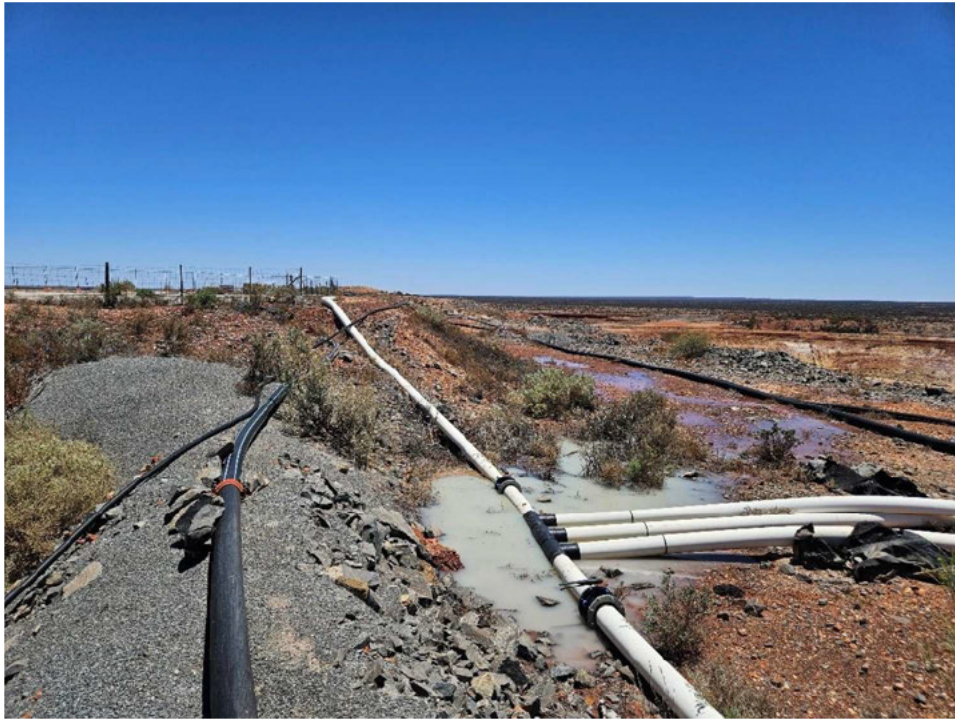
There was negligible actual environmental impact imposed by the uncontrolled discharge of mine dewater from the New Holland Turkey Nest. Mine dewater discharge was wholly contained to the disturbed, bunded area located atop of the New Holland WRD. Field sampling of the water TDS indicated fresh to brackish water quality with 3,489 mg/L TDS. The entire discharge footprint was bunded and left to evaporate naturally.

Figure 3 – New Holland Turkeys nest overflow East side.

The overflow mine dewater pipeline, intended to gravity feed mine dewater into the dewatering circuit and maintain the 300mm freeboard, was blocked by windblown vegetation surrounding the New Holland Turkey Nest. The blockage raised the total freeboard above 300mm over nightshift, with the mining shift supervisor noticing the overflow during the daily inspections, as required by Condition 3, Table 3. As this containment infrastructure lacks float sensors and associated alarms, this overflow event was not instantaneously recognized, prior to breaching the 300mm freeboard. This system is established at the Waroonga Turkey Nest.

Section E – Details of non-compliance with licence condition	
<p>compliance.</p> <p><u>New Holland Turkeys Nest Overflow</u> AGMC proposed/have completed the following mitigation actions</p> <ul style="list-style-type: none"> • Diesel pump bypass was completed to return the 300mm freeboard • Overgrown vegetation removed from New Holland Turkey Nest, and guard installed on gravity fed overflow pipeline • All vegetation removed surrounding embankment of New Holland Turkey Nest • Ongoing dredging of sediment from New Holland Turkey Nest, as per DMPE inspection actions from October 2024. • Installation of permanent power to install float sensors and alarm systems for New Holland Turkey Nest. These alarms will be set at 95% capacity to 300mm freeboard (285mm), to allow time to rectify and isolate mine dewater before non-compliance is triggered. 	
Was this non-compliance previously reported to DWER?

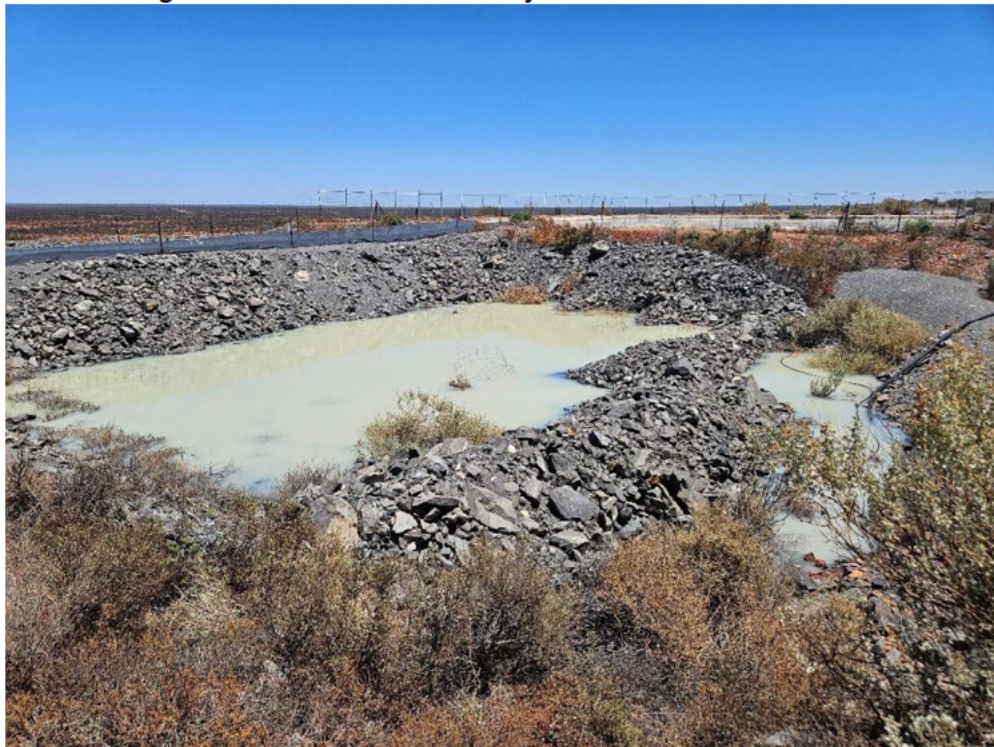
Figure 4 - New Holland Turkeys nest overflow old sediment sump.

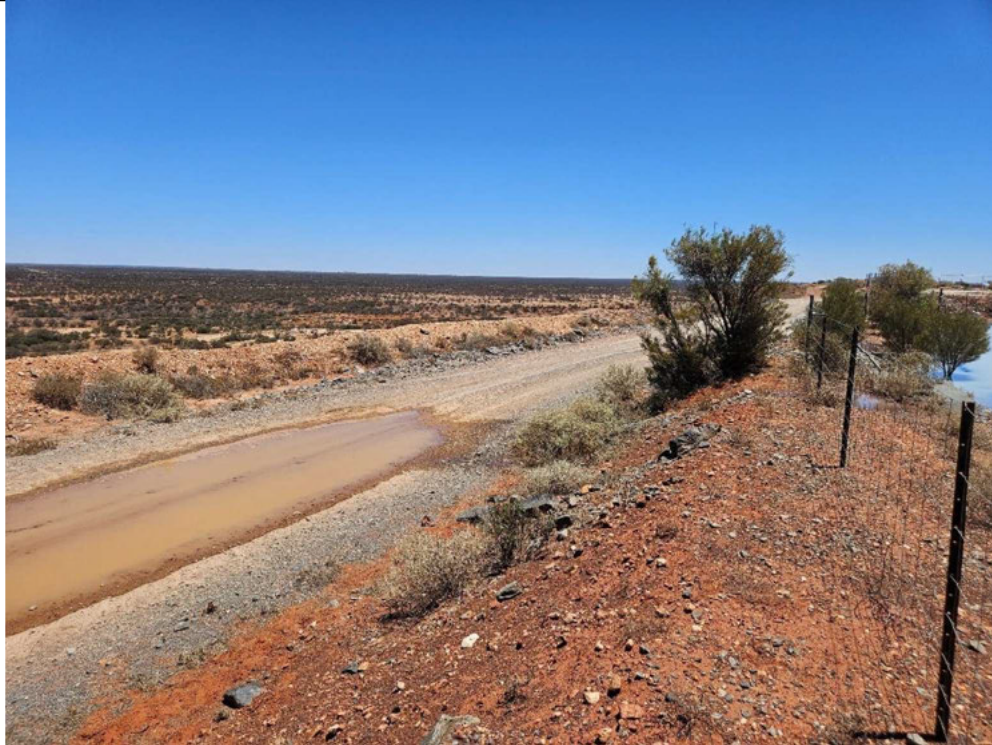
Figure 5 - New Holland Turkeys nest overflow West side.
