## APPENDIX 1: L5206/1987/10 AACR

### Annual Audit Compliance Report Form

Section A – Licence details			
Licence number:	L5206/1987/10	Licence file number:	2012/006906
Licence holder name:	Matilda Operations Pty Ltd		
Trading as:	Blackham Resources		
ACN:	166 954 525		
Registered business address:	Level 3, 1 Altona Street, Wet Perth WA 6005		
Reporting period:	01/01/2019 to 31/12/2019

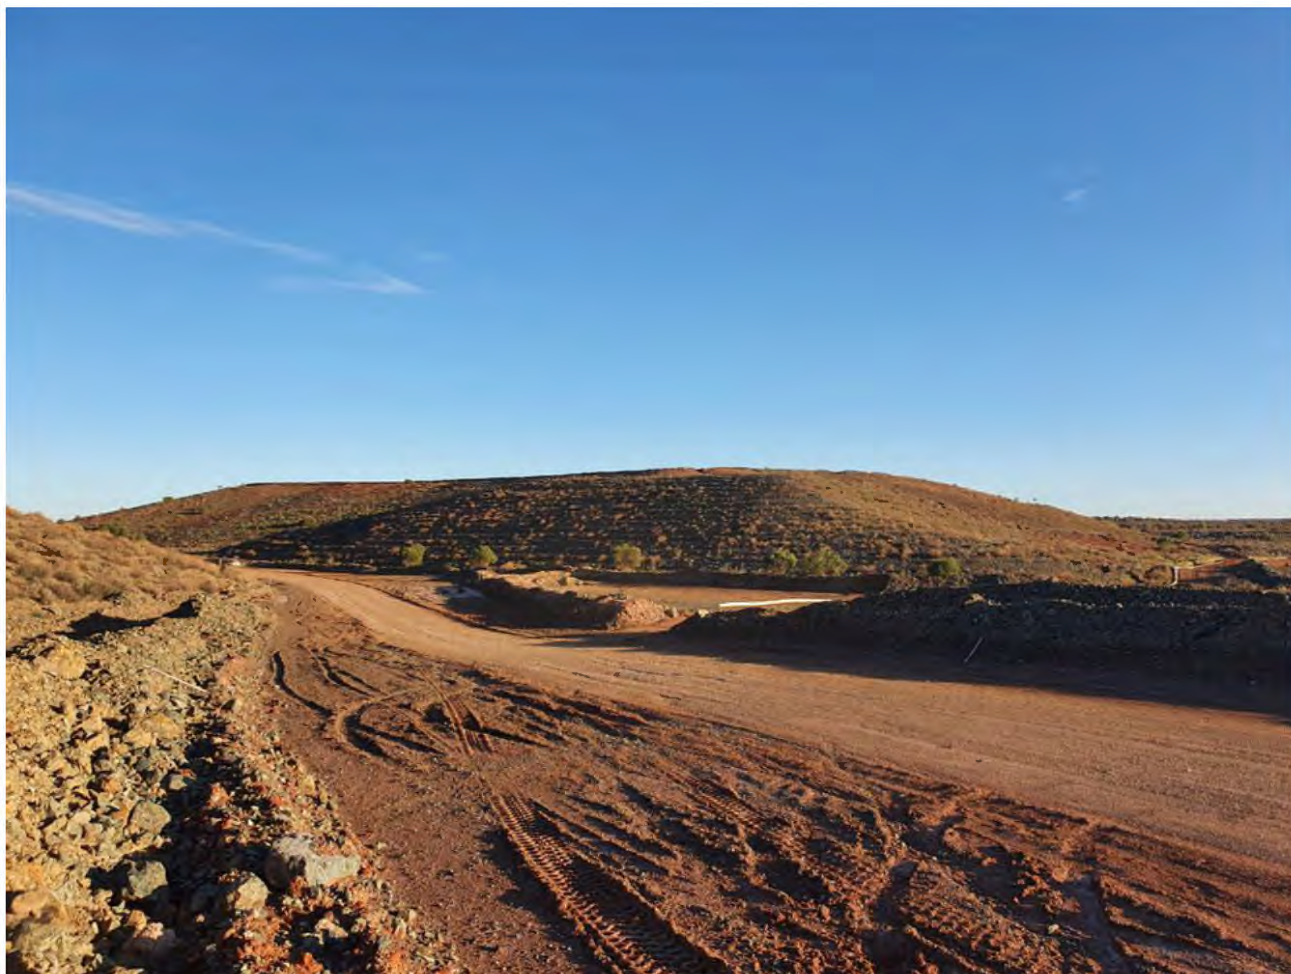
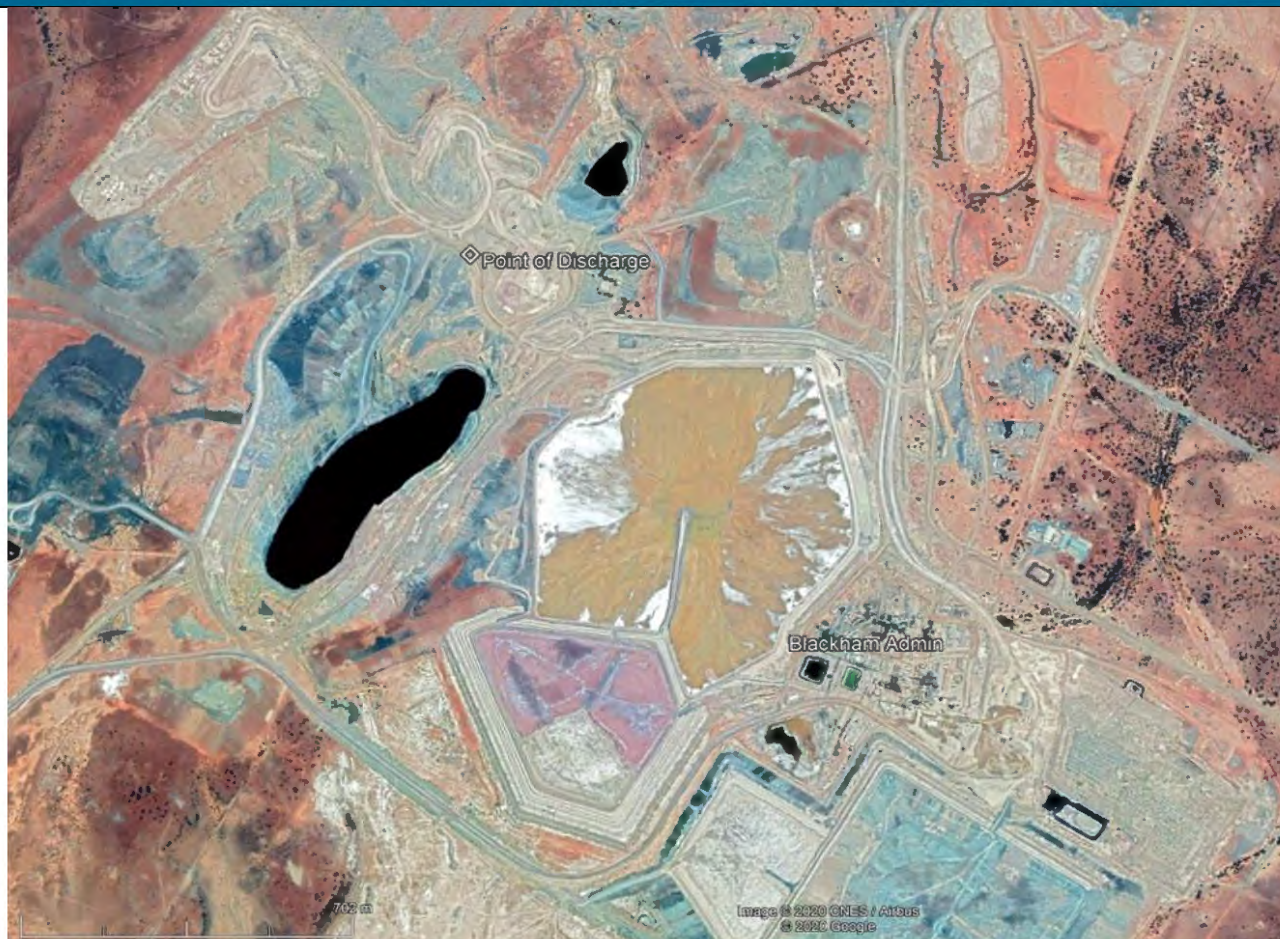
Discharge of approx. 20,000 L of saline water from the Happy Jack dewatering line to surrounds. Surrounding area primarily disturbed gravel.

No environmental impact occurred as the spill was contained within a pre-disturbed gravel area. See below photo.

Upon inspection pipe appeared to be damaged by weight/impact of surrounding rock.

Pipe repaired. Pipe work inspected on a regular basis.

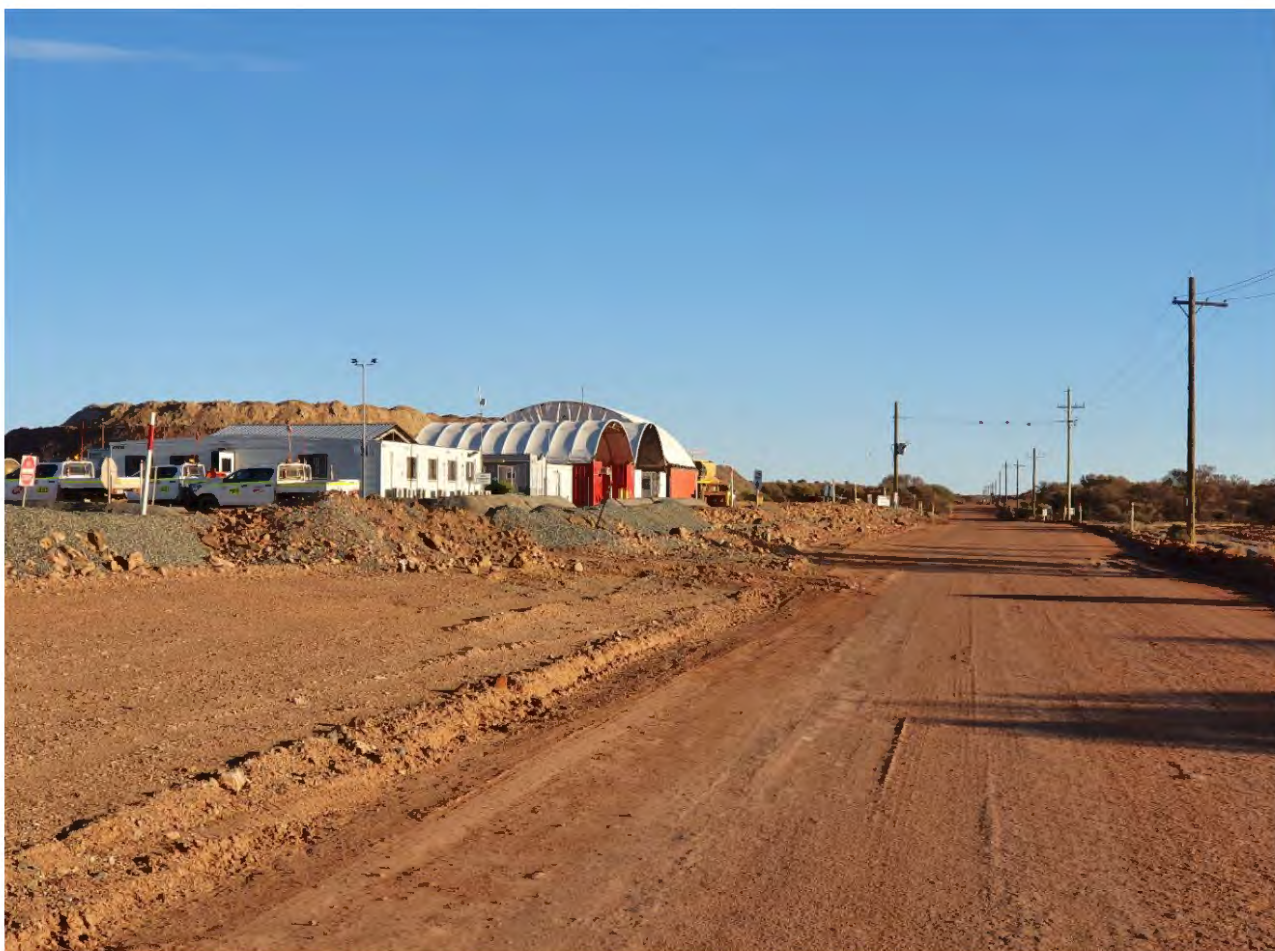
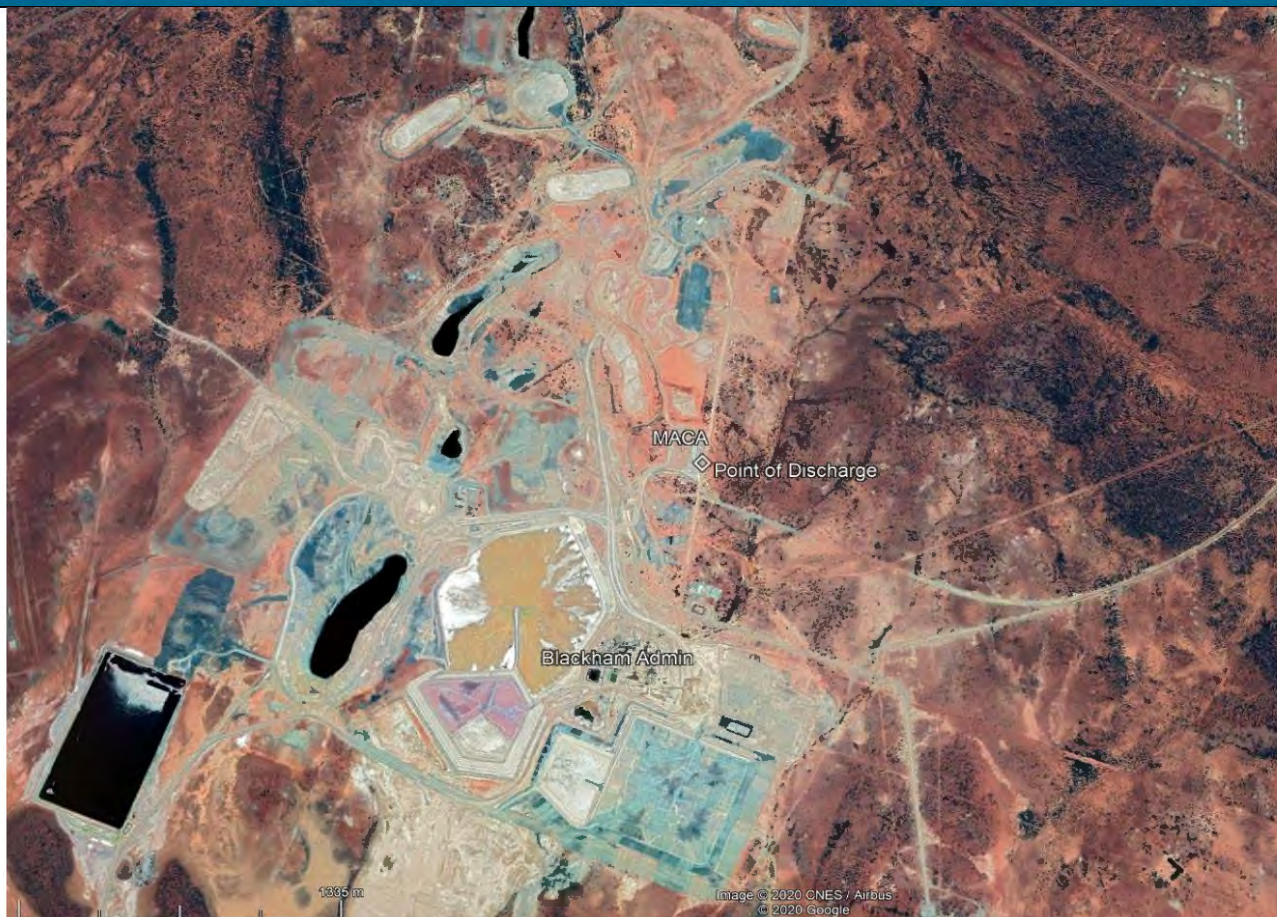
Discharge of sewage from recently installed BIOMAX system to nearby Bulletin Access Road observed during installation/maintenance.

No environmental impact as discharge was contained to the Bulletin Access Road.

Outflow of BIOMAX system was not directed to a leach drain or irrigation area.

Tanks now diverted to leach drains.

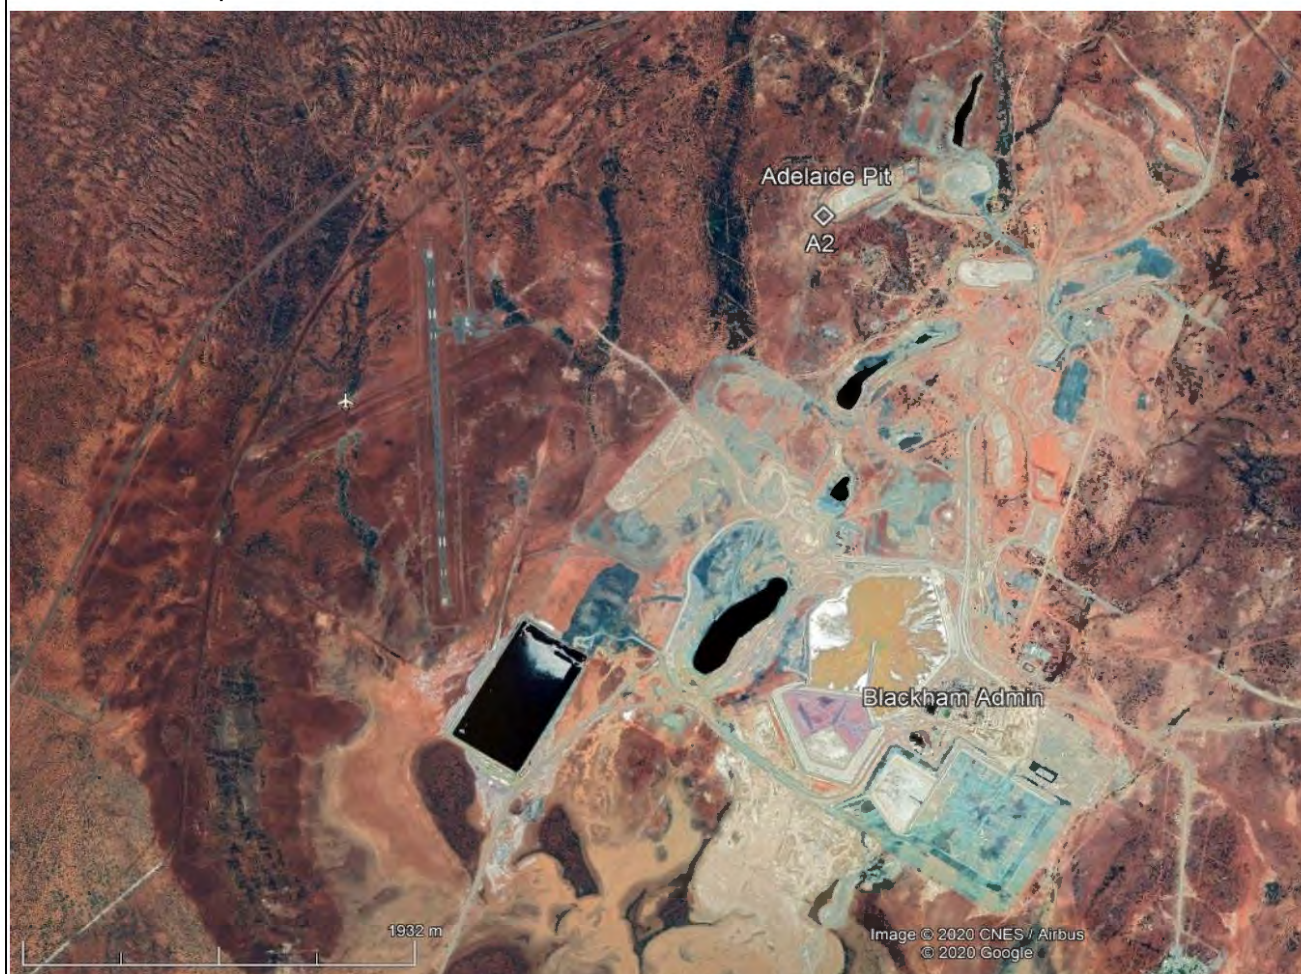
TSF Groundwater Monitoring Bore A2 Arsenic Result Exceeded Licence Limit of 0.4 mg/L, result was 0.75 mg/L.

Minor environmental damage, levels will continue to be monitored.

Wiluna ore has a strong association with arsenopyrite sulphide mineral, with arsenic being detected naturally within the groundwater.

No action taken. Bore continually monitored quarterly. Arsenic concentrations have since dropped below Licence Limits.

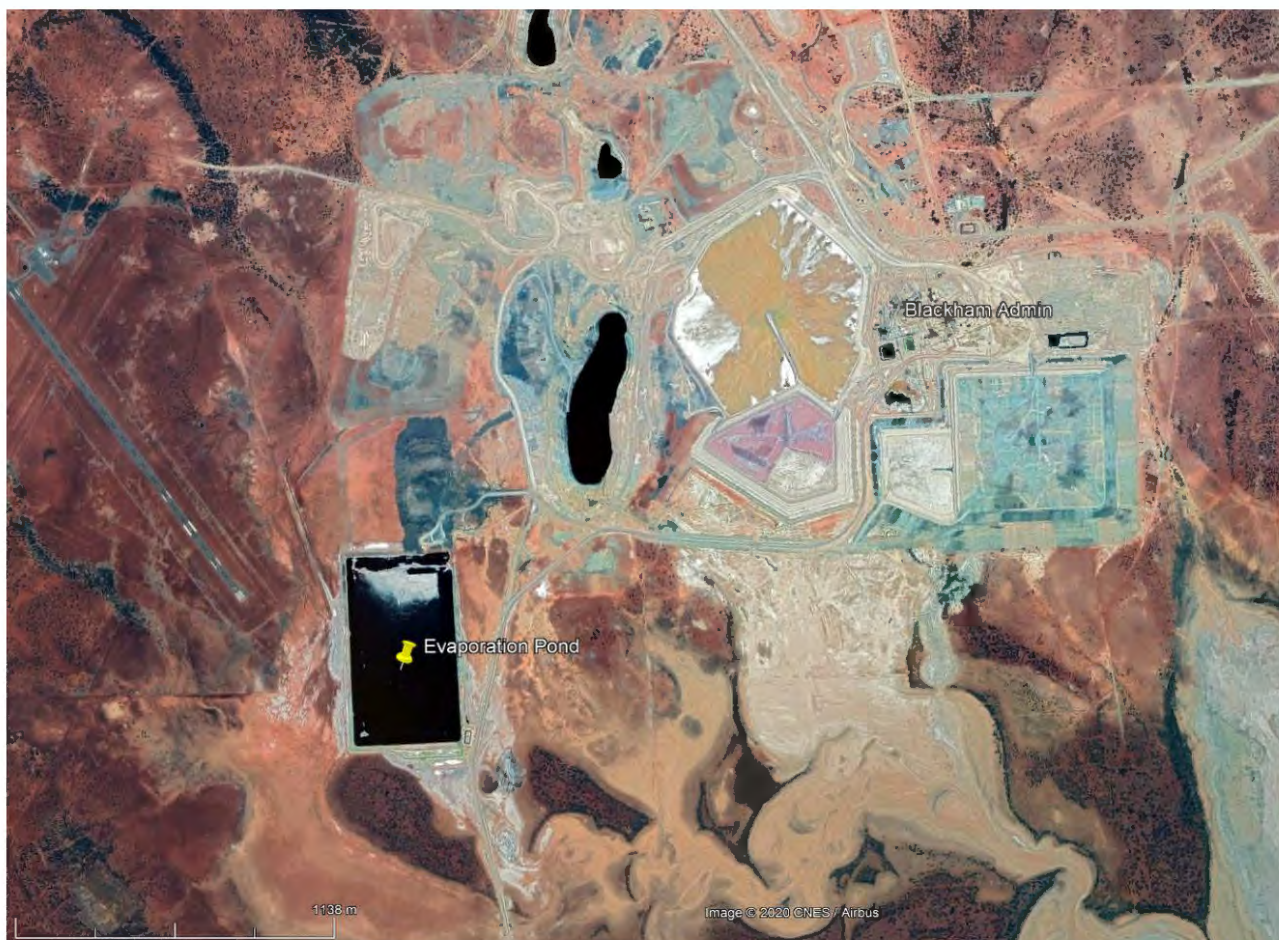
Discharge of approx. 800 L of saline water from pipe to surrounding gravel at Evaporation Pond.

Minor environmental damage to surrounding area, contained in previously disturbed gravel area.

Damaged pipe suspected to have been damaged during repair and maintenance works. Upon pump start up a leak was noticed.

Pipe repaired. Continuation of regular inspections.

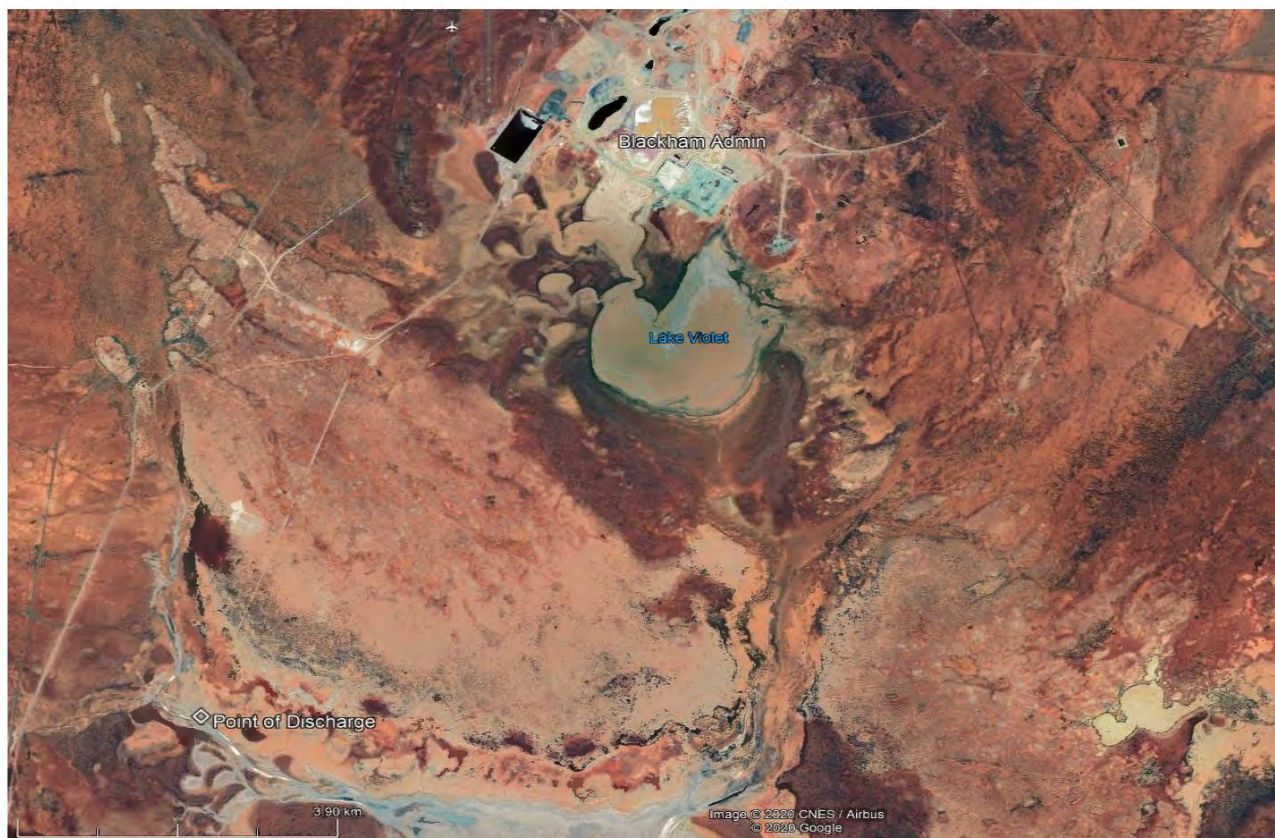
Lake Way Total Suspended Solids Exceeded Licence Limit of 80 mg/L, result was 130 mg/L.

No suspected environmental impact.

The re-commencement and several interruptions Are believed to have resulted increased suspended matter.

Retested on 31/08/2019, result 16 mg/L.

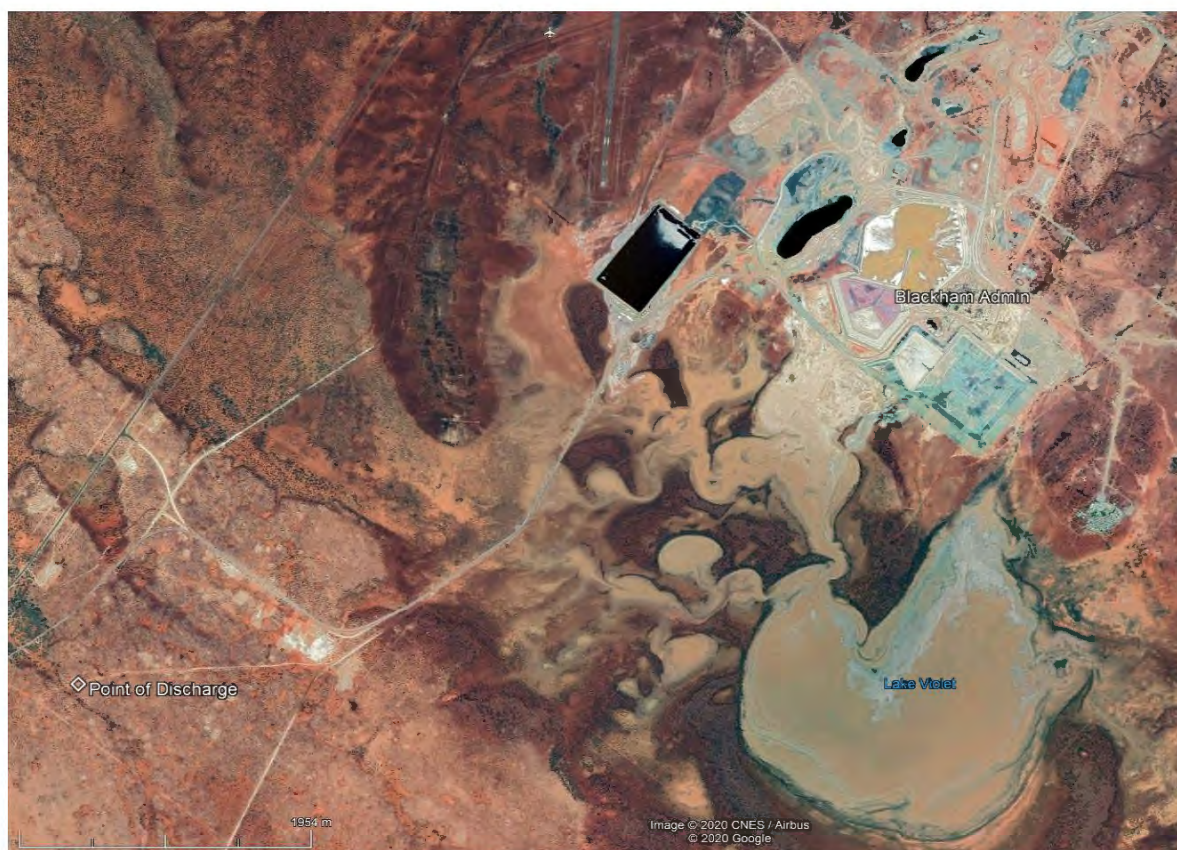
Discharge of saline water to ground from leak in southern borefield pipeline.

Spill was contained to nearby gravel area. No environmental impact is expected.

Unknown damage to pipe.

Pipe repaired. Continue to complete regular inspections.

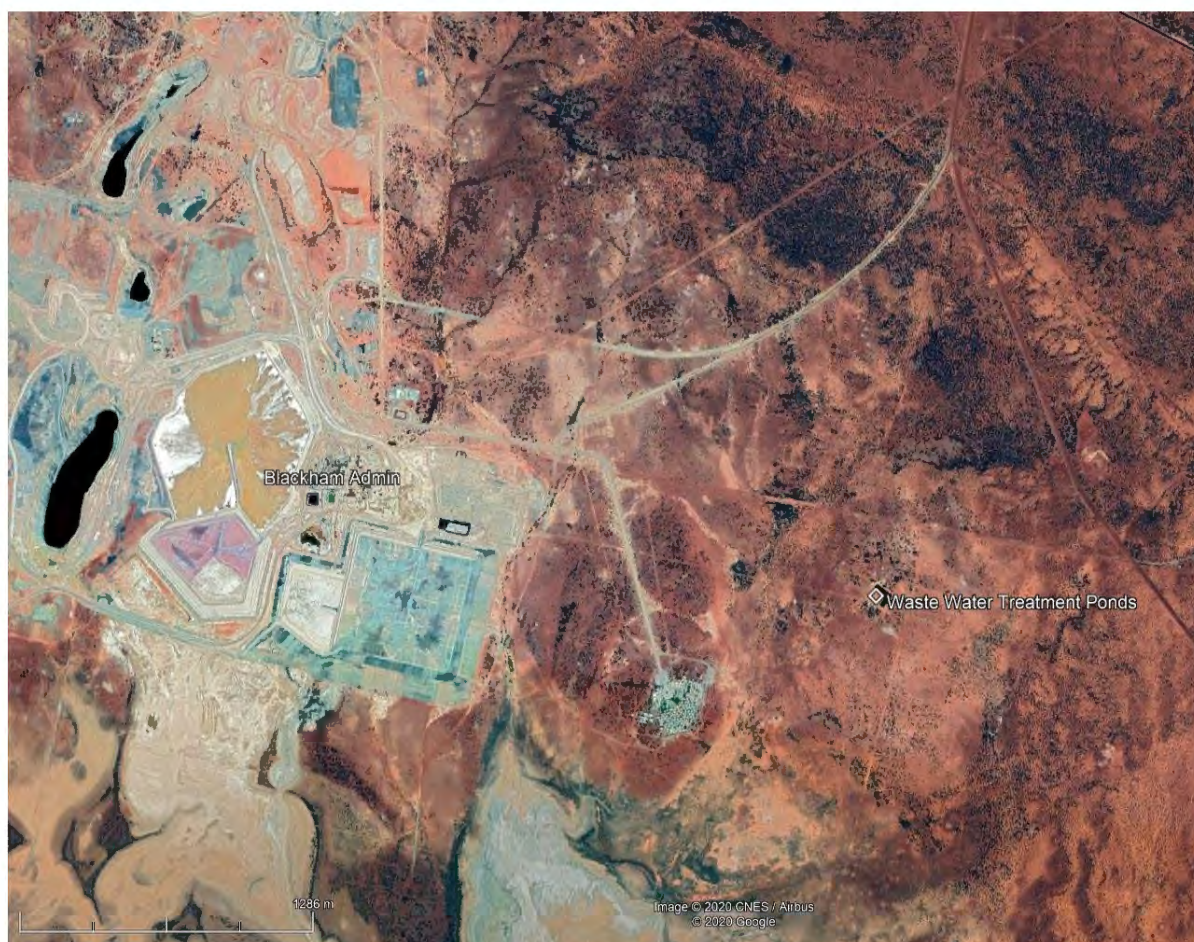
Encroaching vegetation of the Sewage Facility ponds.

No environmental impact is expected.

Section E – Details of non-compliance with licence condition	
Cause (or suspected cause) of non-compliance:	
Seed blown onto the pond has germinated, grown and not being promptly sprayed with herbicide.	
Action taken to mitigate any adverse effects of non-compliance and prevent recurrence of the non-compliance:	
Vegetation sprayed with herbicide. Spraying to be completed promptly if vegetation present.	
Was this non-compliance previously reported to DWER?	
<input checked="" type="checkbox"/> Yes, and	
<input checked="" type="checkbox"/> Reported to DWER verbally  DWER Inspection - Environmental Notice (01753)	Date: 19/11/2019
<input type="checkbox"/> Reported to DWER in writing	Date:     /     /

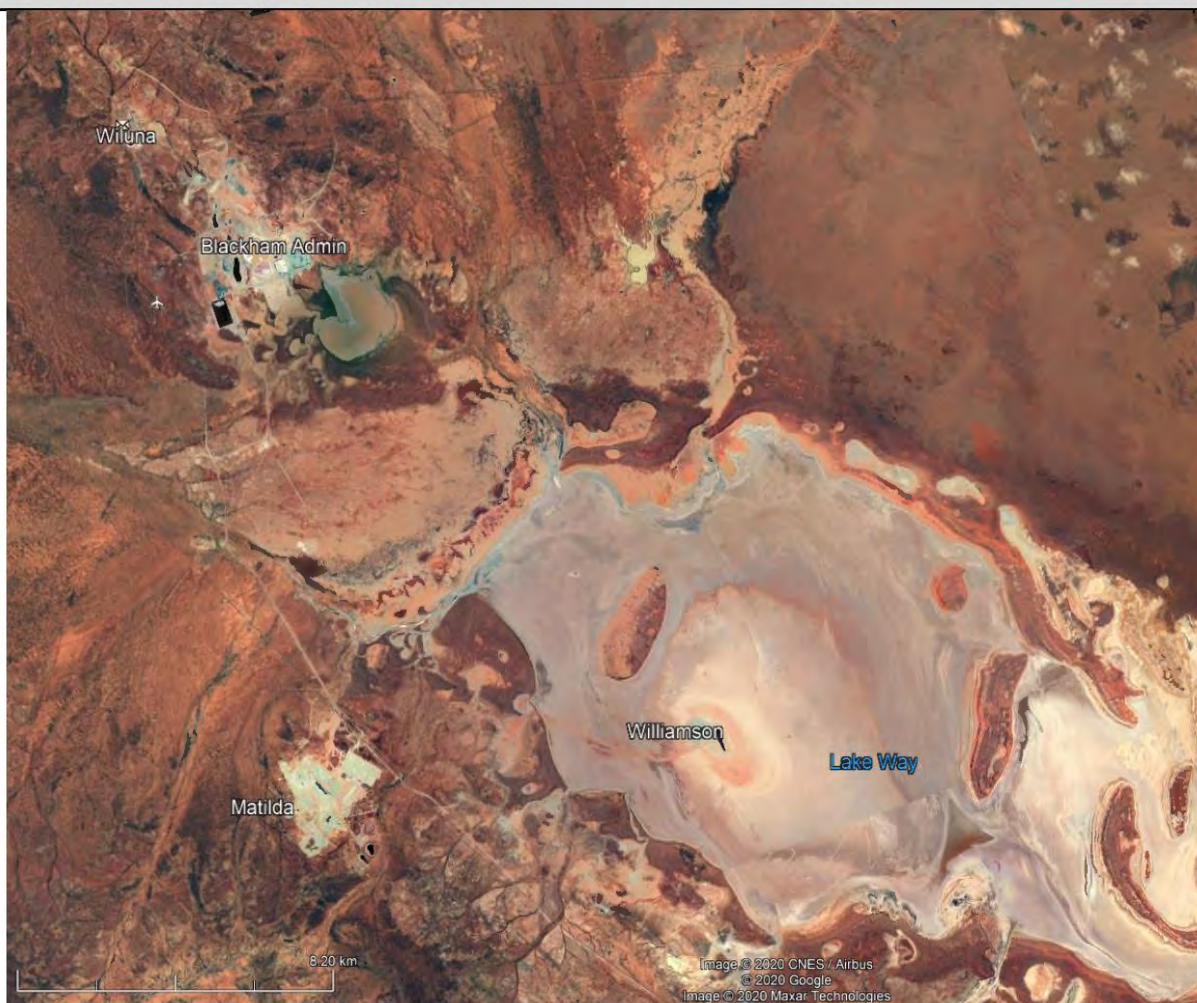
No telemetry, secondary containment or automatic cut off in place on required pipelines.

No environmental impact is expected to have occurred.

Originally installed infrastructure never had required controls.

Installing secondary containment for all pipelines.
