## Annual Audit Compliance Report Form

Licence number:	L5415/1988/9	Licence file number:	DER2013/00900 1
Licence holder name:	BHP Iron Ore Pty Ltd		
Trading as:	BHP Iron Ore Pty Ltd		
ACN:	008 700 981		
Registered business address:	Level 1, City Square Brookfield Place 125 St Georges Terrace PERTH WA 6000		
Reporting period:	01/07/2022 to 30/06/2023

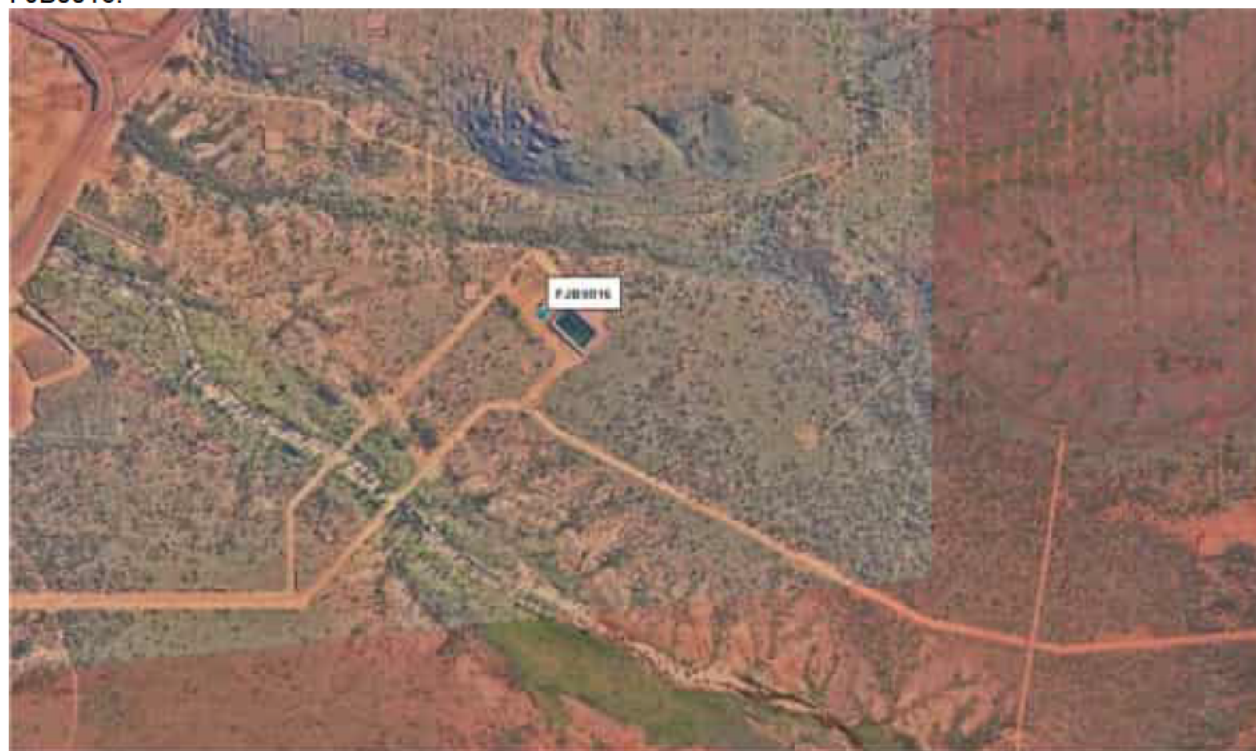
The reinjection/creek discharge point FJB0016 was not monitored for Q2 for the groundwater quality parameters required by Condition 3.2.1 (Table 3.2.1) and Condition 3.3.1 (Table 3.3.1). Quarterly hydrochemistry analysis is required when discharging/reinjecting. There was reinjection and discharge recorded for Q2 at the Caramulla MAR Scheme and creek discharge point.

There was no actual or suspected environmental impact for not recording hydrochemistry data for Q2 for FJB0016.

Discharge was ceased to Caramulla Creek on 23 November 2022 following an exceedance of the wetting front threshold criteria (ID0043976). Following the cessation of creek discharge, water was diverted from the Caramulla Scheme and the turkey nest (FJB0016) water levels dropped. During the quarterly monitoring, the contractor was unable to retrieve a sample due to the water levels. FJB0016 was scheduled to be sampled in December for Q2, however a rainfall event resulted in access to be restricted to the sample point.

Data was successfully collected for Q3 and Q4.

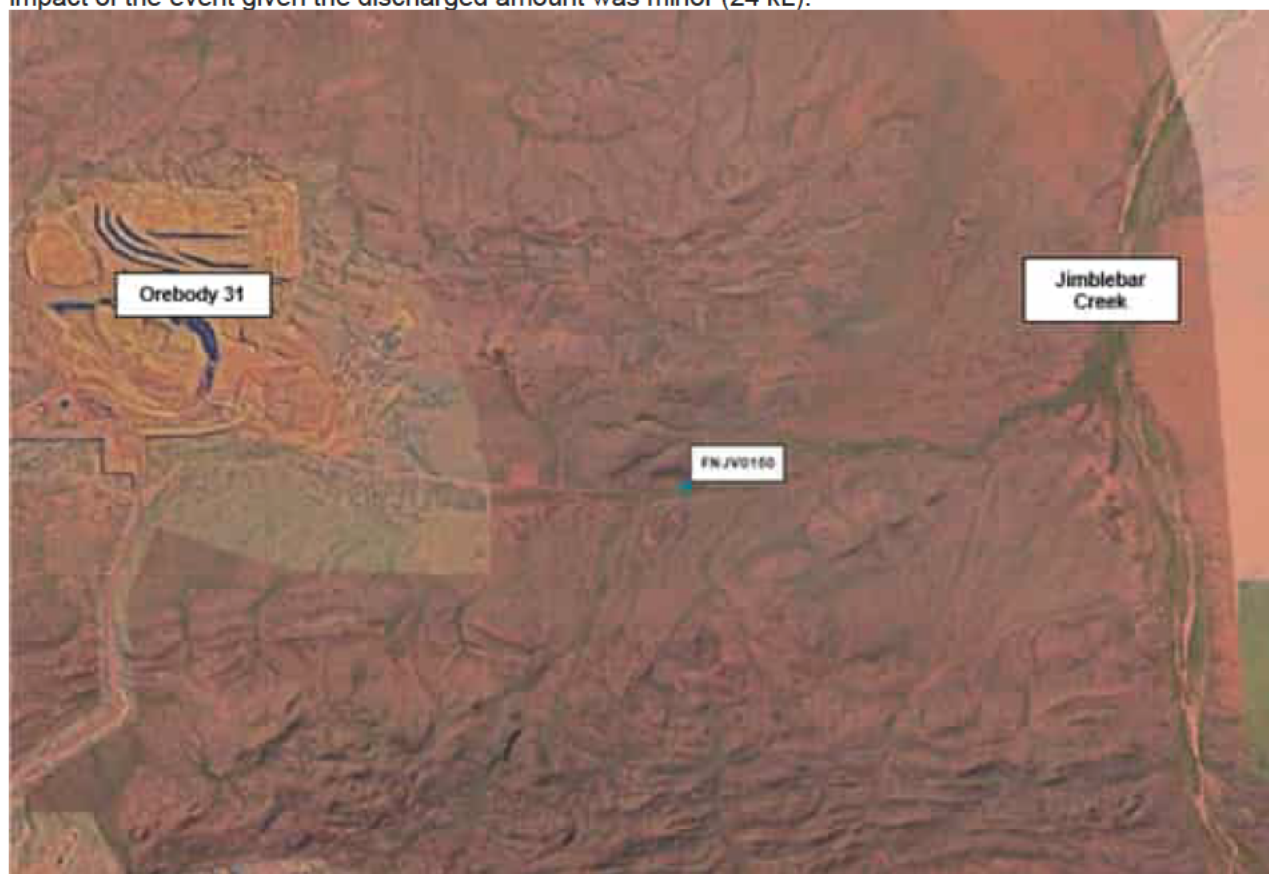
Orebody 31 Creek Discharge point FNJV0150 was not sampled in Q4 for water quality parameter as required by Condition 3.2.1 (Table 3.2.1).

During Q4 in June 2023, a maintenance event to calibrate the Orebody 31 creek discharge point flow meter resulted in 24 kL being discharged to the creek. There is no actual or suspected environmental impact of the event given the discharged amount was minor (24 kL).

A water sample was not obtained by the contractor before the end of the Q4 to fulfil the licence requirement following the annual maintenance event to calibrate the FNJV0150 flow meter.

Internal processes are now in place to ensure that reporting occurs in line with licence conditions for annual maintenance events of flow meter calibrations.

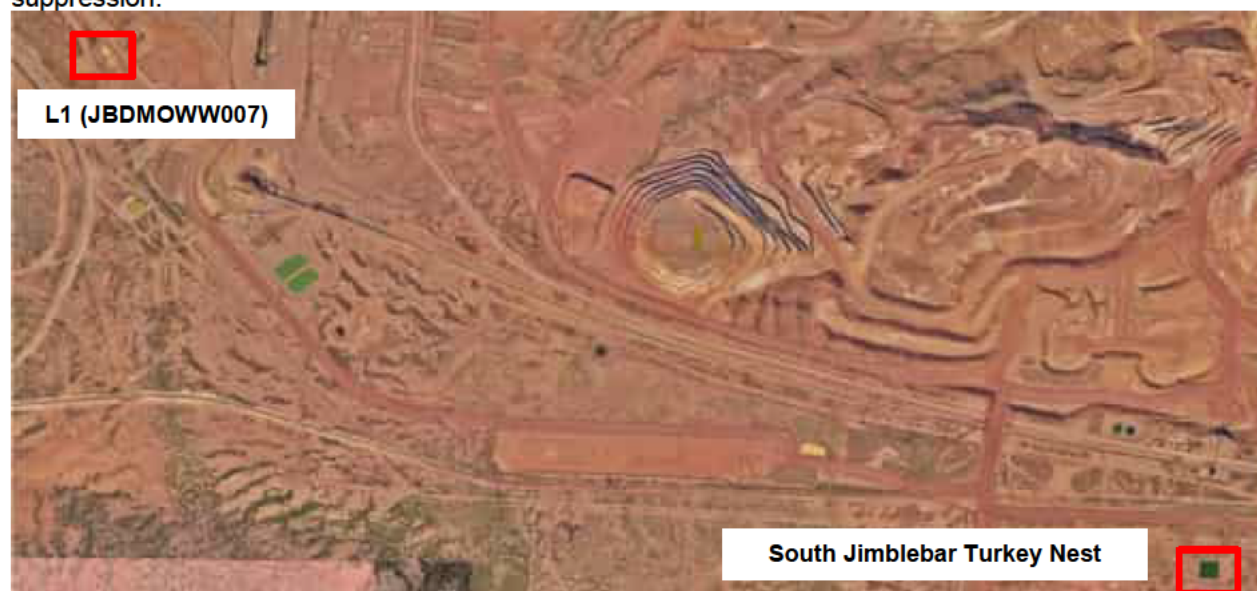
The L1 Jimblebar Oily Wastewater Treatment Plant (JBDMOWW007) monitoring point exceeded the Total Recoverable Hydrocarbons (TRH) licence limit of 15 mg/L for each quarter in FY2023. The treated oily wastewater is used for dust suppression on site and is sampled quarterly as per licence requirements.

There was no actual or suspected environmental impact from the TRH limit exceedance in FY2023. The L1 outflow line discharges to the South Jimblebar turkey's nest and is significantly diluted with raw dewatering water before being used for dust suppression. Monthly TRH samples of the South Jimblebar Turkey Nest confirmed that the TRH did not exceed the 15 mg/L limit and therefore was used for dust suppression.

The sample point is no longer an accurate reflection of the water being used for dust suppression as the standpipe for the water trucks is now located at the South Jimblebar Turkey Nest.

A License Amendment is currently being drafted for submission to update the licence point. Monthly samples will continue to be taken from South Jimblebar Turkey Nest to ensure the TRH concentration is not exceeding the limit for dust suppression.

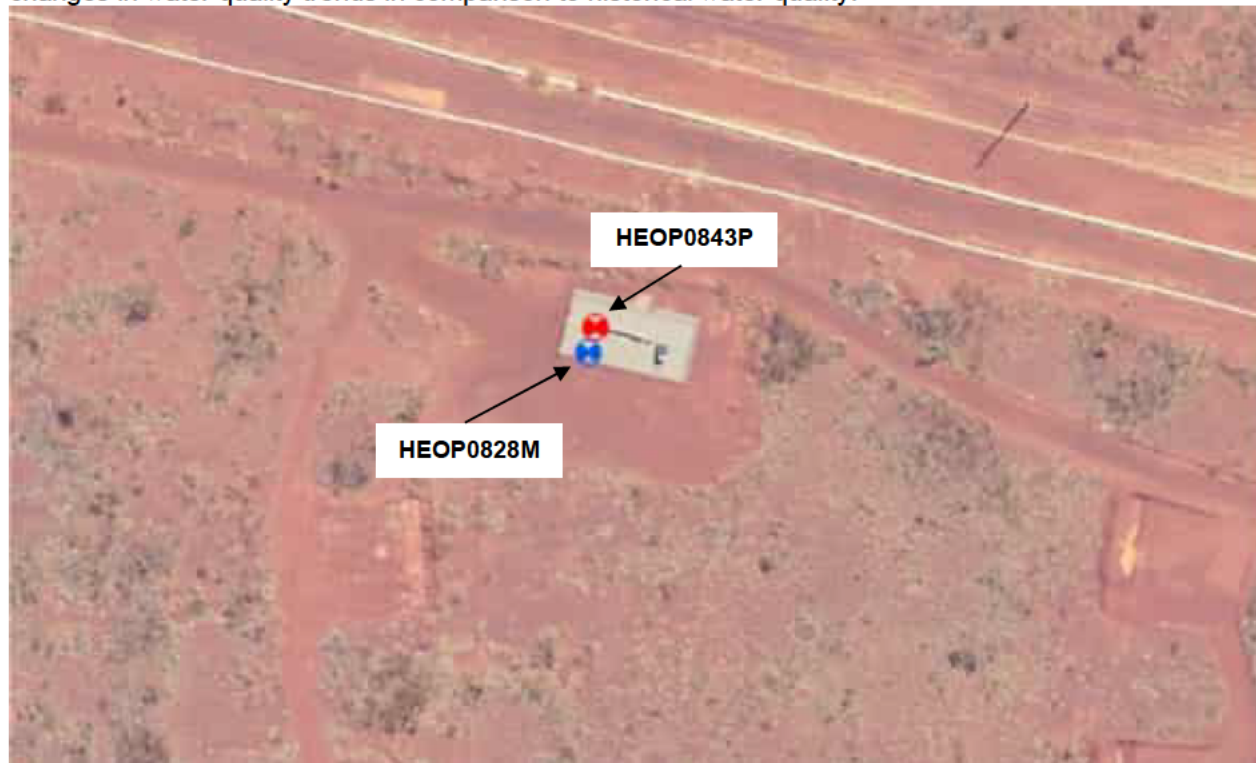
The reinjection bore HEOP0843P was not monitored for Q2 for the groundwater quality parameters required by Condition 3.3.1 (Table 3.3.1).

There was no actual or suspected environmental impact from not sampling during this quarter. The adjacent ambient monitoring bore (HEOP0828M) was sampled in Q2 and did not report any notable changes in water quality trends in comparison to historical water quality.

There was a fault with the telemetered equipment.

The telemetered equipment was replaced, and data was successfully recorded for Q3 and Q4 of FY2023.

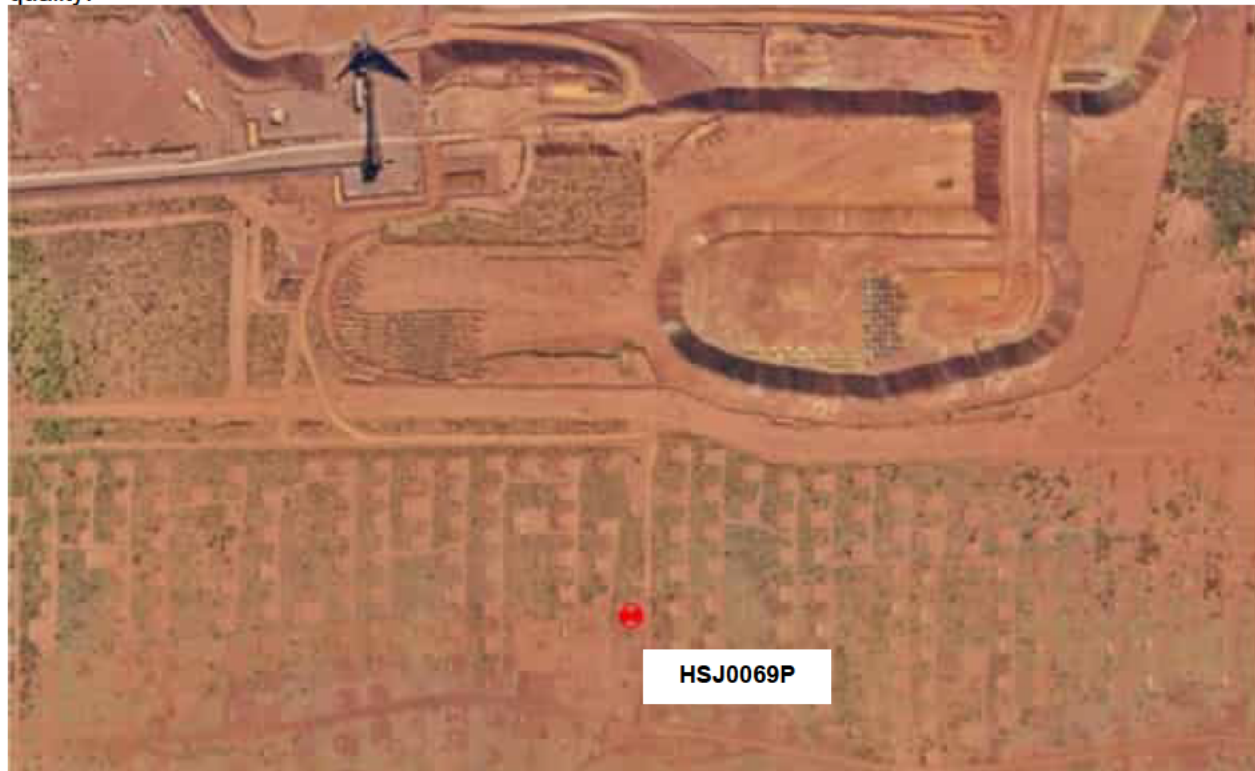
The monitoring point HSJ0069P was not monitored in Q2 for the groundwater quality parameters required by Condition 3.3.1 (Table 3.3.1).

A small volume of water (1,644 kL) was reinjected during October 2022, no further reinjection has occurred since. There was no actual or suspected environmental impact from not sampling during this quarter. The water quality of the two adjacent reinjection bores (HSJ0003P and HSJ0076P) were sampled during Q2 and did not report any notable change in water quality trends in comparison to historical water quality.

As groundwater reinjection was limited during October and no reinjection occurred during November 2022, the scheduled November quarterly water sample was not collected as reinjection has ceased during this time.

The South Jimblebar reinjection network was disconnected in May 2023 and will be removed from the License in the next License Amendment.

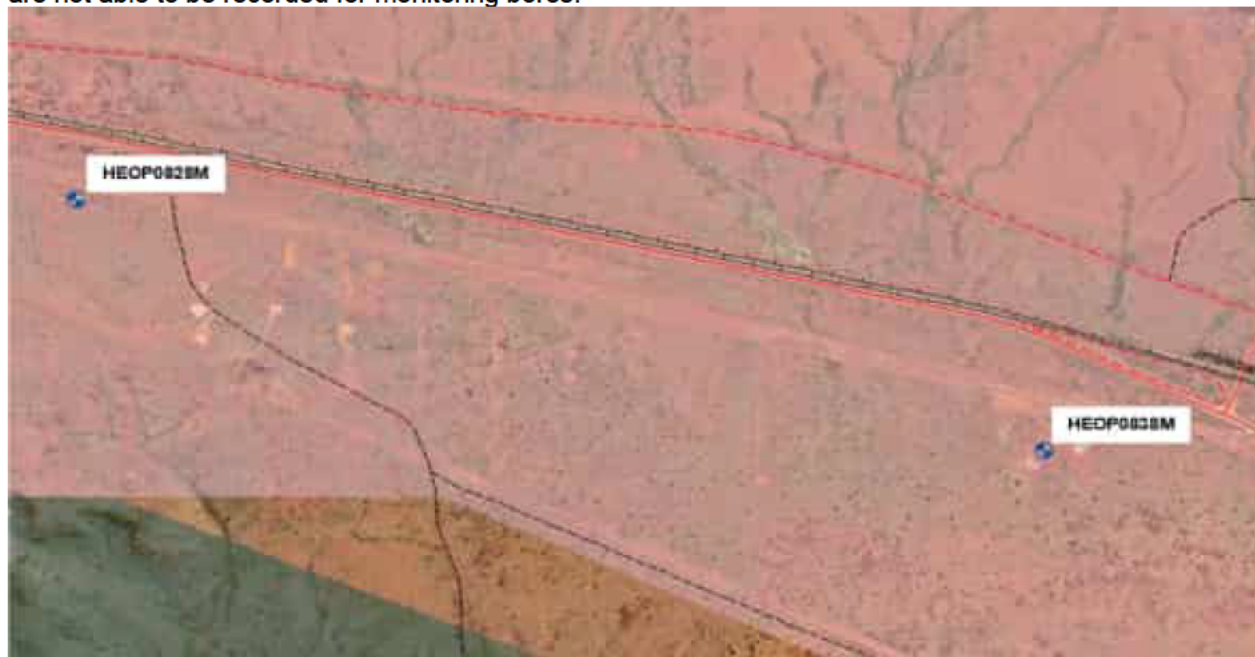
Monthly flow rate and cumulative volume data for OB18 MAR groundwater monitoring bores (HEOP0828M and HEOP0838M) were unable to be recorded for FY2023. The Licence Amendment granted on 17 March 2022 included a change to the licence not requested by BHP to undertake monthly flow rate and cumulative volume monitoring for the two monitoring bores (Table 3.3.1). The two monitoring bores were requested to be removed in the July 2022 Licence Amendment, but DWER advised that *'the removal of the bores would require a review of the risk assessment and advice from the Department's hydrogeologist, which was not undertaken during the assessment of the current Licence Amendment'*.

There was no actual or suspected environmental impact as flow rate and cumulative volume data readings are not able to be recorded for monitoring bores.

The cause of the non-compliance is an administrative error during the Licence Amendment process.

Licence Amendment discussions are currently underway to request Table 3.3.1 to be updated to only require monthly monitoring of water level for the two bores and remove the cumulative volume and flow rate monitoring requirements.

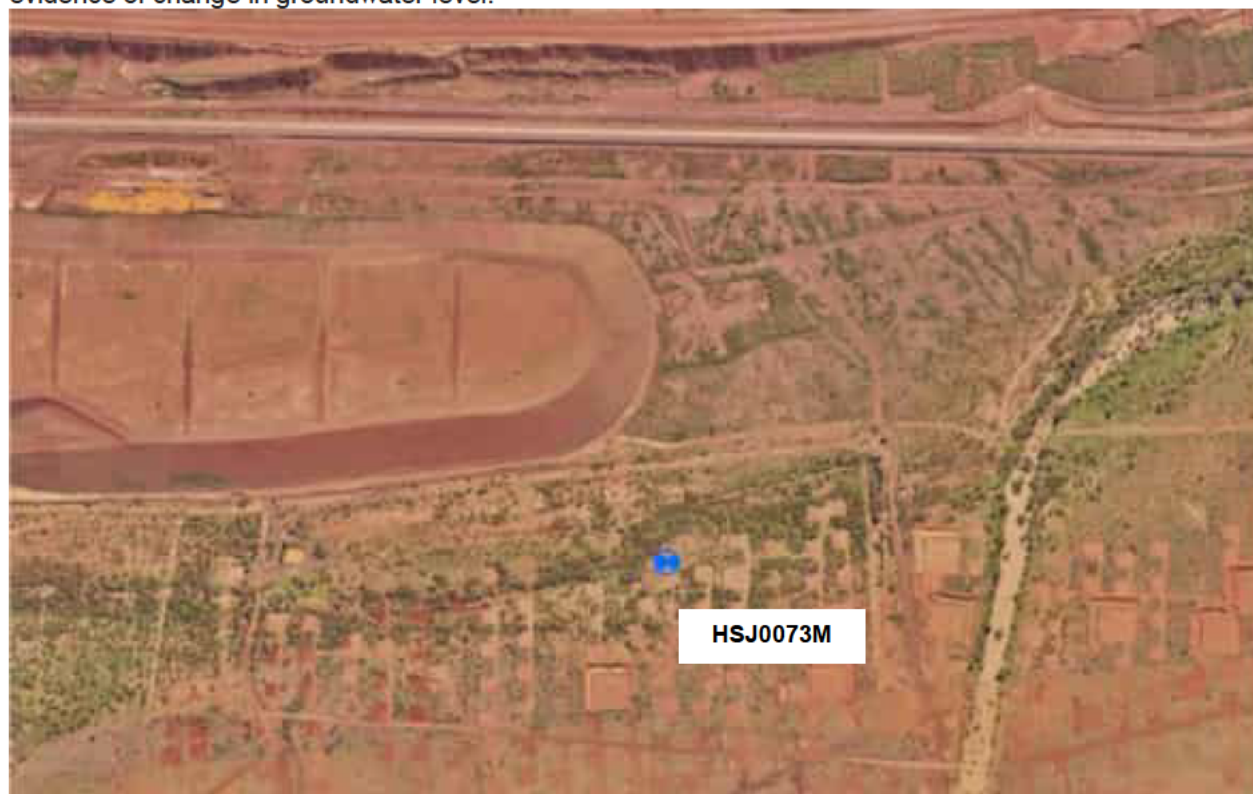
The monitoring point HSJ0073M was not monitored in August 2022 for the depth to groundwater (mbgl) requirement as per Table 3.5.1.

The corresponding reinjection bore HSJ0076P recorded flow, demonstrating that reinjection was occurring. There was no suspected environmental impact from not recording the monthly depth to groundwater reading, the following month reading was 0.1 mbgl different from July, demonstrating no evidence of change in groundwater level.

A fault with the telemetered data logger.

The telemetered data logger was replaced, and data collected for each month following August 2022.

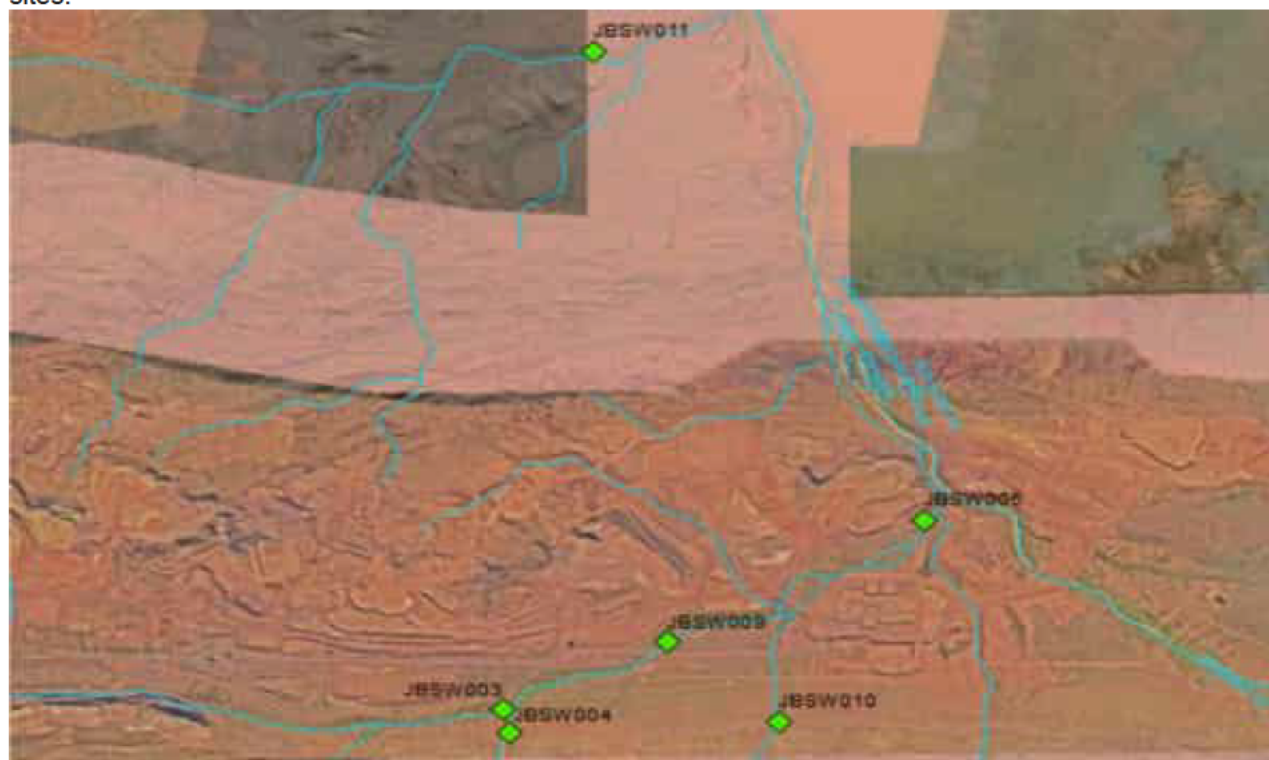
Quarterly monitoring of creek line water quality was not completed as required at six monitoring sites by Table 3.5.2. Following a high rainfall event, four creek line monitoring sites (JBSW003, JBSW004, JBSW0010 and JBSW005) were observed to no longer be in place and have been washed away. Monitoring sites JBSW009 and JBSW011 were still in place and a water sample was able to be retrieved from JBSW009 for Q3.

There is no actual or suspected environmental impact from not monitoring four out of the six creek line sites.

A high rainfall event caused four of the six creek line monitoring site equipment to be destroyed and washed away. Over the course of three days from 29 March to 31 March 2023, a total of 108.6 mm of rainfall was received (BoM, Newman Airport).

New rising stage sampling stations installed at the six creek monitoring sites during Q1 of FY2024.

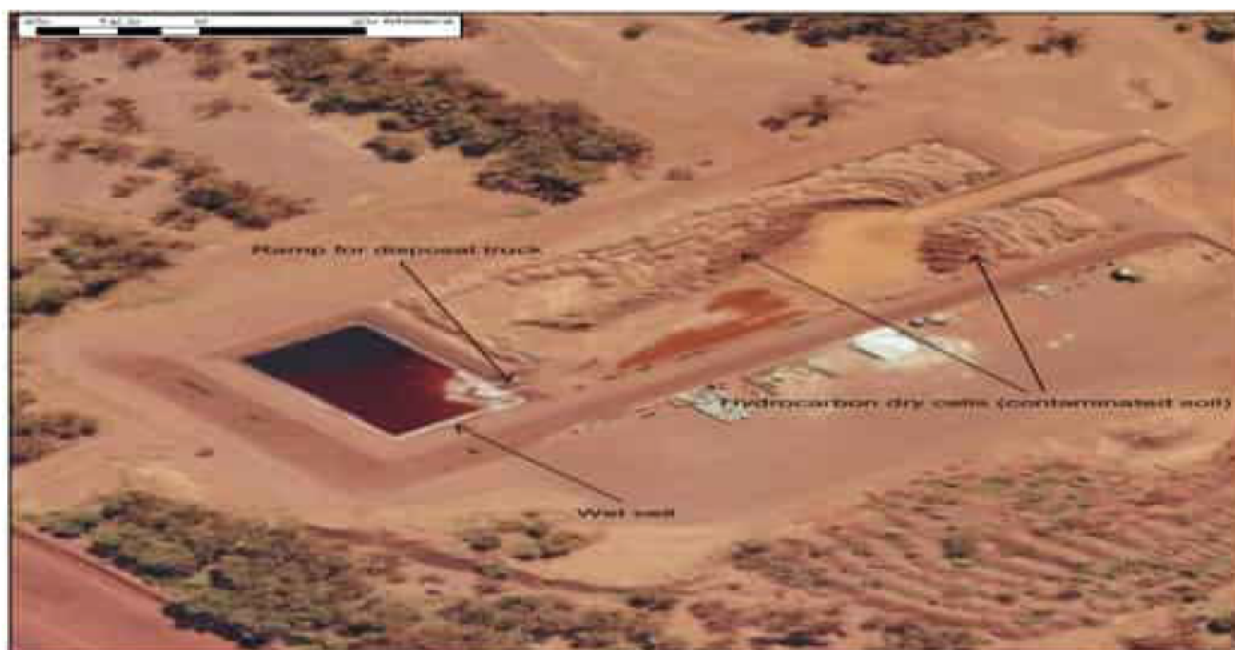
- the cell liner does not meet the permeability requirement of  $\leq 10^{-9}$  m/s;
- potentially contaminated stormwater runoff from the treatment cells is not contained within the bioremediation treatment area; and
- the wet cell is lined for a runoff cell and has been used to accept hydrocarbon contaminated waste.

The Oreboddy 18 bioremediation facility has the following site characteristics which minimise potential environmental risk (as depicted in the figure below):

- Flat/ gently sloping site;
- Located at least 50 m from surface water bodies;
- Separation from the treatment cell/s to groundwater is greater than 3 m; and
- Sufficient distance from potential discharge pathways i.e. drains.

Based on the above site characteristics and site inspection evidence, no known or suspected adverse environmental impact has occurred.

BHP identified that the bioremediation facility management requires improvement to ensure that hydrocarbon contaminated soils are successfully remediated.

BHP has undertaken an investigation into the management of the bioremediation facility and completed improvement works in FY2023 to improve licence compliance. Improvement works include sampling and analysis of contaminated soils and reshaping soil stockpiles to below the height of the facility bunding to ensure potentially contaminated runoff is contained within the facility.

The contaminated material near the boundary of the facility is to be moved or reduced in height

to be below the height of the bunding. Photographic evidence that this has been completed is required to be provided 21 days from the date of the inspection report cover letter.
