Annual Audit Compliance Report Form

Environmental Protection Act 1986, Part V

Section A – Licence Details			
Licence number:	L5415/1988/9	Licence file number:	DER2013/00900 1
Licence holder:	BHP Iron Ore Pty Ltd		
Trading as:	BHP Iron Ore Pty Ltd		
ACN:	008 700 981		
Registered address:	Level 1, City Square Brookfield Place 125 St Georges Terrace PERTH WA 6000		
Reporting period:	01/07/2021 to 30/06/2022

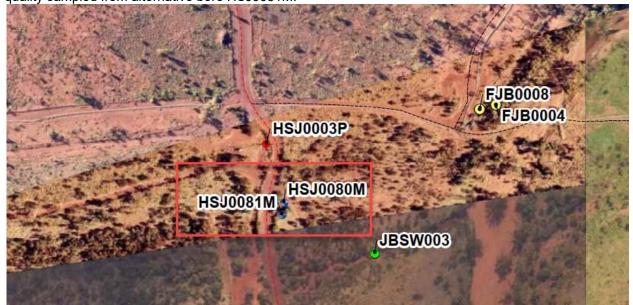
For JBGW0080M, a small water volume (13 kL) was reinjected at adjacent HSJ0003P during this period. There was no suspected environmental impact from not monitoring and no impact identified in water quality sampled from alternative bore HSJ0081M.

Part of the borehole casing for JBGW0080M has collapsed preventing any pumping equipment to pass the blockage.

HSJ0081M was selected to be sampled as it is in close proximity (10 m) to JBGW0080M (HSJ0080M) sufficing the same aguifer type, similar depth, and geology. The Licence Amendment was submitted on 7 December 2021 and approved on 17 March 2022 where JBGW0080M (HSJ0080M) was replaced with HSJ0081M.

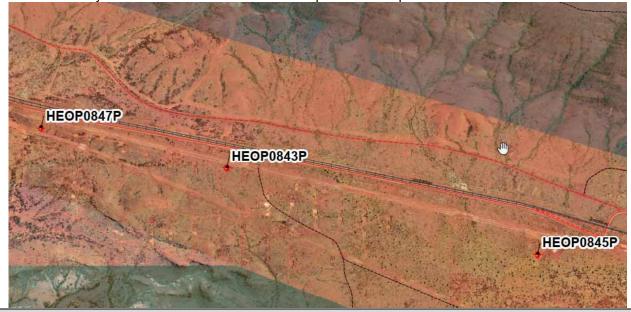
There is no environmental impact of not reporting the monitoring data of the three MAR injection bores. The three injection bores have been monitored as required by the Licence, and the analysis results did not indicate any concentrations that would have the potential to impact on the environment.

The cause of the non-compliance was an administrative error following the April 2020 Licence Amendment.

The FY2022 flow rate, reinjection volume and water quality results for the three reinjection bores have been reported in this FY2022 AER, and internal processes are now in place to ensure that reporting occurs in line with the licence conditions in the future.
