Annual Audit Compliance Report

Environmental Protection Act 1986, Part V Division 3

Section A – Licence details			
Licence number:	L5533/1976/11	Licence file number:	FA278067
Licence holder name:	BHP Nickel West Pty Ltd		
Trading as:	BHP Nickel West		
ACN:	004 184 598		
Registered business address:	125 St Georges Terrace PERTH WA 6000		
Reporting period:	01/01/2024 to 30/06/2025

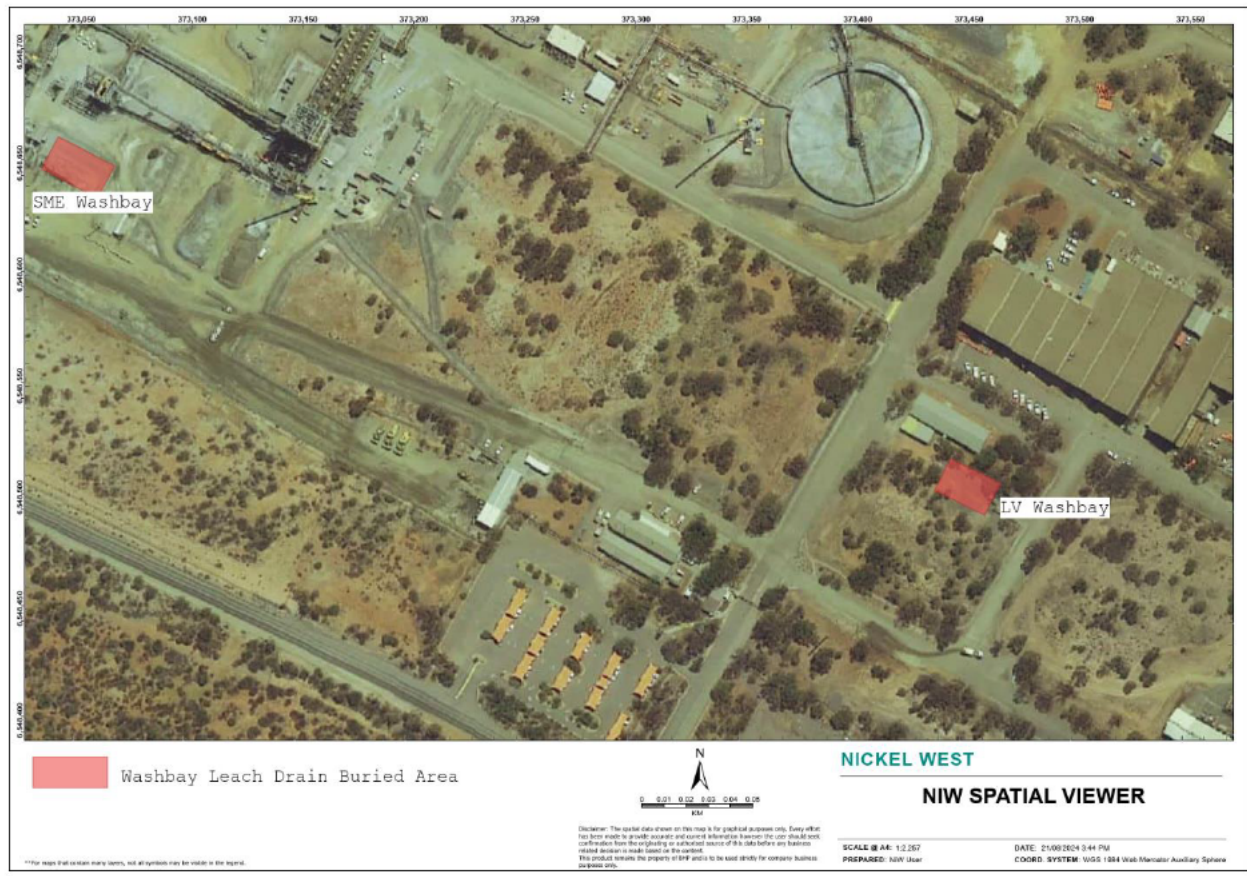
Monitoring conducted on 3 August 2024 indicates that wastewater discharged from the vehicle washdown bay areas did not meet the limits specified in Table 2 of Condition 22 of the Licence. Specifically, the LV washdown bay returned a result of 7mg/L for Surfactants against a limit of 5mg/L, and the SME washdown bay returned a result of pH 4.21 against a limit range of pH 5.5-8.5.

As the discharge was near licence limits and was contained within the site stormwater management system no adverse environmental consequences are anticipated.

Increased utilization of the washdown bay prior to the transition into temporary suspension, resulted in the introduction of additional volume of particulates and detergent which impacted discharge water quality. Light Vehicle washdown bay additional use resulted in higher detergent load to the separator.

Section E – Details of non-compliance with licence condition	
Service oil/water separator to ensure efficient operation Remove current detergent from use and source alternative product Collect samples of washdown bay discharge water to confirm that preventative actions have been effective	
Was this non-compliance previously reported to DWER?	
<input checked="" type="checkbox"/> Yes, and	
<input type="checkbox"/> Reported to DWER verbally	Date: / /
<input checked="" type="checkbox"/> Reported to DWER in writing	Date: 21/8/2024

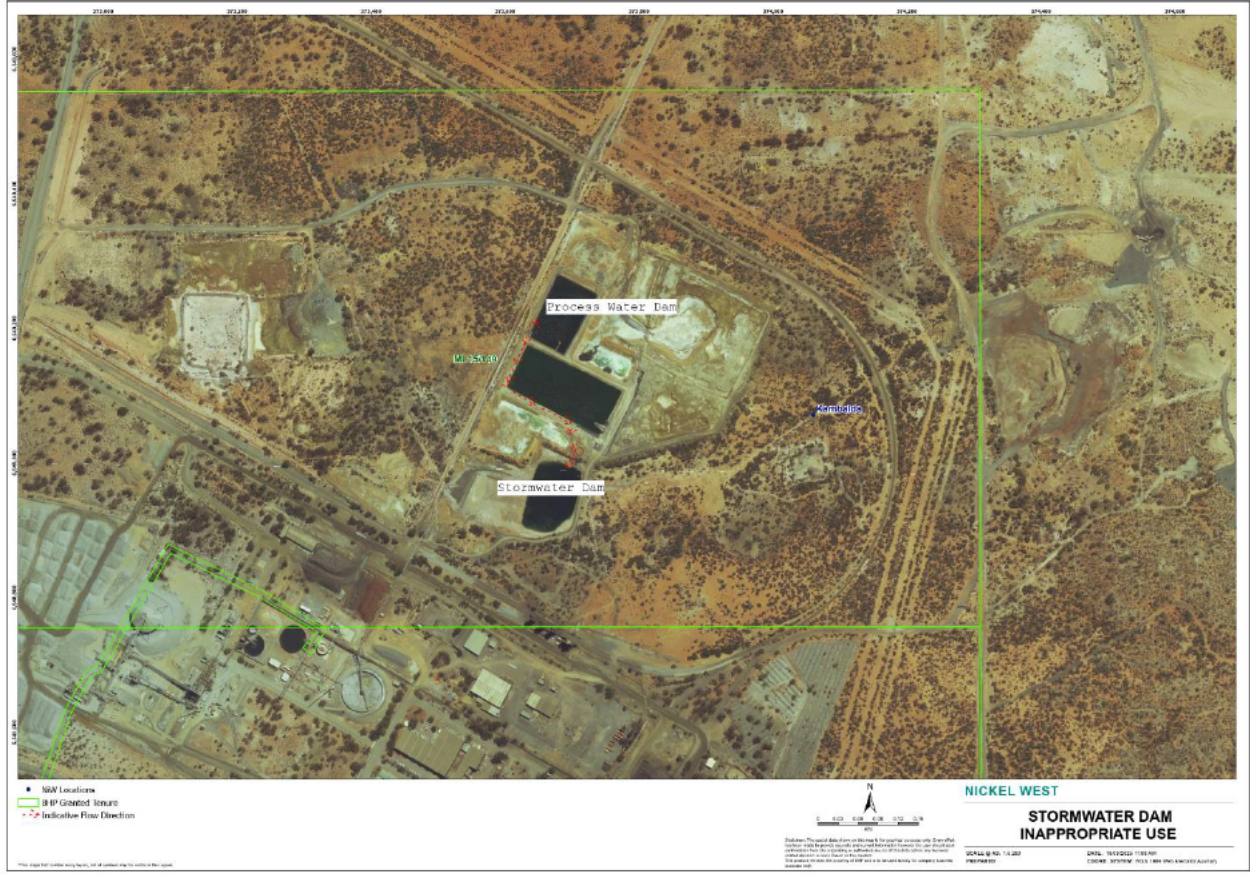
In August 2024, process water was transferred into the stormwater dam.

The actual environmental impact of receiving decant or process water into stormwater dam (SWD) is believed to be minimal, considering the established water quality of SWD, such that the pH of TSF decant water is higher than that of SWD.

- There was excess water onsite due to a combination of:
- Operation is in temporary suspension resulting in a significant decrease of water re-use
 - Significant rainfall events in July and August 2024

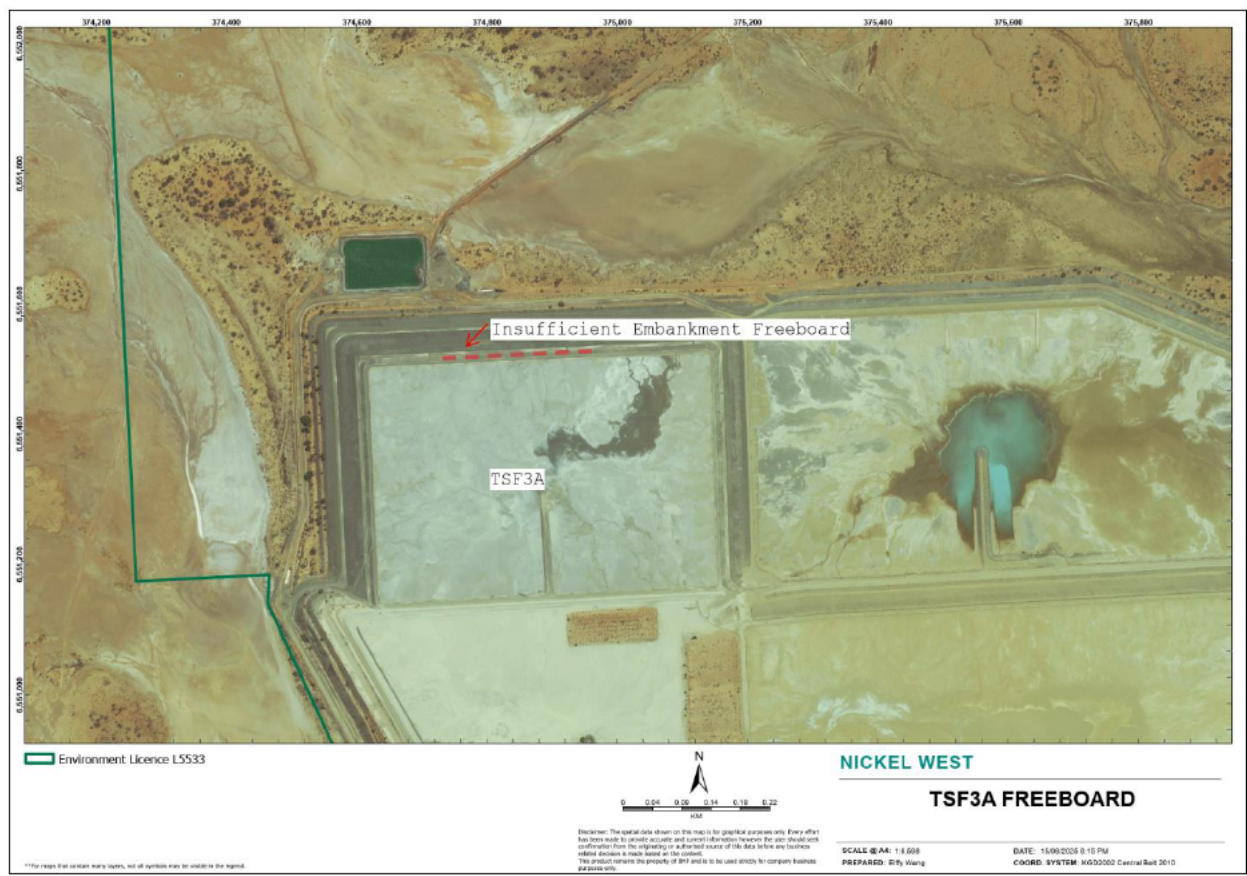
During an internal audit finalised in January 2025, it was observed that TSF3A freeboard from the top of embankment was less than 300 mm.

No actual or suspected environmental impact from this non-compliance. The most recent TSF Engineer of Record Annual Audit (report finalised January 2025) identified that there is sufficient stormwater holding capacity within TSF3A to prevent overtopping.

Section E – Details of non-compliance with licence condition	
<p>The cause of the freeboard non-compliance was incorrect assessment of available freeboard during daily TSF inspections. The tailings material slopes from the perimeter to the central decant, providing sufficient stormwater holding capacity in the centre.</p>	
Action taken to mitigate any adverse effects of non-compliance and prevent recurrence of the non-compliance:	
<ul style="list-style-type: none"> • Deposition to TSF3A ceased in March 2023 • Civil work completed and 300mm freeboard re-instated at TSF3A early Aug 2025 	
Was this non-compliance previously reported to DWER?	
<input type="checkbox"/> Yes, and	
<input type="checkbox"/> Reported to DWER verbally	Date: / /
<input type="checkbox"/> Reported to DWER in writing	Date: / /

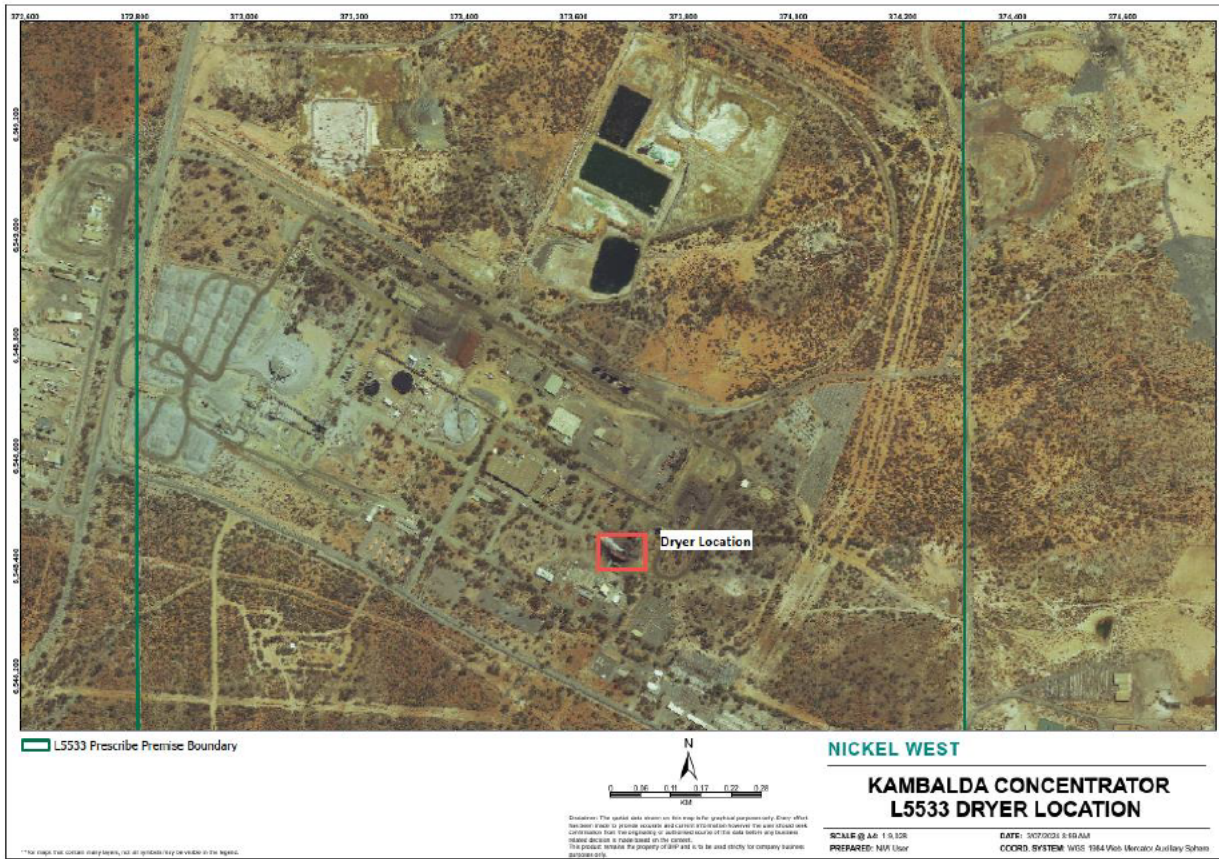
On 29th May 2024, monitoring was conducted in accordance with condition 2, and the results of this monitoring were received by NiW on 2 July 2024. The results show particulate concentration results for dryer stack 2 and dryer stack 3 were 410mg/m³ and 370mg/m³, which exceeded the 250mg/m³ limit.

Post exceedance, a desktop analysis of the potential environmental impacts associated with the elevated particulate measurement was undertaken. The analysis looked at impacts to nearby sensitive receptors at the East Kambalda residential area. In all instances the 24-hour average PM10 concentration was analysed against 50µg/m³ (which is considered the guideline value for adverse impacts to sensitive receptors). This guideline value (DWER, 2019) is sourced from the National Environment Protection (Ambient Air Quality) Measure (NEPC, 2016). Desktop analysis result shows the exceedance event is considered unlikely to have caused any adverse or prolonged impacts to applicable sensitive receptors or to have resulted in observable environmental harm.

The likely cause of the particulate emission exceedance is pump maintenance issues on the scrubber underflow pump.

No discernible environmental impact could be determined that required corrective action. Preventative actions are shown below:

- Maintenance inspection of scrubbers return pumps to confirm mechanically operational

<ul style="list-style-type: none">• Spray bar flow and pressure checked• Scrubber cleaning completed on all scrubbers	
Was this non-compliance previously reported to DWER?	
<input checked="" type="checkbox"/> Yes, and	
<input type="checkbox"/> Reported to DWER verbally	Date: / /
<input checked="" type="checkbox"/> Reported to DWER in writing	Date: 3/7/2024

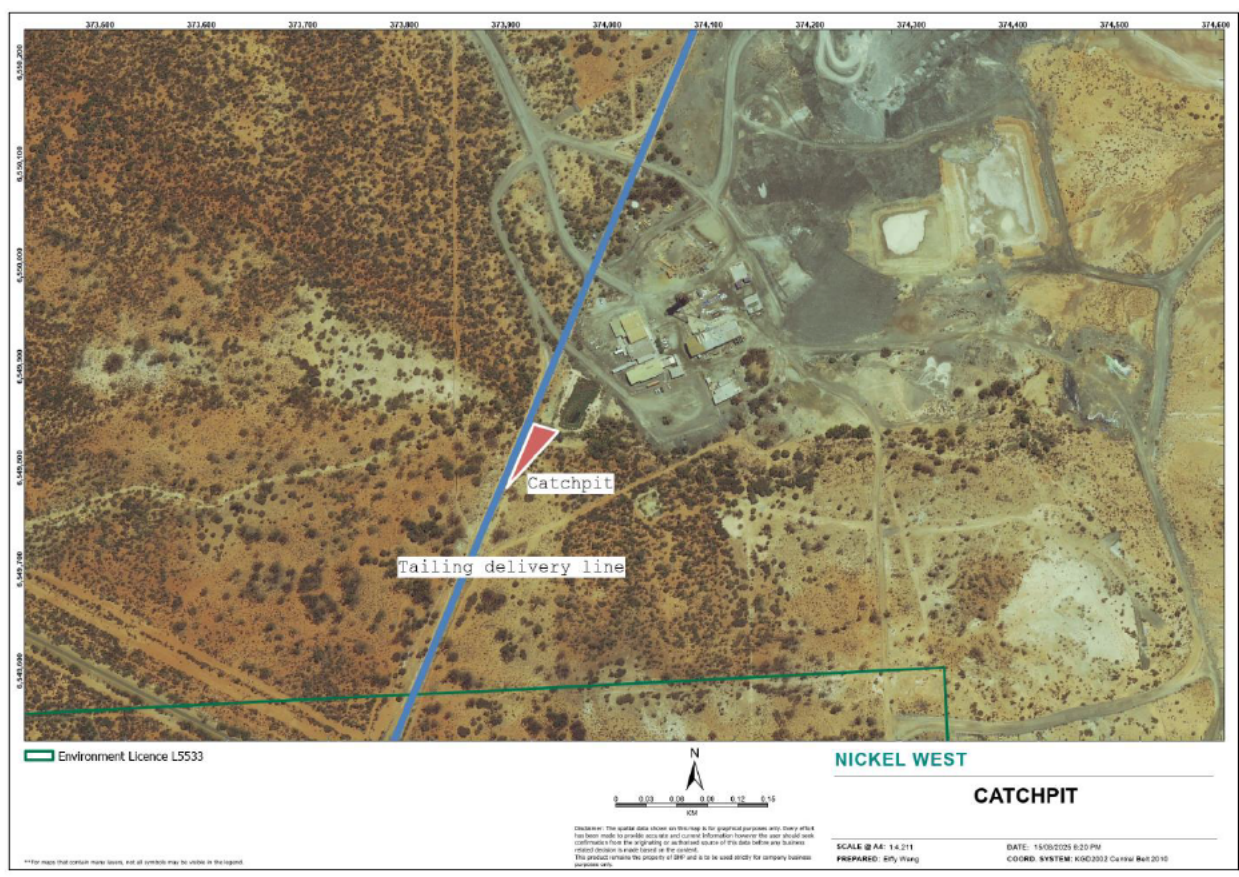
While conducting an internal audit on 14 July 2025, it was identified that the biannual catch pit inspection had not been conducted.

No actual or suspected environmental impact from this non-compliance. The inspection has since been conducted with no major issues identified. The TSF route is still being inspected daily whilst in temporary suspension. No spill or discharge occurred along the tailings line or catch pit between November 2024 – June 2025.

During the transition into temporary suspension there was a licence amendment issued in November 2024, with a new requirement to conduct biannual catchpit inspections. This was during the transition into temporary suspension and with the reduction and changeover in personnel there was an oversight of this requirement.

Upon identification, a catch pit inspection was immediately conducted and an automated work management task established to ensure it is not missed in the future.
