Annual Audit Compliance Report Form

| Trading as: | Northam Wastewater Treatment Plant | | |
| Reporting period: | 01 / 07 / 2019 to 30 / 06 / 2020 | | |

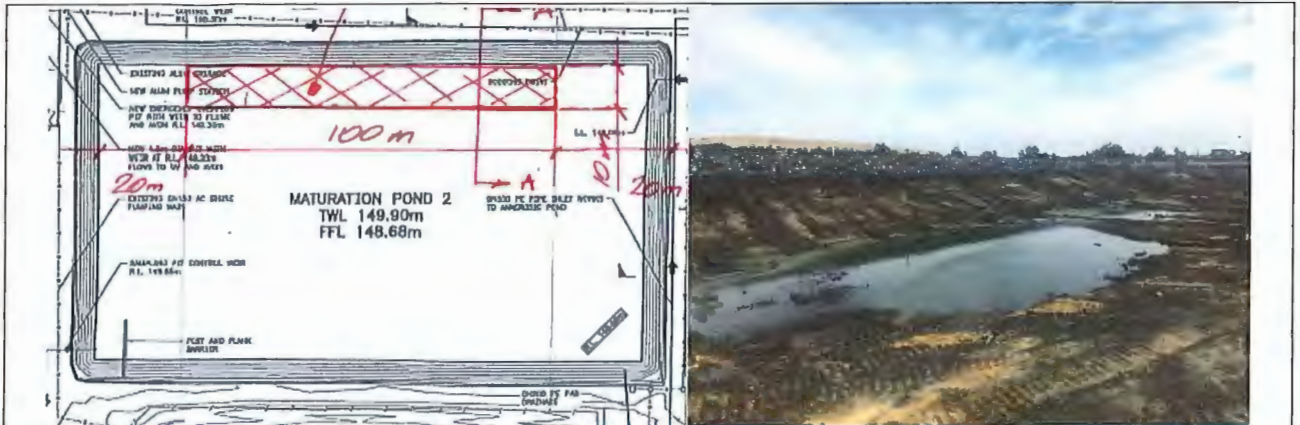
When Secondary Treatment Pond 2 was taken offline and drained for de-sludging works in November 2019, at the time it was observed that the pond floor was undulating with evidence of hard material (possibly cemented lateritic gravel) exposed in several locations and damp areas were observed in the north-western portion of the pond floor. A geotechnical engineering assessment was completed on 18 March 2020 by Water Corporation, which concluded that it is likely that the clay liner has been compromised where the affected damp areas have been observed.

Diagram 2. and image showing area in the north-western portion of Pond 2 where pooling has occurred; and remedial works are to be conducted in the short term

It is suspected that the compromise in the clay liner had resulted due to the cementing of lateritic gravel, a composite material of the clay liner itself. The cementing of the lateritic gravel is likely to have caused cracks in the liner and opportunity/pathway for seepage. The structural integrity of the containment infrastructure itself was not compromised as a result.

Water Corporation undertook relining works to rectify affected areas of the pond using a Geosynthetic Clay Liner (GCL), this work was completed in April 2020.

The Secondary Treatment Pond 2 will be permanently taken offline as part of the upgrade plans (refer to Works Approval 6224/2019/1 issued 23 December 2019).
