**Nickel West Pty Ltd**

**Mount Keith Operations**

**Annual Audit Compliance  
Report**

**L6453/1990/12**

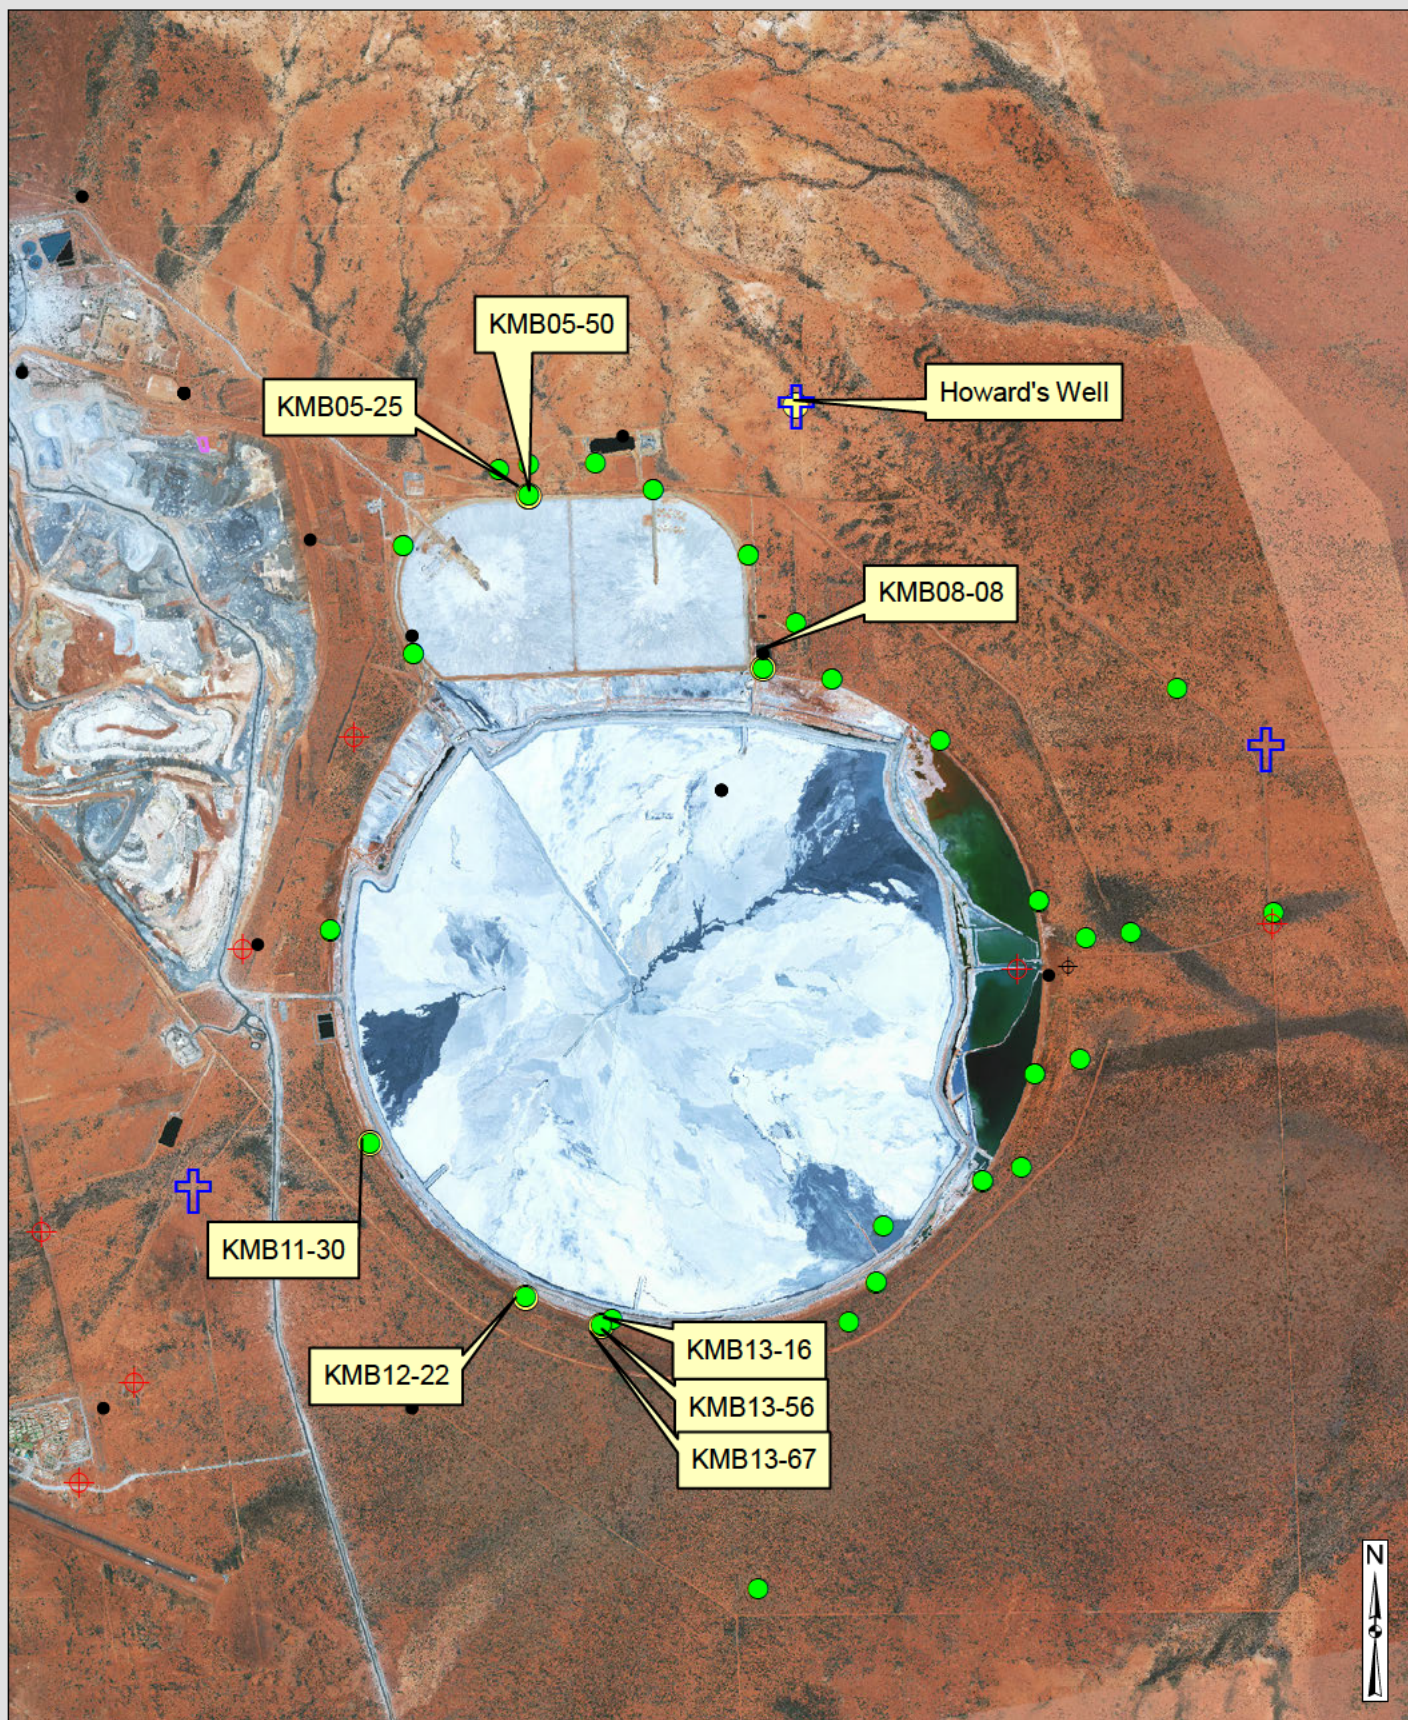
## L6453/1990/12 Monitoring Bores

Samples and measurements were not obtained from 8 monitoring bores due to access issues and 1 bore has been dry at each monitoring event. Refer to map of Monitoring Bores.

- KMB05-25 and KMB05-50 bore casings were damaged at the time and could not be sampled. They have been subsequently repaired.
- KMB08-08 is not accessible by vehicle and cannot be sampled by vehicle mounted pump. Steps are being taken to investigate access options.
- KMB11-07 and KMB12-22 bore caps have rusted and seized. There is a maintenance work order for these caps to be replaced.
- KMB13-16, KMB13-56 and KMB13-67 bores were inaccessible for vehicle access due to poor ground conditions. There is a maintenance work order being implemented to improve ground conditions.
- Howard's Well was accessible, but was dry at time of sampling.

Nickel West will investigate and remediate the above access issues to enable resumption of the required monitoring as soon as practicable to ensure results can be recorded for the next period as required by Condition 17.
