## Annual Audit Compliance Report Form

Section A – Licence Details			
Licence number:	L6453/1990/12	Licence file number:	2011/009443
Licence holder:	BHP Billiton Nickel West Pty Ltd		
Trading as:			
ACN:	004184598		
Registered address:	125 St Georges Terrace PERTH 6000		
Reporting period:	01/01/2020 to 31 /12 /2020

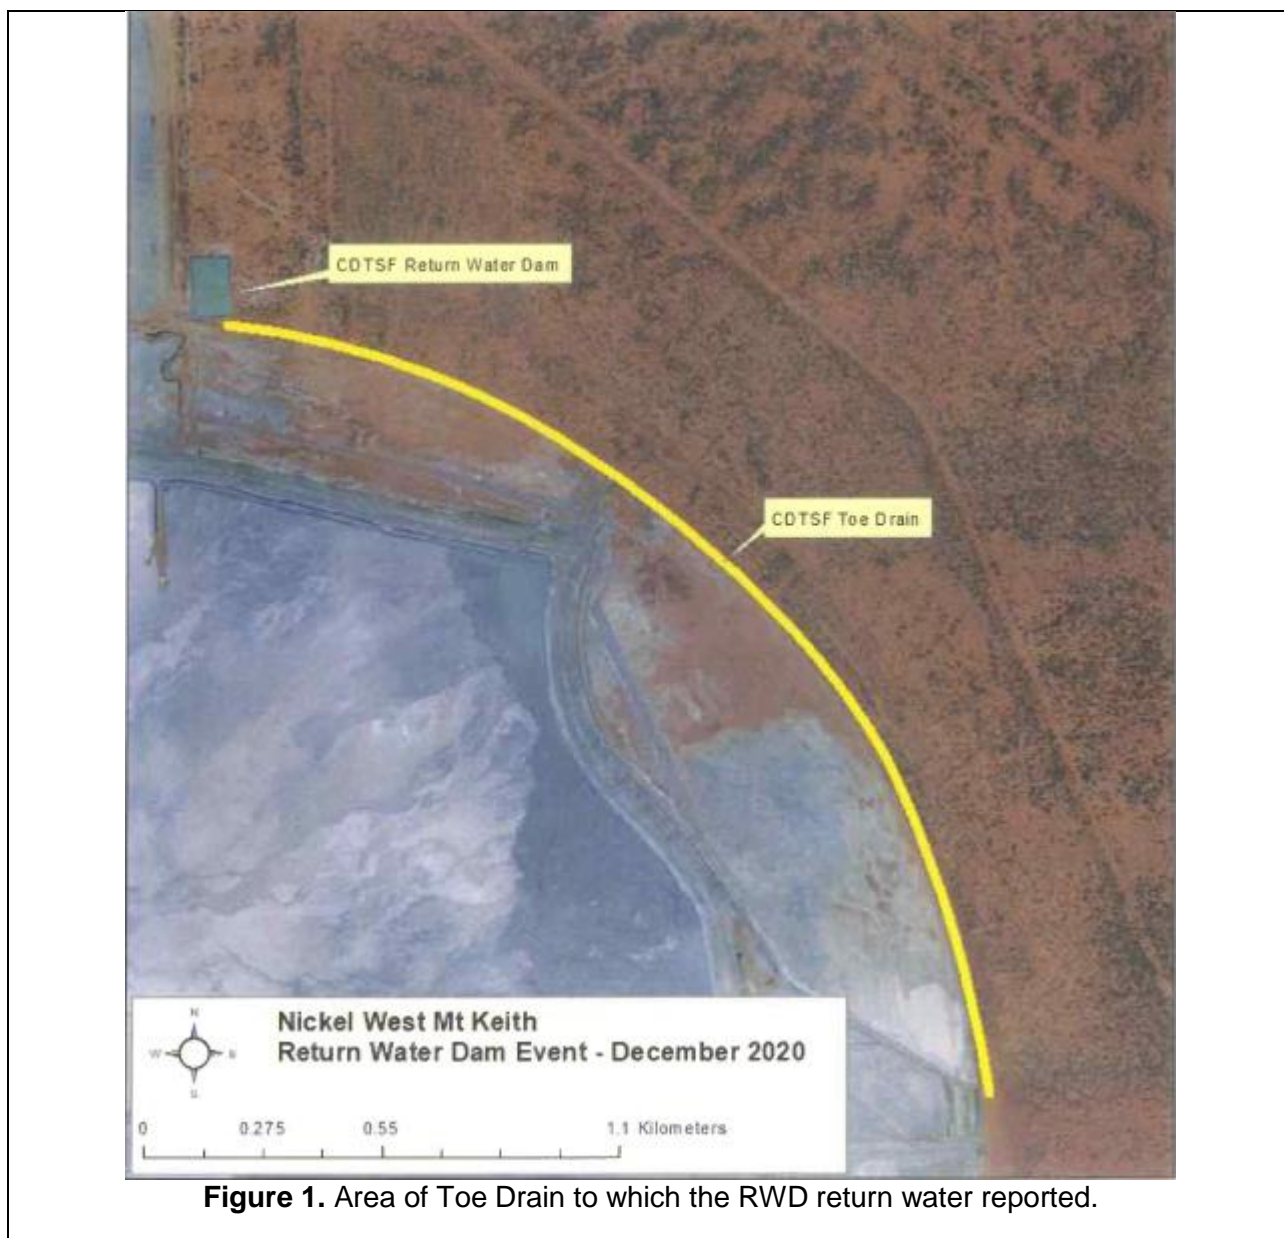
A release of centralised discharge tailings storage facility (CDTSF) return water, from the Mt Keith CDTSF Return Water Dam (RWD), occurred at approximately 21:50 pm on Saturday December 19 2020. This event was identified during a routine daily inspection by the site Water Services technician, at approximately 05:45 am the following day (Sunday December 20).

No environmental impact occurred. Water remained within the dam infrastructure.

**Figure 1.** Area of Toe Drain to which the RWD return water reported.

- Thunderstorm activity resulted in an outage of the telemetry link between the RWD and the Mt Keith Concentrator Plant.
- The loss of telemetry caused the inflow pumps that fill the RWD to cease operation. Due to the prolonged period of the telemetry outage, the decant pumps were started in 'local' at approximately 18:00 pm that day.
- One of the pumps that direct water from the WRD to the Concentrator Plant was then started. As only the smaller pump was started (in error), flow into the RWD exceeded the rate of discharge out of the facility resulting in an increase in the volume of water retained in the RWD beyond the licence freeboard level.

The ability to operate the CDTSF decant pumps (that feed the RWD) in 'local' has been removed, through incorporating a system interlock. This action will prevent the pumps from being manually started when the telemetry system is unavailable, thereby avoiding a repeat of this event.
