Annual Audit Compliance Report Form

Environmental Protection Act 1986, Part V Division 3

Licence number:	L6498/1995/11	Licence file number:	2012/006868-1
Licence holder name:	Northern Star Resources Ltd		
Trading as:	Northern Star Resources Ltd		
ACN:	092832892		
Registered business address:	Level 4, 500 Hay Street Subiaco		
Reporting period:	01/01/2024 to 31/12/2024

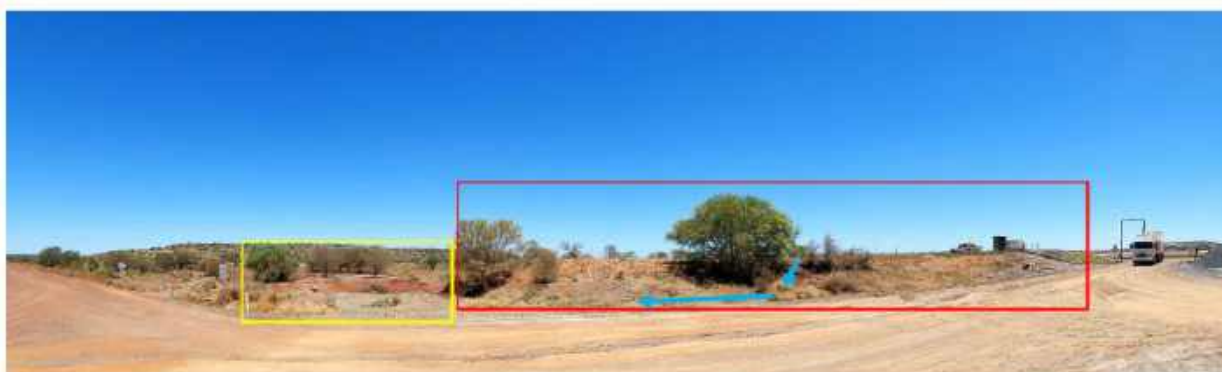
Following an inspection, it was identified that minor spillage had occurred from the North-Eastern embankment of the Main Turkeys Nest Dam, in breach of condition 1.2.2. The spillage did not extend beyond the Main Turkeys Nest Dam embankment and adjoining sump that captures any roadside run-off from the water cart refilling area.

No actual environmental impacts were identified throughout the investigation. Spill material was contained within the road drainage sump.

Figure 1: shows the Main Turkeys Nest Dam within the red square, and location of overflow with approximate extent of spillage highlighted by blue arrows. The yellow square highlights the road drainage sump adjacent to the Main Turkeys Nest Dam.

Section E – Details of non-compliance with licence condition	
Cause (or suspected cause) of non-compliance:	
<p>An in-depth investigation into the cause of the freeboard breach and discharge event determined:</p> <ul style="list-style-type: none"> Pumping from the Turkey nest for dust suppression ceased approximately 4 weeks prior to the incident due to faults with the diesel pump. Inclement weather saw 68mm fall onsite during the period leading to the event. Regular freeboard inspections were not conducted as per Condition 1.2.5 which would have identified the freeboard breach prior to the overflow. 	
Action taken to mitigate any adverse effects of non-compliance and prevent recurrence of the non-compliance:	
<p>Immediate corrective actions are as follows:</p> <p>Action 1: <i>04 February 2024</i> – Immediate notification to responsible department managers of missed compliance inspections. Daily check sheets updated to capture condition 1.2.5, stipulated in table 1.2.3.</p> <p>Action 2: <i>07 February 2024</i> – Manual transfer of water from Turkey nest to water truck.</p> <p>Action 3: <i>09 February 2024</i> – Delivery of replacement pump brought forward. Installation of electric pump completed on the same day. Replacement pump now fully operational and 300mm freeboard level restored.</p> <p>Action 4: <i>16 February 2024</i> – Meeting with relevant department managers, supervisors, and operators to provide training relevant to environmental operating licence requirements. Additional communication will be provided to ensure both crews are covered.</p> <p>Action 5: Northern Star will implement a compliance audit schedule which will include the review of compliance inspections across the Jundee Operation monthly.</p>

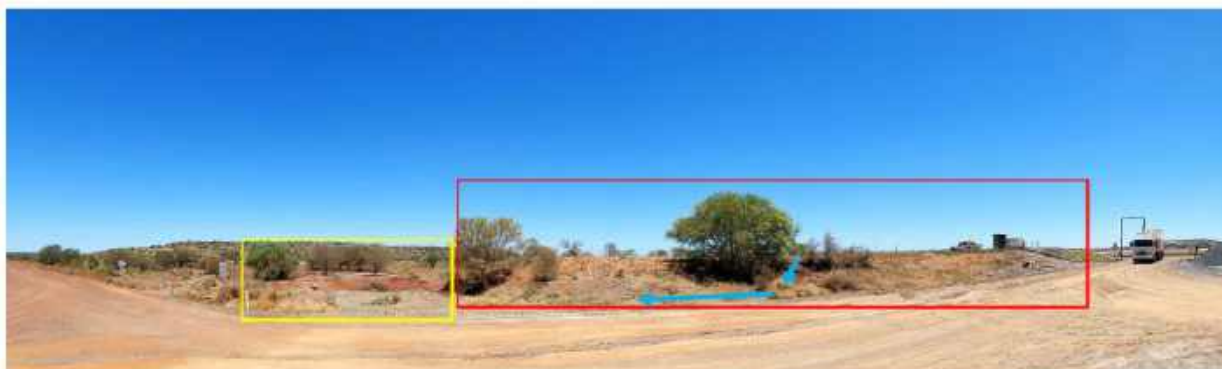
No actual environmental impacts were identified throughout the investigation. Spill material was contained within the road drainage sump.

Figure 1: shows the Main Turkey's Nest Dam within the red square, and location of overflow with approximate extent of spillage highlighted by blue arrows. The yellow square highlights the road drainage sump adjacent to the Main Turkey's Nest Dam.

An in-depth investigation into the cause of the freeboard breach and discharge event determined:

- Pumping from the Turkey nest for dust suppression ceased approximately 4 weeks prior to the incident due to faults with the diesel pump.
- Inclement weather saw 68mm fall onsite during the period leading to the event.
- Regular freeboard inspections were not conducted as per Condition 1.2.5 which would have identified the freeboard breach prior to the overflow.

Immediate corrective actions are as follows:

Action 1: *04 February 2024* - Immediate notification to responsible department managers of missed compliance inspections. Daily check sheets updated to capture condition 1.2.5, stipulated in table 1.2.3.

Action 2: *07 February 2024* – Manual transfer of water from Turkey nest to water truck.

Action 3: *09 February 2024* – Delivery of replacement pump brought forward. Installation of electric pump completed on the same day. Replacement pump now fully operational and 300mm freeboard level restored.

Action 4: *16 February 2024* – Meeting with relevant department managers, supervisors, and operators to provide training relevant to environmental operating licence requirements. Additional communication will be provided to ensure both crews are covered.

Action 5: Northern Star will implement a compliance audit schedule which will include the review of compliance inspections across the Jundee Operation monthly.

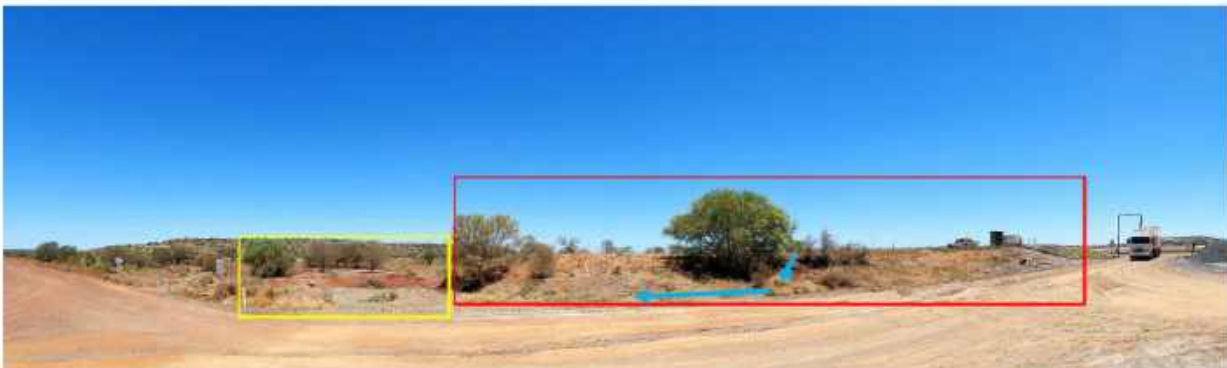
<p>Figure 1: shows the Main Turkeys Nest Dam within the red square, and location of overflow with approximate extent of spillage highlighted by blue arrows. The yellow square highlights the road drainage sump adjacent to the Main Turkeys Nest Dam.</p>			
Cause (or suspected cause) of non-compliance:

Section E – Details of non-compliance with licence condition	
An in-depth investigation into the cause of the freeboard breach and discharge event determined:	
<ul style="list-style-type: none"> • Pumping from the Turkey nest for dust suppression ceased approximately 4 weeks prior to the incident due to faults with the diesel pump. • Inclement weather saw 68mm fall onsite during the period leading to the event. • Regular freeboard inspections were not conducted as per Condition 1.2.5 which would have identified the freeboard breach prior to the overflow. 	
Action taken to mitigate any adverse effects of non-compliance and prevent recurrence of the non-compliance:	
Immediate corrective actions are as follows:	
<p>Action 1: <i>04 February 2024</i> - Immediate notification to responsible department managers of missed compliance inspections. Daily check sheets updated to capture condition 1.2.5, stipulated in table 1.2.3.</p> <p>Action 2: <i>07 February 2024</i> – Manual transfer of water from Turkey nest to water truck.</p> <p>Action 3: <i>09 February 2024</i> – Delivery of replacement pump brought forward. Installation of electric pump completed on the same day. Replacement pump now fully operational and 300mm freeboard level restored.</p> <p>Action 4: <i>16 February 2024</i> – Meeting with relevant department managers, supervisors, and operators to provide training relevant to environmental operating licence requirements. Additional communication will be provided to ensure both crews are covered.</p> <p>Action 5: Northern Star will implement a compliance audit schedule which will include the review of compliance inspections across the Jundee Operation monthly.</p>

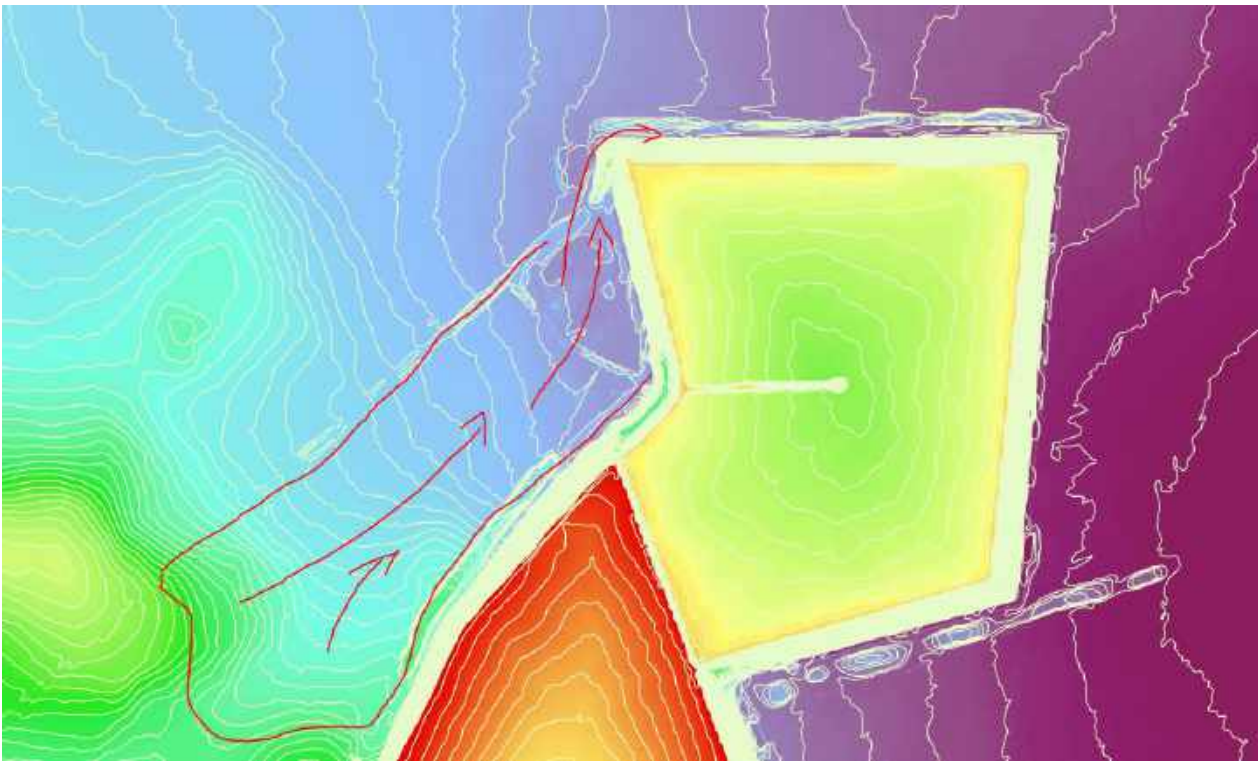
Section E – Details of non-compliance with licence condition			
Please use a separate page for each condition with which the licence holder was non-compliant at a time during the reporting period.			
Condition no:	1.2.2	Date(s) of non-compliance:	14/03/24
<p>Details of non-compliance:</p> <p>Condition 1.2.2 (Table 1.2.1) - Containment Infrastructure - requires seepage groundwater recovered near TSF2 to be contained in R2D2 seepage water dam.</p> <p>Heavy rainfall and insufficient pumping capacity has caused the TSF2 Recovery dam R2D2 to overflow.</p>			
<p>What was the actual (or suspected) environmental impact of the non-compliance?</p> <p>NOTE – please attach maps or diagrams to provide insight into the precise location of where the non-compliance took place.</p>			
<p>Through continued vegetation monitoring, no impact has been identified to vegetation within the incident area.</p>

<p>Cause (or suspected cause) of non-compliance:</p> <p>As a result of heavy rainfall on 14 March 2024, to the value of 81.6mm, and surface runoff from adjacent areas entering the seepage toe drain, R2D2 was not able to contain the volume it was receiving. This resulted in an inability of R2D2 to maintain the required minimum freeboard and, as a result, containment could not be maintained. This was observed at 15:00 on 14 March 2024.</p>

Section E – Details of non-compliance with licence condition			
Please use a separate page for each condition with which the licence holder was non-compliant at a time during the reporting period.			
Corrective actions to prevent recurrence of this event include:			
Action 1: Repair of damaged areas using more competent material.			
Action 2: Increase toe drain Windrow height by 500mm to be more resilient during periods of flooding.			
Action 3: Remove sediment from TSF2 toe drain to increase capacity and effectiveness of intercepting surface water flows off the TSF2 batter.			
Action 4: Review of site contours to better determine surface water flow paths and modify infrastructure accordingly to divert heavy rainfall flows away from the toe drain.			
Action 5: Continuation of existing monthly photo monitoring until September 2024			
Was this non-compliance previously reported to DWER?			
<input checked="" type="checkbox"/> Yes, and

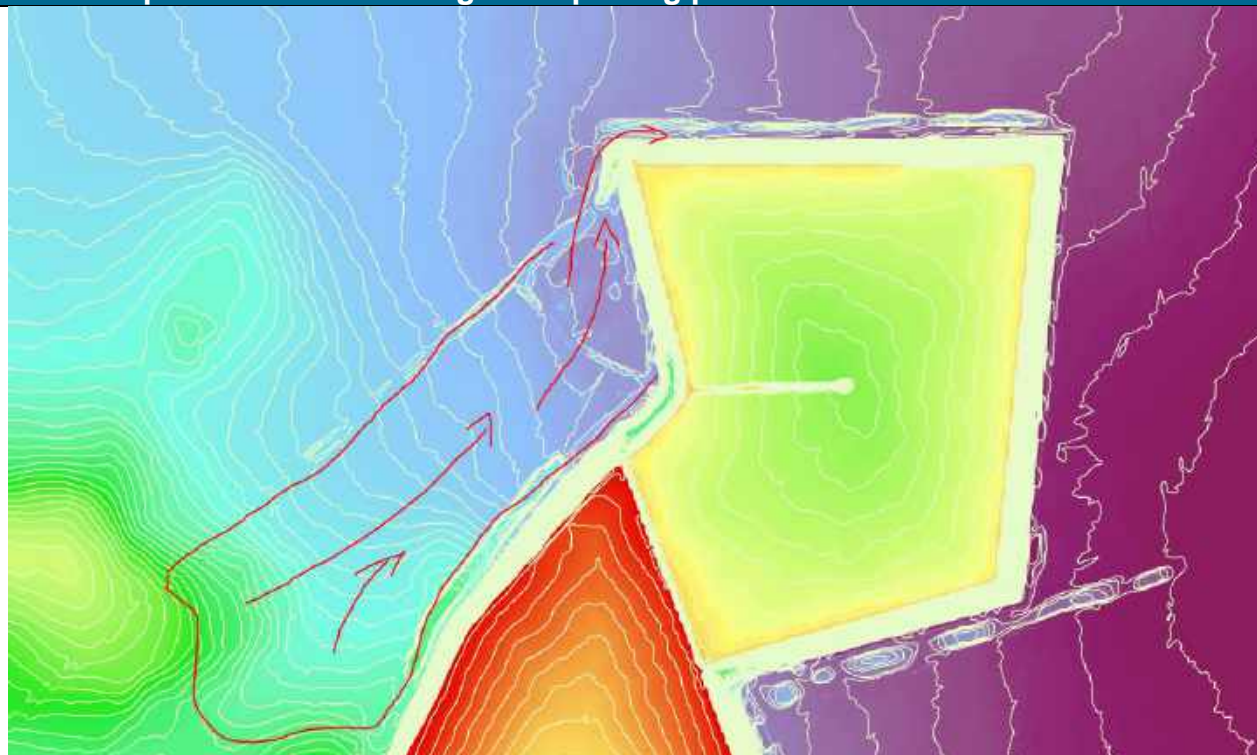
Through continued vegetation monitoring, no impact has been identified to vegetation within the incident area

As a result of heavy rainfall on 14 March 2024, to the value of 81.6mm, and surface runoff from adjacent areas entering the seepage toe drain, R2D2 was not able to contain the volume it was receiving. This resulted in an inability of R2D2 to maintain the required minimum freeboard and, as a result, containment could not be maintained. This was observed at 15:00 on 14 March 2024.

Action 1: Repair of damaged areas using more competent material.

Action 2: Increase toe drain Windrow height by 500mm to be more resilient during periods of flooding.

Action 3: Remove sediment from TSF2 toe drain to increase capacity and effectiveness of intercepting surface water flows off the TSF2 batter.

Action 4: Review of site contours to better determine surface water flow paths and modify infrastructure accordingly to divert heavy rainfall flows away from the toe drain.

Action 5: Continuation of existing monthly photo monitoring until September 2024

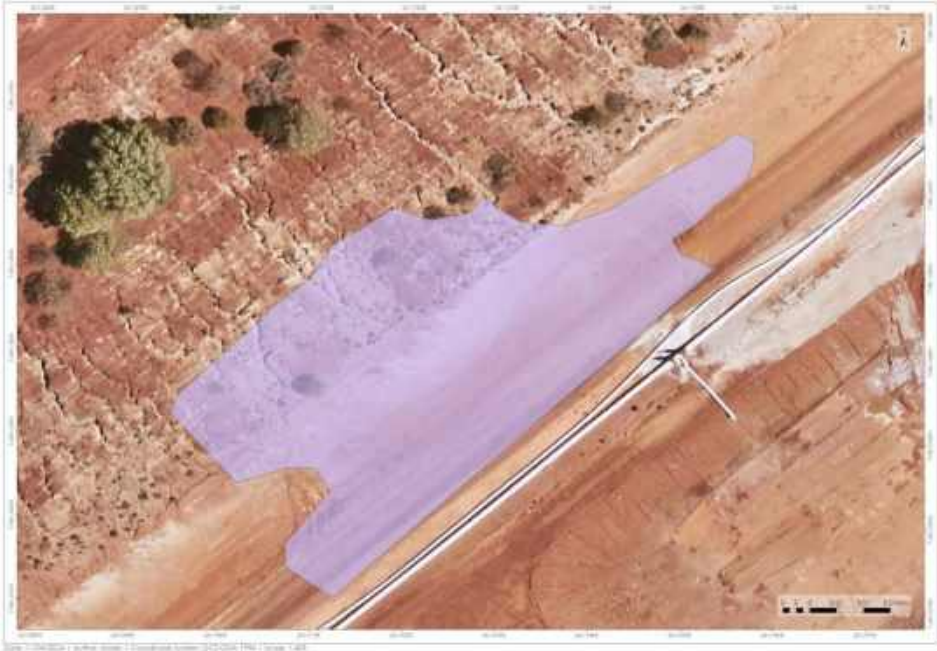
Section E – Details of non-compliance with licence condition			
Please use a separate page for each condition with which the licence holder was non-compliant at a time during the reporting period.			
Condition no:	1.2.2	Date(s) of non-compliance:	04/04/24
<p>Details of non-compliance:</p> <p>Condition 1.2.2 The Licence Holder shall ensure that waste material is only stored and/or treated within vessels or compounds provided with infrastructure requirements and at the locations specified in Table 1.2.1.</p> <p>On 04/04/24 a member of the processing team was completing routine inspections of the TSF3 tailings discharge pipeline when a leak in the line was identified at a knife gate valve, spraying tailings slurry beyond the V drain containing the pipeline.</p> <p>The leak has created a small, condensed spill directly adject to the knife gate and windblown residue has been sprayed across a total area of approximately 1445m², with approximately 500m² of a rehabilitated WRL batter affected.</p>

<p>What was the actual (or suspected) environmental impact of the non-compliance?</p> <p>NOTE – please attach maps or diagrams to provide insight into the precise location of where the non-compliance took place.</p>			
<p>No environmental impacts were identified. Due to the superficial nature of the discharge, clean up effectively removed all waste from rehabilitated waste dump batter.</p>

<p>Cause (or suspected cause) of non-compliance:</p>			
<p>The cause of the non-compliance was due to failure in a pipeline valve seal which as allowed tailings slurry to discharge beyond containment.</p>

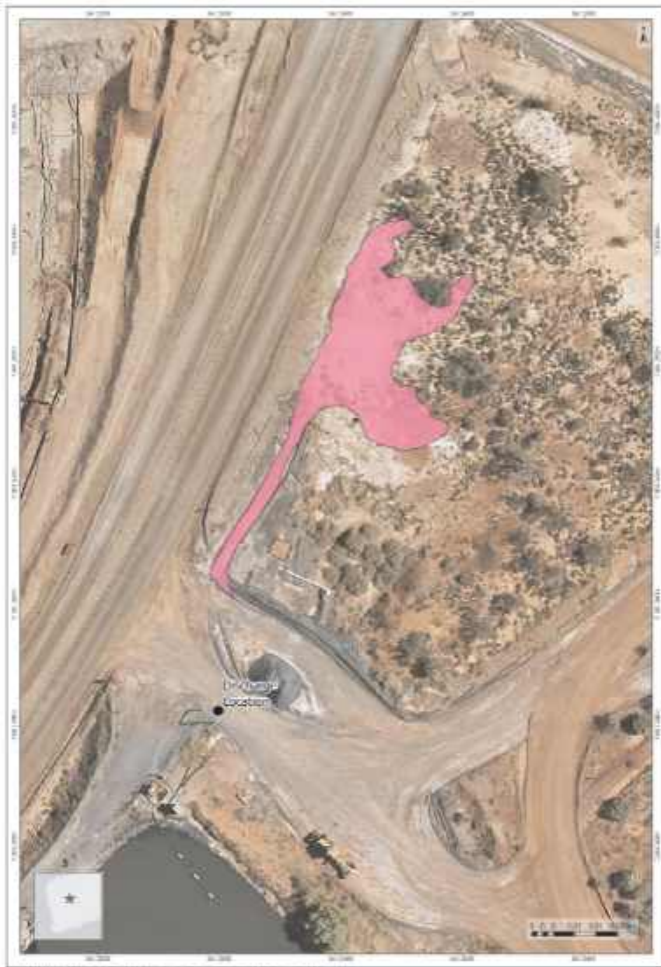
Condition no:	1.2.2	Date(s) of non-compliance:	09/04/24
<p>Details of non-compliance:</p> <p>Condition 1.2.2 The Licence Holder shall ensure that waste material is only stored and/or treated within vessels or compounds provided with infrastructure requirements and at the locations specified in Table 1.2.1.</p> <p>Discharge of mine dewater from turkeys nest via standpipe (fill point) spillage. Water has covered 567m2 of pre-disturbed area and vegetation.</p>			
<p>What was the actual (or suspected) environmental impact of the non-compliance?</p> <p>NOTE – please attach maps or diagrams to provide insight into the precise location of where the non-compliance took place.</p>			
<p>Vegetation within incident area is already heavily impacted from mining activities, located beside an in pit TFS and WRL utilized as a landfill.</p> <p>Further vegetation degradation has not been identified since the incident.</p>

Section E – Details of non-compliance with licence condition	
Please use a separate page for each condition with which the licence holder was non-compliant at a time during the reporting period.	
Non-compliance occurred due to the distance between the standpipe outlet and the shortest water cart inlet was considerably large, which meant that due to the wind and the poor positioning of the watercart, spillage would occur. Mine dewater was spilt onto the ground, and via a runoff trench the mine dewater discharged into a vegetation area.	
Action taken to mitigate any adverse effects of non-compliance and prevent recurrence of the non-compliance:	
Action 1: Earthworks was undertaken immediately and has stopped potential standpipe spillage from entering areas of undisturbed native vegetation.	
Action 2: Standpipe has been upgraded to minimize the risk of spillage when filling watercarts.	
Was this non-compliance previously reported to DWER?

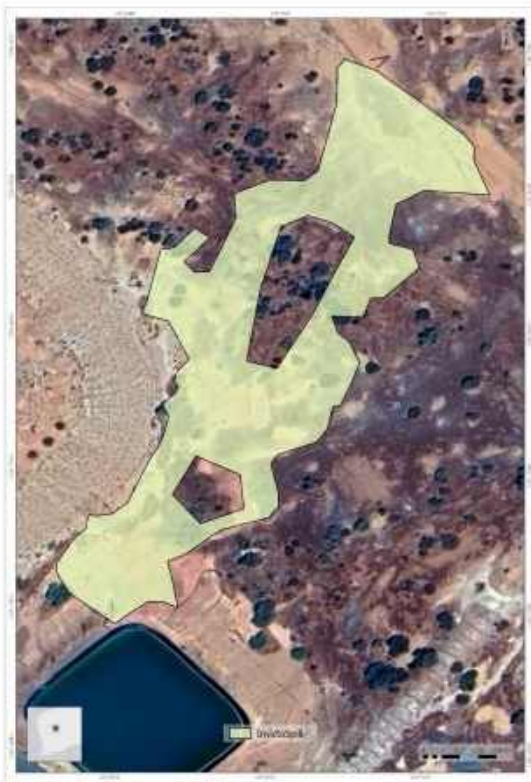
Section E – Details of non-compliance with licence condition			
Please use a separate page for each condition with which the licence holder was non-compliant at a time during the reporting period.			
Section E – Details of non-compliance with licence condition			
Please use a separate page for each condition with which the licence holder was non-compliant at a time during the reporting period.			
Condition no:	1.2.2	Date(s) of non-compliance:	18/09/24
<p>Details of non-compliance:</p> <p>Condition 1.2.2 The Licence Holder shall ensure that waste material is only stored and/or treated within vessels or compounds provided with infrastructure requirements and at the locations specified in Table 1.2.1.</p> <p>A Turkey Nest containing mine dewater was filled beyond its capacity and overtopped the embankment, spilling into previously disturbed vegetation.</p> <p>Mine Dewater quality Water Quality field test EC = 18,700 µC TDS = 12,020 ppm T = 24.3°C pH = 7.9</p>

<p>What was the actual (or suspected) environmental impact of the non-compliance?</p> <p>NOTE – please attach maps or diagrams to provide insight into the precise location of where the non-compliance took place.</p>			
<p>Vegetation surrounding the Invicta Turkey Nest was already heavily impacted from mining activities, being located within the active mining area. Sparse previously disturbed vegetation was not adversely impacted from the spill.</p>

The dewatering pump located in Invicta underground mine to Invicta Turkey Nest was running, however the return pump from the Turkey Nest was off.

This resulted in Invicta Turkey Nest filling to capacity and then resulting in discharge.

Action 1: Investigate feasibility into installing float level alarm/shut off system

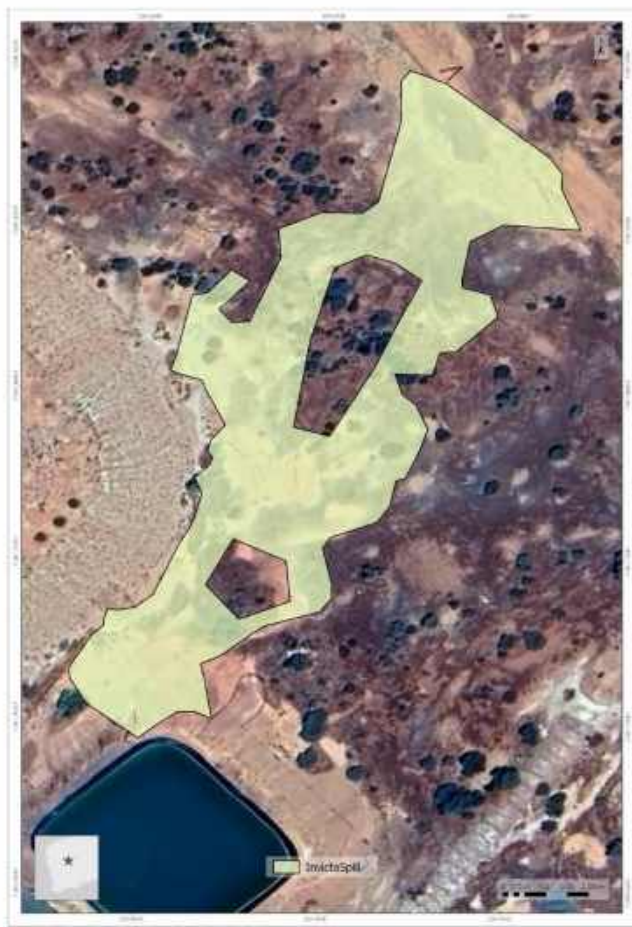
Section E – Details of non-compliance with licence condition			
Please use a separate page for each condition with which the licence holder was non-compliant at a time during the reporting period.			
Condition no:	1.2.4	Date(s) of non-compliance:	18/09/24
<p>Details of non-compliance:</p> <p>Condition 1.2.4 (Table 1.2.2) - Freeboard - requires a minimum freeboard to be maintained for storage vessels. The freeboard requirement for R2D2 is to maintain water levels below the underdrainage outflow pipes flowing into that storage vessel.</p> <p>A Turkey Nest containing mine dewater was filled beyond its capacity and overtopped the embankment, spilling into previously disturbed vegetation.</p> <p>Mine Dewater quality Water Quality field test EC = 18,700 µC TDS = 12,020 ppm T = 24.3°C pH = 7.9</p>			
<p>What was the actual (or suspected) environmental impact of the non-compliance?</p> <p>NOTE – please attach maps or diagrams to provide insight into the precise location of where the non-compliance took place.</p>

The dewatering pump located in Invicta underground mine to Invicta Turkey Nest was running, however the return pump from the Turkey Nest was off.

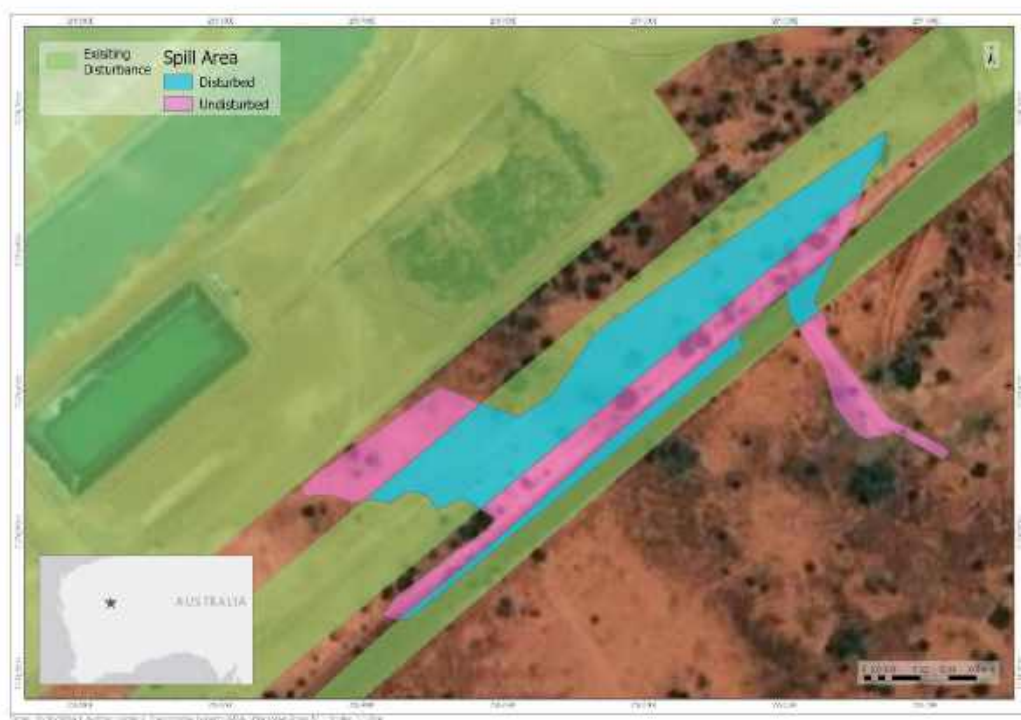
Vegetation surrounding the TSF3 decant recover dam R4D4 had already been impacted by mining activities. A significant amount of the spill was contained to a diversion channel for an old haul road. No Impact was identified to the sparsely vegetated area.

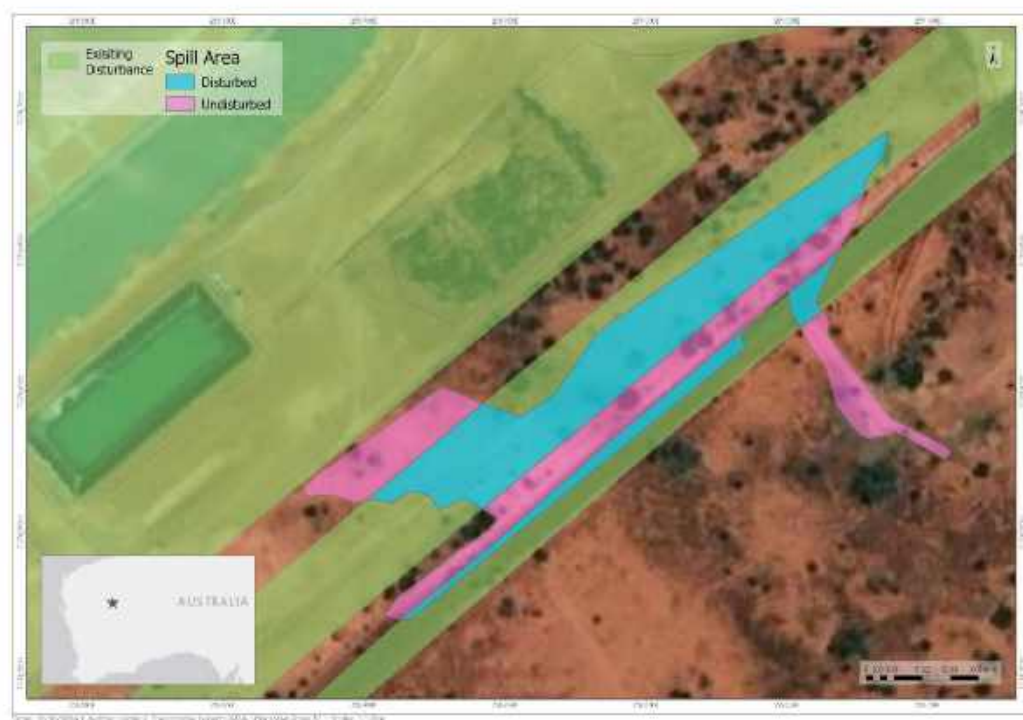
Section E – Details of non-compliance with licence condition			
Please use a separate page for each condition with which the licence holder was non-compliant at a time during the reporting period.			
Condition no:	1.2.4	Date(s) of non-compliance:	14/08/24
Details of non-compliance:			
<p>Condition 1.2.4 (Table 1.2.2) - Freeboard - requires a minimum freeboard to be maintained for storage vessels. The freeboard requirement for R2D2 is to maintain water levels below the underdrainage outflow pipes flowing into that storage vessel.</p> <p>A Turkey Nest containing mine recovered water from TSF3 supernatant pond was filled beyond its capacity and overtopped the embankment, spilling into previously disturbed vegetation. Majority of the spill was captured in an old haul road diversion channel.</p> <p>Low cyanide containing water. Measured at 2.7ppm free cyanide.</p> <p>Spill covered an area of approximately 0.83ha.</p>

The spill was the result of the Tailings Storage Facility 3_decant pump being mistakenly left running beyond the capacity of the dam. This resulted in excess recovered water discharging to R4D4 dam, causing the overflow.

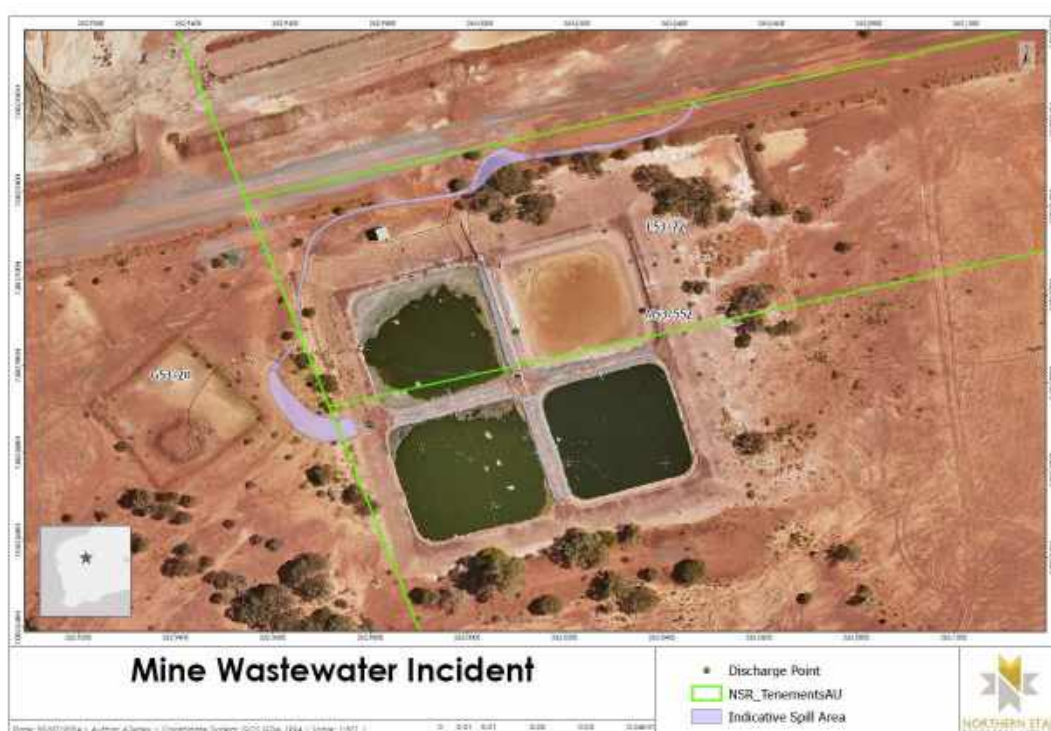
A sewage pipe has become untethered at the discharge point and caused a spill of untreated sewage beyond containment.

No identifiable environmental impact. Sewage spilled into an already disturbed access track and into a road v drain. Spill was cleaned up and covered with clean material.

The spill was caused by a loose tether securing the discharge pipe in position.

Section E – Details of non-compliance with licence condition	
Please use a separate page for each condition with which the licence holder was non-compliant at a time during the reporting period.	
Action 2: Tethering the pipeline in two locations.	
Action 3: Organization of vac truck to move waste from area to the bioremediation farm adjacent to the ponds.	
Action 4: Organization of bobcat to spread soil onto shallow depth areas to absorb any present wastewater and relocate soil into bioremediation farm.	
Was this non-compliance previously reported to DWER?	
<input checked="" type="checkbox"/> Yes, and	
<input checked="" type="checkbox"/> Reported to DWER verbally	Date: 19/07/24
<input checked="" type="checkbox"/> Reported to DWER in writing	Date: 20/07/24
