Annual Environmental Report 2020-21

1 May 2020 to 30 June 2021

Business name:		Ref/licence #:	L7065/1997/11
Premises address:		Property #:	A3919 DP183655 1210 P069587 531
Proprietor:	Shire of Carnarvon	File #:	ADM0008
Manager/contact person:		Report date:	13/12/2021

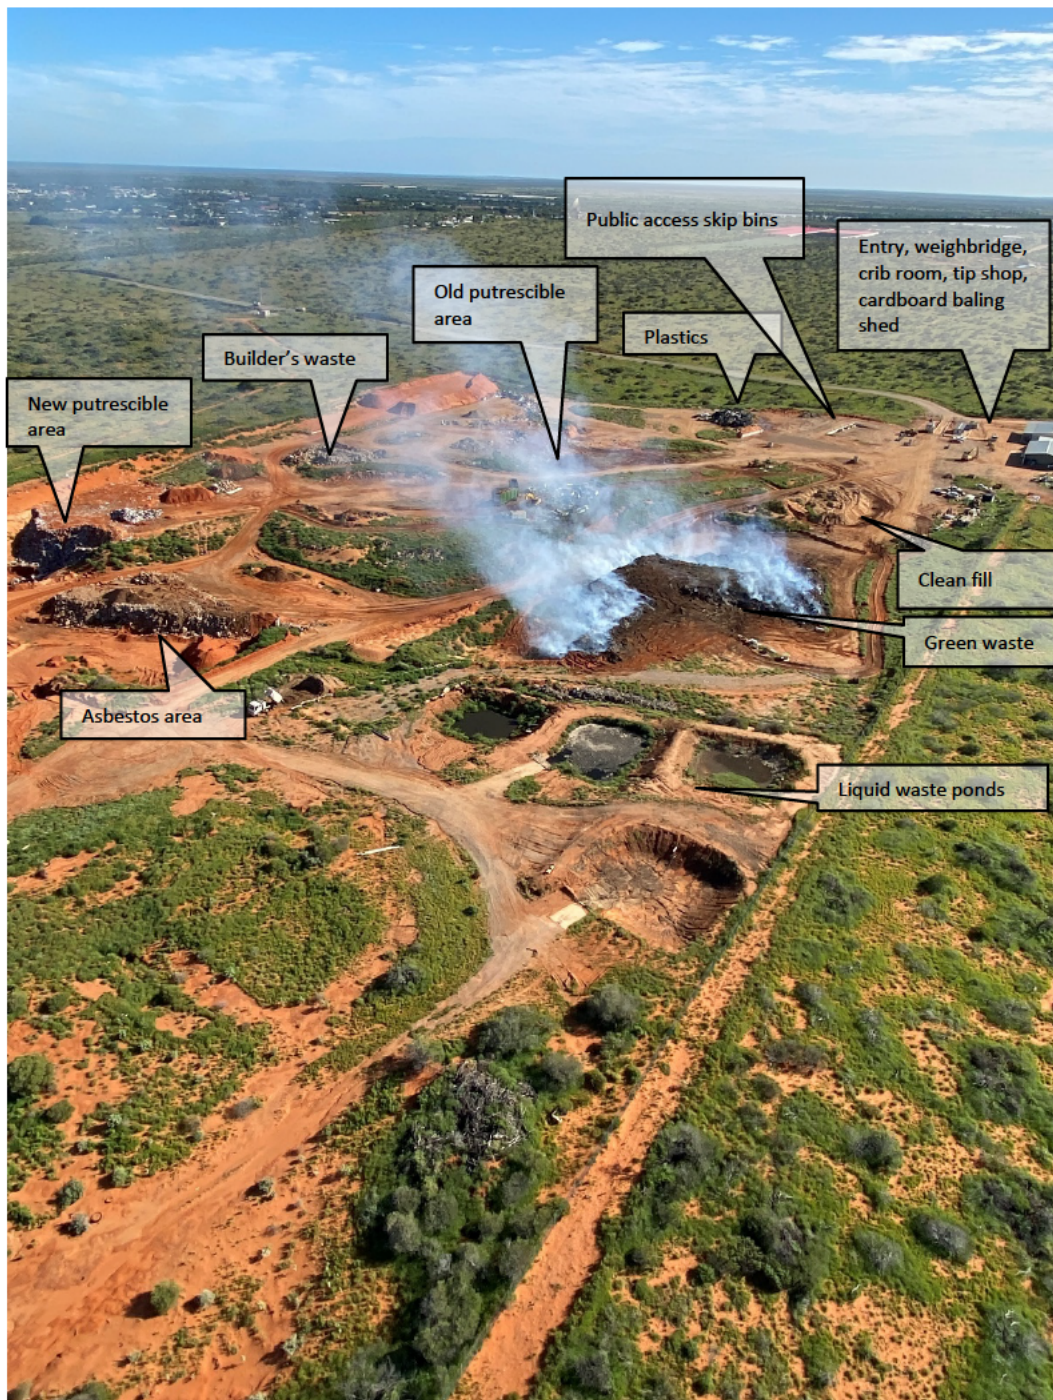
Green waste: A significant fire occurred in the green waste area on 29 May 2021 as reported to DWER on 31 May 2021 (pictures in appendix). The fire appeared to be spontaneous originating from deep within the green waste and rainfall may have insulated the deeper parts allowing heat to build up. The Shire worked in conjunction with DFES to manage the fire but it was unable to be put out with water. Waste facility staff used heavy machinery to aerate the pile during the day to promote burning of the green waste material, to minimize smoke and to decrease the long-term burning time. It was considered that aerating the pile would reduce the available fuel in the safest and most efficient manner. The smoke caused nuisance in Carnarvon over the next few weeks especially to the houses on Craggs Court, Brown Range. After 1-2 months, the fire was deemed to be out and the quantity of green waste was significantly reduced.

Figure 1. Aerial photos taken of the green waste fire can be used to specify areas of the waste facility

Recommendation: maximise reuse of green waste. Logs/branches could be separated and cut into firewood for sale. Mulch could be extracted and sold. A machine could be purchased for turning green waste into pellet fuel.

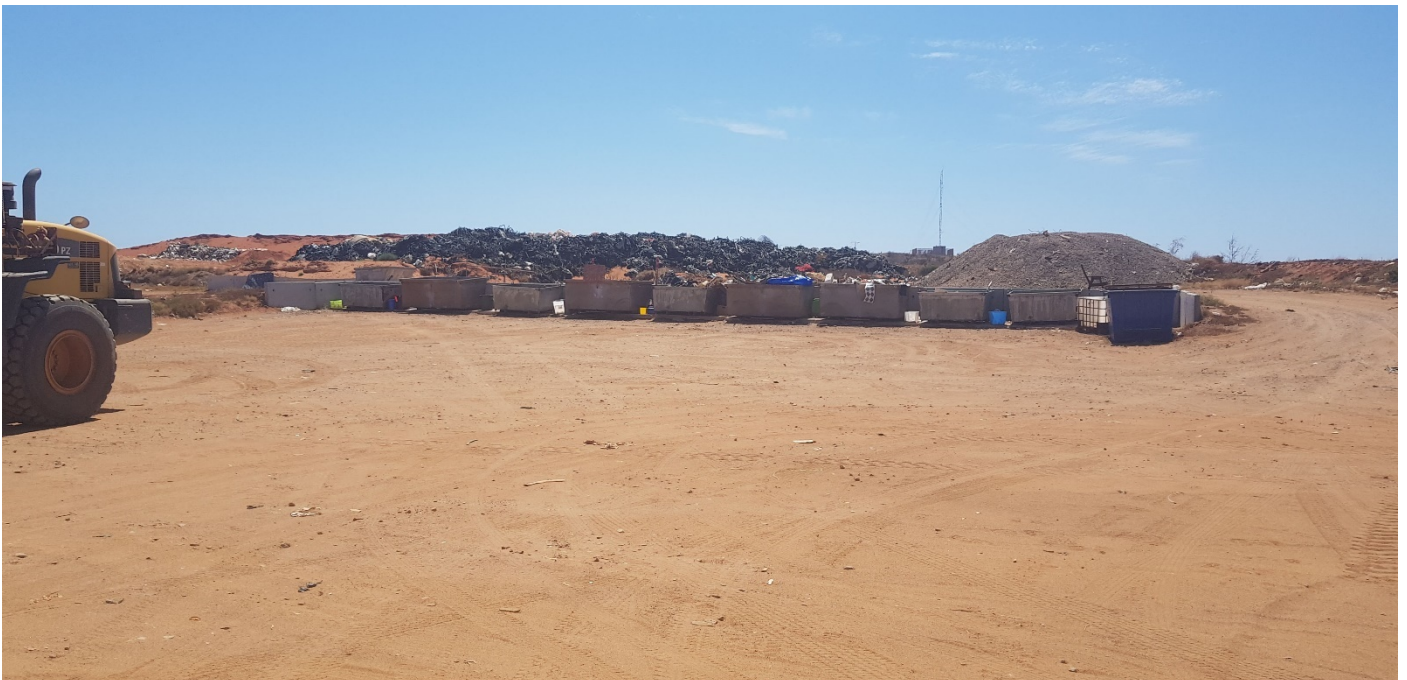
Figure 2. Public access skip bins. The public have for the most part been restricted to only this area which has aided with the better overall management of the waste facility and greatly minimised waste being put in the wrong area

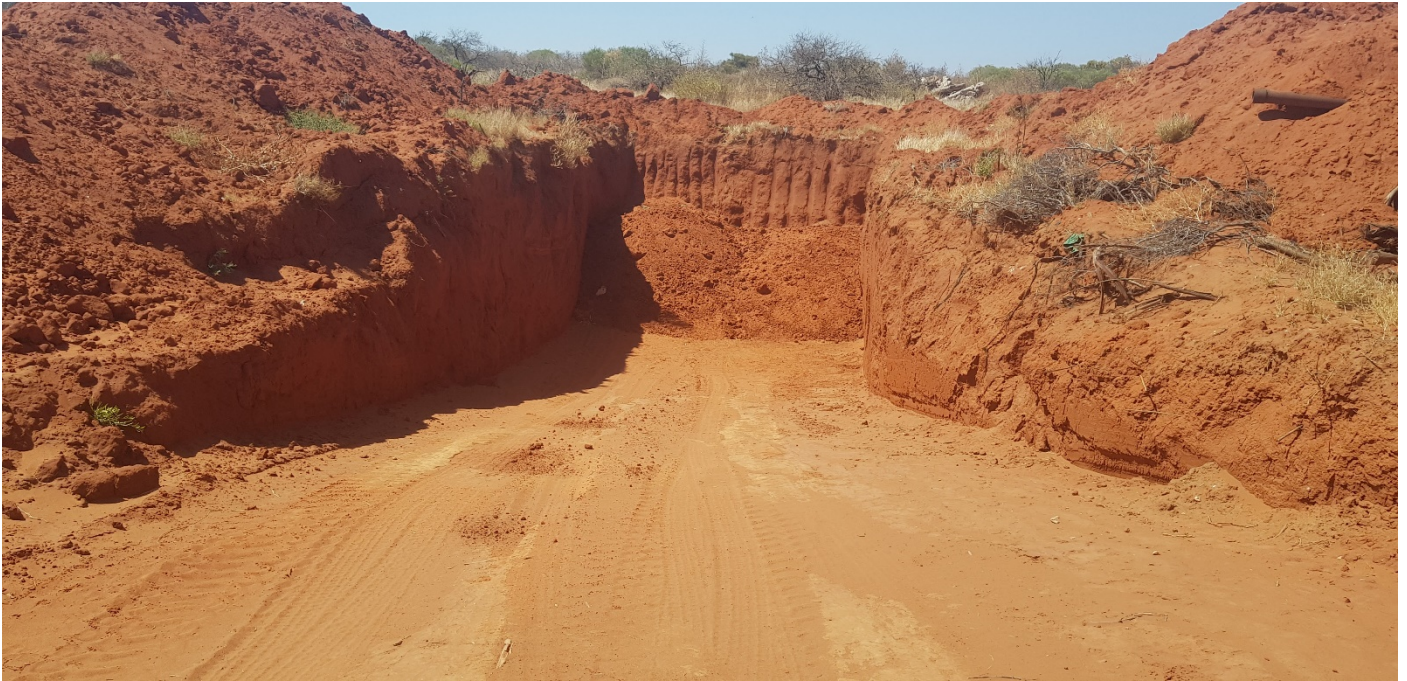
Figure 3. New animal/carcass pit is safer, easier to access by staff but secure against access from the public

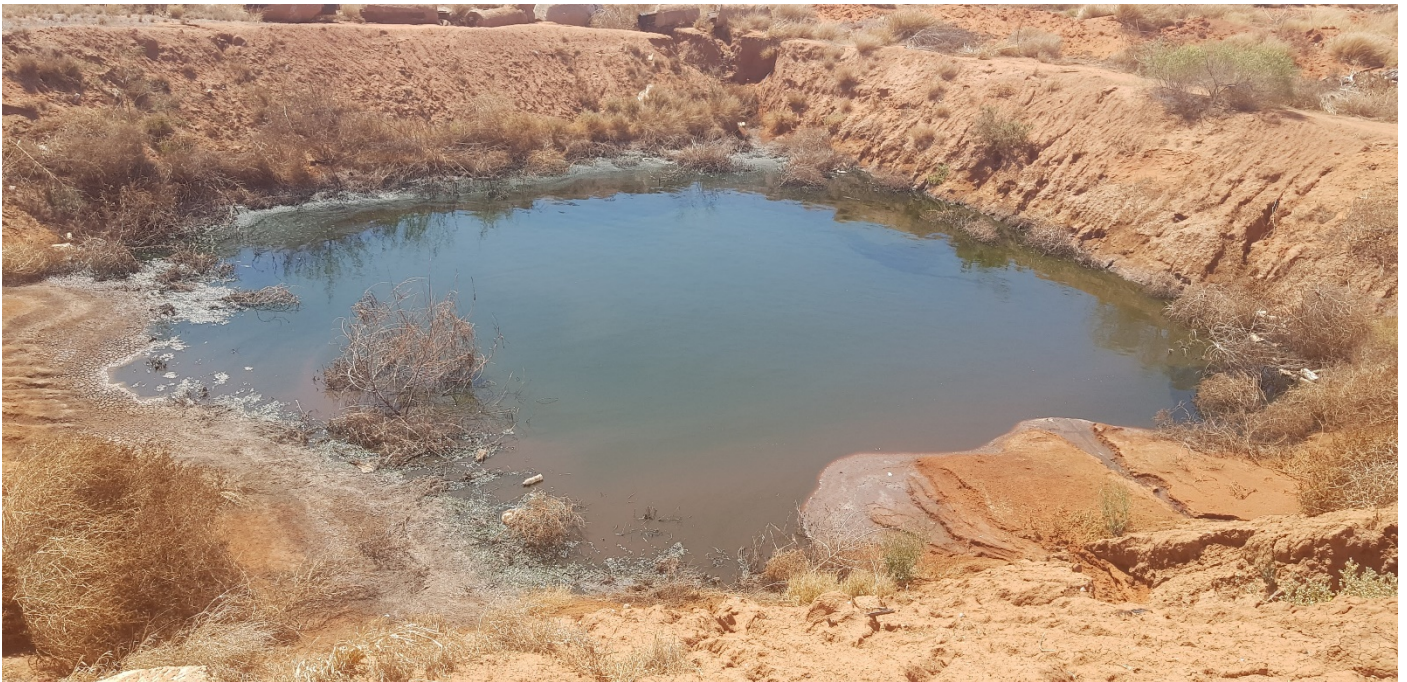
Liquid waste quantity: The liquid waste pump-outs have been increasing which we think is a result of the vastly increased caravan/camping tourism in the region along with increased activity in the resources sector. More increases in the resources sector are envisaged also. The liquid waste ponds are also upwind from the tip entrance area and the smell sometimes causes stress to workers. The Shire will be applying to increase the liquid waste cap.

Figure 4. Liquid waste is increasing and a new location and design is recommended. Currently there are 2 primary pits and 2 secondary pits but the secondary pits should be larger and shallower to promote more evaporation, and all should be further from the tip entrance to reduce odour. Ideally the tip entrance and buildings would be on the southern side of the premises (upwind) but they are currently directly downwind of the liquid waste ponds.

Recommendation: Consider relocating the liquid waste ponds further to the south provided dense clay can be identified. Recommend redesign allowing for 3x deep primary ponds with chutes for direct delivery from the trucks without splashing, and 1x large shallow evaporation pond connected via a long square from each primary pond. Consider allowing room for another evaporation pond in the event that the first needs drying out and removal of biosolids.

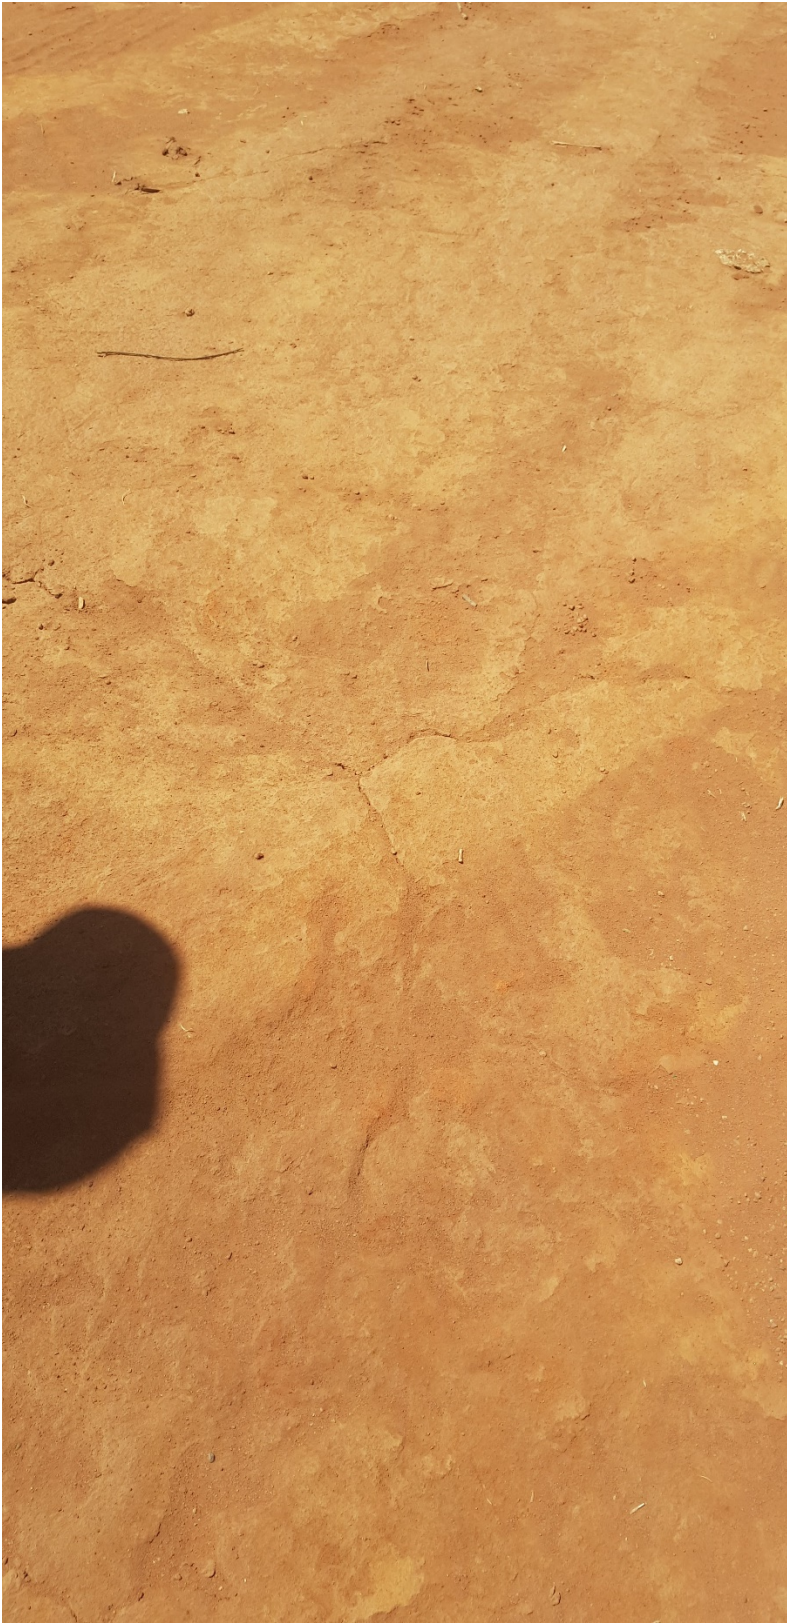
Figure 5. This picture shows the type of clay that lines the bottom of the liquid waste ponds. The clay dries very hard.

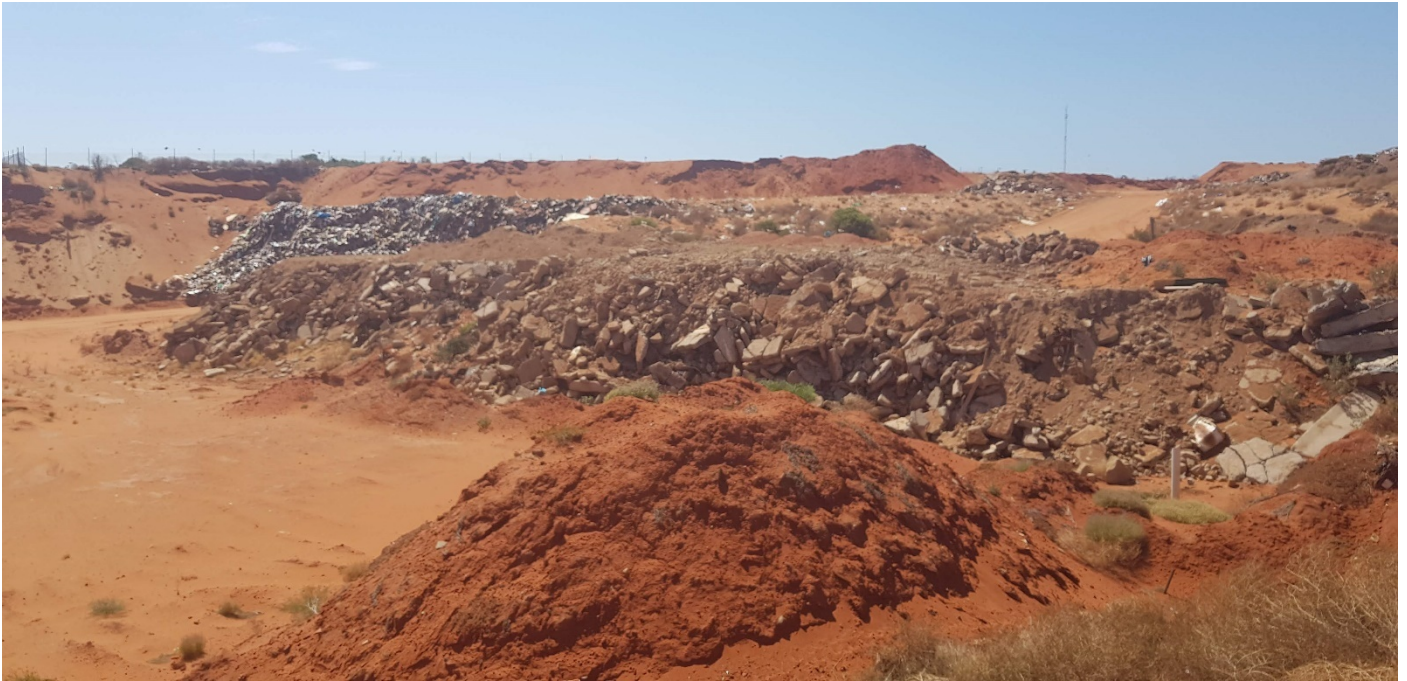
Significant demolition projects (including the old Brickhouse concrete tanks) resulted in much more asbestos containing or potentially containing material being buried in the asbestos area during 2020-21. The bulk of this material was concrete and demolition earth. Some concrete is piled up into a kind of wall on the slope.

Figure 6. Asbestos area showing the concrete wall. It is recommended to put clean fill over this to cover it. In the distance is the putrescible area.

Recommendation: put clean fill over the exposed concrete wall to reduce any asbestos risk.

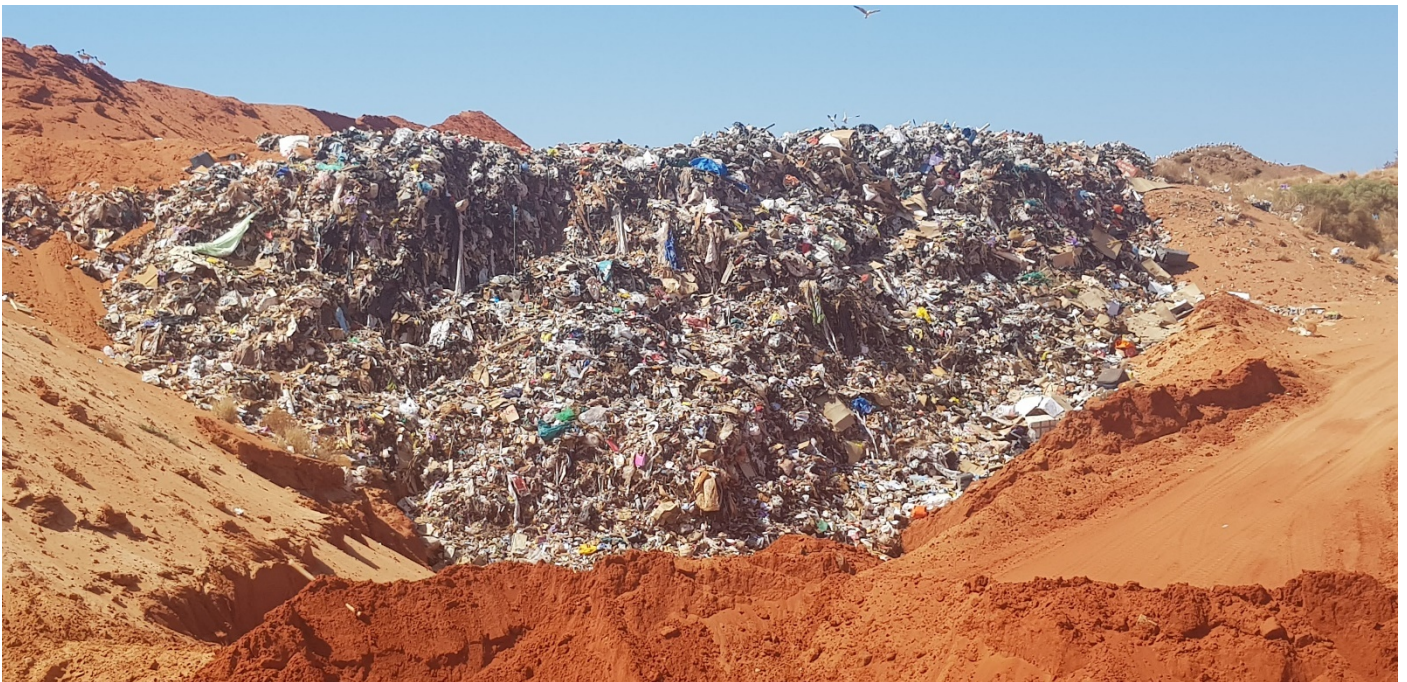
Figure 7. Putrescible area was being covered on the top during the inspection. There was very little wind blown waste on top and no obvious odour. The prevailing wind blows into the face.

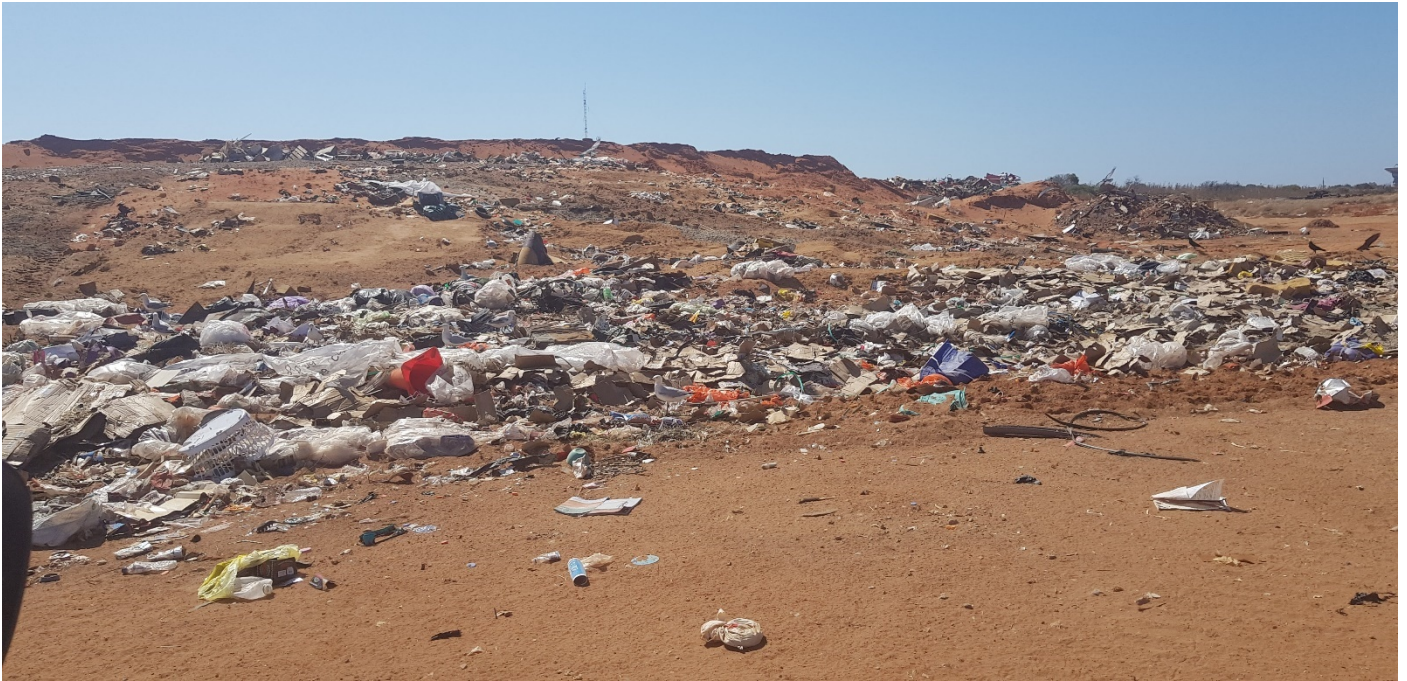
Windblown waste was minimal overall and very little observed outside the waste facility. However improvements could be made. Most putrescible waste goes into the commercial area and the old public putrescible area is being used less. The old area faces to the north-east (crosswind) and has more indication of windblown waste compared to the commercial area (new area) which looks much tidier.

Figure 8. This is the old publicly accessible putrescible area which could use some improvement. This area is more prone to windblown waste blowing sideways. It is recommended to phase this out now that public entry is predominantly limited to the skip bins.

Recommendation: consider phasing out the old putrescible area altogether and use the new commercial area.

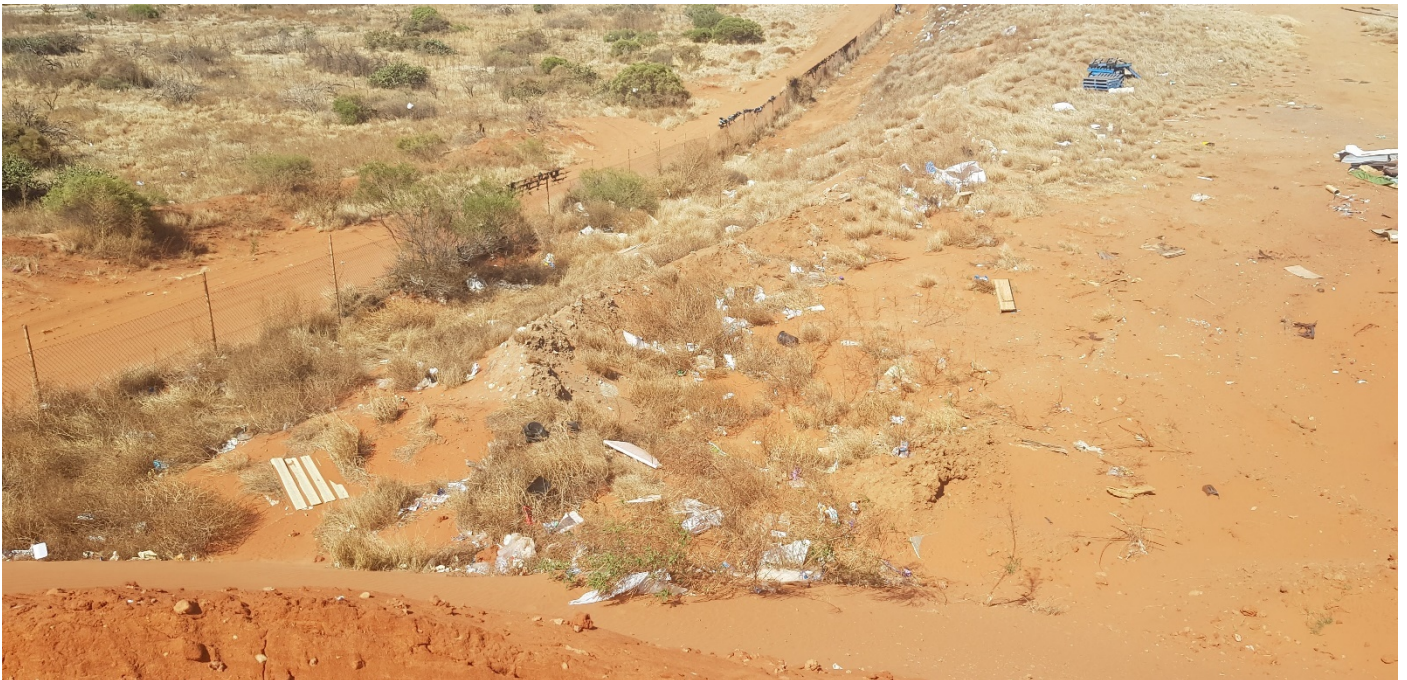
Figure 9. There is some wind blown waste on the northern side of the facility

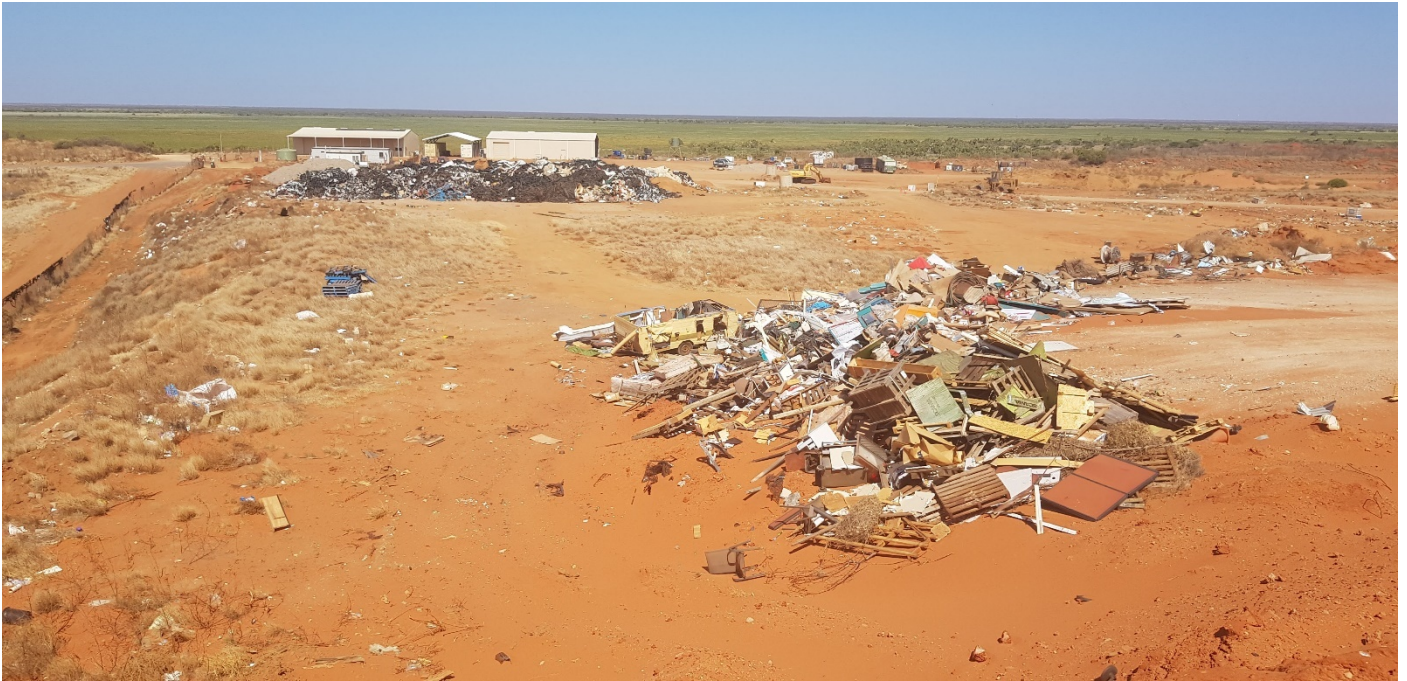
Figure 10. Builders waste and plastic waste in background

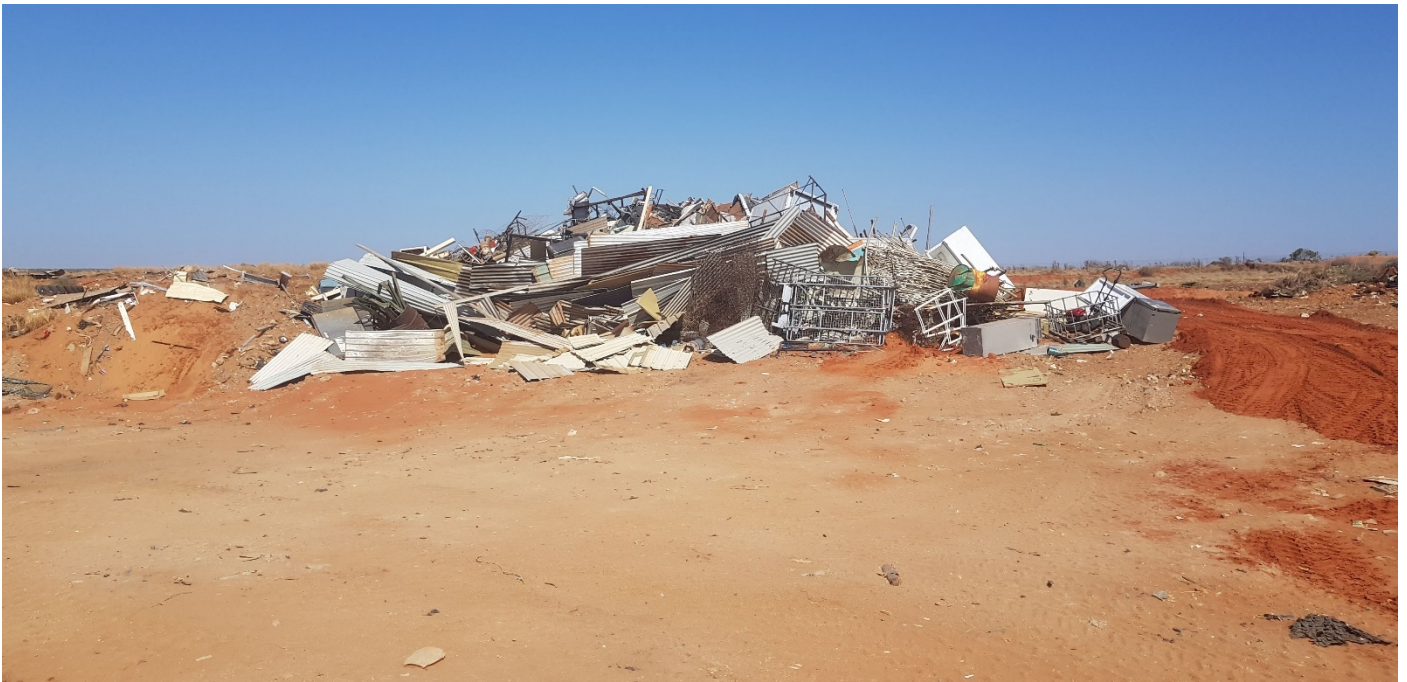
Figure 11. Scrap metal quantity stored onsite is greatly reduced

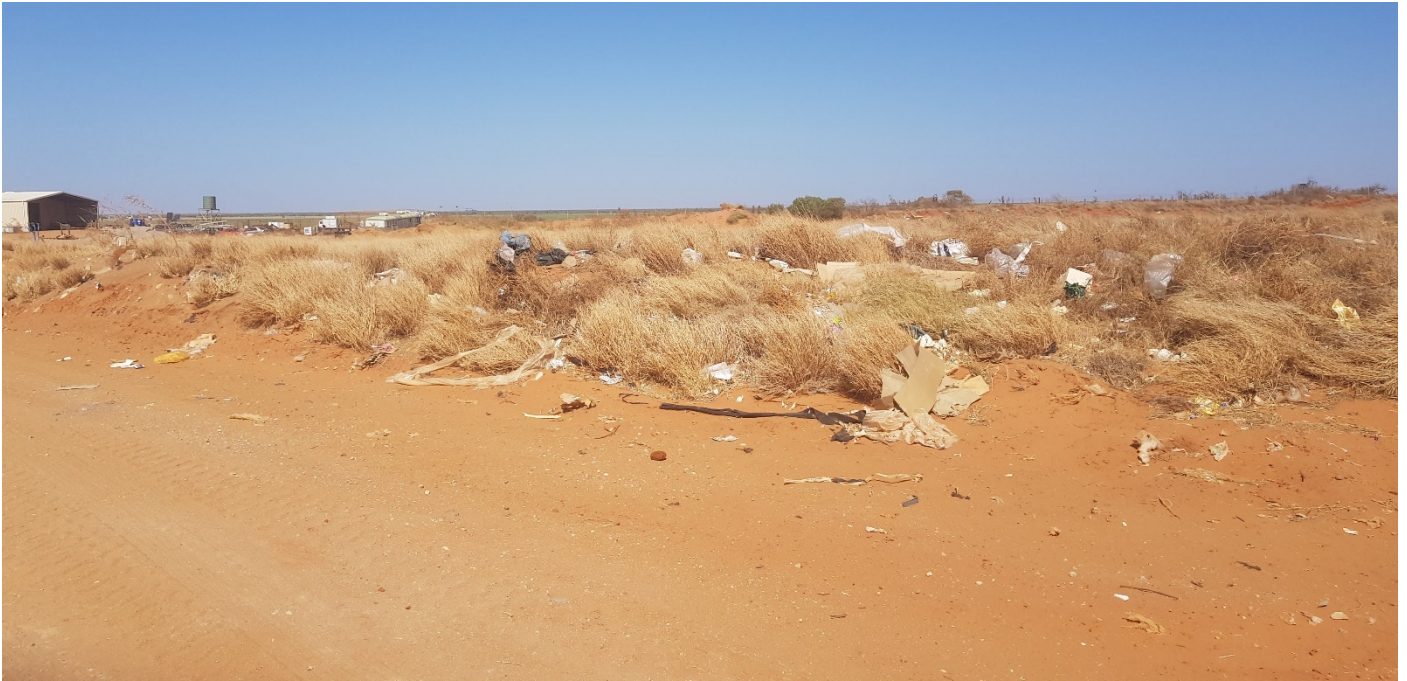
Figure 12. Some improvements can be made to windblown waste despite the overall level being much improved to past years.

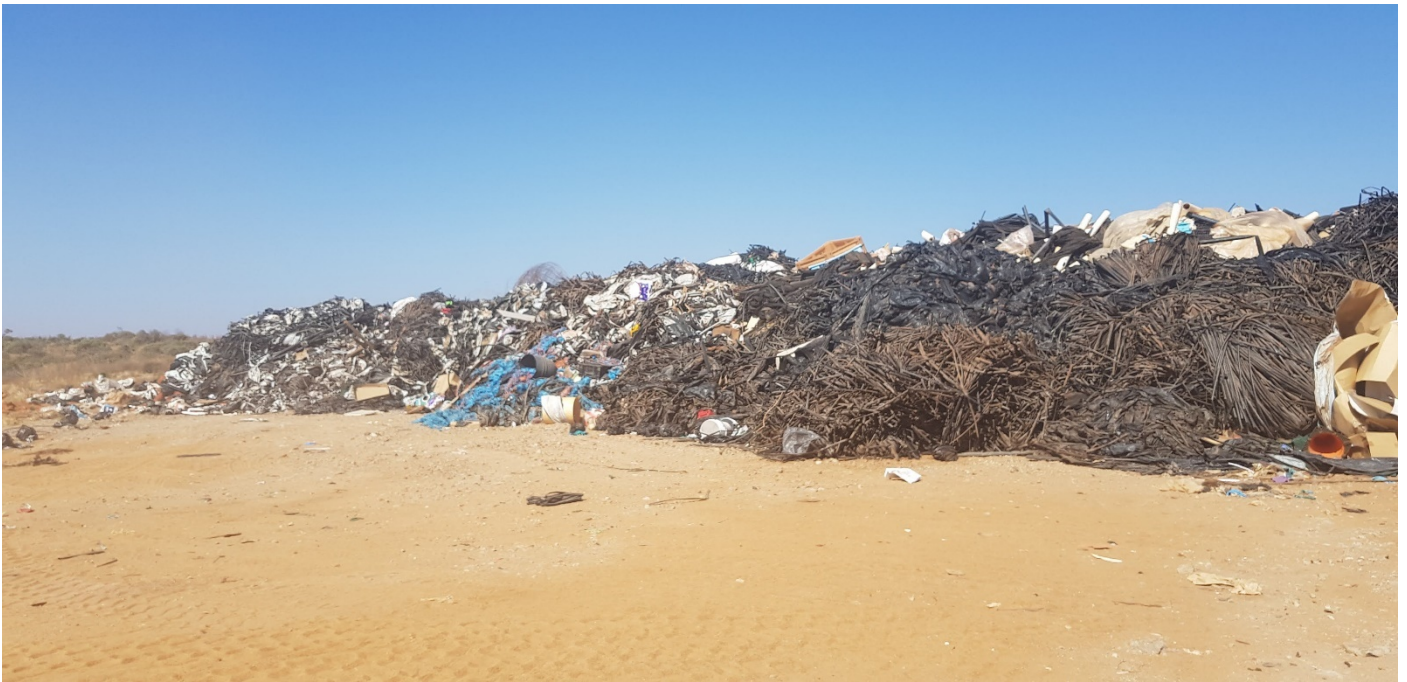
Plastic storage: There is still a large pile of horticultural plastics, which will eventually be covered and compressed if they can't be given away for recycling. All three flammable waste categories—green waste, tyres and plastics—are well-separated on-site.

Figure 13. Plastic waste. This is a fire and pollution risk. Consider separating into separate piles. Look for opportunity to shred/recycle to reduce the risk. Burial would reduce the risk but also reduces the opportunity for recycling due to the dirt contamination.

Recommendation: seek opportunities to reduce the accumulation of plastics due to fire and subsequent pollution risk. Consider separating into fire separated storage areas.

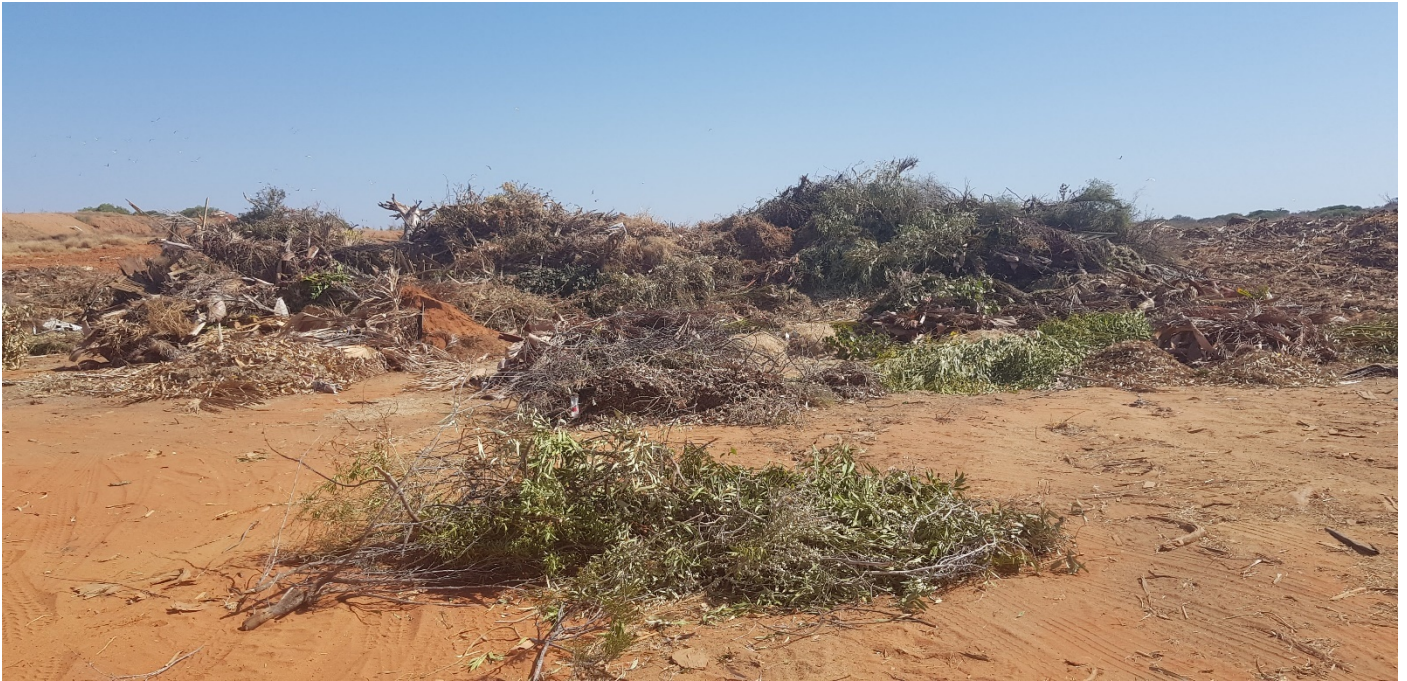
Figure 14. Green waste is much reduced after the fire

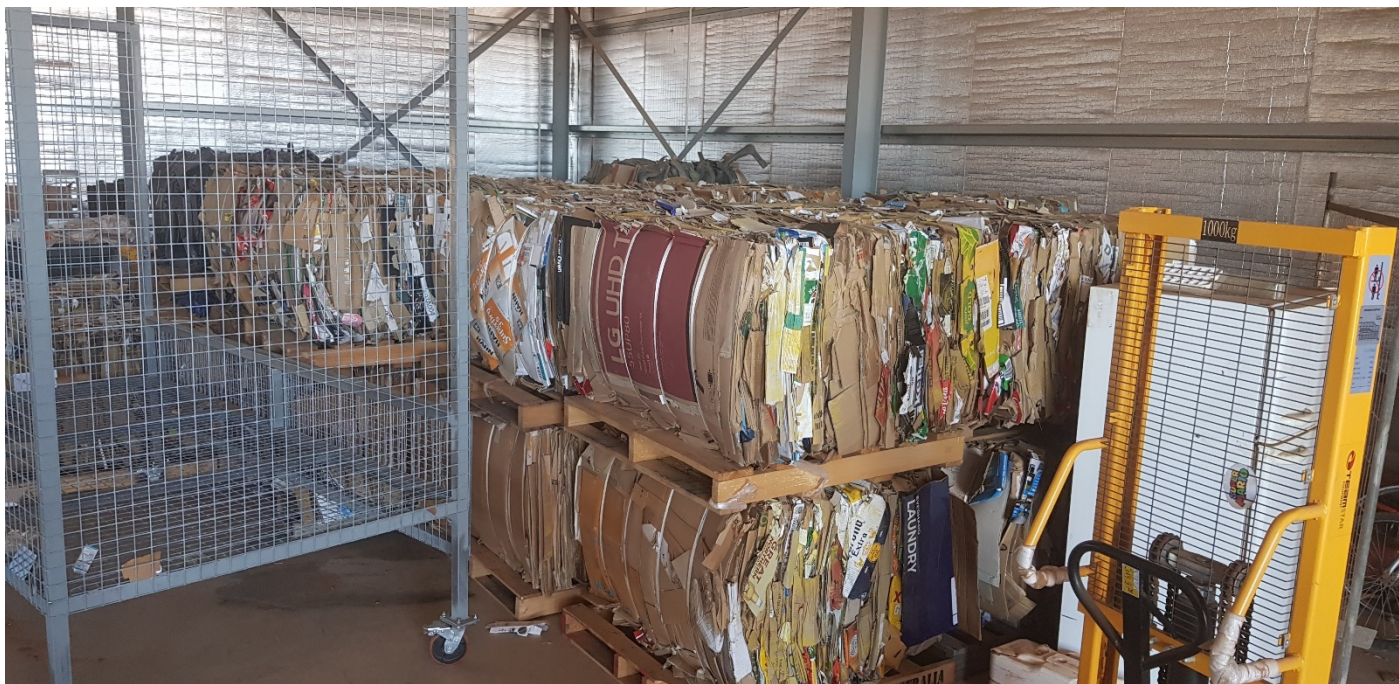
Figure 16. The cardboard baler is being put to good use

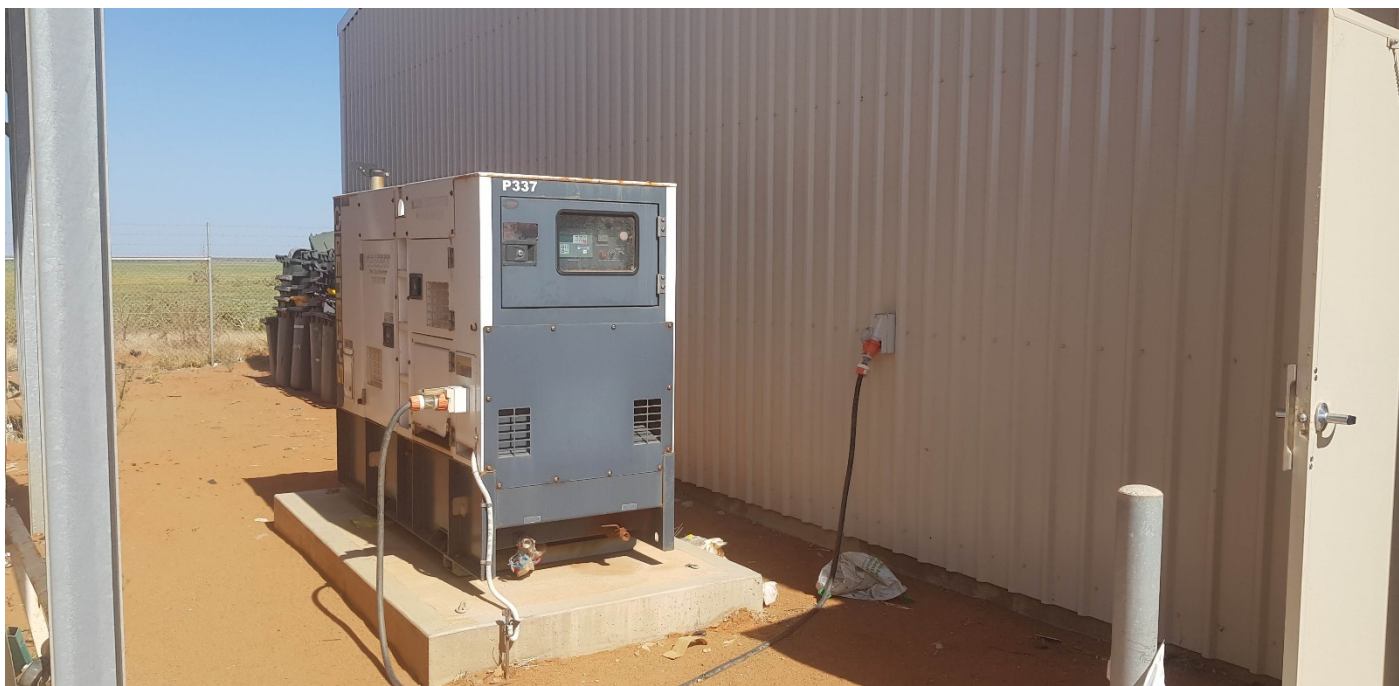
Figure 17. A lot of money has been spent on the waste facility in recent years.

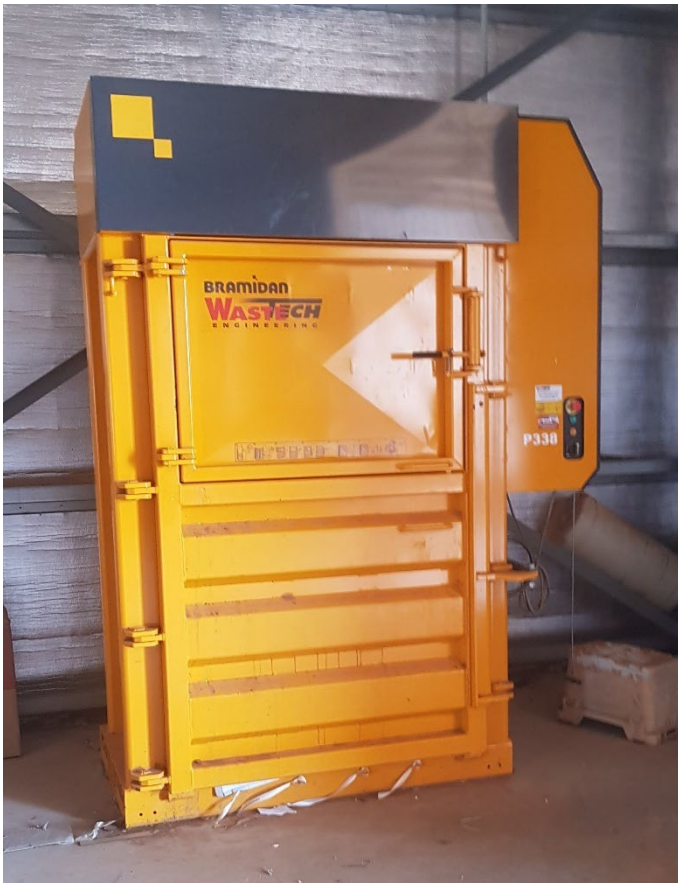
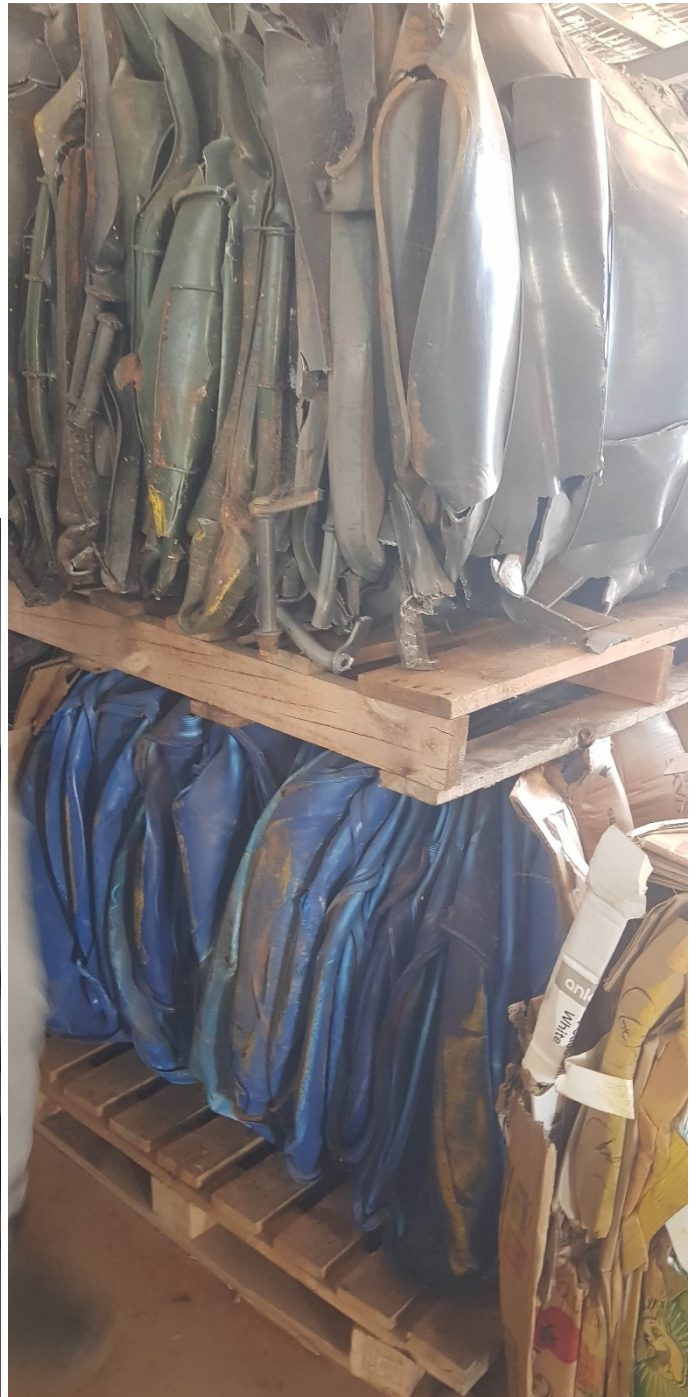
Figure 18. Even green bins and 205L blue drums are being baled
