## Annual Audit Compliance Report Form

Section A – Licence details			
Licence number:	L7750/2001/10	Licence file number:	APP-0030521 1
Licence holder name:	Evolution Mining (Mungari) Pty Ltd		
Trading as:	Evolution Mining		
ACN:	002 124 745		
Registered business address:	Level 30 175 Liverpool Street SYDNEY NSW 2000		
Reporting period:	01/01/2025 to 31/12/2025

**Section E – Details of non-compliance with licence condition**

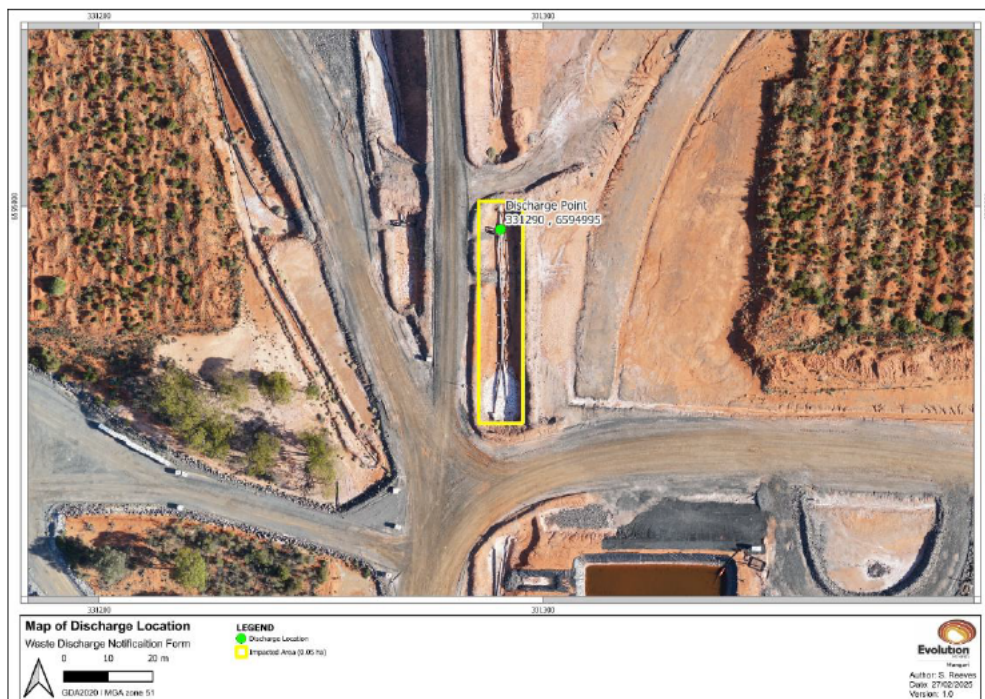
Figure 1: TSF T-Piece Discharge Location

**TSF T-Piece Discharge (#1 of 3 non-compliances)**

On the 25<sup>th</sup> February, it was identified that tailings had leaked from a t-piece of the Mungari Mill tailings line. Once identified, the tailings pumps were immediately turned off. The spill was almost completely contained within the containment bund with a small amount (<100L) outside the bund on previously disturbed land within the operational footprint. Remediation actions included use of a vacuum truck to remove the wet material, disposing it to the TSF and use of earthmoving equipment to clean up the remainder of material once dried to ensure bund capacity was maintained.

Section E – Details of non-compliance with licence condition	
<p>What was the actual (or suspected) environmental impact of the non-compliance?  <b>NOTE</b> – please attach maps or diagrams to provide insight into the precise location of where the non-compliance took place.</p>	
<p>No environmental impact was identified. The spill occurred within an operational area associated with the TSF that had been previously disturbed, and the material was contained and remediated promptly. (See map above.)</p>	
<p>Cause (or suspected cause) of non-compliance:</p>	
<p>Wear rates of tailings pipeline bends vary depending on the material being processed. In this instance, more abrasive material being processed then pumped through the tailings pipeline wore through a corner of the pipe bend, leading to the leak.</p>	
<p>Action taken to mitigate any adverse effects of non-compliance and prevent recurrence of the non-compliance:</p>

<p>A vacuum truck was mobilised to remove the wet tailings material, which was returned to the TSF. Earthmoving equipment was then used to remove remaining dried material and restore the bund capacity.</p>	
<p>Was this non-compliance previously reported to DWER?</p>	
<p><input checked="" type="checkbox"/> Yes, and</p>	
<p><input type="checkbox"/> Reported to DWER verbally</p>	<p>Date: / /</p>
<p><input checked="" type="checkbox"/> Reported to DWER in writing</p>	<p>Date: 28/02/2025</p>

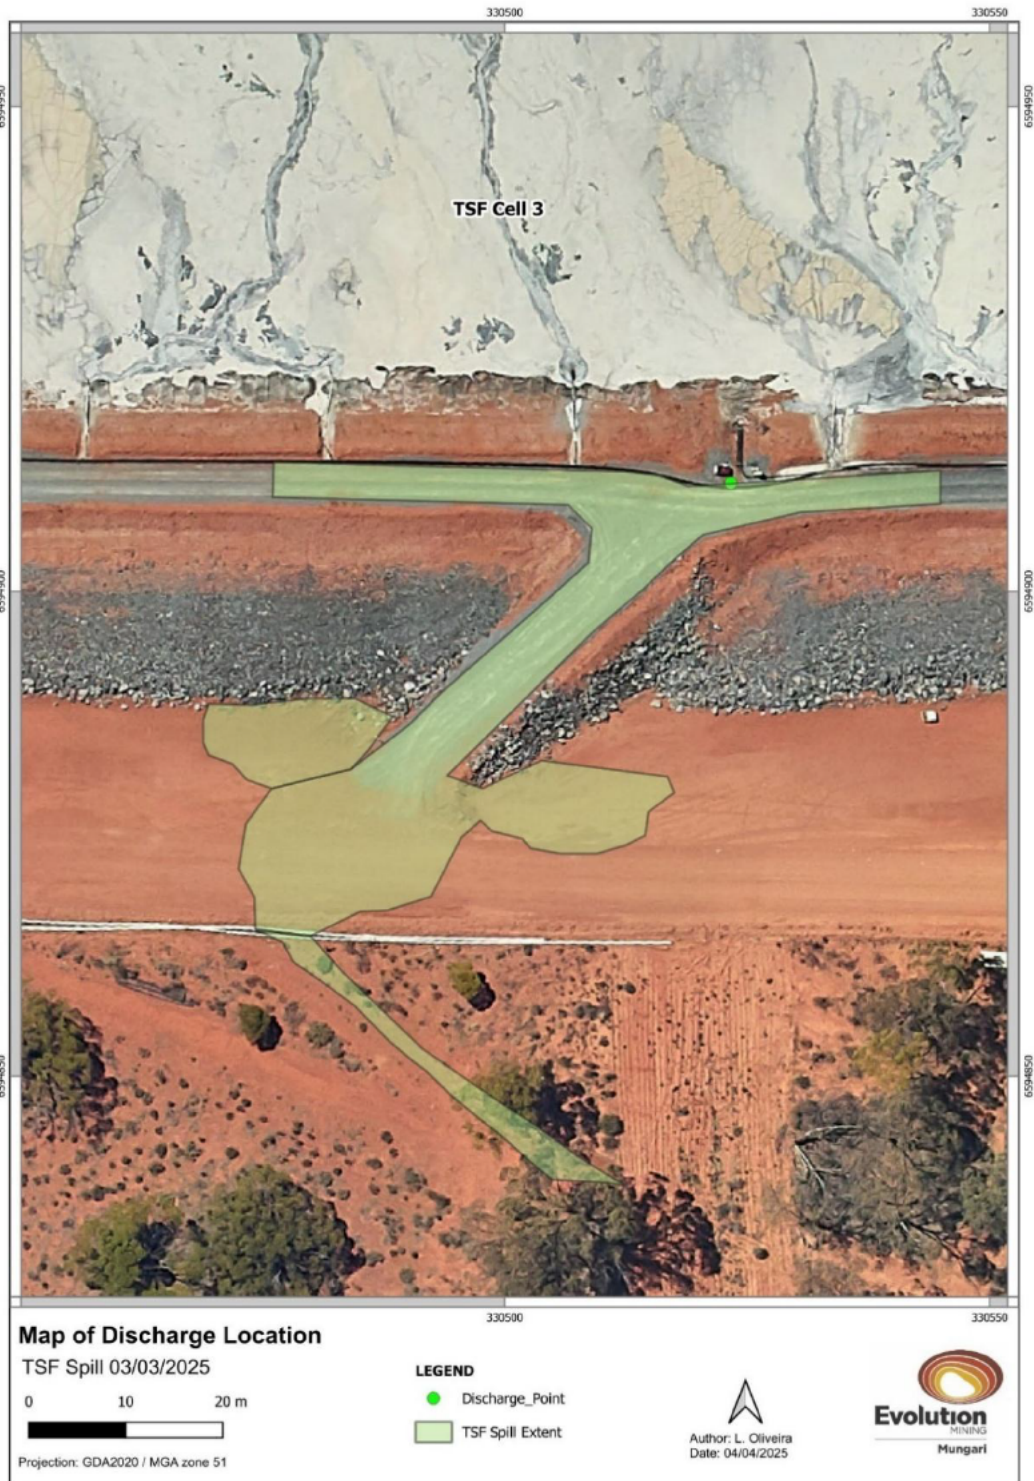
Figure 2: TSF Spigot Failure Location

Section E – Details of non-compliance with licence condition			
Please use a separate page for each condition with which the licence holder was non-compliant at a time during the reporting period.			
Condition no:	2	Date(s) of non-compliance:	03/04/2025
Details of non-compliance:			
<p><b>TSF Discharge Spigot Failure (#2 of 3 non-compliances)</b></p> <p>On the 3rd April it was identified that a hose on spigot 21S TSF Cell 3 failed between the spigot hose clamps and spigot clamp, resulting in tailings being discharged behind the TSF line and down the southern embankment of Cell 3. The majority of spilled material was contained to previously disturbed area on and around the TSF. The spilled entered a small area of approximately 100m<sup>2</sup> containing several small shrubs. The tailings line was changed to a single line discharge during the spigot replacement. Further line inspections resulted in additional hoses being replaced. The spill area was scraped and material removed to the TSF.</p>

Section E – Details of non-compliance with licence condition	
<p>Majority of spilled material was contained to previously disturbed area on and around the TSF. The spilled entered a small area of approximately 100m<sup>2</sup> containing several small shrubs.</p>	
Cause (or suspected cause) of non-compliance:	
<p>Suspected cause: Spigot clamps were not tightened enough to hold the hoses onto the spigots.</p>	
Action taken to mitigate any adverse effects of non-compliance and prevent recurrence of the non-compliance:	
<p>Remediation action included:</p> <ul style="list-style-type: none"> <li>• spigot hose was replaced</li> <li>• a vacuum truck to remove the wet material, disposing it to the TSF and earthmoving equipment to clean up the remainder of material once dried to ensure bund capacity was maintained.</li> <li>• Physical inspection of all Hoses, Clamps, Hoses etc to be undertaken every time the deposition line is flushed.</li> </ul>

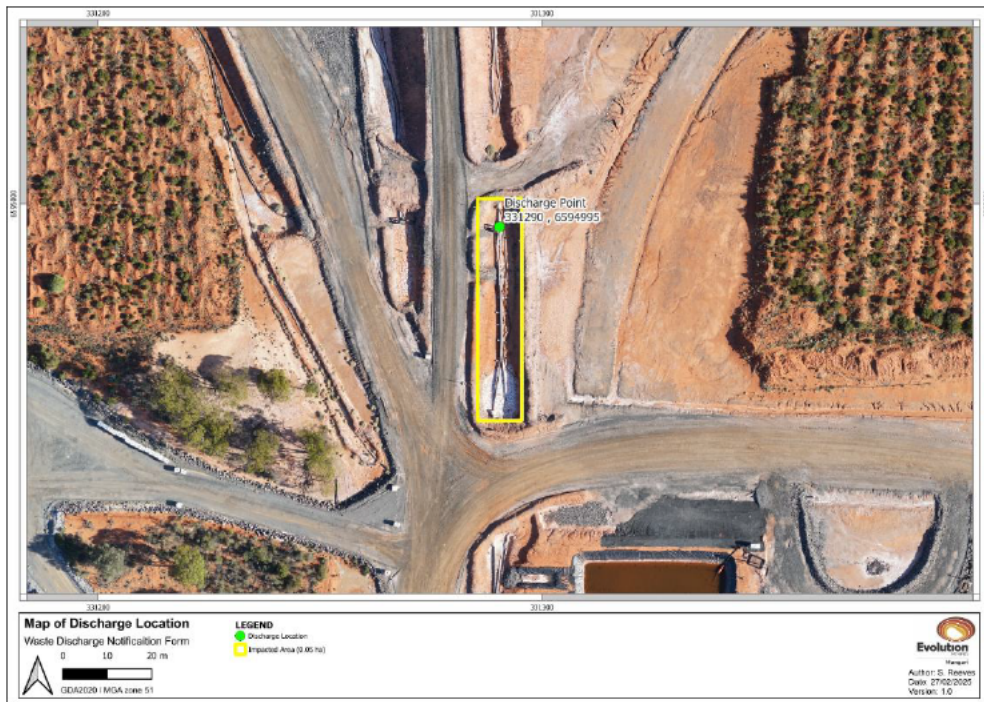
Figure 3: TSF T-Piece Discharge Location

**TSF T-Piece Discharge (#3 of 3 non-compliances)**

On the 23rd August a leak occurred between a flanged joint of the tailings pipeline from the Mungari Processing Plant to the Mungari TSF, resulting in tailings being sprayed outside the containment bund. Majority of the spilled material was contained within the containment trench and access road. Approximately 600m<sup>2</sup> entered the vegetation containing small shrubs. The impacted spill area was scraped and removed. Figure 3 shows the incident area.

Majority of the spilled material was contained within the containment trench and access road. Approximately 600m<sup>2</sup> entered the vegetation containing small shrubs.

Section E – Details of non-compliance with licence condition	
Cause (or suspected cause) of non-compliance:	
The incident was caused by failure at a flanged joint on the high-pressure tailings pipeline, resulting in loss of containment at the connection point.	
Action taken to mitigate any adverse effects of non-compliance and prevent recurrence of the non-compliance:	
Tailings pumps were immediately turned off and maintenance personnel called to inspect and repair the pipeline.	
Was this non-compliance previously reported to DWER?	
<input checked="" type="checkbox"/> Yes, and	
<input type="checkbox"/> Reported to DWER verbally	Date: / /
<input checked="" type="checkbox"/> Reported to DWER in writing	Date: 24/08/2025
