Annual Audit Compliance Report Form

Environmental Protection Act 1986, Part V Division 3

Section A – Licence details			
Licence number:	L7851/2002/6	Licence file number:	DER2013/000925-1
Licence holder:	BHP Iron Ore Pty Ltd		
Trading as:	BHP Iron Ore Pty Ltd		
ACN:	008 700 981		
Registered address:	Level 1, City Square Brookfield Place 125 St Georges Terrace PERTH WA 6000		
Reporting period:	01/07/2024 to 30/06/2025

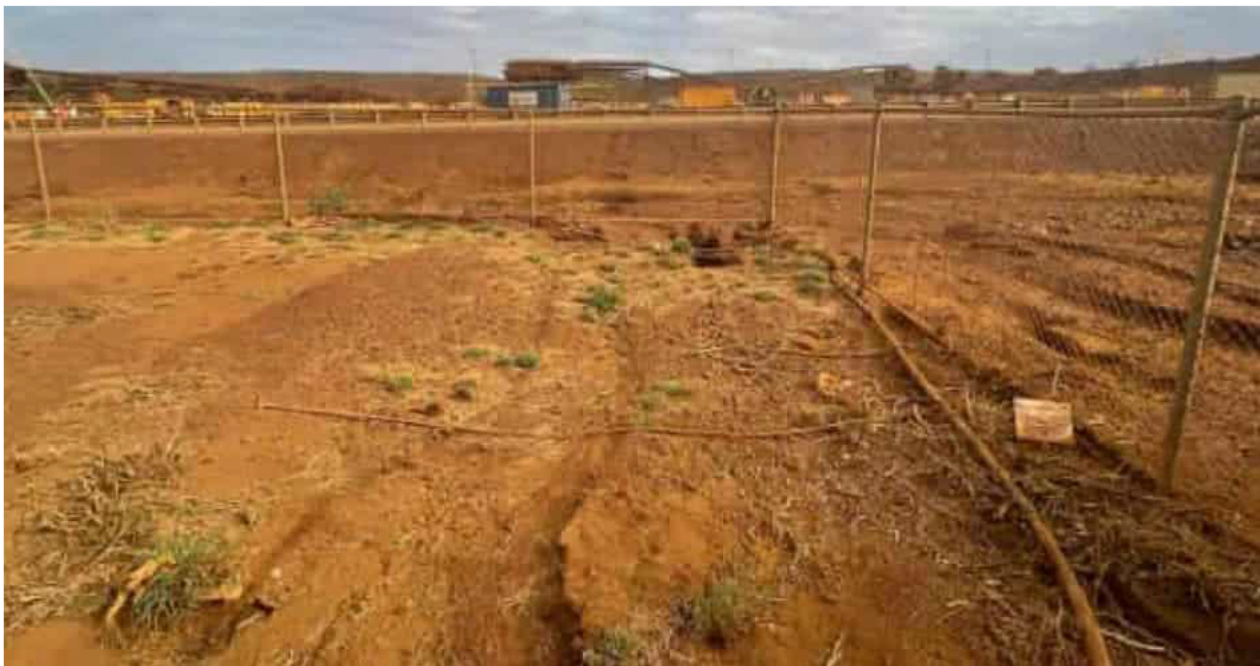
Section E – Details of Non-Compliance with Licence Condition			
Please use a separate page for each condition with which the licence holder was non-compliant at a time during the reporting period.			
Condition no:	Condition 10	Date(s) of non-compliance:	March 2024
Details of non-compliance:			
Previously reported each year since 2022, BHP identified that the MAC Auxiliary Workshop WWTP irrigation area had been eroded by stormwater runoff from the adjacent carpark apron. As a result, treated effluent (wastewater) was discharging into the site drainage system.			
What was the actual (or suspected) environmental impact of the non-compliance?			
NOTE – please attach maps or diagrams to provide insight into the precise location of where the non-compliance took place.			
No known or suspected environmental impact has occurred as a result of this non-compliance as it is treated effluent.

Cause (or suspected cause) of non-compliance:

Stormwater runoff from adjacent Auxiliary Workshop carpark had eroded the irrigation area bund and damaged irrigation area pipework.			
Action taken to mitigate any adverse effects of non-compliance and prevent recurrence of the non-compliance:			
The facility was repaired and reinstated in April 2025			
Was this non-compliance previously reported to DWER?			
<input checked="" type="checkbox"/> Yes, and			
<input type="checkbox"/> Reported to DWER verbally		Date:	
<input checked="" type="checkbox"/> Reported to DWER in writing		Date: AER FY2024
