Annual Audit Compliance Report Form

Environmental Protection Act 1986, Part V Division 3

Licence number:	L7851/2002/6	Licence file number:	DER2013/000925
Licence holder:	BHP Iron Ore Pty Ltd		
Trading as:	BHP Iron Ore Pty Ltd		
ACN:	008 700 981		
Registered address:	Level 1, City Square Brookfield Place 125 St Georges Terrace PERTH WA 6000		
Reporting period:	01/07/2022 to 30/06/2023

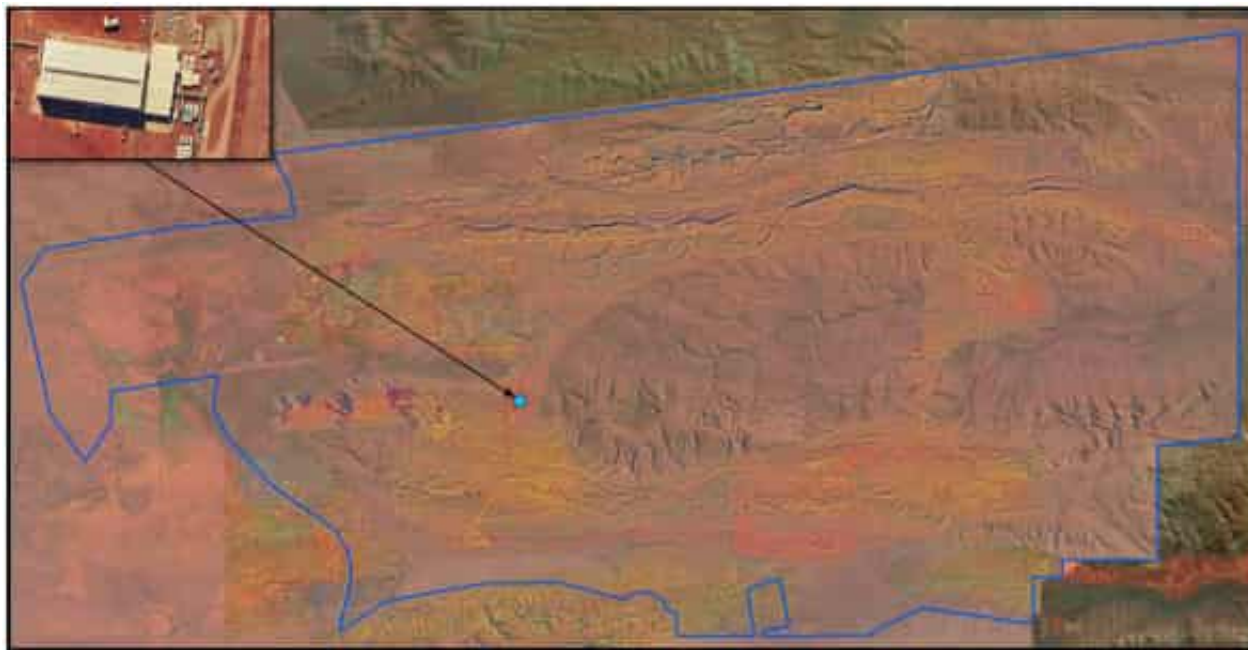
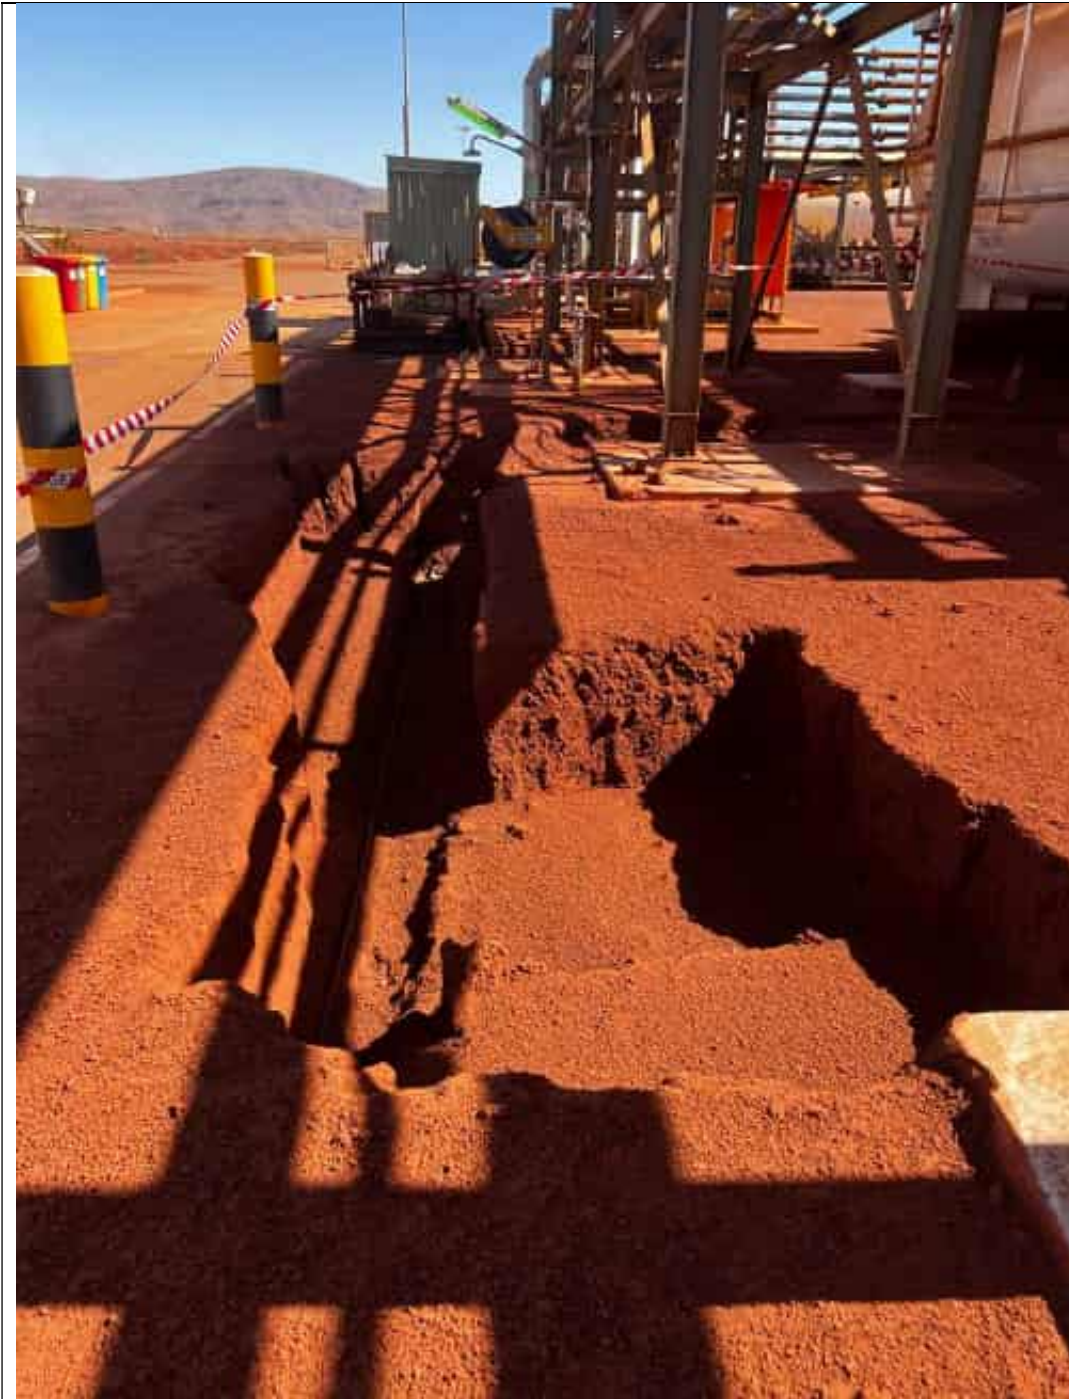
At approximately 8:00am on 15/09/22, the waste coolant tank at the South Flank Mobile Equipment Maintenance (MEM) Workshop has overflowed out of the vent pipe causing a discharge of approximately 1000 L onto bare earth.

Impact constrained to bare earth which was remediated. Discharge did not enter any drainage lines.

Automatic shut off system failed to close when waste tank level rose above the trigger point.

- 5,000 L removed from the waste coolant tank to prevent further overflow.
- Spill was contained and cleaned up using spill response kits.
- Contaminated soil removed and disposed of by a third-party contractor.
- Investigation revealed the shut off system was jammed because it had not been triggered in a while. System was re-tested and operated as designed.

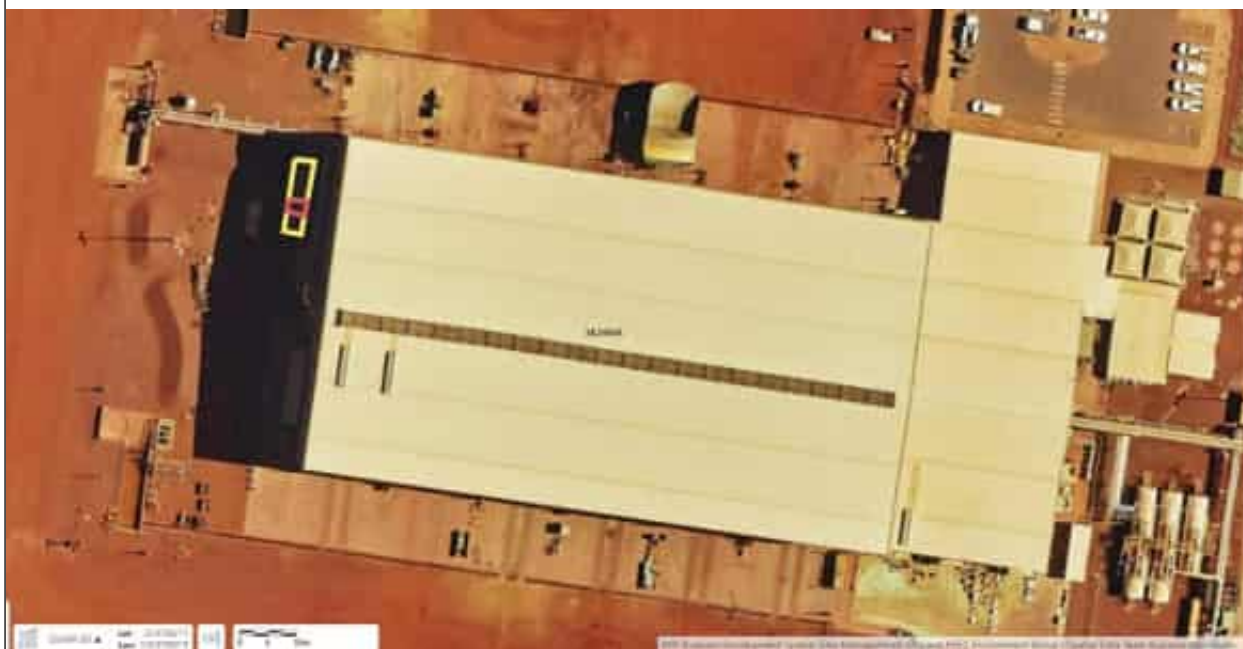
On 15/09/22, liquid discharge observed at the South Flank Mobile Equipment Maintenance (MEM) Workshop male ablution block, causing a discharge of approximately 200 L onto bare earth. Upon investigation, a previous spill adjacent to the area on 21/10/2022 was observed. This was estimated to be approximately 500 L.

Impact constrained to bare earth which was remediated. Discharge did not enter any drainage lines.

Discharge occurred as a result of incorrectly installed plumbing.

- Soil samples taken adjacent ablution block to determine chemical and hydrocarbon concentrations.
- Ablutions were tagged out of service and water turned off at source.
- Area barricaded off with signage to prevent unauthorized access.
- Contaminated soil removed and disposed of by a third-party contractor.
- Plumbing repaired.

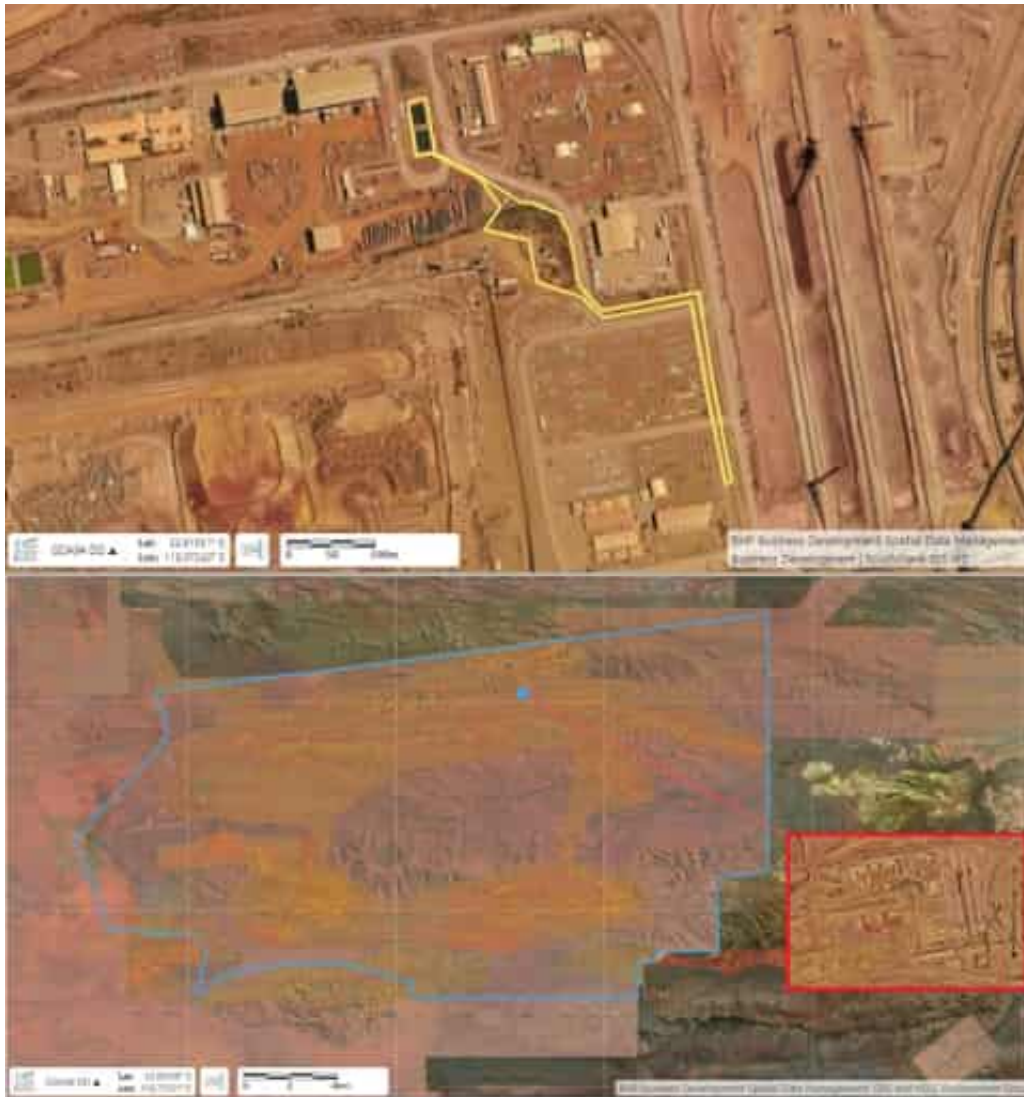
On 15/12/22, treated wastewater overflowed from wastewater treatment basins, causing a discharge of approximately 30,000 L into a drainage system (100 year drain line).

Impact constrained to constructed drainage line located within the Production Processing area. The wastewater did not enter any waterways or creek systems and as such, the environmental impact is considered to be limited.

The overflow occurred because a raw water addition valve to the turkey nest directly was left on. This caused the turkey nest to overflow.	
Action taken to mitigate any adverse effects of non-compliance and prevent recurrence of the non-compliance:	
<ul style="list-style-type: none"> • The source of wastewater pumping water to the basins was isolated. • Water samples taken to determine any chemical and hydrocarbon contaminant concentrations. Results indicated non-detects for hydrocarbons, therefore no remediation works were undertaken. 	
Was this non-compliance previously reported to DWER?	
<input checked="" type="checkbox"/> Yes, and	
<input type="checkbox"/> Reported to DWER verbally	Date:
<input checked="" type="checkbox"/> Reported to DWER in writing	Date: 23/12/2022

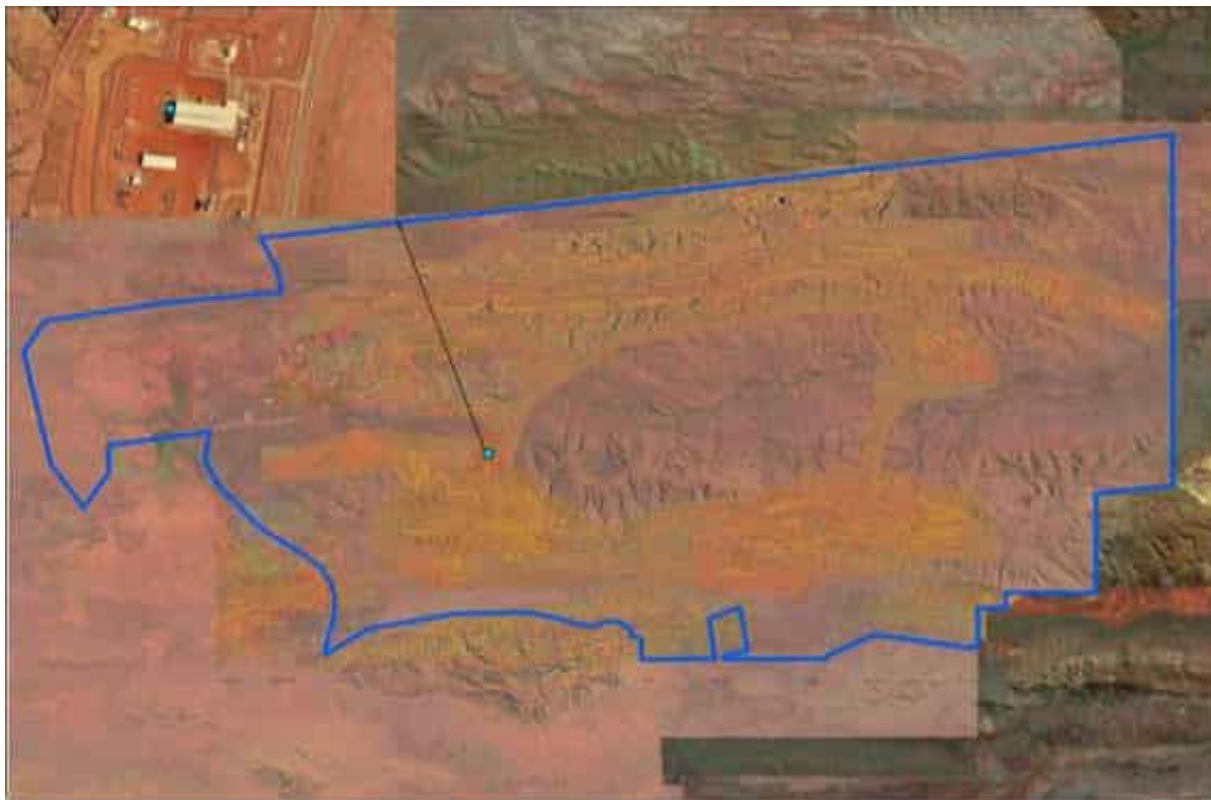
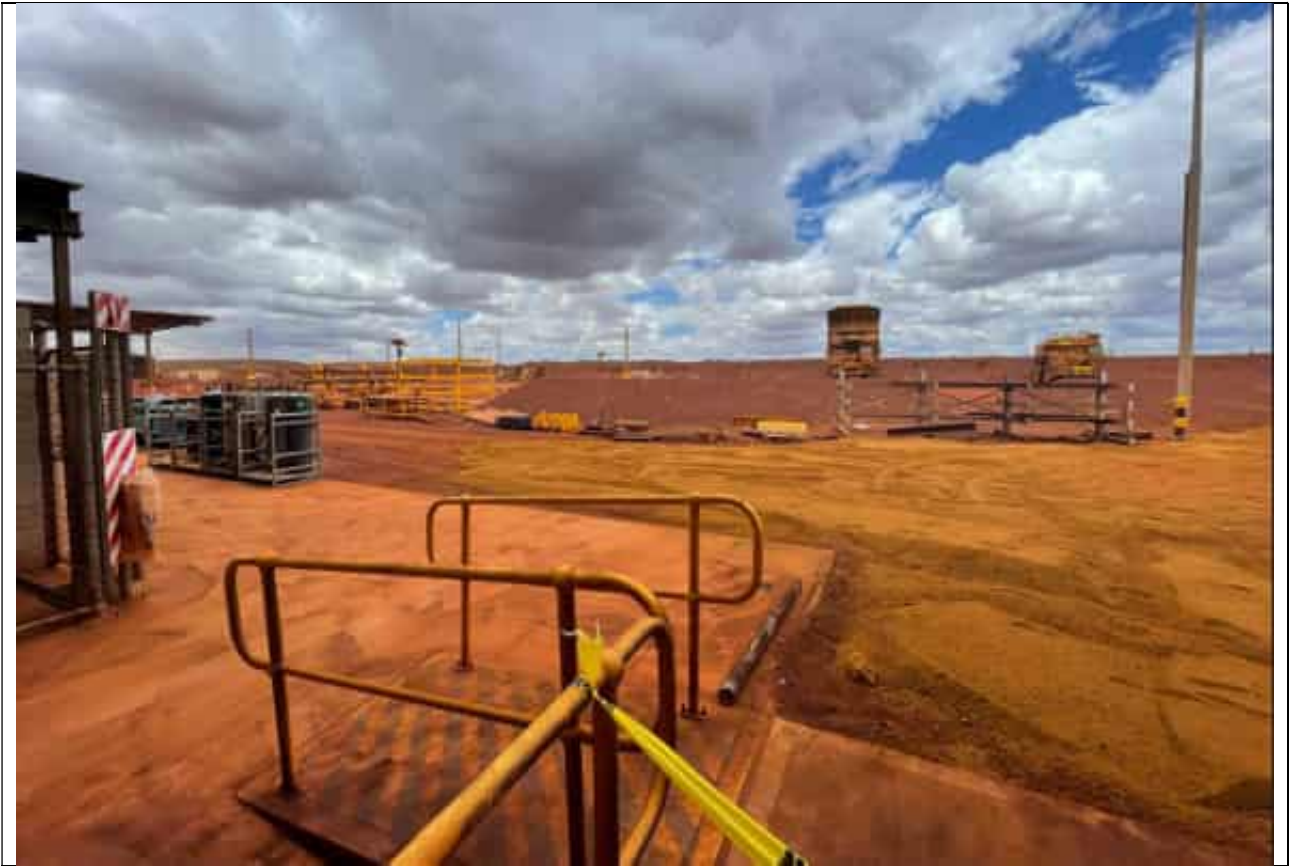
On 12/01/23, a waste oil pipe (designed to transport repair waste oil to holding tanks) at the South Flank Mobile Equipment Maintenance (MEM) Workshop has dislodged causing a discharge of approximately 1200 L of waste hydrocarbons onto bare earth.

Impact constrained to bare earth which was remediated. Discharge did not enter any drainage lines.

Section of pipeline dislodged for unknown reason.

- The source of the waste oil was isolated.
- Area barricaded off with signage to prevent unauthorized access.
- Contaminated soil removed and disposed of by a third-party contractor.
- Pipework repaired.

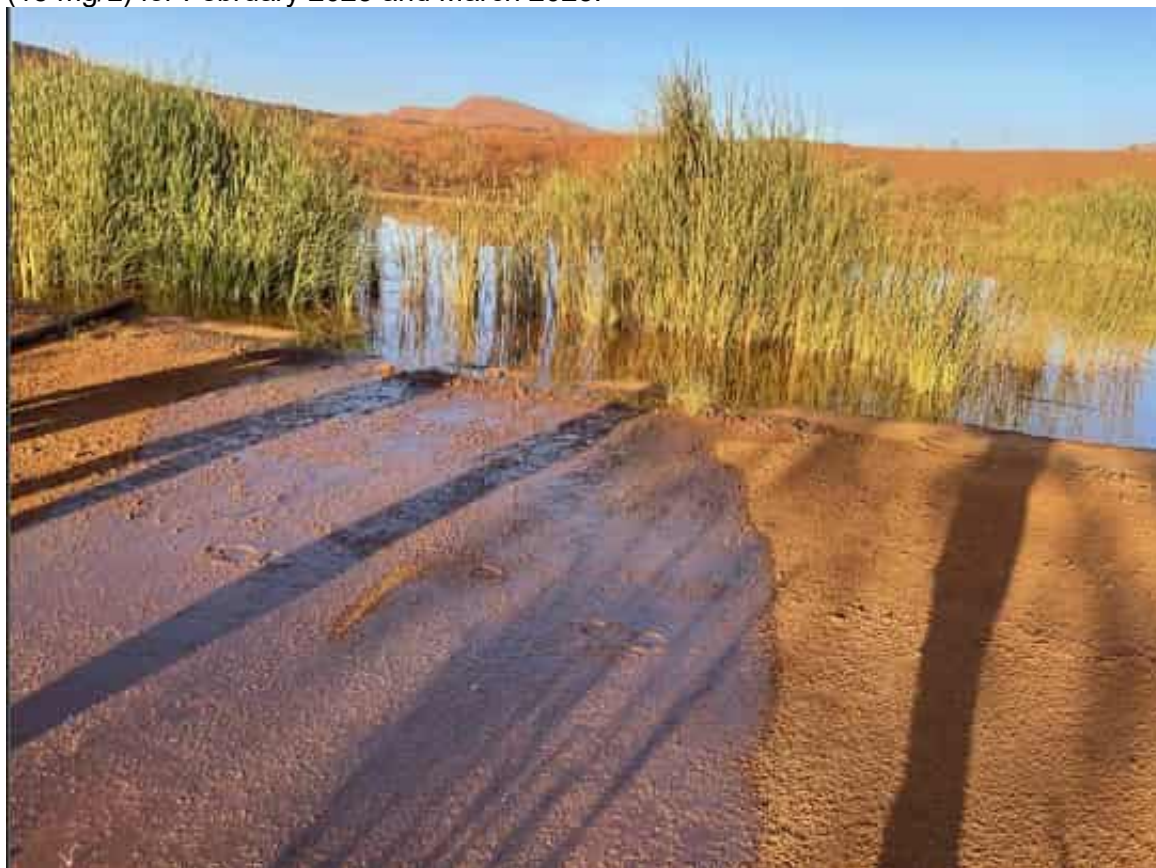
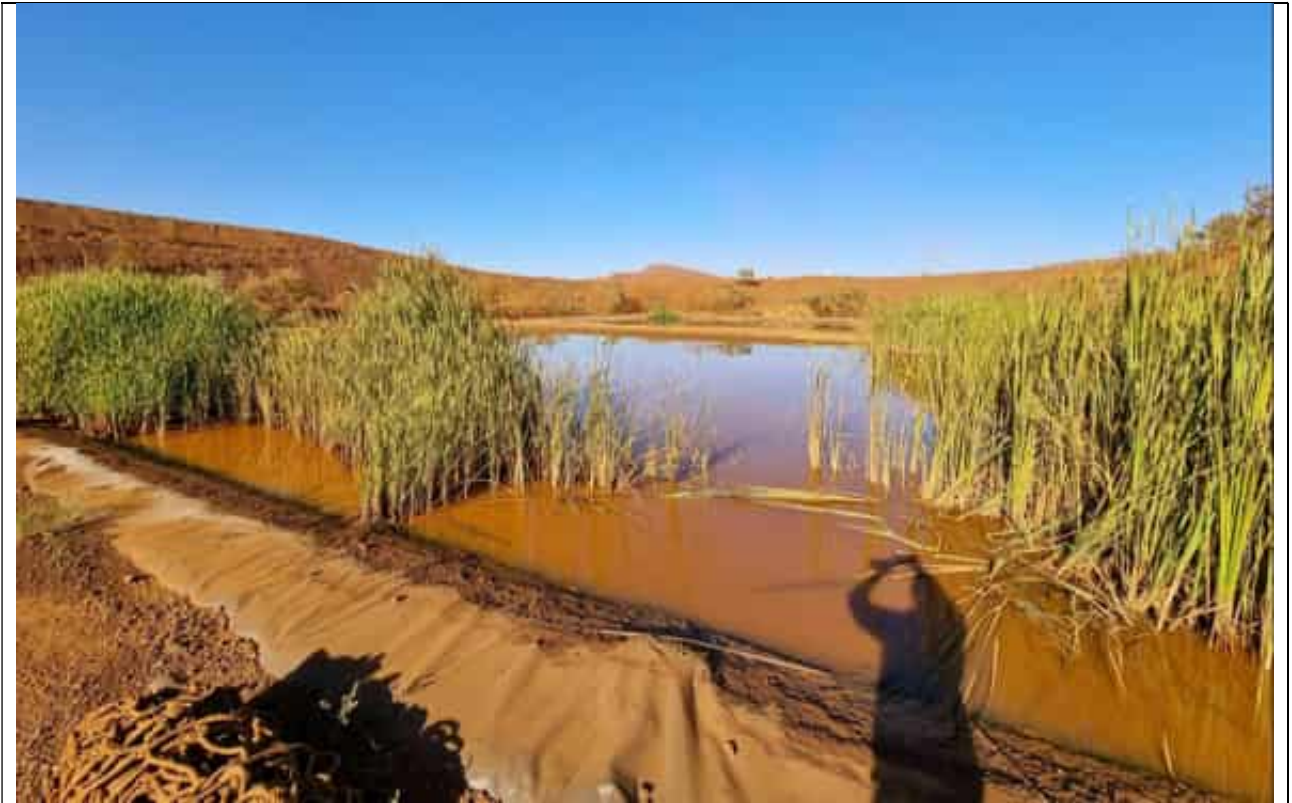
HV washdown Bay Ponds behind the MAC admin were overflowing. Pond was overtopping the bund walls not via the flow meter causing unmonitored discharge.

Non-compliance is administrative in nature. No suspected adverse impact on the environment occurred as a result of this non-compliance as the TRH concentrations were below the limits (15 mg/L) for February 2023 and March 2023.

The overflow point on the western end where the flow meter is attached, was blocked preventing water to flow.

Responsible team was notified, and the overflow point was unblocked. Eventually the water level dropped back to well below 300 mm freeboard.

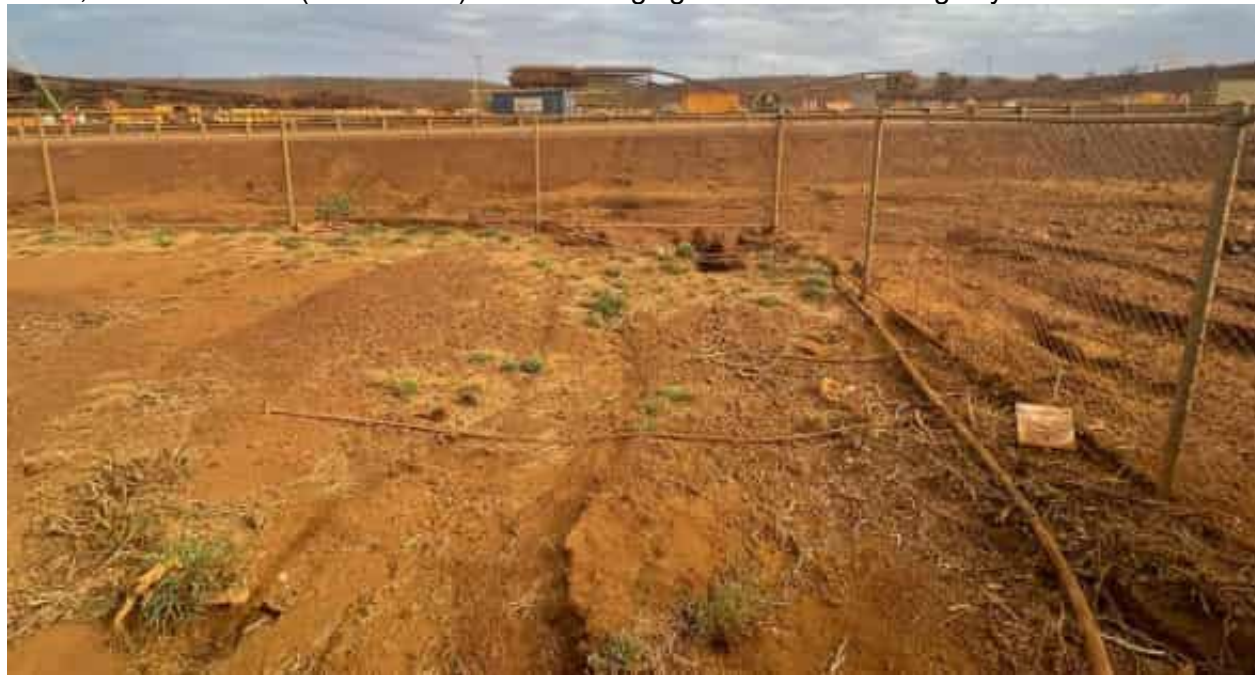
In September 2022, it was identified that the MAC Auxiliary Workshop WWTP irrigation area had been eroded by stormwater runoff from the adjacent Auxiliary Workshop carpark apron. As a result, treated effluent (wastewater) was discharging into the site drainage system.

No suspected adverse impact on the environment occurred as a result of this non-compliance as it is a treated effluent.

Stormwater runoff from the adjacent Auxiliary workshop carpark had eroded the irrigation area bund and damaged irrigation area pipework.

The system has been tagged out of use and repairs are scheduled for FY2024. A review of the management and conditions of the WWTP will also be undertaken in FY2024.
