## Annual Audit Compliance Report Form

Environmental Protection Act 1986, Part V Division 3

Section A – Licence details			
Licence number:	8155/2004/2	Licence file number:	
Licence holder name:	EDL NGD (WA) Pty Ltd		
Trading as:	EDL NGD (WA) Pty Ltd		
ACN:	070 941 721		
Registered business address:	Level 6, 1 Eagle Street Brisbane QLD 4000		
Reporting period:	01/07/2021 to 30/06/2022

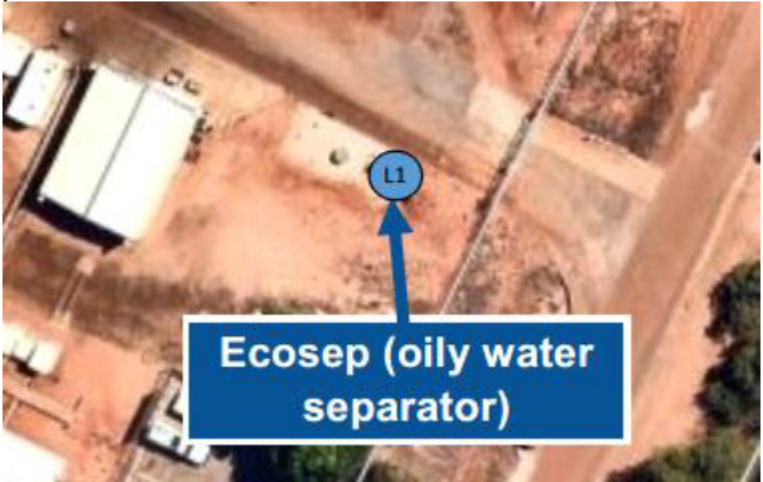
Section E – Details of Non-compliance with Licence Condition																			
Condition no:	5	Date(s) of non-compliance:	02/02/2022																
Details of non-compliance:																			
<p>Condition 5 requires output of the Oily Water Separator (L1) to be less than 15 mg/L of Total Recoverable Hydrocarbons. Testing of L1 was conducted on 2<sup>nd</sup> February 2022 and returned a non-compliant result of 193 mg/L TRH. The laboratory report is included in Attachment 3.</p> <p>The sample was taken at the end of an extreme weather event, with 652mm of rain falling in 7 days, and 564mm falling in just two of those days. The rain event was far beyond the design capacity of the oily water separator. The sustained force of the water damaged and forced open the inlet valve which is designed to close if the chamber is full. This allowed any stored oil in the chamber to be pushed through the system. The system exits into an underground leach drain and upon thorough examination there are no visible signs of oil. We do not have any evidence to suggest harm was caused.</p>																			
What was the actual (or suspected) environmental impact of the non-compliance?																			
<p><b>NOTE</b> – please attach maps or diagrams to provide insight into the precise location of where the non-compliance took place.</p> <p>It is suspected a small amount of oil was released underground, in the context of an enormous quantity of rainwater flowing through the system and the landscape in general. No oil has been found at the surface and there is no evidence to suggest harm has been caused. The release location was the licenced release point L1.</p>

Cause (or suspected cause) of non-compliance:																			
<p>Extreme rainfall (582mm in 2 days). BOM data for Broome Airport:</p>

While the weather event was uncontrollable, EDL has put in place some measures to minimise the consequence of such an event in future:

- The manufacturer was consulted about the design of the system (however no engineering solutions to reinforce the system are available);
- A disused drain upstream of the system has been blocked to help reduce the amount of stormwater entering the system; and
- Maintenance intervals for the system have been modified in an attempt to minimise the amount of oil stored in the system at any time (particularly prior to the wet season).
