Annual Audit Compliance Report Form

Section A – Licence Details			
Licence number:	L8337/2009/2	Licence file number:	2012/006861
Licence holder:	Genesis Minerals Limited		
Trading as:	Genesis Minerals Limited		
ACN:	124772041		
Registered address:	Lvl 7, 40 The Esplanade, Perth, WA, 6000		
Reporting period:	1/09/2022 to 31	1/08/2023

Condition no:	1.2.1 & 1.2.2	Date(s) of non- compliance:	23/11/22
	l .	i Cultibilatice.

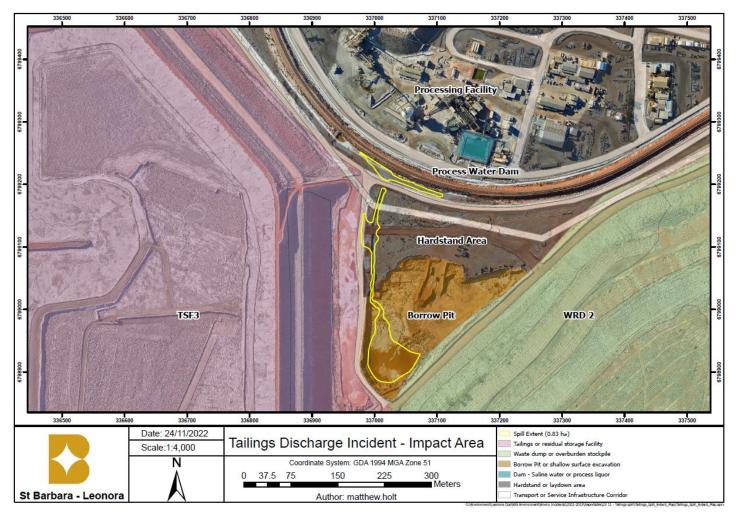
At approximately 11.30pm on 22/11/22 a small drop in pressure was identified on the tailings discharge line (to TSF3). Upon immediate investigation, discharge spigots on the tailings facility were inspected as the possible cause of the pressure drop was suspected to be a partial blockage, however the discharge flow rate from the spigots was deemed consistent and no blockage identified. At approximately 5.30am on 23/11/22 the tailings spill incident was identified. Tailings were flowing out from the buried tailings discharge line approximately 30m from the tailings facility. The estimated volume of tailings discharged was approximately 322.5m³

Process tailings material typically containing cyanide concentrations of around 7.88mg/L (WAD CN) was discharged into previously disturbed areas listed as haul/access road, hardstand area and borrow pit (final storm water capture dam) in close proximity of the tailings dam. Some storm water was already present within the borrow pit, where significant dilution occurred and a significant storm followed after. Upon the completion of clean up and remediation works, smothering of material will present little to no impact. Ground water quality in the area is hypersaline and it is not expected that the discharge will have significant impact (Figure 1, Plate 1-2).

Figure 1. Map detailing extent of discharge.

- Discharge ceased, incident reported.
- Inspection of the impact area and mapping of the discharge extent.
- Spill clean-up commenced.
- Samples of the water body located within the borrow pit taken from the eastern and western sections samples sent to NATA accredited lab for analysis.

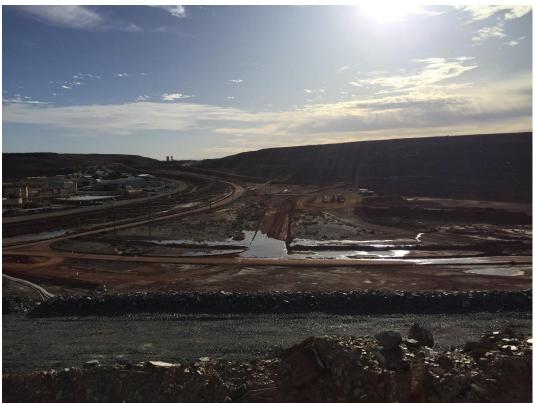
Leaking valves (located inside the TSF facility) were identified on the primary tailings line approximately 2 weeks prior to the event. Maintenance was scheduled to coincide with a planned mill shutdown on 26/11/22. To avoid further leakage or a larger leak, tailings were temporarily diverted through a secondary line that didn't have a leak detection system installed until the planned repair would be completed.

Plate 1. Tailings discharge outside of contained area.

- Repair works on ruptured pipeline completed.
- Repair works to faulty valves located on primary discharge line was completed.
- Review of the maintenance schedule was completed upon finalization of repair works.
- Review of procedure around responding to pressure changes was undertaken
- Continued monitoring regime of tailings discharge to tailings storage facility and monitoring bores around the TSF as per the license conditions.

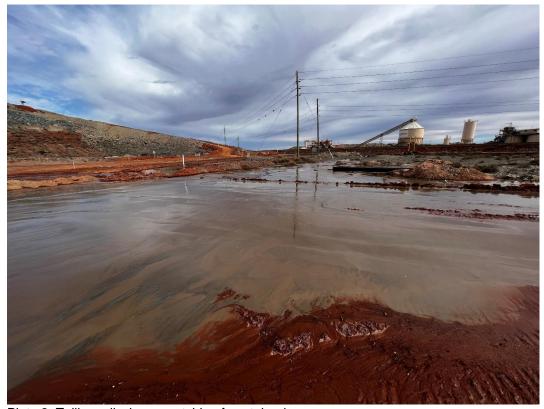
Plate 2. Tailings discharge outside of contained area.
