Annual Audit Compliance Report Form

Environmental Protection Act 1986, Part V

Section A – Licence Details			
Licence number:	L8337/2009/2	Licence file number:	2012/006861
Licence holder:	Genesis Minerals (Leonora) Pty Ltd		
Trading as:	Genesis Minerals Limited		
ACN:	667 073 681		
Registered address:	Lvl 7, 40 The Esplanade, Perth, WA, 6000		
Reporting period:	1/09/2023 to 31/08/2024

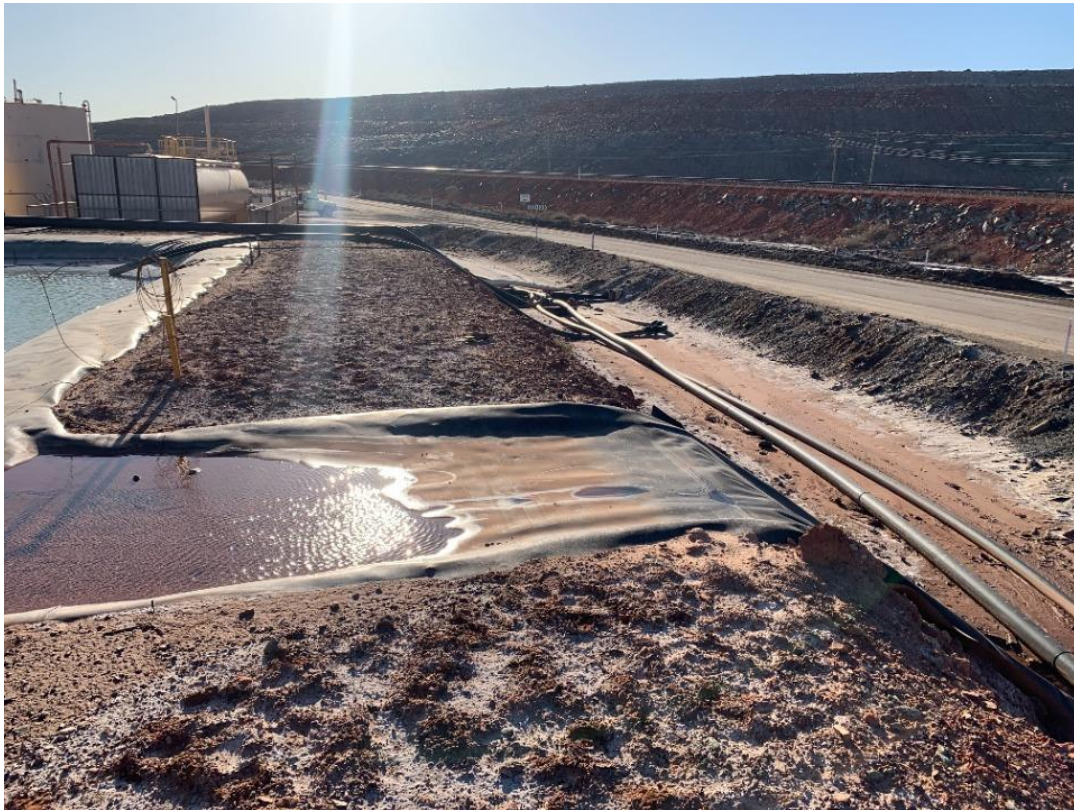
Section E – Details of Non-Compliance with Licence Condition			
Please use a separate page for each condition with which the licence holder was non-compliant at a time during the reporting period.			
Condition no:	2	Date(s) of non-compliance:	01/12/2023
Details of non-compliance:			
Process water dam overflowed for approximately 30 mins (with 150m ³ feed rate) site drainage to the site drainage catch pond.			
What was the actual (or suspected) environmental impact of the non-compliance?			
NOTE – please attach maps or diagrams to provide insight into the precise location of where the non-compliance took place.			
No environmental impact – the overflow was contained within the surrounding site drainage pond (historic site borrow pit).			
See Appendix for images relating to overflow event.			
Cause (or suspected cause) of non-compliance:			
The detection warning system was not set up to alarm or prevent overflow, and the alarm had been disabled. No information was relayed during handover from dayshift to nightshift crew regarding additional resources feeding the PWD level.

Figure 1: Location of process water dam overflow

Action taken to mitigate any adverse effects of non-compliance and prevent recurrence of the non-compliance:			
Immediate actions involved re-enabling high level alarm that had been disabled, reiterating the importance of daily handovers and recording information, and ensuring that communication occurs if a change is made. Furthermore, the Citech telemetry system was updated to prevent the PWD level alarm from being turned off.			
Was this non-compliance previously reported to DWER?			
<input checked="" type="checkbox"/> No			
<input type="checkbox"/> Yes, and			
<input type="checkbox"/> Reported to DWER verbally		Date: / /	
<input type="checkbox"/> Reported to DWER in writing		Date:

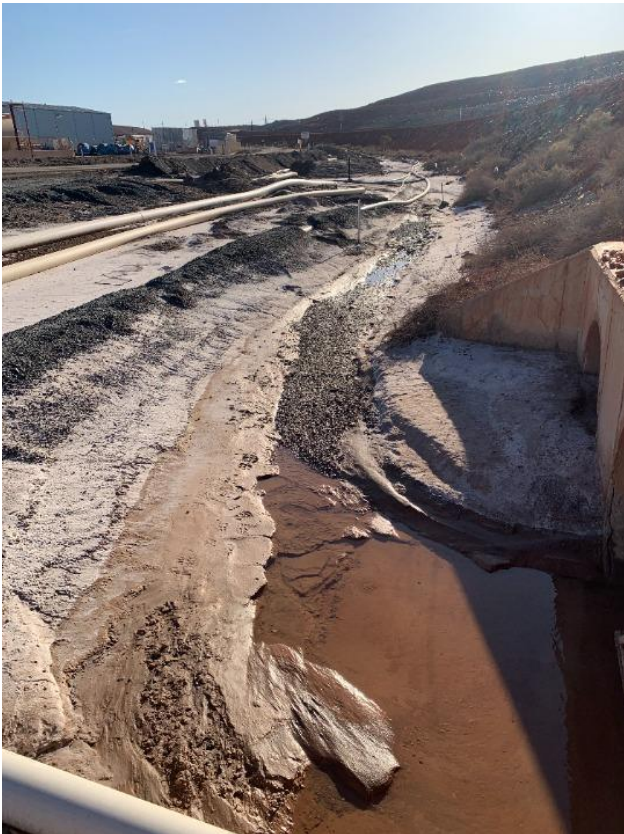
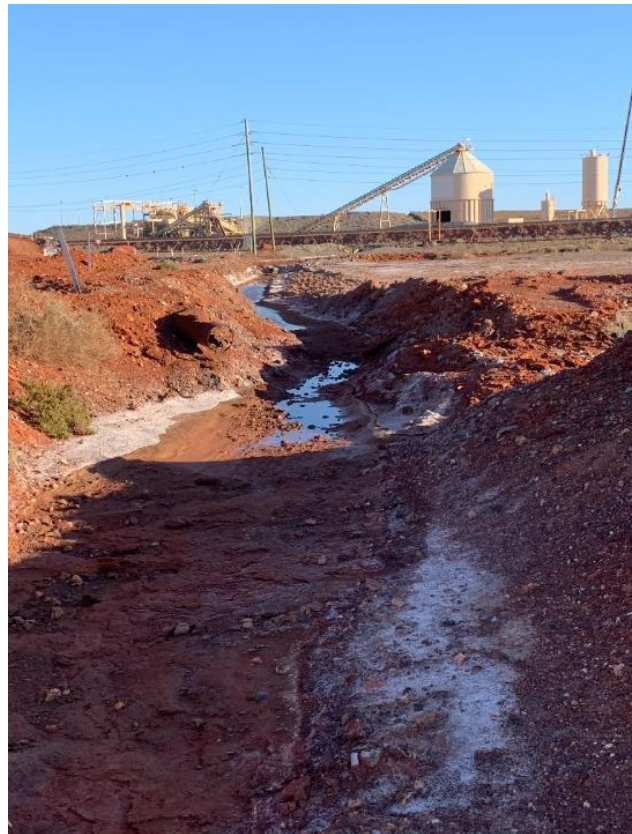
Figure 2 and 3: Extent of overflow within site drainage pond
