Annual Audit Compliance Report Form

Section A – Licence details			
Licence number:	L8485/2010/2	Licence file number:	DER2018/000300-1
Licence holder name:	St Ives Gold Mining Company Pty Limited		
Trading as:			
ACN:	098 386 273		
Registered business address:	Level 4, 235 St Georges Terrace Perth WA 6000		
Reporting period:	01/01/2025 to 31/12/2025

N1 Notifications Submitted 2025

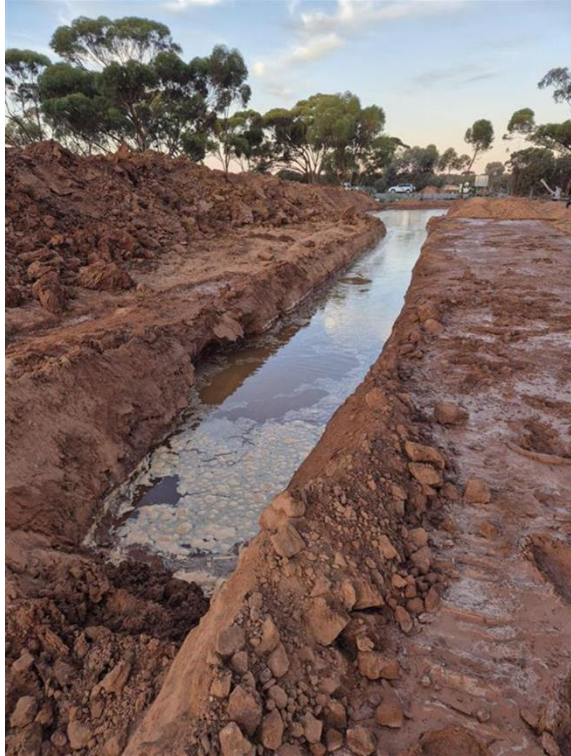
Notification requirements for the breach of a limit	
Emission point reference/ source	During ongoing pipeline replacement works at the Mt Morgan borefield, the existing pipeline was struck by a digger at approximately 2:20 PM. The incident resulted in a release of water from the pipeline.
Parameter(s)	Saline Water
Limit	Water samples were collected from the area affected by the saline water release. Sampling was undertaken to assess the quality of the discharged water and evaluate the potential environmental impact of the incident. The samples will be analysed for pH and Total Dissolved Solids (TDS) parameters. Based on historical data from this pipeline, the water is known to be hypersaline.

Measured value	9,000 L release from pipeline trench to v-drain
Date and time of monitoring	28/05/2025 at 4:00 PM
Measures taken, or intended to be taken, to stop the emission	<p>Following the incident, the water pump was shut down immediately to prevent further discharge. Most of the released water was contained within the designated work area, specifically within the pipeline trench associated with the pipeline replacement works.</p> <p>It is estimated that approximately 9,000 L of water discharged from the pipeline trench (designated work area) into the V-drains located along the eastern and western side of the highway.</p> <p>A small portion of the water also migrated along the Gas Pipeline corridor. This area comprises predominantly previously disturbed ground, and minimal water was observed to extend into undisturbed bushland.</p> <p>The extent of the released water is currently being mapped to evaluate its spread and better understand any potential environmental impacts.</p>

Photo-01 – Release water contained within the trench line

<p>The pumping system was shutdown automatically by the leak detection system. The NPI services team opened scour pit valves and isolated the transfer tank to prevent further water draining from the tank and line.</p> <p>After the pipeline was isolated, the earthworks contracting team promptly constructed an earthen bund to minimise the spread of saline water. Immediate earthwork-related remediation was not undertaken, primarily because the spill occurred within an area of previously disturbed land (e.g. the existing gas pipeline corridor). Rainfall was forecast for the night of the incident and the following days. Based on previous experience with saline spill remediation, it was recommended to wait and determine whether the rainfall would assist in diluting the saline concentration. This approach proved effective — no visible saline crust remained, indicating natural dilution had occurred.</p> <p>The regulator was notified via Form N1 and monthly photo monitoring was carried out for a period of 6 months to assess vegetation and determine if further remediation was required (Associated reports are attached in Appendix).</p>

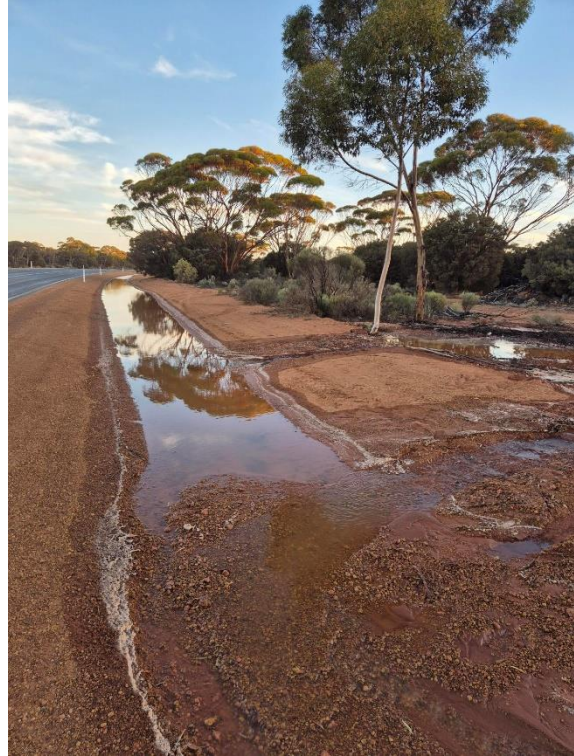
Photo-02 – Water from the trench overflow toward the V drain on the side of the road

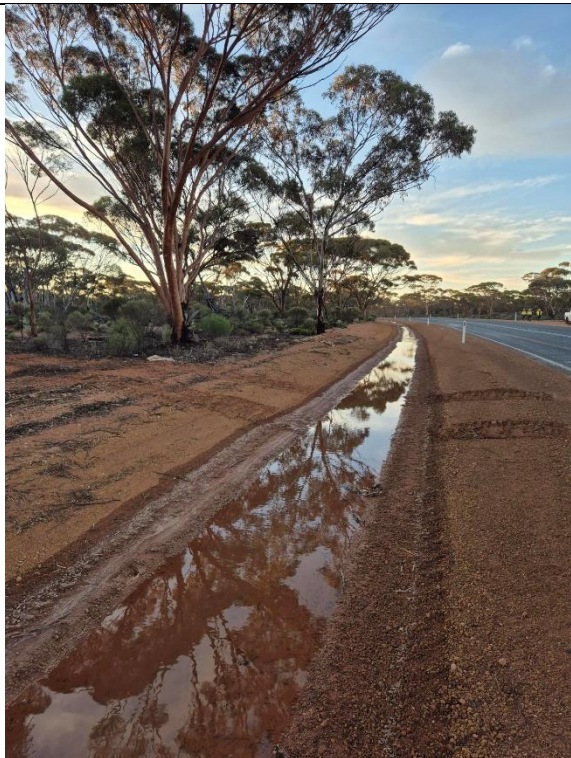
Photo-03 – Water from the trench overflow toward the V drain on the side of the road

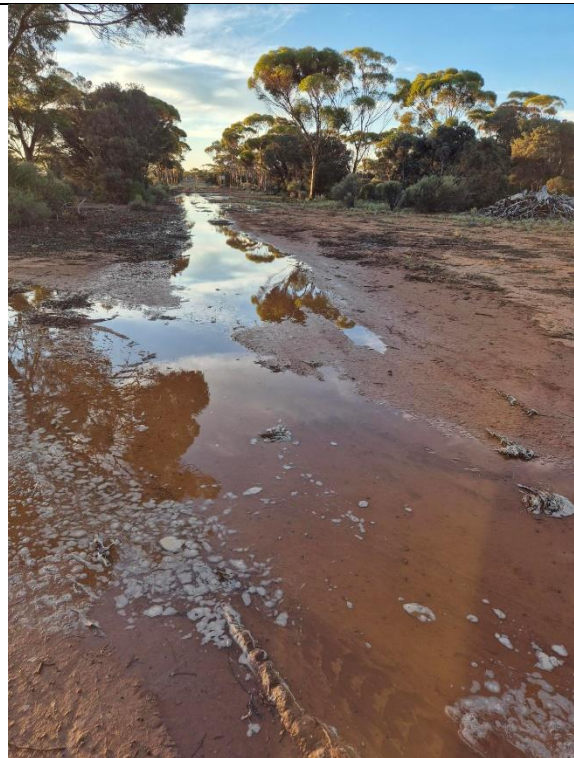
Photo-04 – Portion of water release to the gas line corridor
