Annual Audit Compliance Report Form

Section A – Licence Details			
Licence number:	L8579/2011/2	Licence file number:	2012/006902-1
Licence holder:	AngloGold Ashanti Australia Limited		
Trading as:	AngloGold Ashanti Australia Limited		
ACN:	008 737 424		
Registered address:	Level 10, 140 St Georges Tce, Perth WA 6000		
Reporting period:	01/01/2023 to 31/12/2023

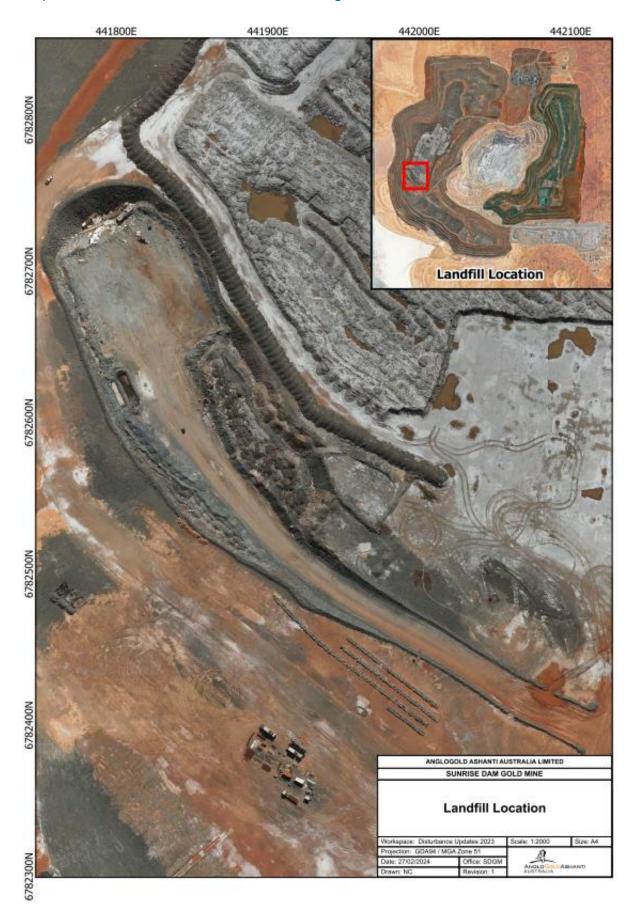
Figure 1 Landfill Location

Condition no:	4	Date(s) of non-complian	ce:	2023
Details of non-compliance:				
Windblown rubb	ish collect	on did not occur weekly		
What was the a	ctual (or su	spected) environmental	impact of the non-compli	ance?
NOTE – please a compliance took p		or diagrams to provide insi	ght into the precise location	of where the non-
Waste Rock Lar Iandfill).	ndform and	l it is well within the Pren	o the location of the landfi nises boundary (Figure 1 ot always on a weekly ba	Location of the

e) of non-compliance:	or always on a weekly ba	313.
Staff turnover a	nd lack of o	clarity for accountability f	or the activity.	
Action taken to non-compliance	_	y adverse effects of non	-compliance and prevent	recurrence of the
AGAA is current new acc new sys	tly investig countabilitie stem to ens	es for the landfill, and	ucted in a timely manner. s one.	
Was this non-co	mpliance p	previously reported to D\	WER?	
No				
Reported to	DWER ver	bally	Date: / /	
Reported to	DWER in v	vriting	Date:	
DWER referer 61245	ice number	for this report is ICMS

Staff turnover and lack of clarity for accountabil	ity for the activity.
Action taken to mitigate any adverse effects of compliance:	non-compliance and prevent recurrence of the non-
AGAA is currently investigating: new accountabilities for the landfill, and new system to ensure the landfill is bad In addition, a new landfill will soon be replacing	kfilled in a timely manner.
Was this non-compliance previously reported to	DWER?
No	
Reported to DWER verbally	Date: / /
Reported to DWER in writing	Date:
DWER reference number for this report is ICMS 61245

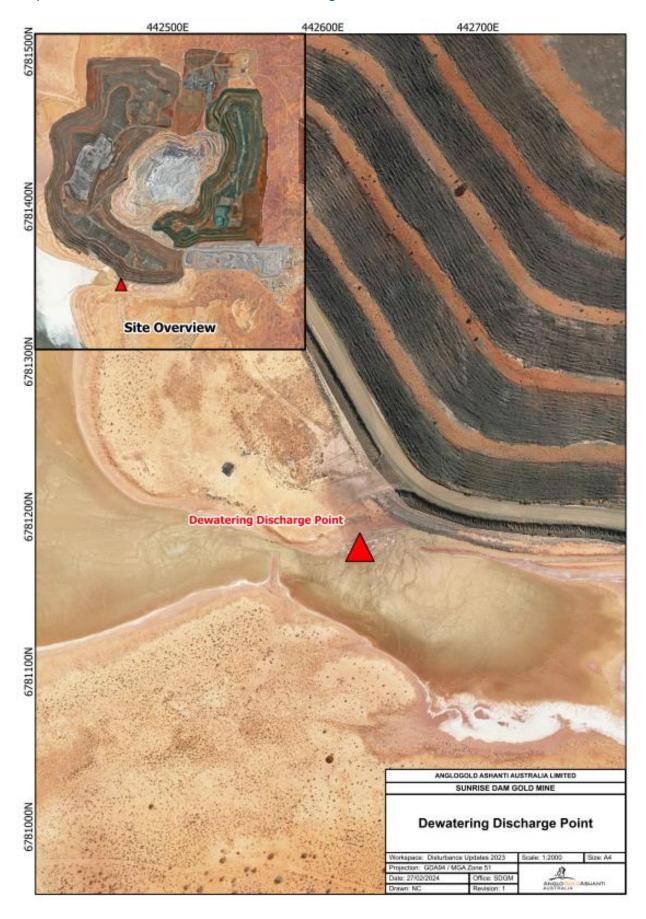
Figure 2 Dewatering Discharge Point Location

Condition no:		Date(s) of non- compliance:	December 2023
Details of non-comp	Details of non-compliance:		
No dewatering discharge sample was collected in Q4 2023 as there was no water being discharged on the days in December when the technician went to collect the samples.			
What was the actua	l (or suspected) environmen	ntal impact of the non-	-compliance?
NOTE – please attach maps or diagrams to provide insight into the precise location of where the non-compliance took place.			
Technical non-compliance only, no impact to the receiving environment. Please see Figure 2 for the location of Dewatering Discharge Point			
Cause (or suspecte	Cause (or suspected cause) of non-compliance:		
Monitoring schedule did not allow sufficient time to go back for a sample if discharge was not occurring at the time of planned sampling.			
Action taken to mitigate any adverse effects of non-compliance and prevent recurrence of the non-compliance:

The monitoring scheduled will be amended to the first month of the quarter, in order to provide more opportunity for sampling days if they are required. However, this will be staged to maintain compliance with the timing specified in Condition 15.			
Was this non-compliance previously reported to DWER?			
No			
Reported to DW	ER verbally	Date: / /	
Reported to DW	ER in writing	Date:	
DWER reference r 61245	number for this report is ICMS
