Annual Audit Compliance Report Form

Licence number:	L8839/2014/1	Licence file number:	DER2014/001936
Licence holder name:	Shire of Ravensthorpe		
Trading as:	Shire of Ravensthorpe		
ACN:	No ACN held by the Shire, but do have ABN 52 674 538 418		
Registered business address:	65 Morgan Street RAVENSTHORPE WA 6346		
Reporting period:	1 / 4 / 2022 to 31 / 3 / 2023

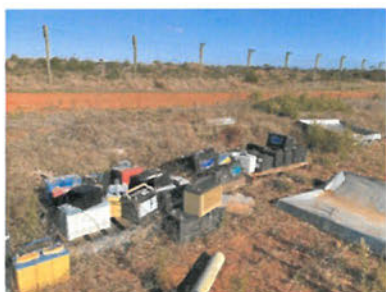
Vehicle batteries not stored in a covered area on hardstand
Contaminated waste stored outside landfilling area (recent aircraft incident class II waste)

Photograph 3: Vehicle batteries not stored in a covered area.

Possible leakage of battery chemicals into the environment, although no such leakage has been observed.

The correct operating procedure was not in place and clear direction was not provided to maintenance and operating staff of licensing requirements.

All batteries were moved onto pallets and are being stored on a concrete floor in a lockable shed adjacent to the tip attendant office.
The contaminated solid waste from the aircraft incident has been moved to the landfill cell and correctly covered.

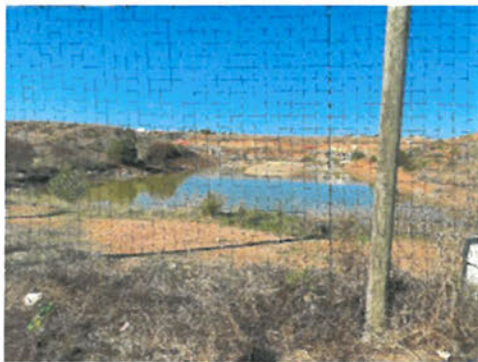
Landfill leachate is stored outside the landfill leachate pond (leachate is ponding in between the leachate pond and low point of landfill cell)

Photograph 8: Landfill leachate ponding in between leachate pond and low point of landfill cell

The correct operating procedure for leachate management and shut off valve usage was not in place causing some of the leachate to pool outside of lined leachate pond. Insufficient landfill covering enabled water to percolate quickly and not be absorbed.

Subsequent training of landfill maintenance staff and the development of correct operating procedure and management plan.
Landfill cover has been increased to the prescribed 300mm thickness which will increase absorption capacity and reduce water flow.
Concrete hardstand, shed, pump and sprinkler system were also put in place adjacent to the leachate pond area to assist with dispersion of leachate water onto the active landfill area for evaporation.
