# **Application for Works Approval**

Works Approval Number	W6927/2024/1
Applicant	Silver Lake (Integra) Pty Limited
ACN	093 278 436
File number	DER2024/000132
Premises	Randalls Gold Processing Facility EMU FLAT WA 6431
	Legal description –
	Mining tenements M25/71, M25/125, M25/133, M25/307, M25/347;
	General purpose lease L25/27, L25/29, L25/31, L25/33, L25/41; and
	Miscellaneous licence G25/02,
	As defined by the premises maps attached to the issued works approval
Date of report	06 August 2024
Decision	Works approval granted

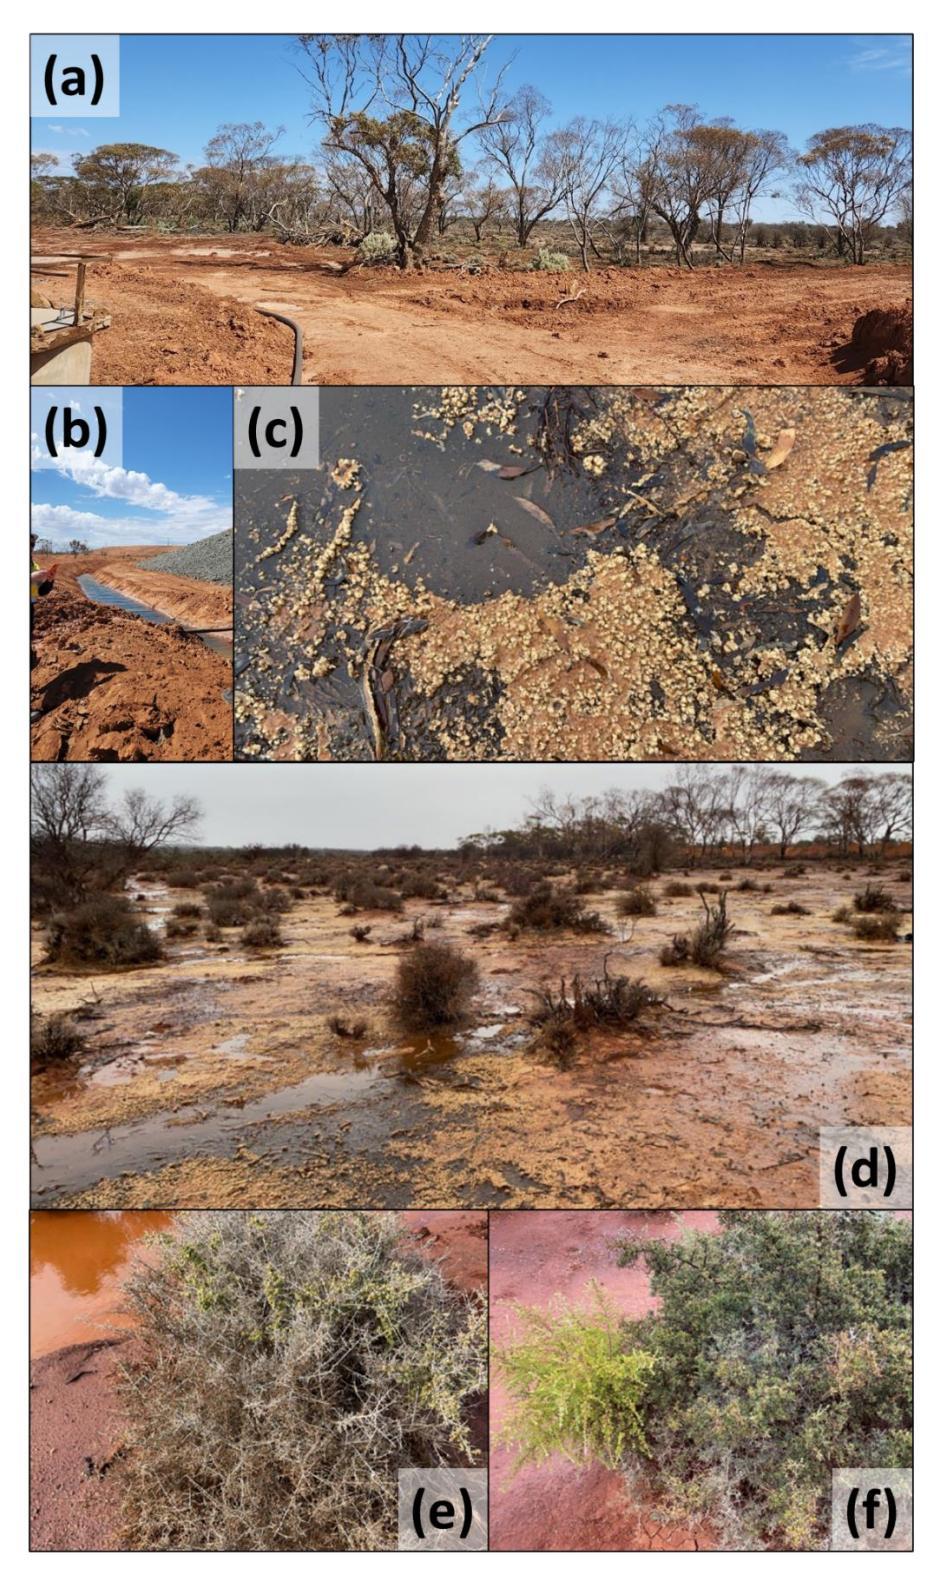
Figure 1: Photographic documentation of environmental impacts from surface expression at TSF2<sup>3</sup>

<sup>&</sup>lt;sup>3</sup> (a) Vegetation stress and potentially vegetation death on the northern boundary of TSF2, observed at an inspection by Department of Energy, Mines, Industry Regulation and Safety in March 2023. (b) TSF2 toe drain filled with intercepted groundwater, (c) Salt crusting and (d) Vegetation degradation due to surface expression of groundwater, (e) Stressed vegetation condition in the impacted area, compared to (f) vegetation outside the impacted area.

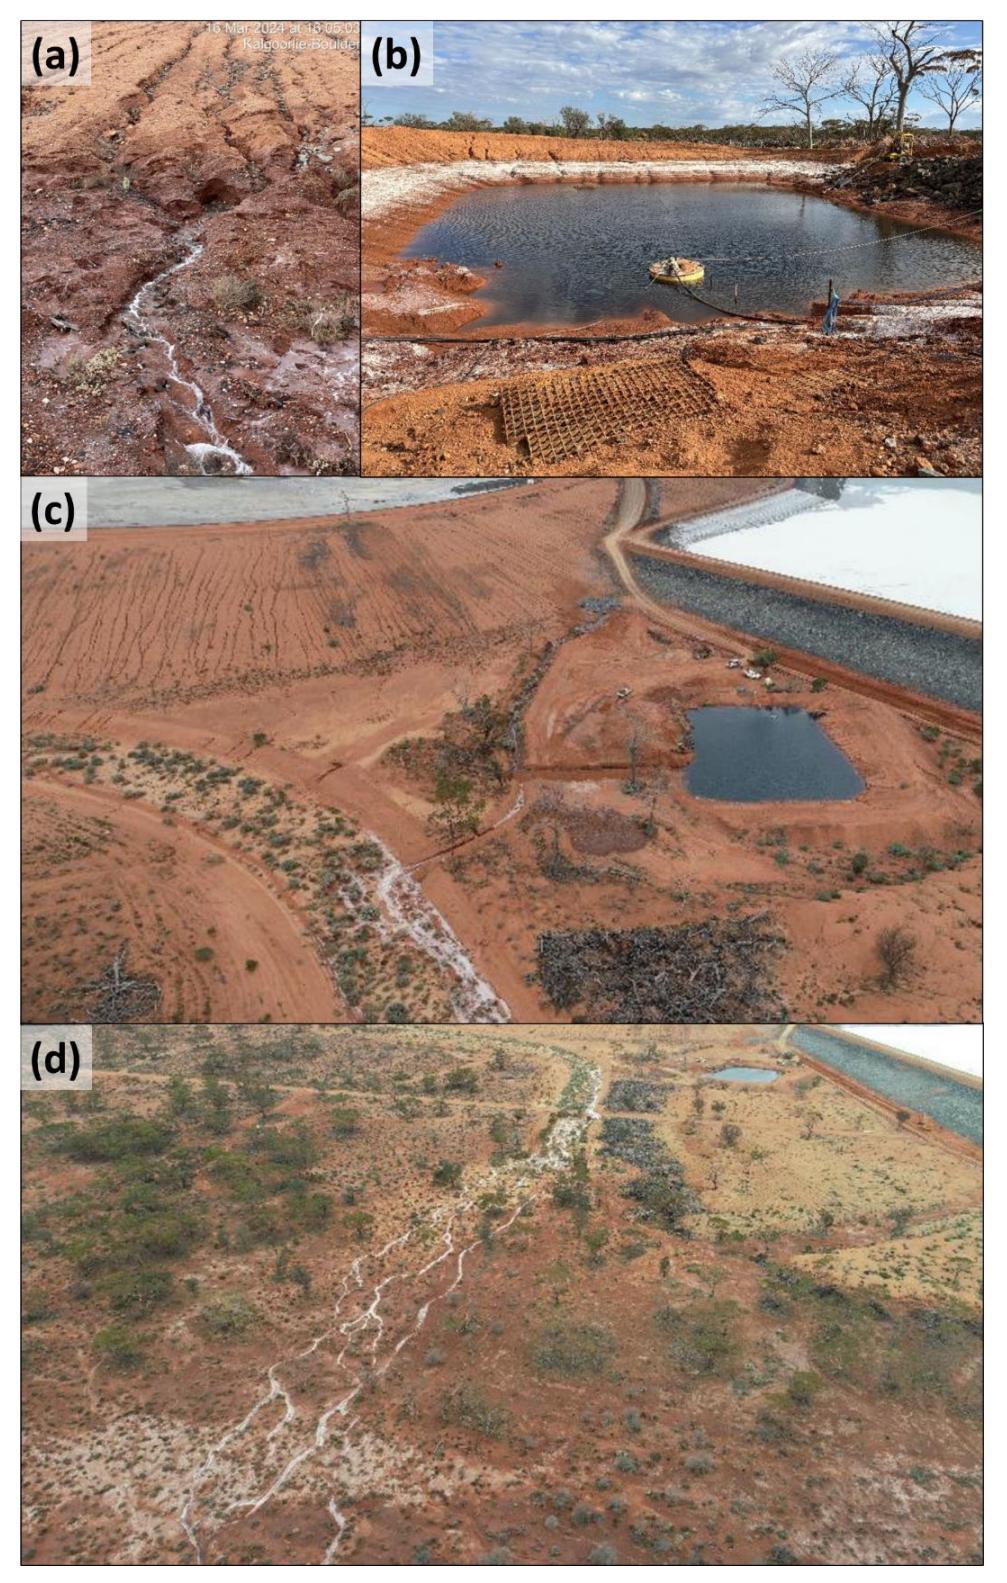
Figure 2: Photographic documentation of environmental impacts from surface expression at TSF1 $^4$

Separate from TSF2, surface expression of groundwater was found occurring at the base of the TSF1 embankment toe on 16 March 2023 (Figure 2a) and reported to the department on 18 March 2024, likely from an un-grouted historical exploration borehole. The bore had likely become artesian and began expressing groundwater as a result of heavy rainfall during the preceding fortnight, resulting in saturated subsurface conditions (Coffey 2024b).

Nevertheless, there was evidence of salt crusting and deterioration of vegetation condition in the flow path to Salt Creek. Salt scarring of Salt Creek is also evident in the aerial drone imagery (Figure 2d). The discharge was promptly diverted to an existing turkeys nest, located north of TSF2 (Figure 2b). The rate of water flow entering the turkeys nest was estimated to be up to 7 L/s, though it has since been reduced to approximately 1 L/s. The turkeys nest is equipped with a pump to return the diverted water to the TSF2 supernatant pond. The applicant has also expanded their vegetation monitoring program to include this area, with a snapshot of vegetation condition shown in Figure 3.

<sup>&</sup>lt;sup>4</sup> (a) Surface expression of groundwater from the toe of TSF1 western embankment, (b) Surface expression directed to the TSF turkeys nest for storage, (c) Aerial view of trench diverting surface expression to TSF turkeys nest, where it had previously flowed into and along Salt Creek, (d) Salt crusting along Salt Creek showing the extent of the discharge.

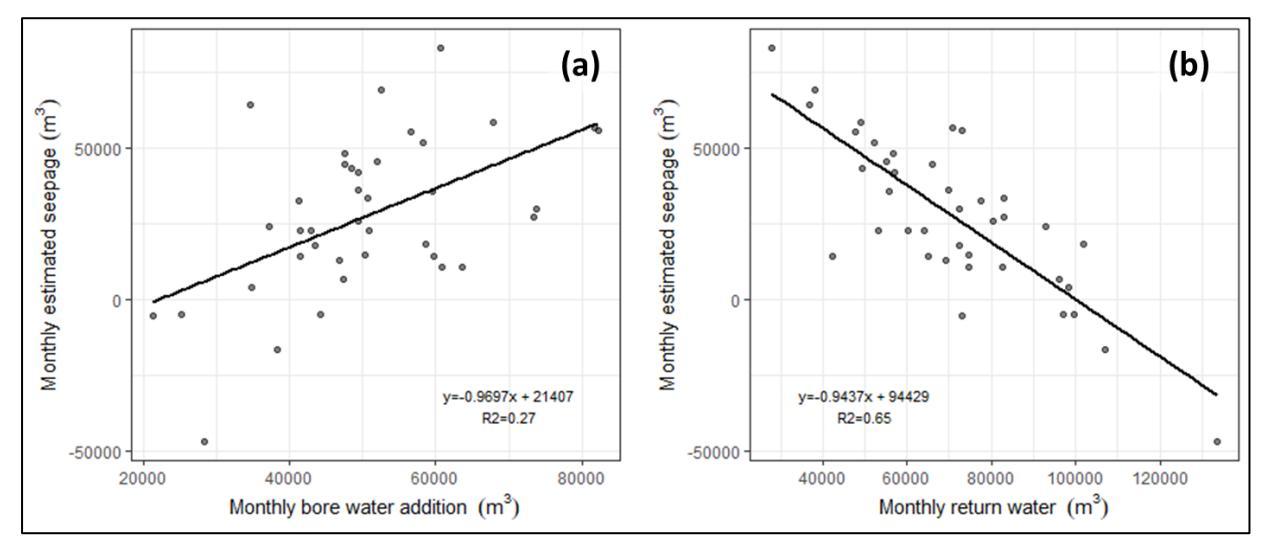
# Figure 5: Linear regression analysis between estimated seepage and (a) monthly bore water addition and (b) return water

Overall, empirical seepage data collected to date has shown a high degree of variability, without exhibiting strong seasonal trends. Nevertheless, linear regression analysis has indicated that the strongest predictors of seepage volume was the volume of bore water added ( $R^2 = 0.27$ ) and volume of return water recovered ( $R^2 = 0.65$ ) (Figure 5), more so than environmental factors such as rainfall and evaporation. This highlights the importance of minimising additional water inputs into the TSF and maximising water recovery, respectively.

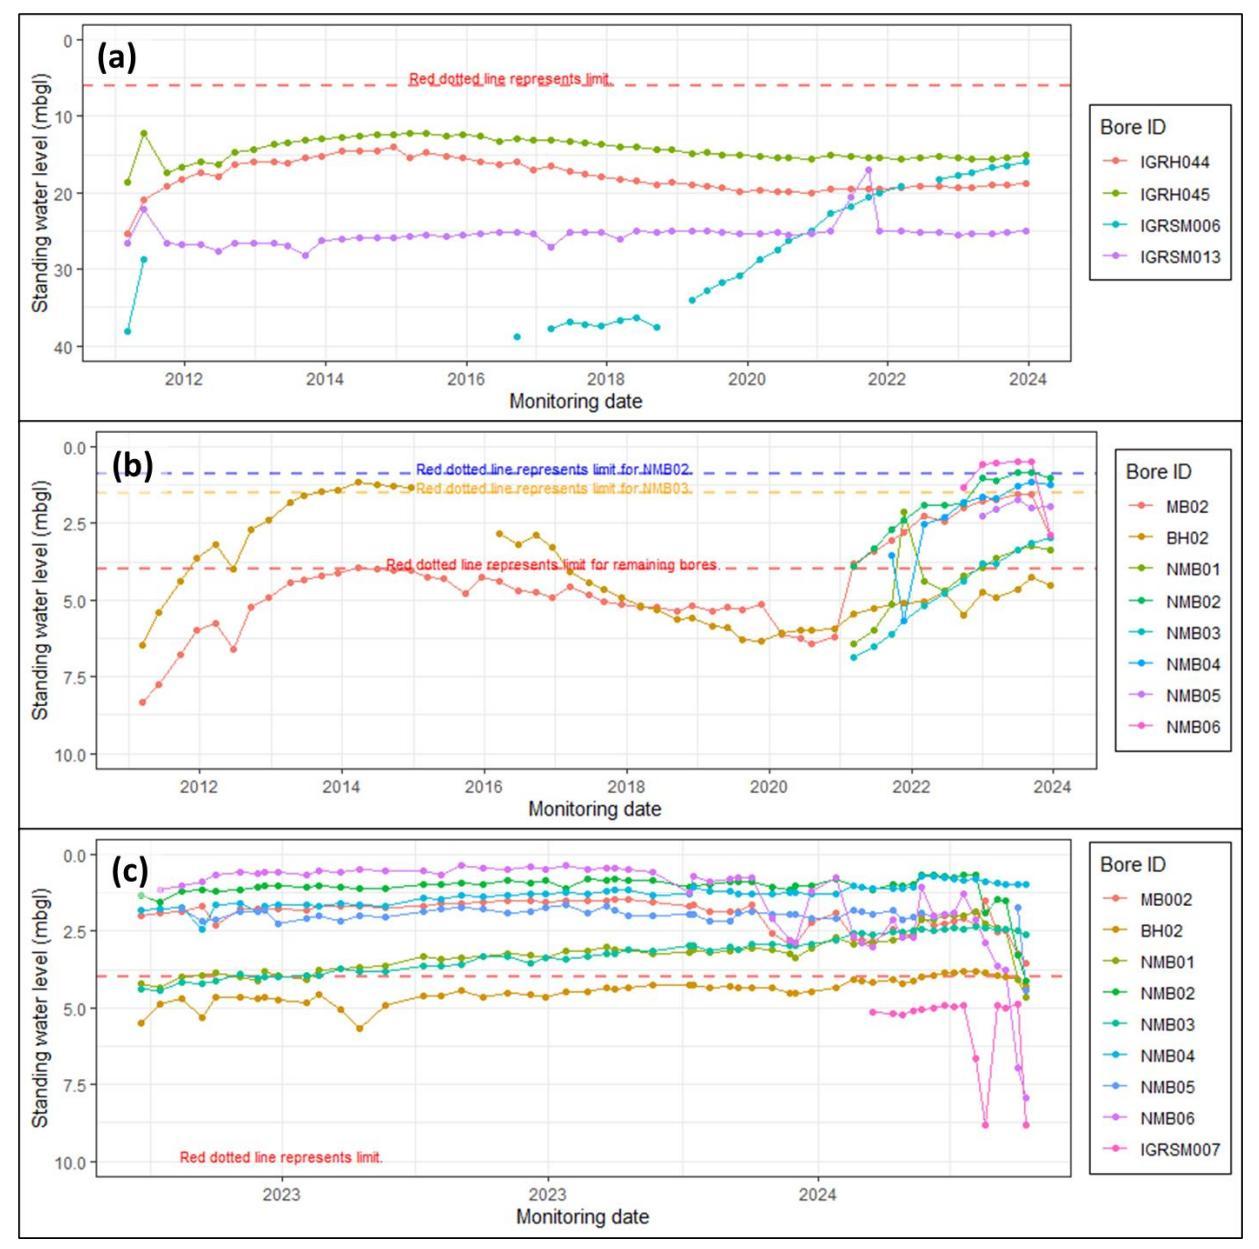
Figure 6: Standing water level trends at groundwater monitoring bores (a) east of TSF area, (b) west of TSF area, and (c) west of TSF area (high frequency)<sup>9</sup>

The most significant groundwater mounding, and consequently the shallowest groundwater, have been primarily observed in monitoring bores located west of the TSF area, along the Salt

Creek. While this trend is consistent with the regional hydrogeology pre-mining, groundwater levels are significantly shallower to the west (Rockwater 2024).

On the other hand, groundwater monitoring bores located to the east have remained relatively deep and compliant with their corresponding SWL limit (i.e., 6 mbgl) throughout their monitoring lifetime. It is worth noting that, while compliant with its SWL limit, monitoring bore IGRSM006 located south-east of TSF2 has experienced a significant increase in SWL (i.e., approximately 24 m) since 2017, which could potentially be caused by tailings deposition at the Salt Creek In-Pit TSF and TSF2. Rockwater (2024) postulated that IGRSM006 may represent the south-east extent of the groundwater mound.

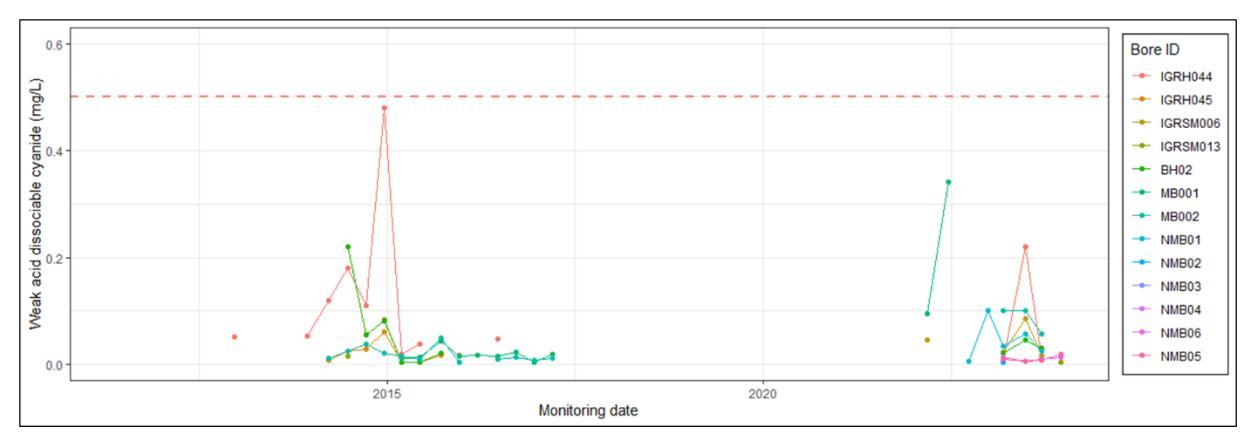
Figure 7: WAD CN concentrations in ambient groundwater<sup>10</sup>

- While the impacts of groundwater mounding have not been clearly evident in SWL monitoring data, WAD CN has been detected above its limit of reporting at the eastern and south-eastern monitoring bores (e.g., IGRSM006, IGRSM013, IGRH044, and IGRH045) during the 2023 annual period. WAD CN was also detected at these monitoring bores during the previous operation of TSF1 (Figure 7).

- Rockwater (2024) stated that monitoring bore IGRSM013 was a regional bore, unlikely to be impacted by tailings seepage. However, WAD CN was subsequently detected at 0.004 mg/L during the December 2023 monitoring event (Figure 7), suggesting some levels of impact. The source of the WAD CN is currently not known. Similarly, it is unclear whether WAD CN was detected at monitoring bore IGRH044 as a result of tailings seepage from the TSF area or the gold processing facility.
