1 Environmental Management

2 Nickel West Mt Keith

2.1 L6453/1990/12

This report has been prepared to meet the Condition 24 reporting requirements (covering the period 1 July 2024 to 30 June 2025) for Part V Licence L6453/1990/12.

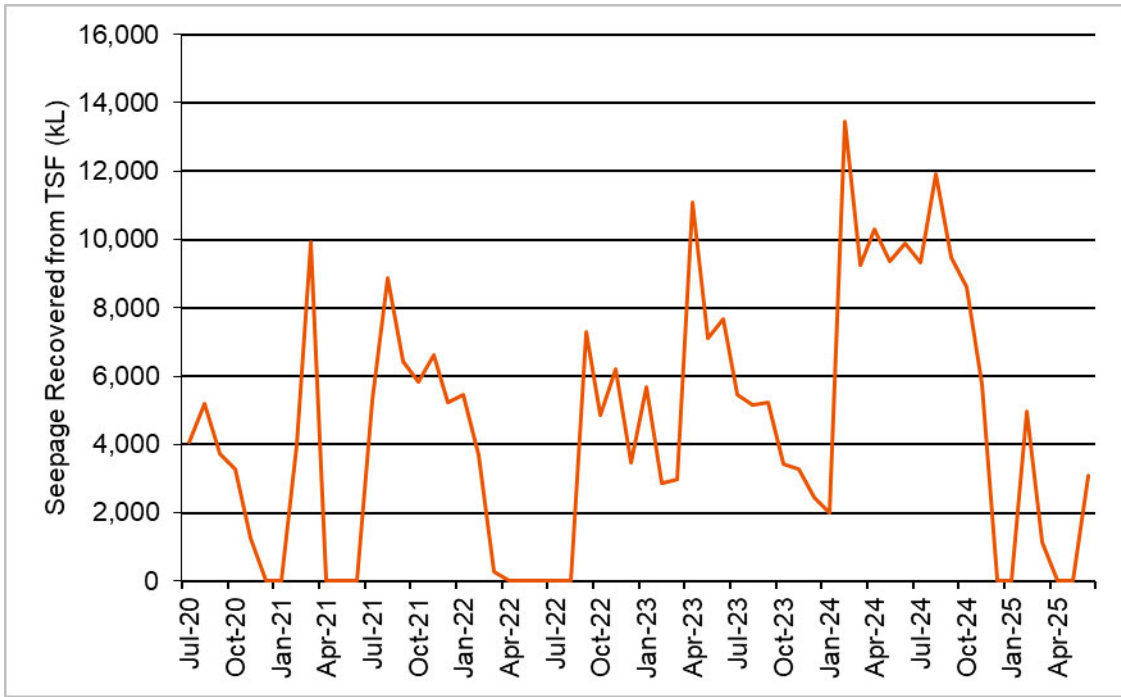
Figure 2-4 NMK CDTSF Interception Trench Seepage Recovered

- Seepage recovered from the CDTSF remained relatively consistent throughout the first five months of the reporting period. Reduced recovery in December and January was a result of reduced personnel due to temporary suspension. During April and May 2025 there was a mechanical issue with the meter. While water continued to be recovered, volumetric records were not possible. From June 2025 process monitoring has resumed as required.

** Faulty meter, seepage recovery maintained. Fixed June 2025
