Southern Piggyback Cell Stability Risk Assessment

Tamala Park Waste Management Facility

Prepared for Mindarie Regional Council

Project Number: TW23015

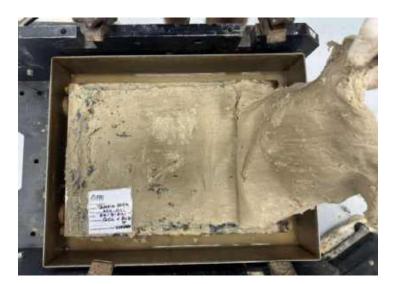
200kPa

Test Conditions				
Upper Box	Elcoseal X2000 GCL Carrier Layer Facing Down				
Lower Box	Subgrade, Compacted to 95% of 1790kg/m ³ @13.7% moisture content				
Box Dimension	ns: 305 mm x 305 mm x 102 mm				
Interface Conditioning:	Interface soaked and loading applied for a minimum of 24 hour prior to shear.				
Test Condition: Wet					
Shearing Rate	: 0.1 mm/minute

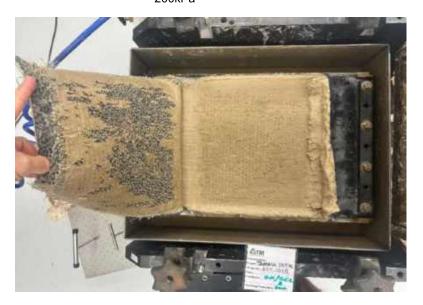
Test Conditions					
Upper Box	Elcoseal X2000 GCL Cover Layer Facing Down					
Lower Box Solmax Double Sided Textured LLDPE Geomembrane						
Box Dimension	ns: 305 mm x 305 mm x 102 mm					
Interface Conditioning:	Interface soaked and loading applied for a minimum of 24 hour prior to shear.					
Test Condition: Wet						
Shearing Rate	: 0.1 mm/minute
