Western Queen South Geotechnical Review

Prepared for:
MEGA Resources
Effective Date: May 2025
FINAL

Project reference:	MER058
Effective date:	May 2025
Status:	Published
File:	SME_MER058_Report_WesternQueenSouth_GeotechnicalReview_May2025_FINAL.docx

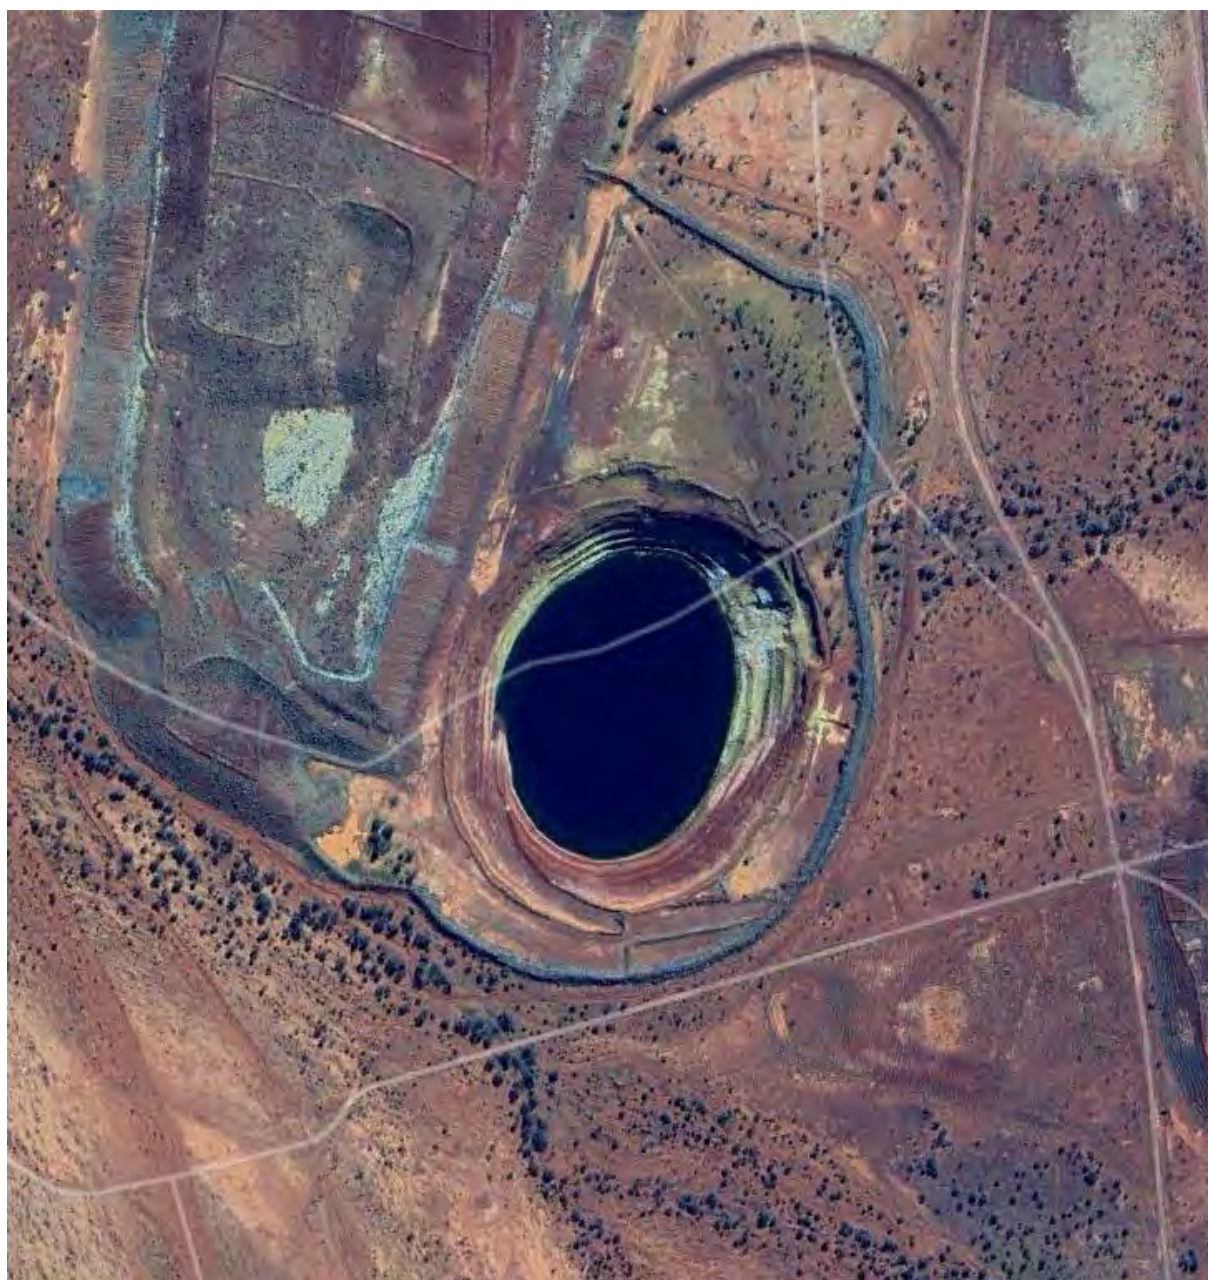
Figure 1.1: Aerial View of Western Queen South Pit in 2023 (source Google Earth Pro).

Figure 1.1 presents a recent aerial view of the existing (Stage 2) Western Queen South pit (sourced from Google Earth Pro image date 22/05/2023) which is currently filled with water and has not been mined since 2013.

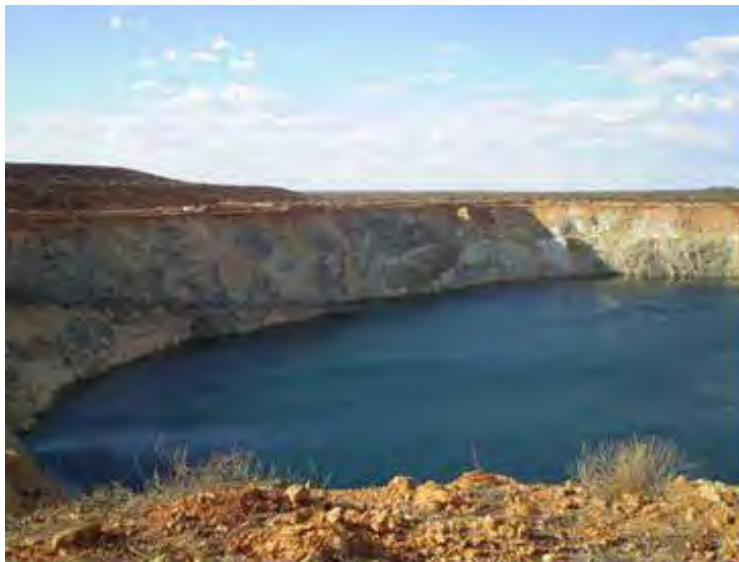
Figure 3.2: Original Western Queen pit water level ~ 255mRL (AMC 2007 Fig. 3.2)

Observations in the pit indicate that the pit bottom is now well below the natural water level. These observations are in agreement with the water level in the original Western Queen pit around 700m further north. The water level in this pit is estimated at 255-355mRL, and the Western Queen South pit is currently at 250-350mRL (5m below 255-355mRL).

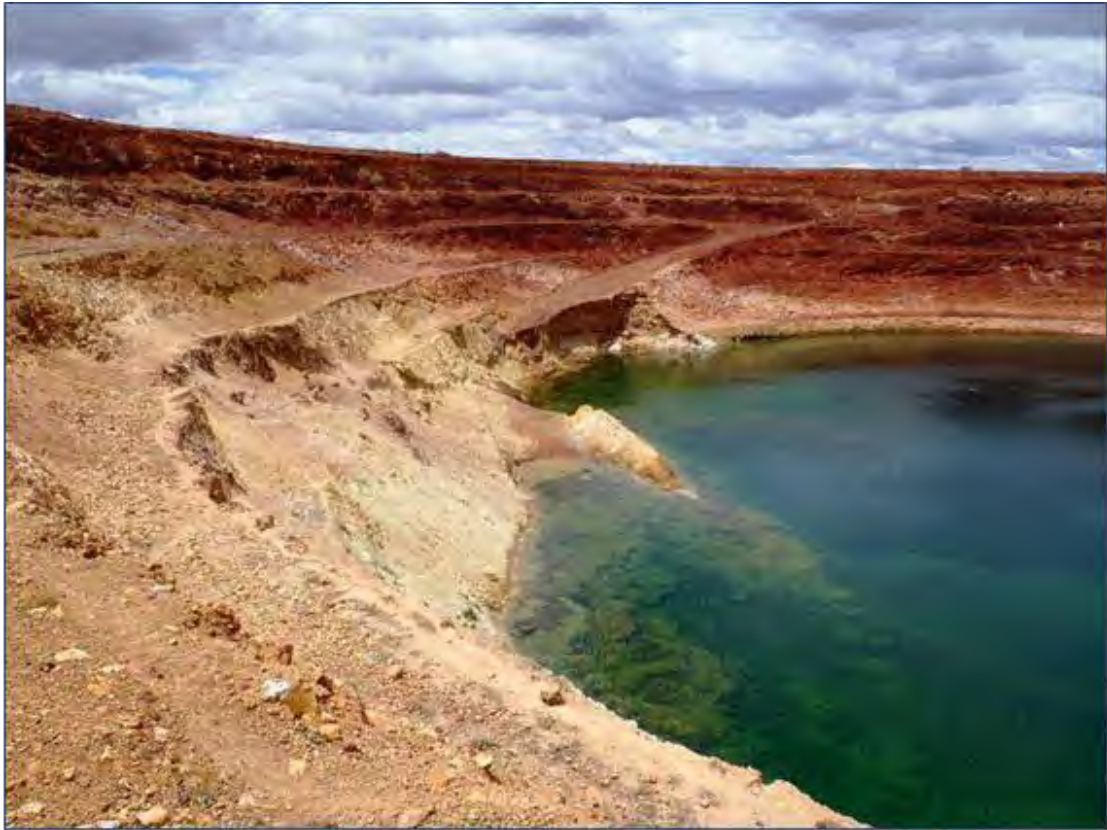
Figure 3.6: WQS East Wall Instability December 2011 view looking south (POBA 2012 Plate 2)

At the east wall location indicated by 1A (Figure 1 and Plate 2), slumping failure has occurred between the ramp at ~ 367mRL and the pit floor. This ramp failure is reported to have ended mining at WQS prematurely in November 2007.

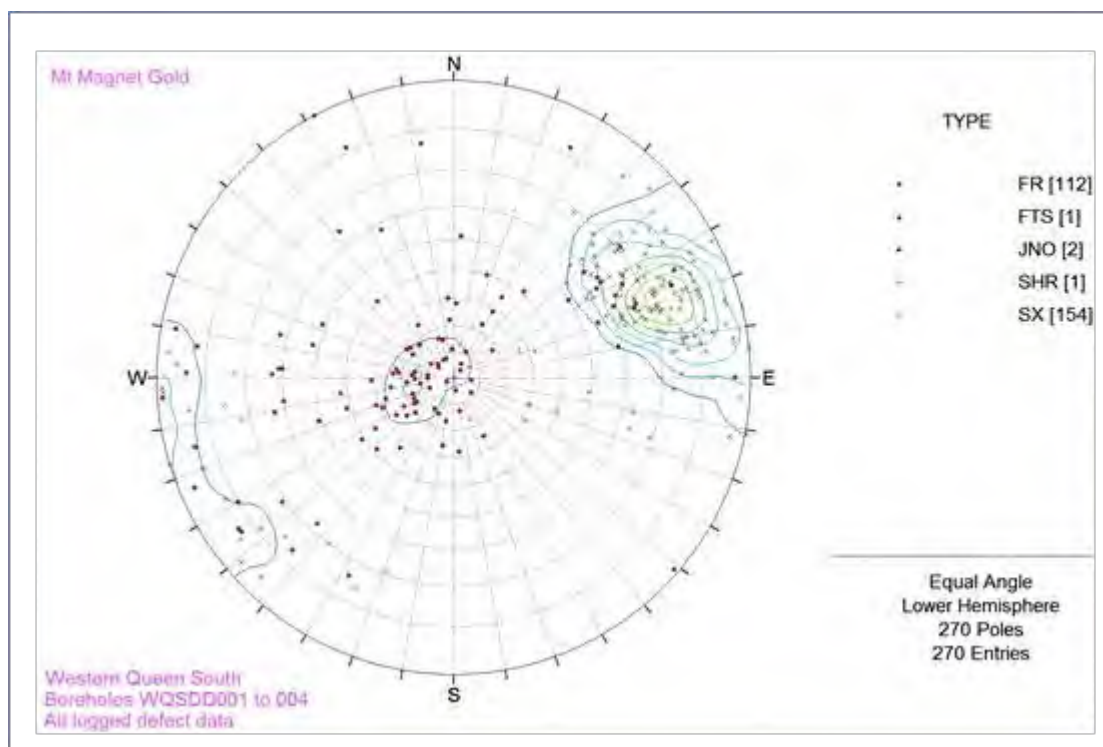
Figure 3.9: WQS: Boreholes WQSD001 to 004 Structural Data Pole Plot (POBA 2012 Fig. 4)

- Steep west dipping to sub-vertical foliation and fractures
- Sub-horizontal to shallow easterly dipping fractures.

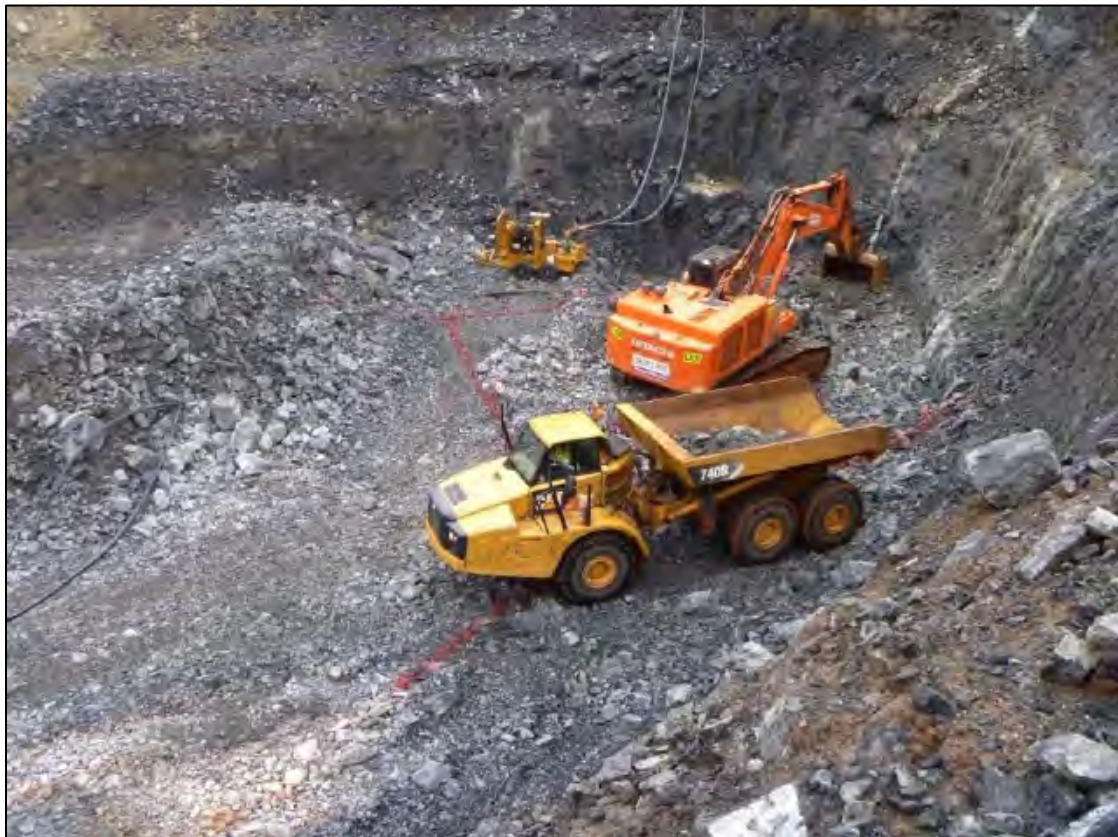
Figure 3.20: Top loading of fresh ore around 320mRL (Ramelius 2014 Image 3)

Ore is difficult to visually differentiate from a distance and on ore margins. Colour is similar. Fresh ore is more siliceous and possibly a little lighter in colour. It contains fine sulphides but these can only be seen at hand specimen level. Some degree of increased structure and foliation is also present and can be seen in Figure 3.20 above where the excavator is digging.

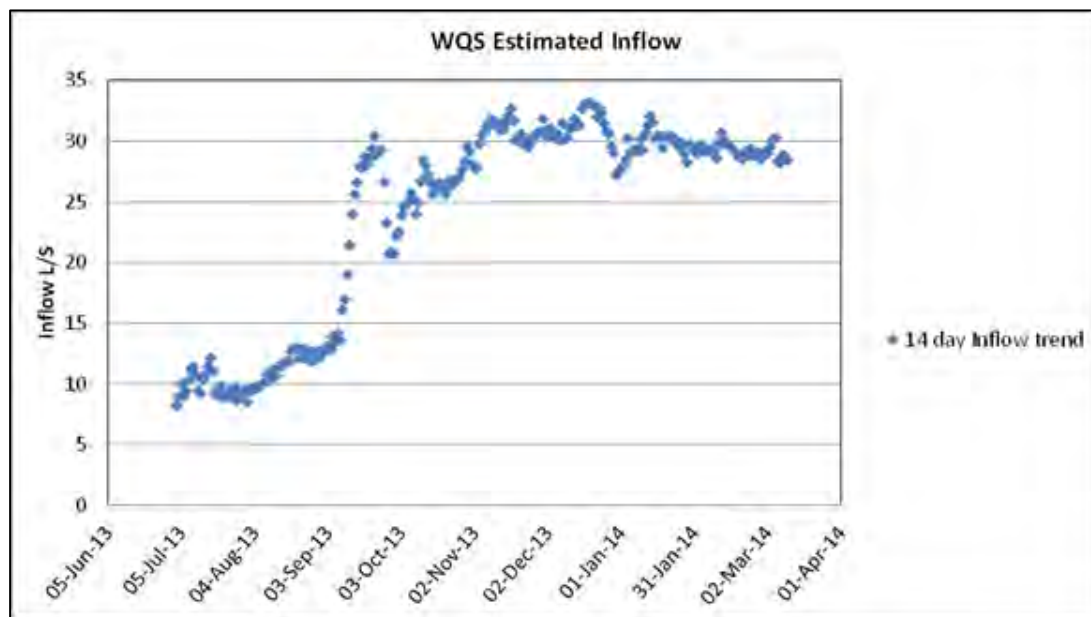
Figure 3.21: Estimated water inflow into WQS pit over life of project (Ramelius 2014 Fig. 7)

movement along them, thus water inflows increased when the transitional and fresh rock boundaries were passed as the pit progressed.

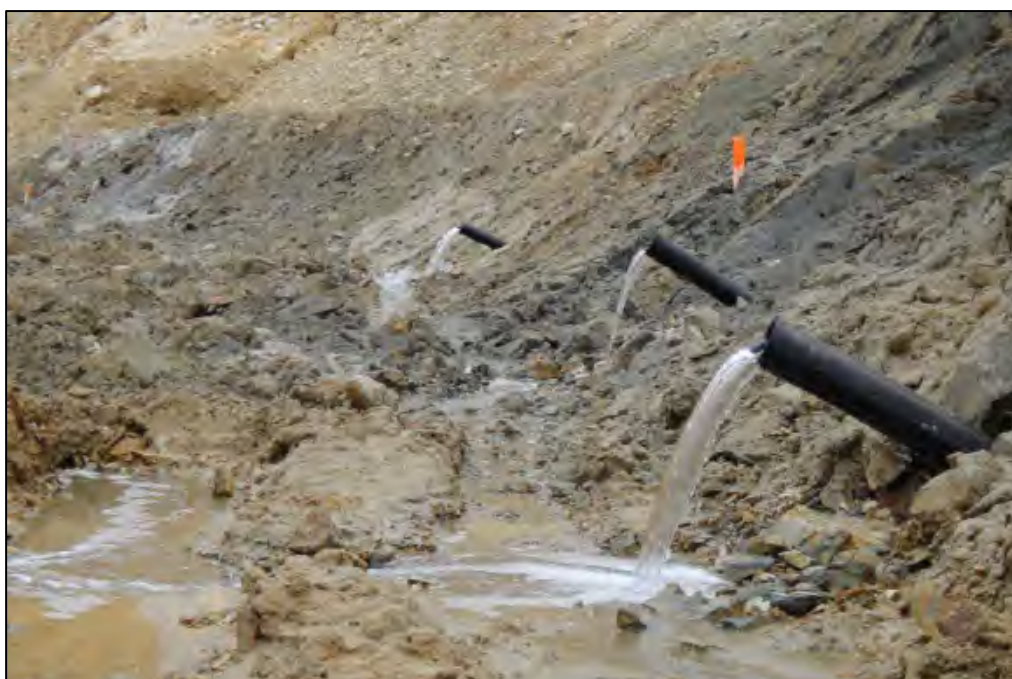
Figure 3.22: Wall holes draining water from the East on the 355 RL (Ramelius 2014 Image 4)

Ramelius dewatered the existing pit as the cutback was mined to the 350 mRL floor, however due to the oxide nature of the rock below this level (top of fresh was approximately 335 mRL in the North end and 320 mRL in the South end) it was still very wet. The resulting swampy conditions significantly slowed production until the fresh rock boundary had been reached across the majority of the pit. **Numerous sub-horizontal dewatering holes were drilled in the cutback walls to promote drainage** (see Figure 3.23). These holes were locally successful in drying out the walls and bringing the water table down in oxide and transitional zones. Some small flows however, were still present at relatively high-levels (see Figure 3.30) which shows the relatively poor connectivity of water flows at WQS.

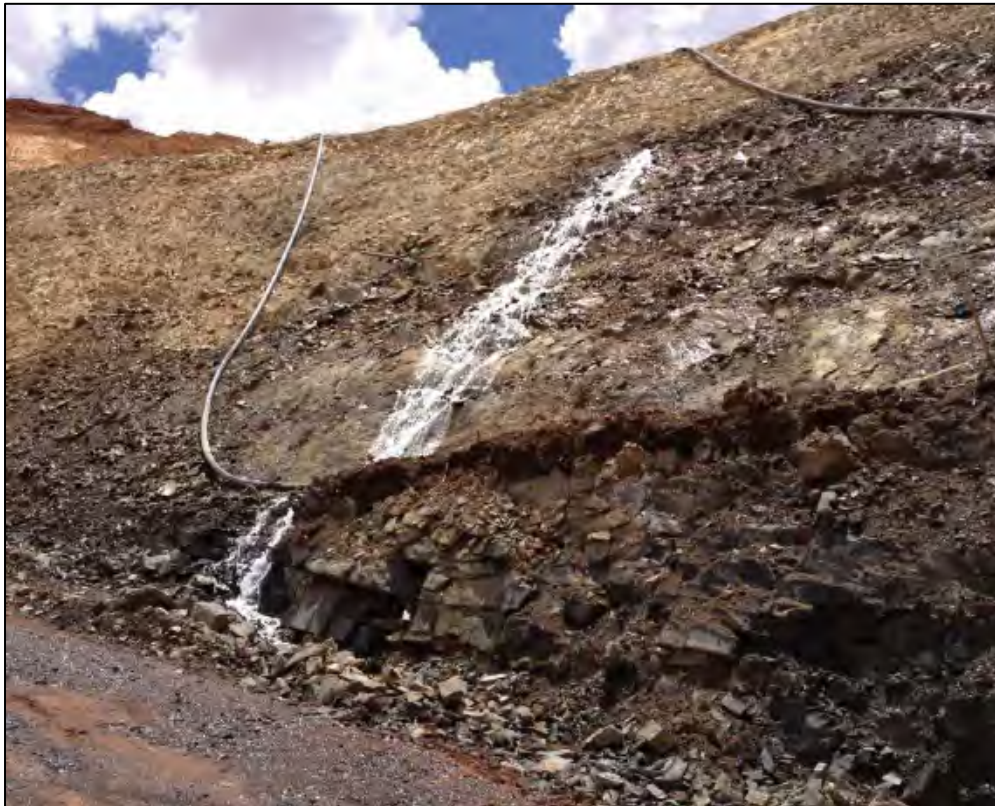
Figure 3.23: Major inflow location top of fresh rock around 345mRL (Ramelius 2014 Image 5)

Once the pit reached fresh rock the largest flows occurred and remained at the weathering interface. One area on the north-eastern wall had a major flow from around the 345 mRL which remained quite constant for the rest of the pit.

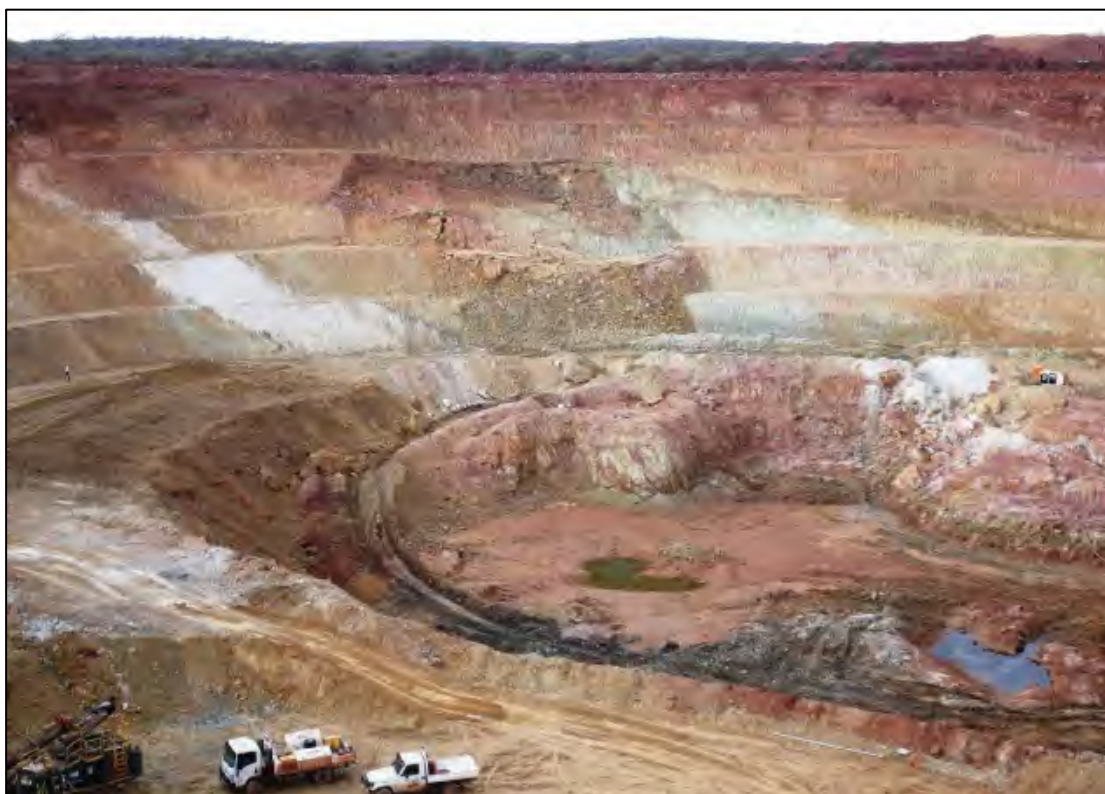
Figure 3.26: Northeastern wall failure soon after initial slump, over the next week it continued to creep and grow larger (Ramelius Image 6)

On 31/08/2013 a portion of the oxide zone of the NE wall failed (refer Figure 3.26), slumping along a slip plane in the ultramafic, characterised by wet, talc textured clay. The lateritic overburden was not affected. It was slow moving and once stabilised, the slump material was removed and the wall was laid back at a shallower angle. A bund was also placed at the foot of the slump to strengthen the base of the wall and prevent further movement (refer Figure 3.27). This slump did not enter the working area or cover the ramp and so did not significantly affect production, however remedial measures did add to the overall cost of the pit.

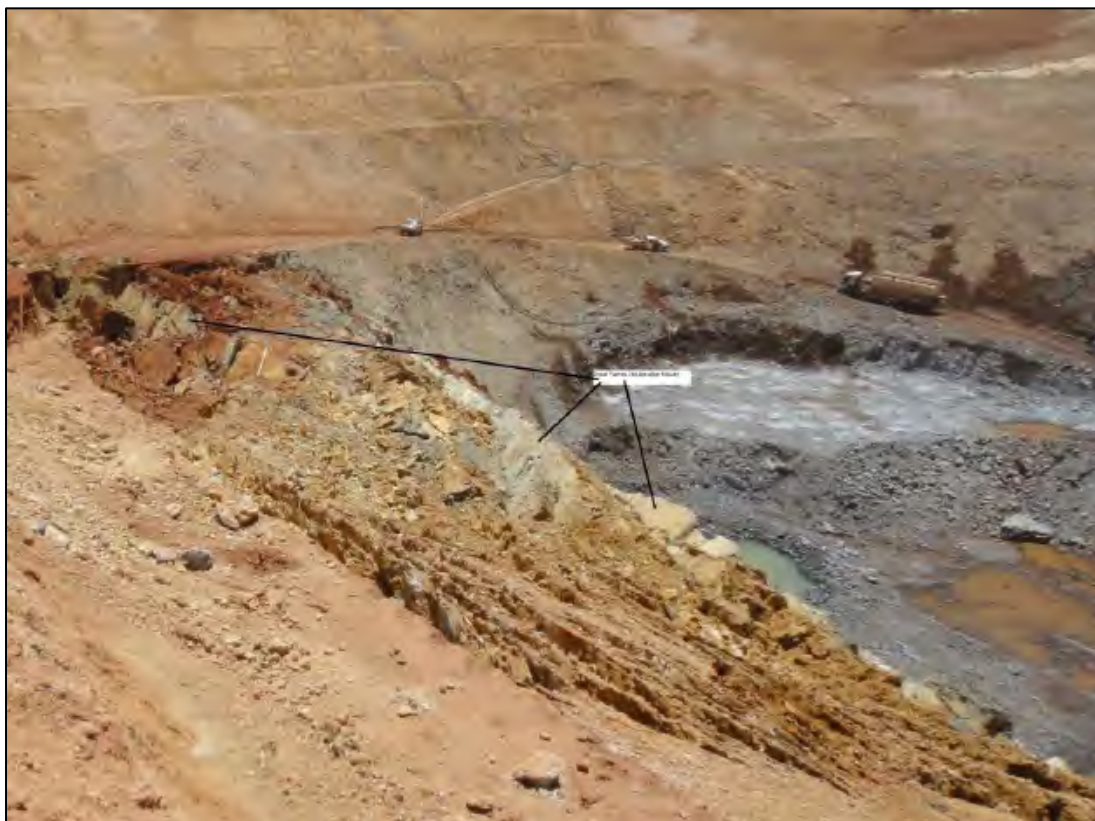
Figure 3.28: *Top of Western wall collapse showing failure planes (Ramelius Image 8)*

On 04/12/2013 a large section of the Western wall failed (refer Figure 3.28, Figure 3.29) *between the ramp at 355 mRL and the pit floor (325 mRL). The failure was caused by toppling along steep, smooth, westerly dipping geological structures and contacts, spanning the oxide and transitional zones of the weathered insitu saprolite – saprock zone.*

The relatively competent lateritic overburden was not affected. Hydrostatic pressure from groundwater was also deemed to be a factor, despite the presence of weep holes with initially high outflows. Once the failure had stabilised the rock debris was dug out and the

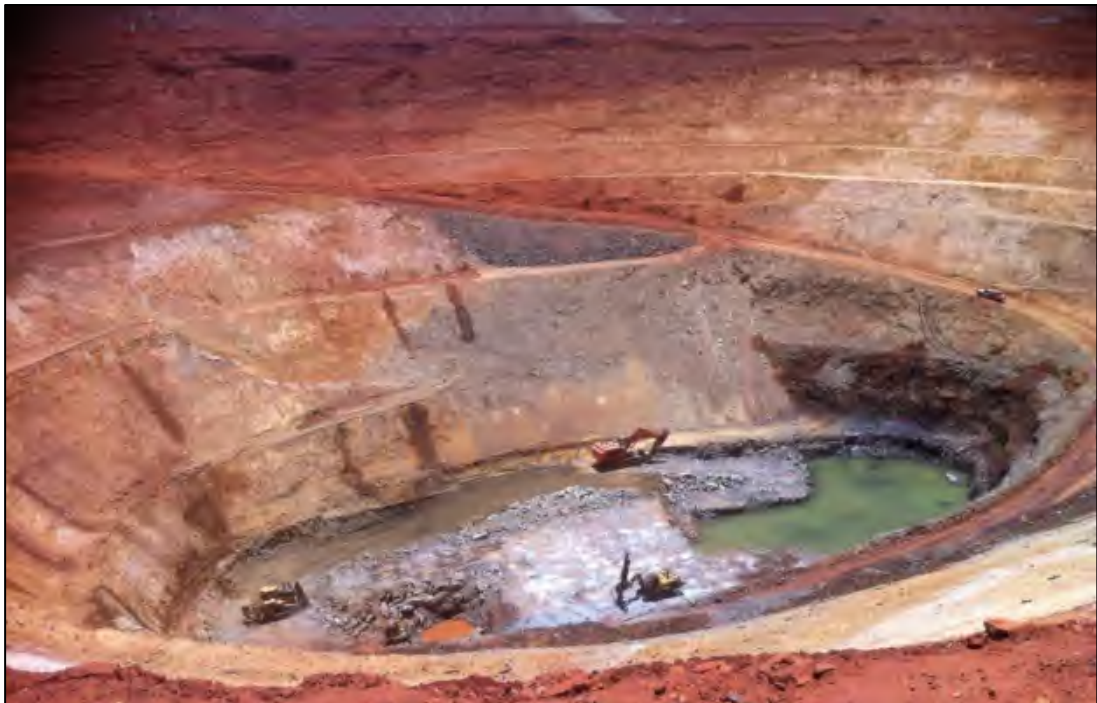
Figure 3.30: Western wall after remediation (Ramelius Image 10)

slope laid back. The pit design was also changed to include an extra-large berm at the 325 mRL to strengthen the wall and prevent further slippage (refer Figure 3.30). This design change had a knock on effect of limiting the maximum pit depth from 290-300 mRL. Another issue resulting from the failure was the loss of a 40 by 6m section of ramp, forcing the ramp into a single lane higher than expected, also slowing production.

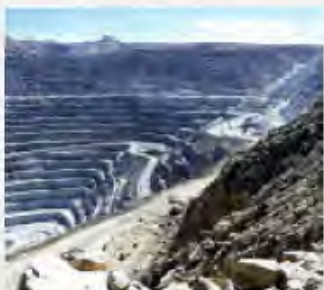
Small scale blasting in civil engineering slopes results in modest rock mass damage, particularly if controlled blasting is used as shown on the left hand side of the photograph. However, stress relief results in some disturbance.	D=0.7 Good Blasting D=1.0 Poor Blasting

Very large open pit mine slopes suffer significant disturbance due to heavy production blasting and also due to stress relief from overburden removal. In some softer rocks excavation can be carried out by ripping and dozing and the degree of damage to the slopes is less.	D=1.0 Production Blasting D=0.7 Mechanical Excavation

The disturbance factor should only be applied to damaged rock around the excavations or behind a slope and not to the entire rock mass.
