ALLAWUNA FARM LANDFILL

Geotechnical Investigations for Landfill Development

Report Number. 147645033-008-R-Rev0

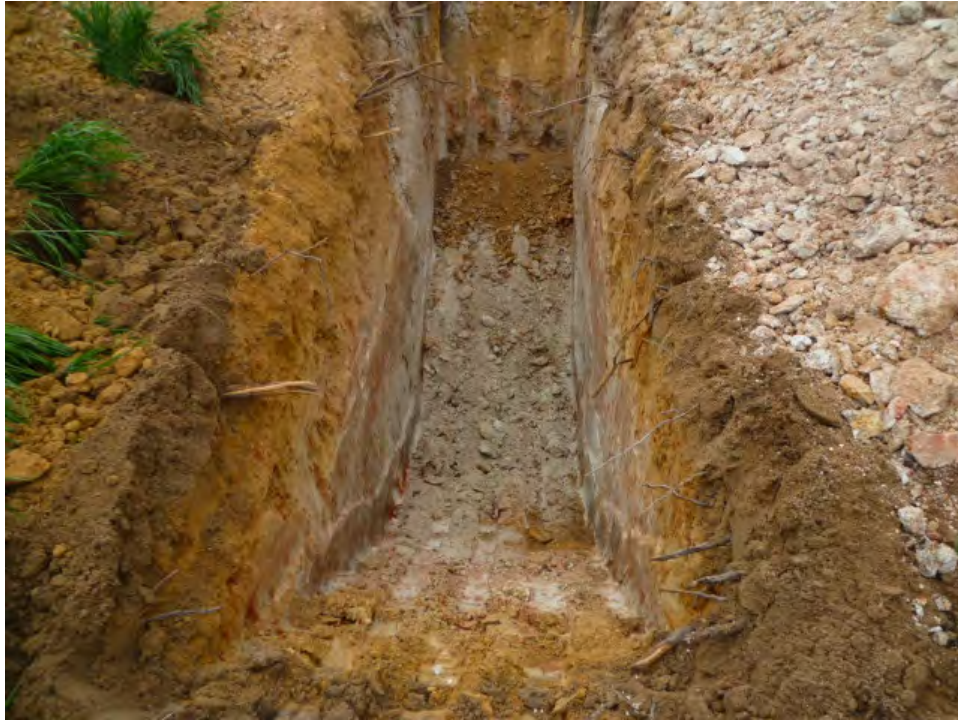
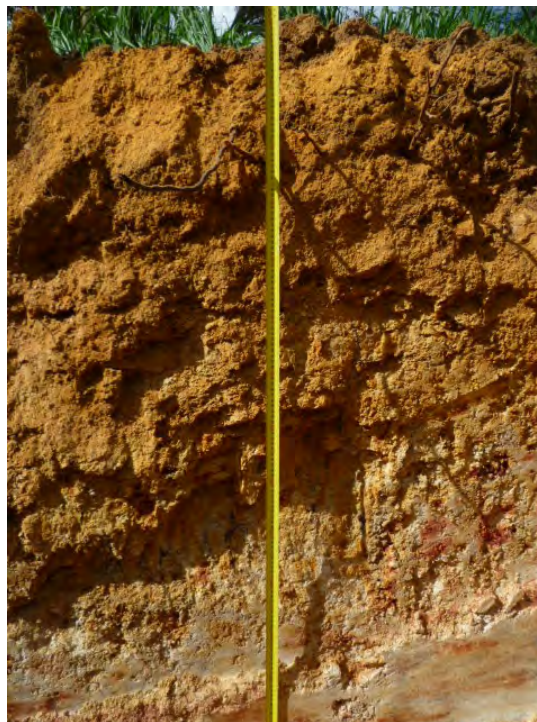
Excavation				Sampling		Field Material Description										
METHOD	EXCAVATION RESISTANCE	WATER	DEPTH (metres)	DEPTH RL	SAMPLE OR FIELD TEST	RECOVERED	GRAPHIC LOG	USCS SYMBOL	SOIL/ROCK MATERIAL DESCRIPTION		MOISTURE CONDITION	CONSISTENCY	DENSITY	STRUCTURE AND ADDITIONAL OBSERVATIONS		
EX	L		0.0						TOPSOIL				Density inferred from observations

0.30													
			0.5	0.60				GC	Clayey GRAVEL fine to medium grained gravel, rounded to sub-rounded particles, pale brown, with low plasticity fines, with some roots and rootlets.					L		
	M		1.0					SC	Clayey SAND fine to coarse grained, yellow and white and red staining, medium plasticity fines, with some roots and rootlets.	M	D

1.40													
	M-H		1.5						SC / CI	Silty Clayey SAND to Sandy Silty CLAY fine to coarse grained, orange and white with red staining reducing at depth, medium plasticity fines, with some roots and rootlets.	D - M	St - VSt

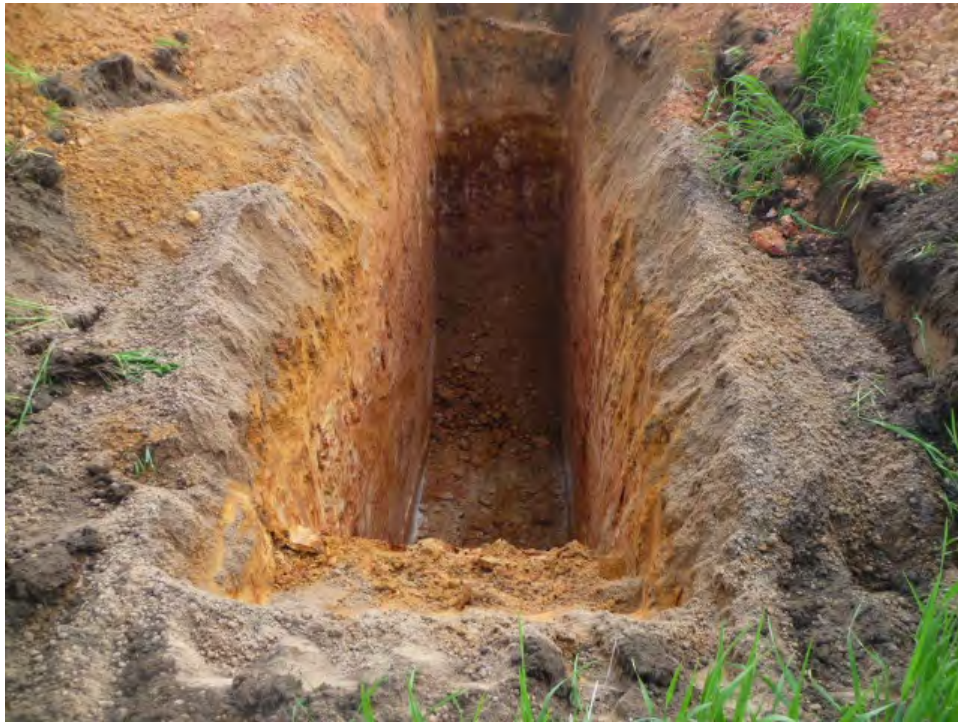
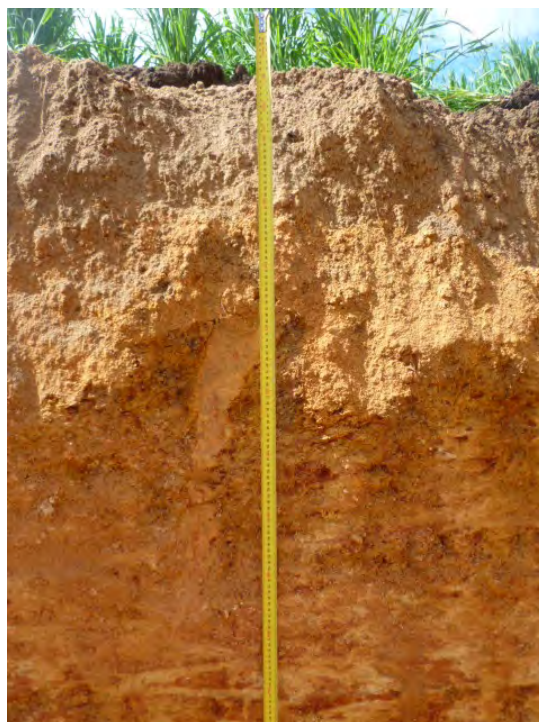
0.20	SC				Clayey SAND fine to coarse grained, pale brown with white and red staining, low to medium plasticity fines, with some rounded to subrounded gravel, with some roots and rootlets.

0.50		SC / CI	Silty Clayey SAND to Sandy Silty CLAY fine to coarse grained, orange and white with red staining reducing at depth, medium plasticity fines, with some roots and rootlets.				M - W	St - VSt

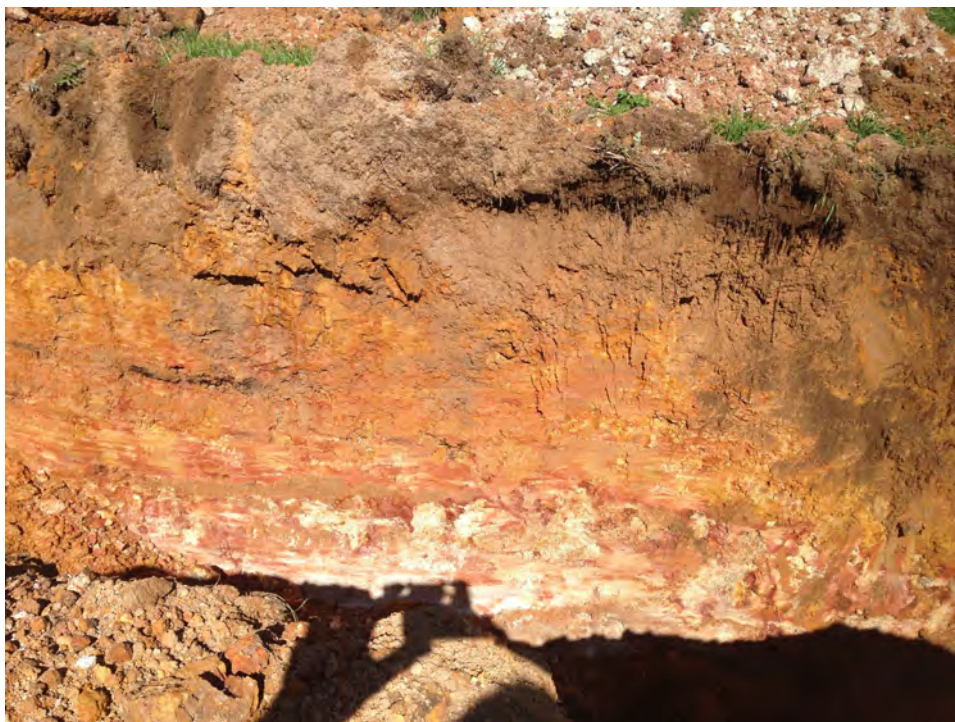
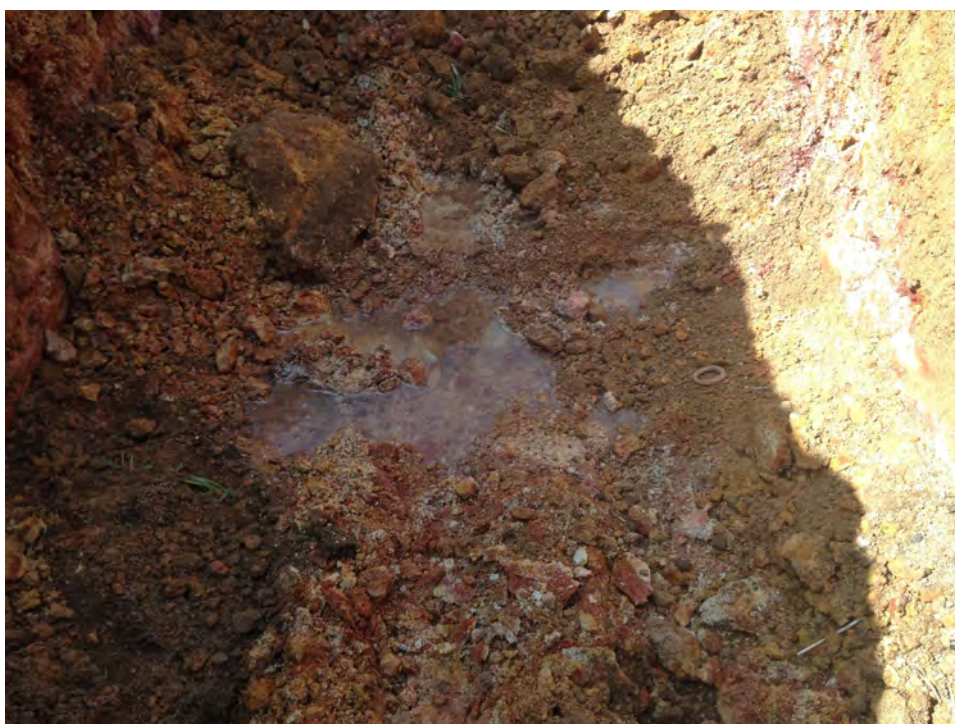
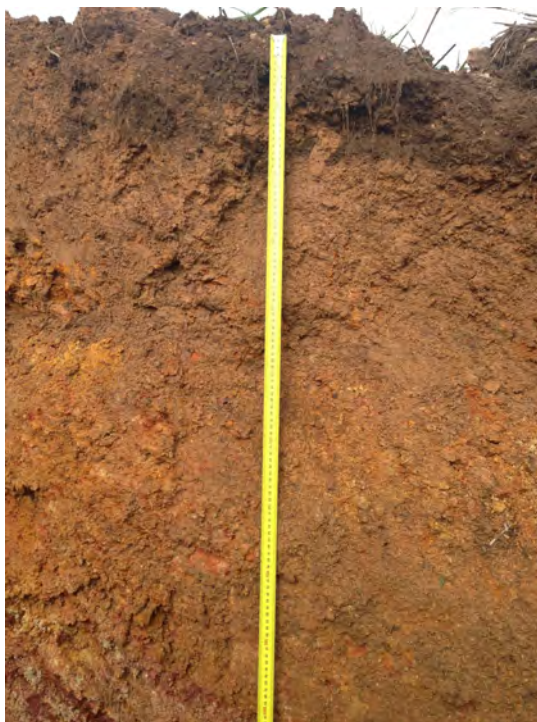
0.30	SC			Clayey SAND fine to coarse grained, pale brown with white and red staining, low to medium plasticity fines, with some rounded to subrounded gravel, with some roots and rootlets.

0.5		SC / CI	Silty Clayey SAND to Sandy Silty CLAY fine to coarse grained, orange and white with red staining reducing at depth, medium plasticity fines, with some roots and rootlets.			D - M	St - VSt

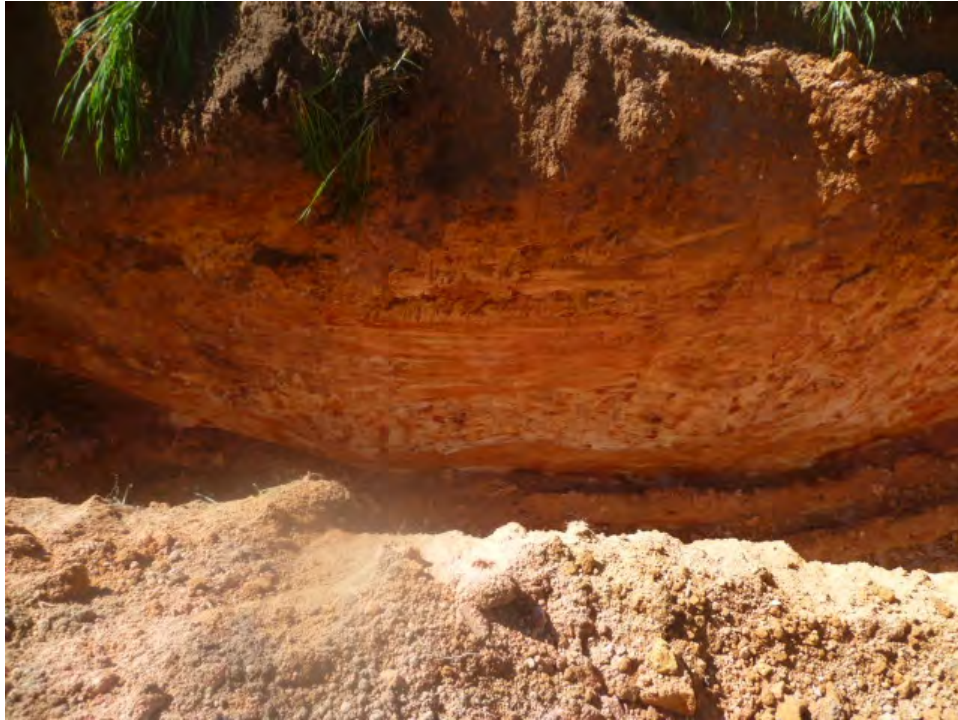
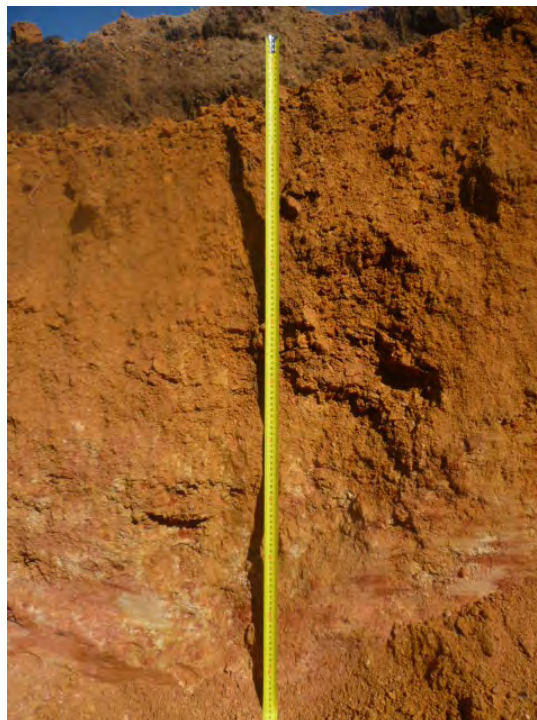
TOPSOIL	M	L	Density inferred from observations
			0.20					SC	Clayey SAND fine to coarse grained, pale brown with white and red staining, low to medium plasticity fines, with some rounded to subrounded gravel, with some roots and rootlets.			
			0.50					SC	Clayey SAND fine to coarse grained, white with red staining, medium plasticity fines, with angular gravel, with some roots and rootlets.			
	H		0.70									
R												
			1.0									
			1.5									
			2.0									
			2.5									
			3.0									
			3.5									
			4.0									
			4.5									
			5.0

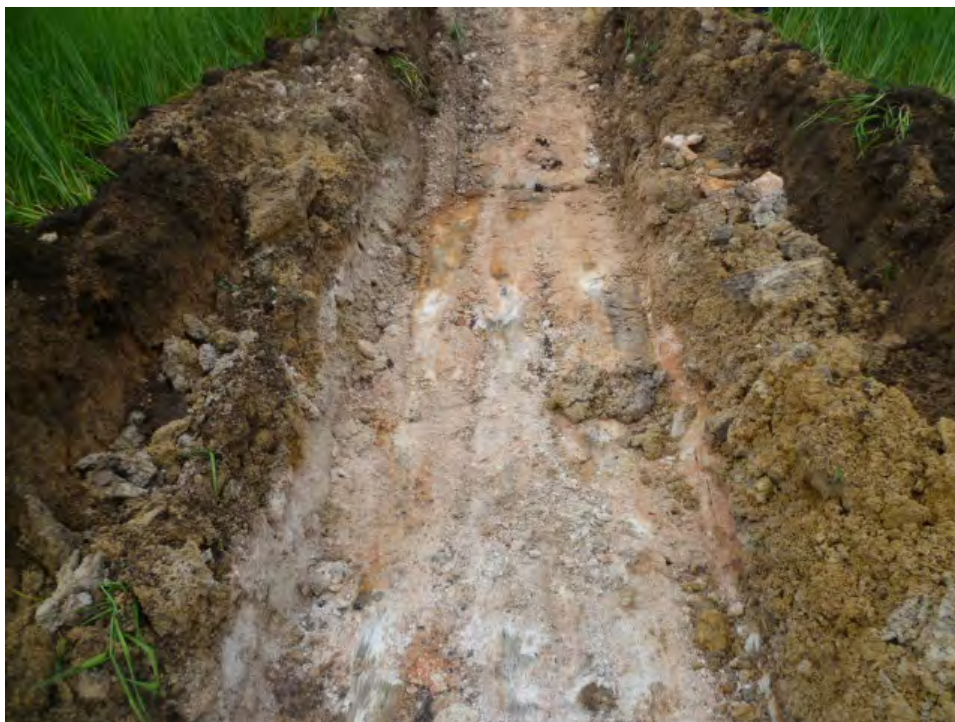
0.20				SC	Clayey SAND fine to coarse grained, pale brown with white and red staining, low to medium plasticity fines, with some rounded to subrounded gravel, with some roots and rootlets.

0.5				SC	Clayey SAND fine to coarse grained, white with red staining, medium plasticity fines, with angular gravel, with some roots and rootlets.	M - W

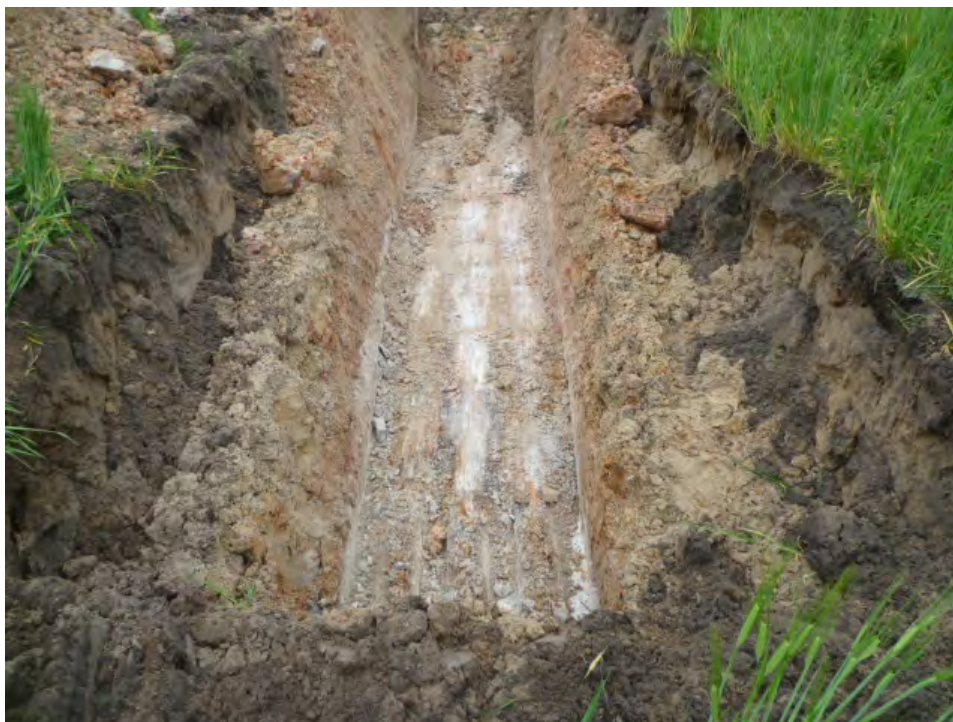
0.20				SC	Clayey SAND fine to coarse grained, pale brown with white and red staining, low to medium plasticity fines, with some rounded to subrounded gravel, with some roots and rootlets.

0.5	0.60			SC	Clayey SAND fine to coarse grained, yellow with white and red staining, with approximately 15% to 30% medium plasticity fines, with some roots and rootlets.	W	L - S

1.0								
EX	M-H		1.5								
			1.90				SC / CI	Silty Clayey SAND to Sandy Silty CLAY fine to coarse grained, orange and white with red staining reducing at depth, medium plasticity fines, with some roots and rootlets.

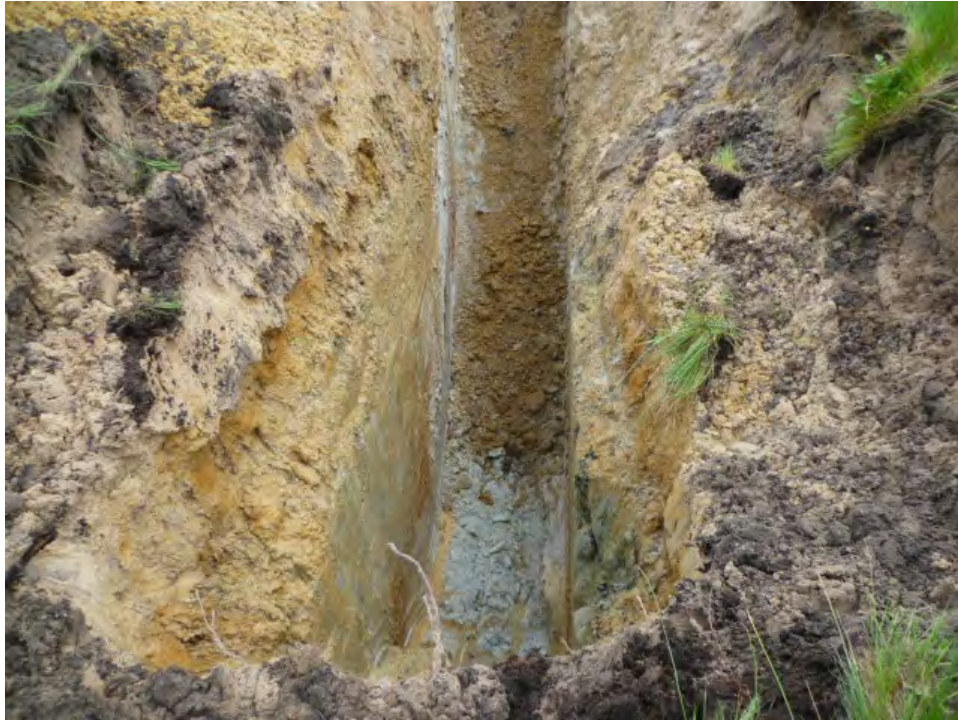
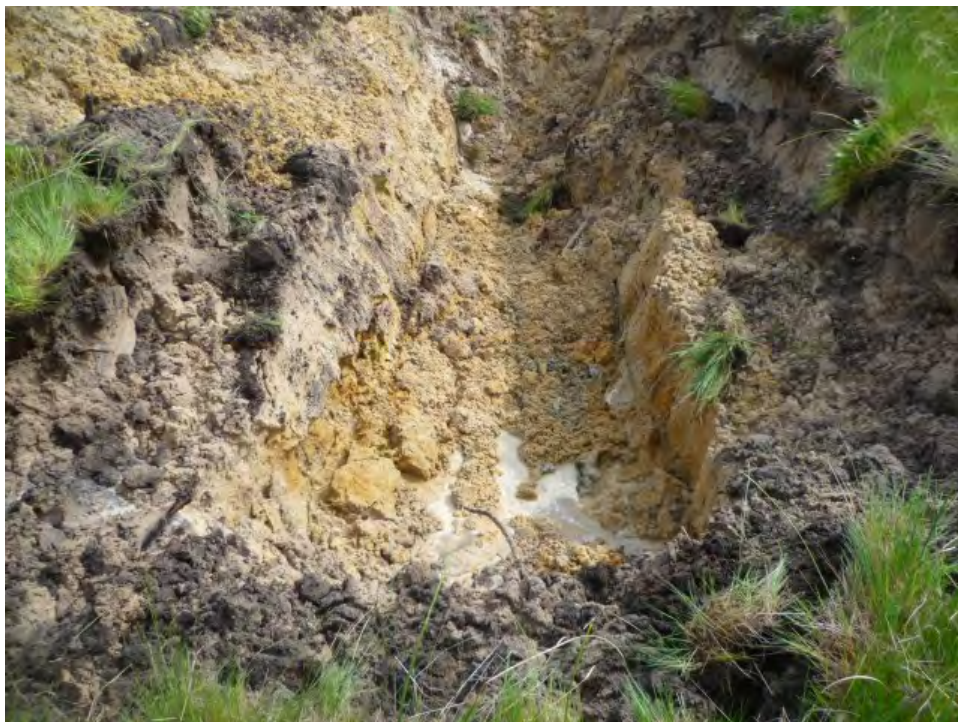
Excavation					Sampling		Field Material Description					
METHOD	EXCAVATION RESISTANCE	WATER	DEPTH (metres)	DEPTH RL	SAMPLE OR FIELD TEST	RECOVERED	GRAPHIC LOG	USCS SYMBOL	SOIL/ROCK MATERIAL DESCRIPTION	MOISTURE CONDITION	CONSISTENCY DENSITY	STRUCTURE AND ADDITIONAL OBSERVATIONS
EX	L		0.0				SC	TOPSOIL	Clayey SAND fine to coarse grained, pale brown with white and red staining, low to medium plasticity fines, with some rounded to subrounded gravel, with some roots and rootlets.	M - W	L	Density inferred from observations

0.20									
			0.5									
			0.70									
	M-H		1.0				SC	Clayey SAND fine to coarse grained, orange and white with red staining, medium plasticity fines, with angular gravel, with some roots and rootlets.	D

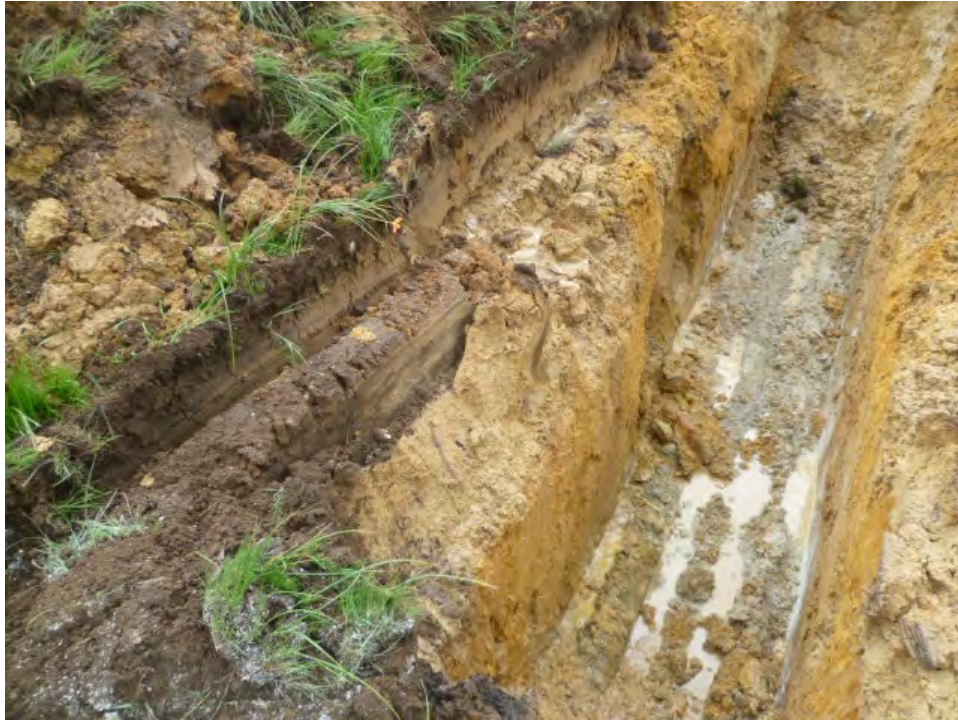
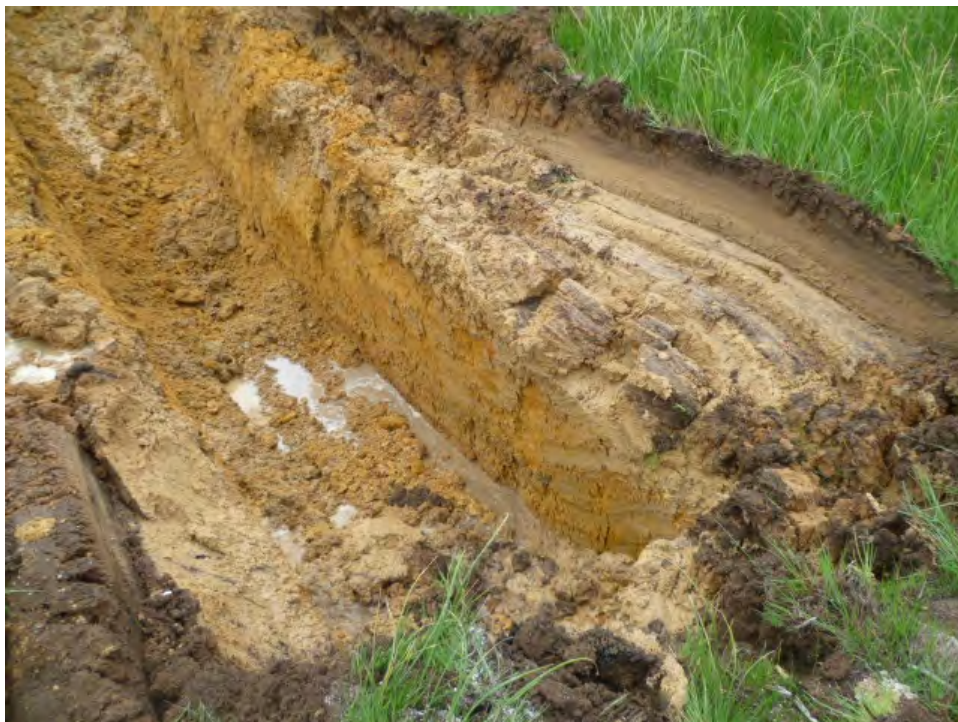
0.20	SC			Clayey SAND fine to coarse grained, pale brown with white and red staining, low to medium plasticity fines, with some rounded to subrounded gravel, with some roots and rootlets.

0.5									
	0.90	SC	Clayey SAND fine to coarse grained, orange and white with red staining, medium plasticity fines, with angular gravel, with some roots and rootlets.	M - W			D					
	M-H		1.0

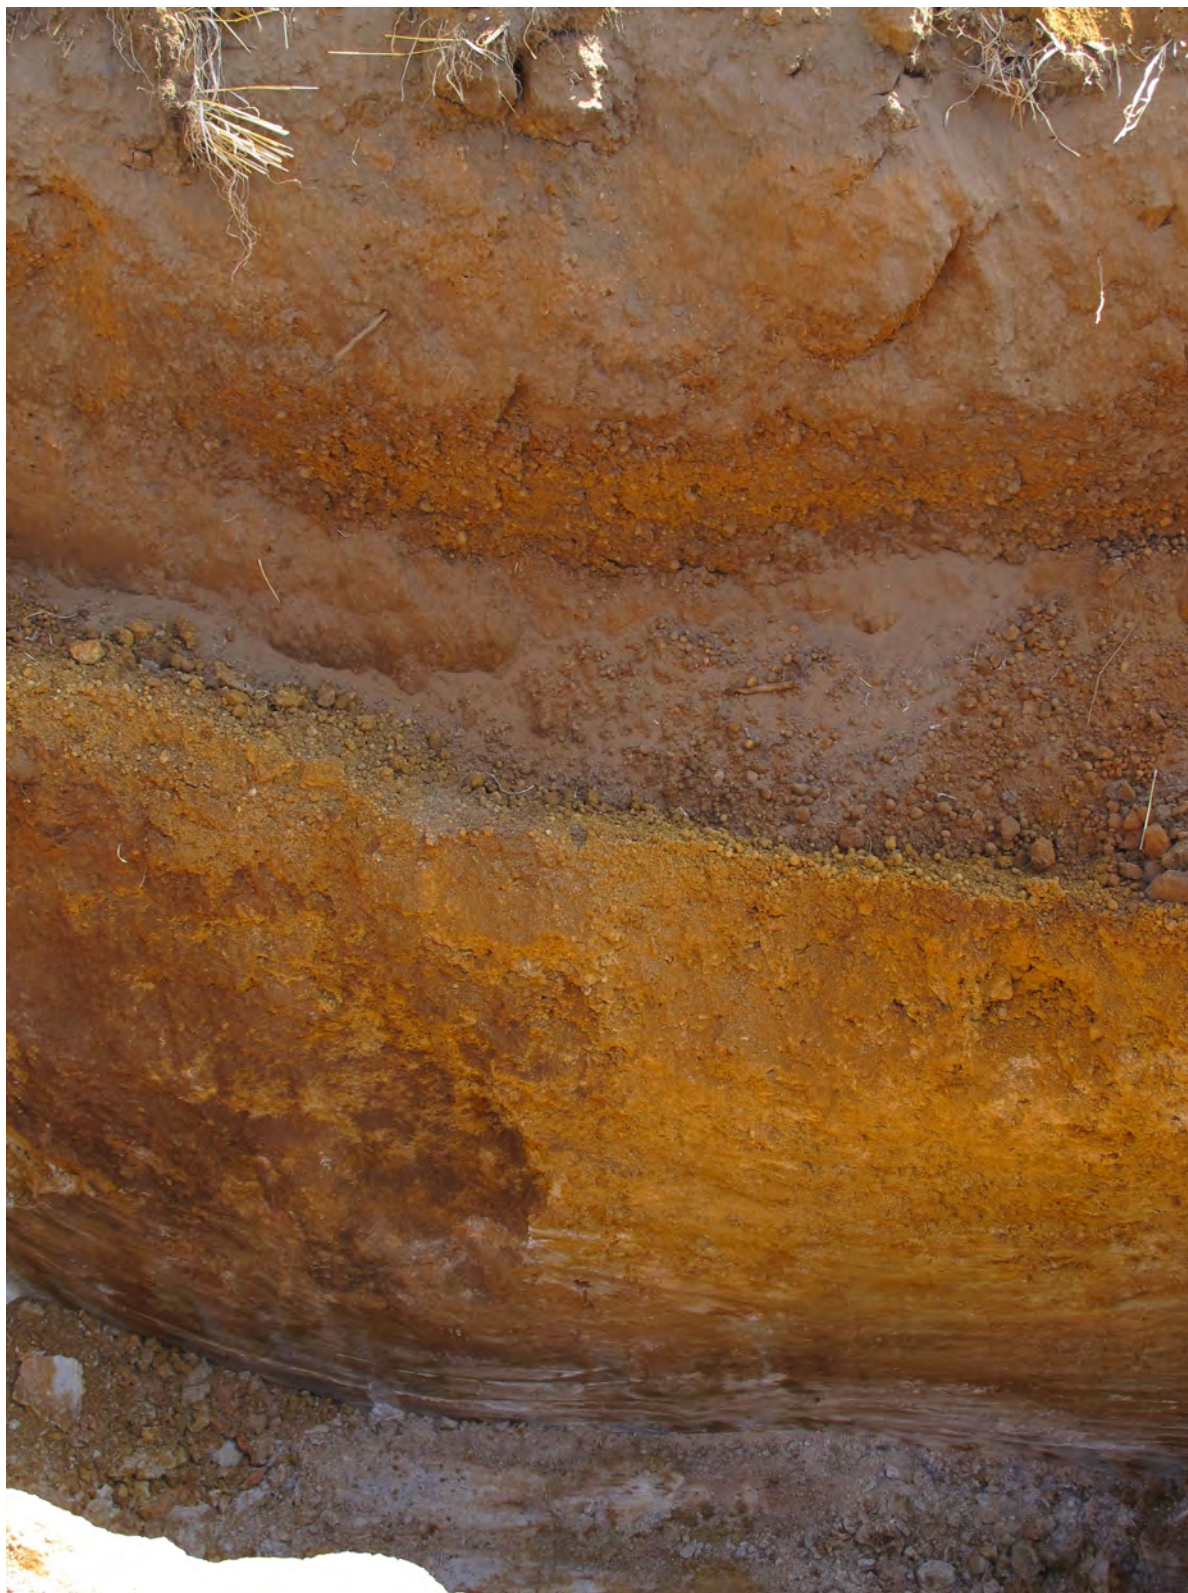
COORDS: 463107 m E 6469414 m N MGA94 50
SURFACE RL: DATUM: AHD
PIT DEPTH: 4.20 m
BUCKET TYPE: 900 mm toothed

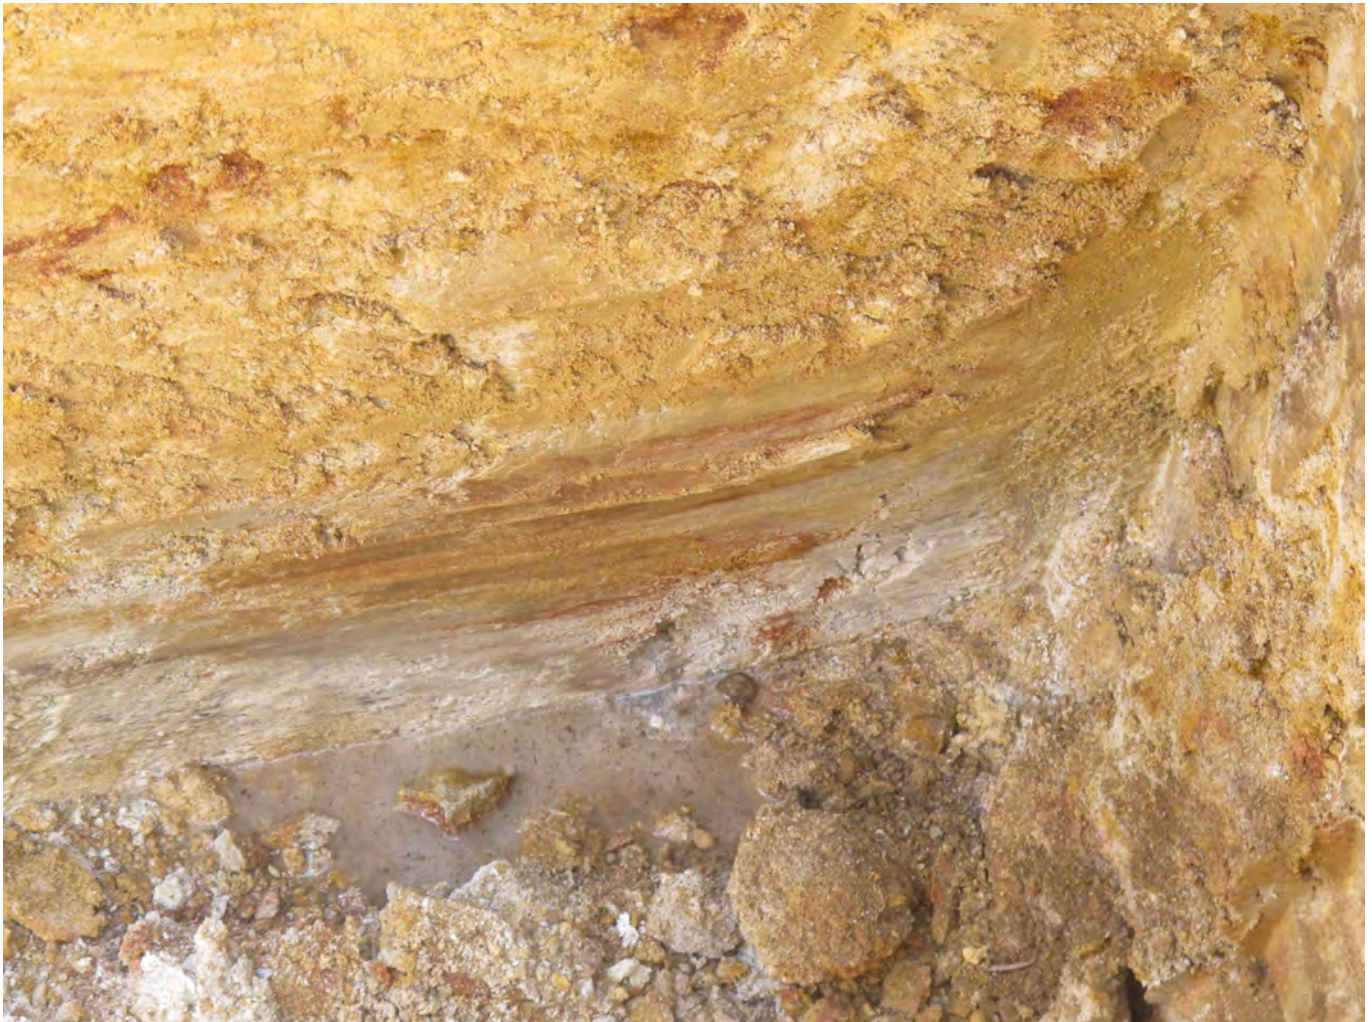
COORDS: 463096 m E 6469307 m N MGA94 50
SURFACE RL: DATUM: AHD
PIT DEPTH: 2.80 m
BUCKET TYPE: 900 mm toothed

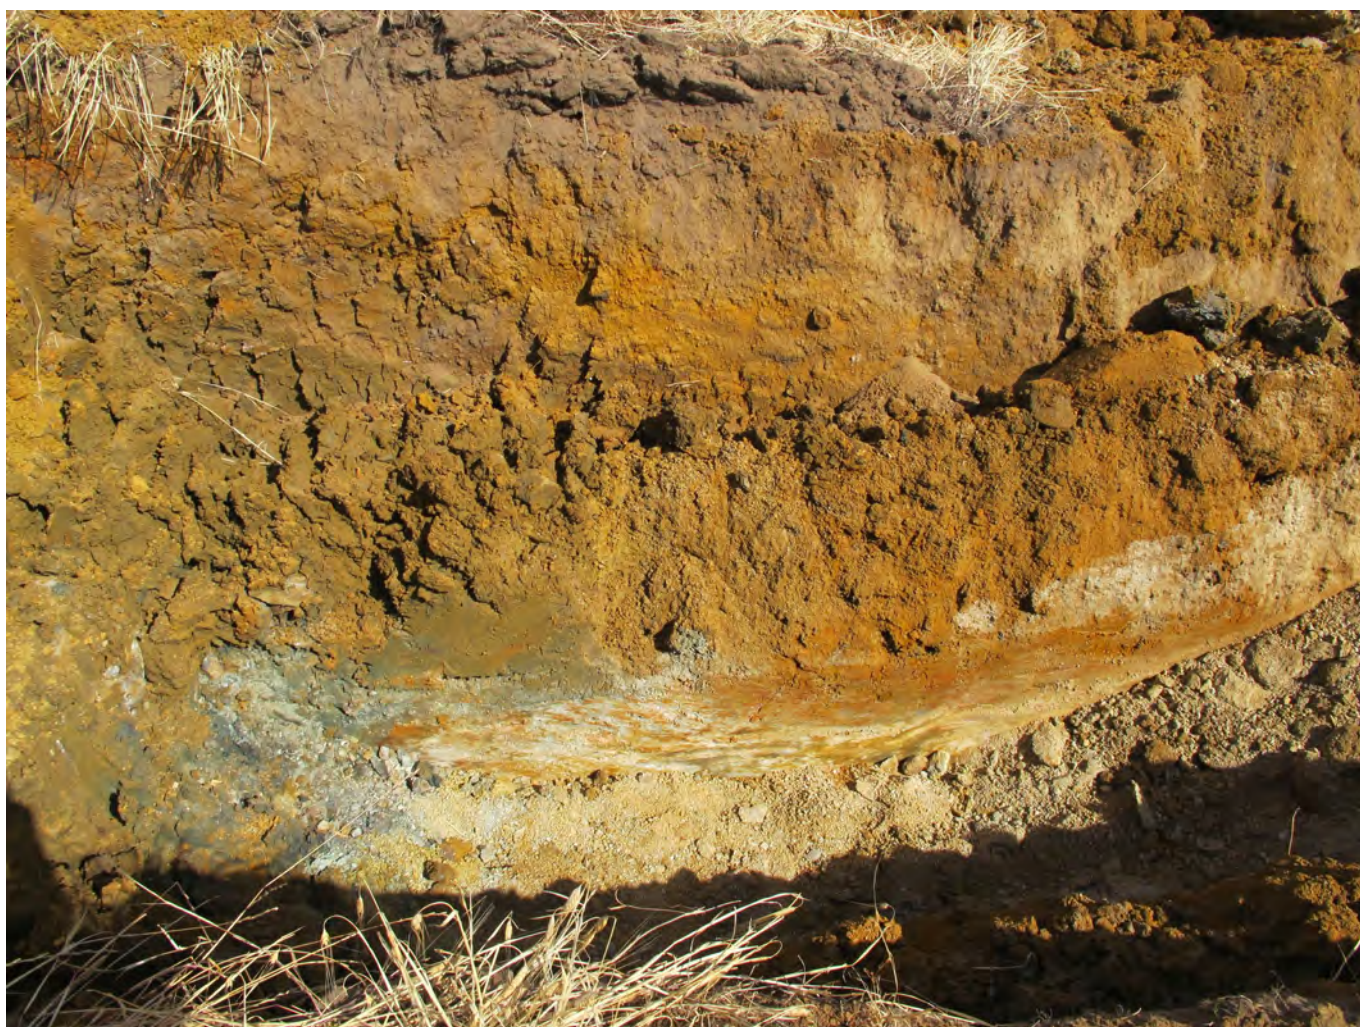
Excavation					Sampling		Field Material Description					
METHOD	EXCAVATION RESISTANCE	WATER	DEPTH (metres)	DEPTH RL	SAMPLE OR FIELD TEST	RECOVERED	GRAPHIC LOG	USCS SYMBOL	SOIL/ROCK MATERIAL DESCRIPTION	MOISTURE CONDITION	CONSISTENCY DENSITY	STRUCTURE AND ADDITIONAL OBSERVATIONS
EX			0.0						TOPSOIL some weathered dolerite cobbles at surface	D	L	Density inferred from observations
			0.20				CL	CLAY Green to dark grey CLAY, medium plasticity, with sand and gravel rock fragments, and weathered blocks increasing with depth - weathered Dolerite	M	St		
			1.5	BDS 1.50-1.80 m Rec = 300/300 mm 3/4 Bag				W				
			2.0							St - VSt		
			2.20						REFUSAL @ 2.2m GROUNDWATER ENCOUNTERED @ 1.9m - seepage inflows BACKFILLED. Part hole intersects similar profile: 0.2 - 0.9 Clayey SAND, 0.9 - 2.2 Silty Clayey SAND to Sandy Silty Clay TEST PIT DISCONTINUED @ 2.20 m			
			2.5

COORDS: 462880 m E 6469214 m N MGA94 50
SURFACE RL: DATUM: AHD
PIT DEPTH: 2.20 m
BUCKET TYPE: 900 mm toothed

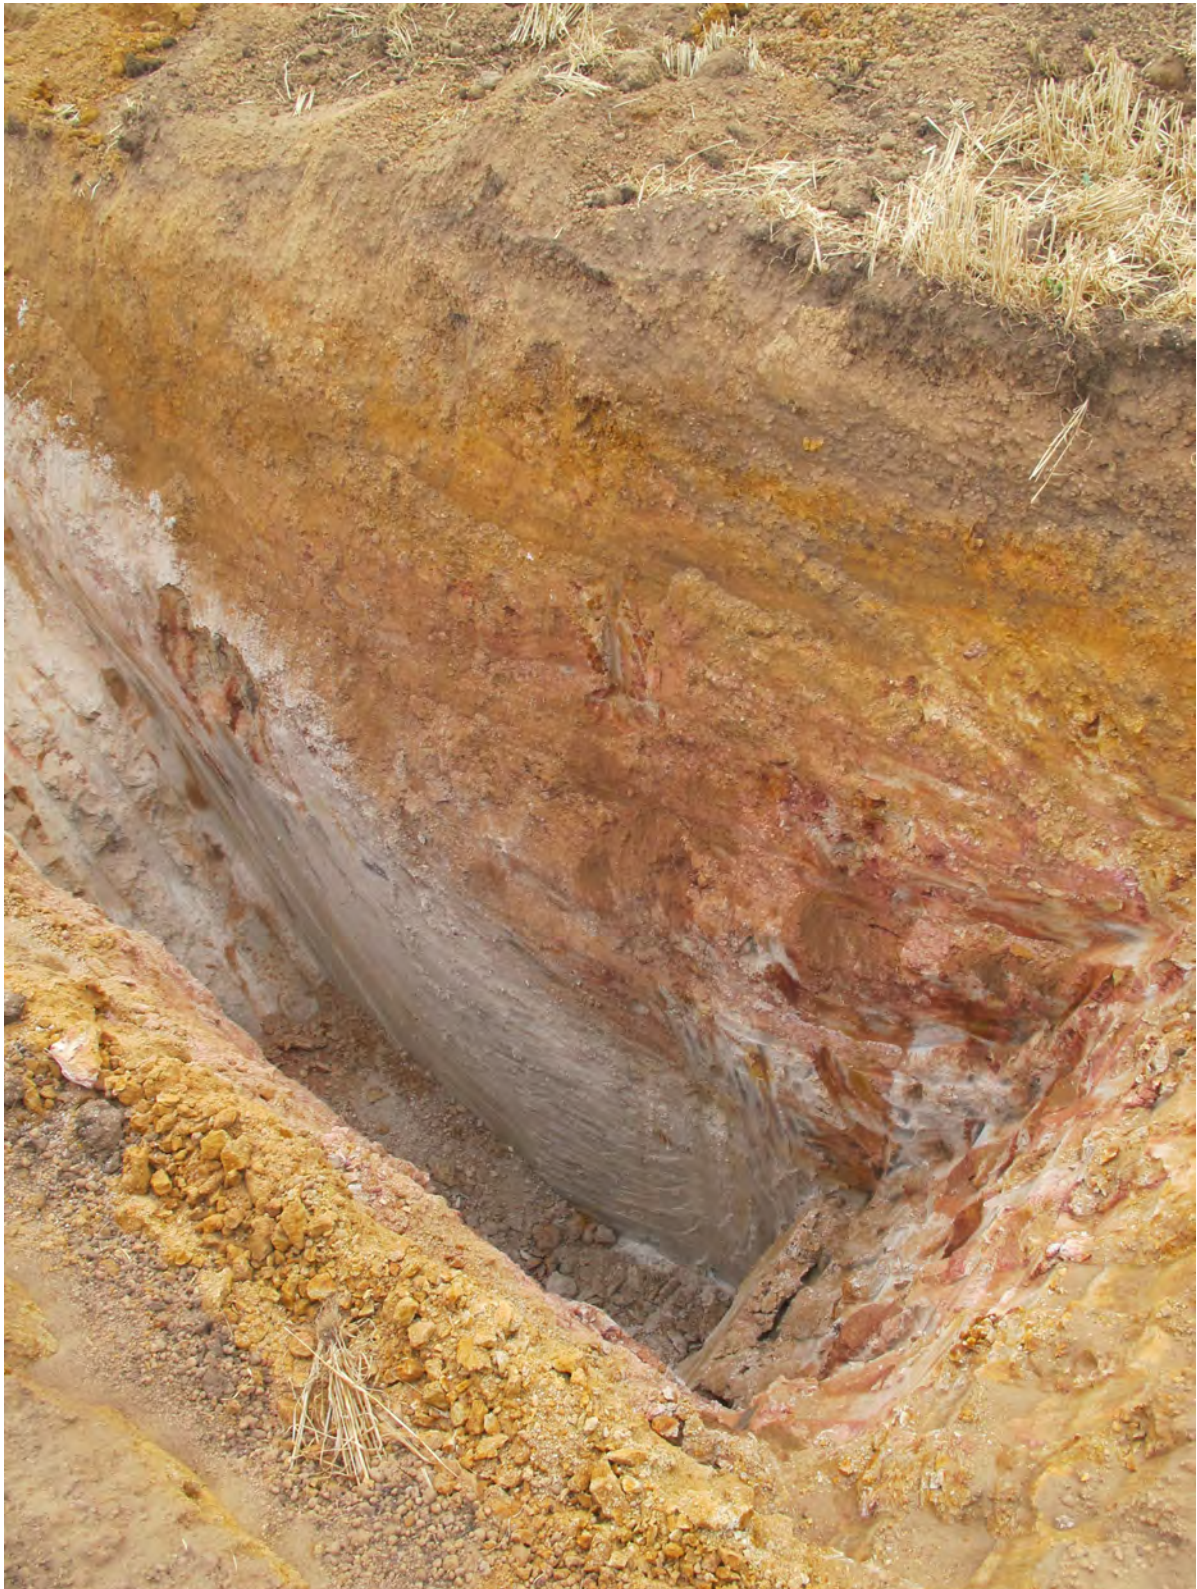
2.50		BDS 3.00-3.50 m Rec = 500/500 mm 2 Bags		SC / CI	Silty Clayey SAND to Sandy Silty CLAY mostly white, with orange and red, laminated in part, medium plasticity fines. Fine to coarse grained sand, pockets of predominantly sand and gravel (angular to subangular, poorly sorted quartz - from weathered granite). Pockets of predominantly clay.	M - W	St - VSt	
	M	19/11/14, 2 springs observed @ ~2.5m	4.30					TARGET DEPTH ACHIEVED GROUNDWATER ENCOUNTERED @ 1.9m - seepage inflows BACKFILLED. TEST PIT DISCONTINUED @ 4.30 m

COORDS: 462766 m E 6469168 m N MGA94 50
SURFACE RL: DATUM: AHD
PIT DEPTH: 4.30 m
BUCKET TYPE: 900 mm toothed

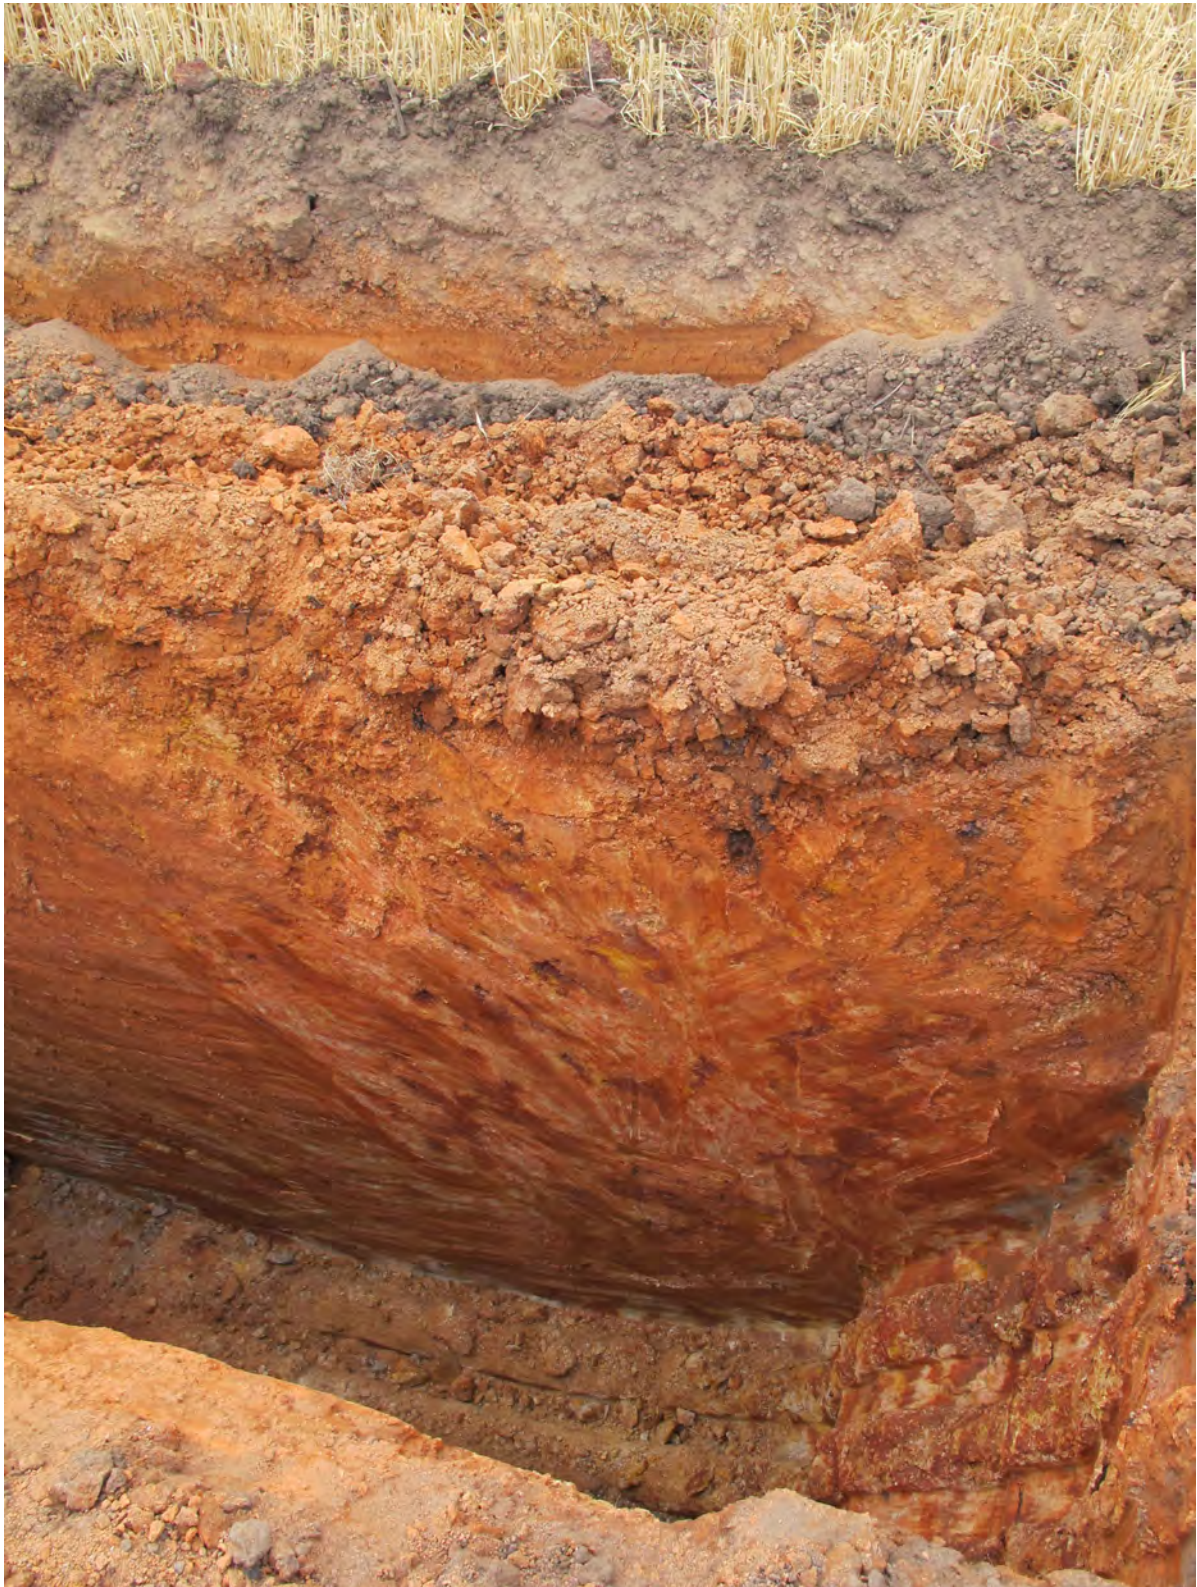
3.10					REFUSAL AT 3.1m NO GROUNDWATER ENCOUNTERED BACKFILLED. Part of hole intersected grey to dark grey clay (weathered Dolerite) @ 0.9m to full depth. Mostly stiff to very stiff, more friable at the top, moist, intermediate plasticity, with roots and rootlets TEST PIT DISCONTINUED @ 3.10 m

COORDS: 463331 m E 6469108 m N MGA94 50
SURFACE RL: DATUM: AHD
PIT DEPTH: 3.10 m
BUCKET TYPE: 900 mm toothed

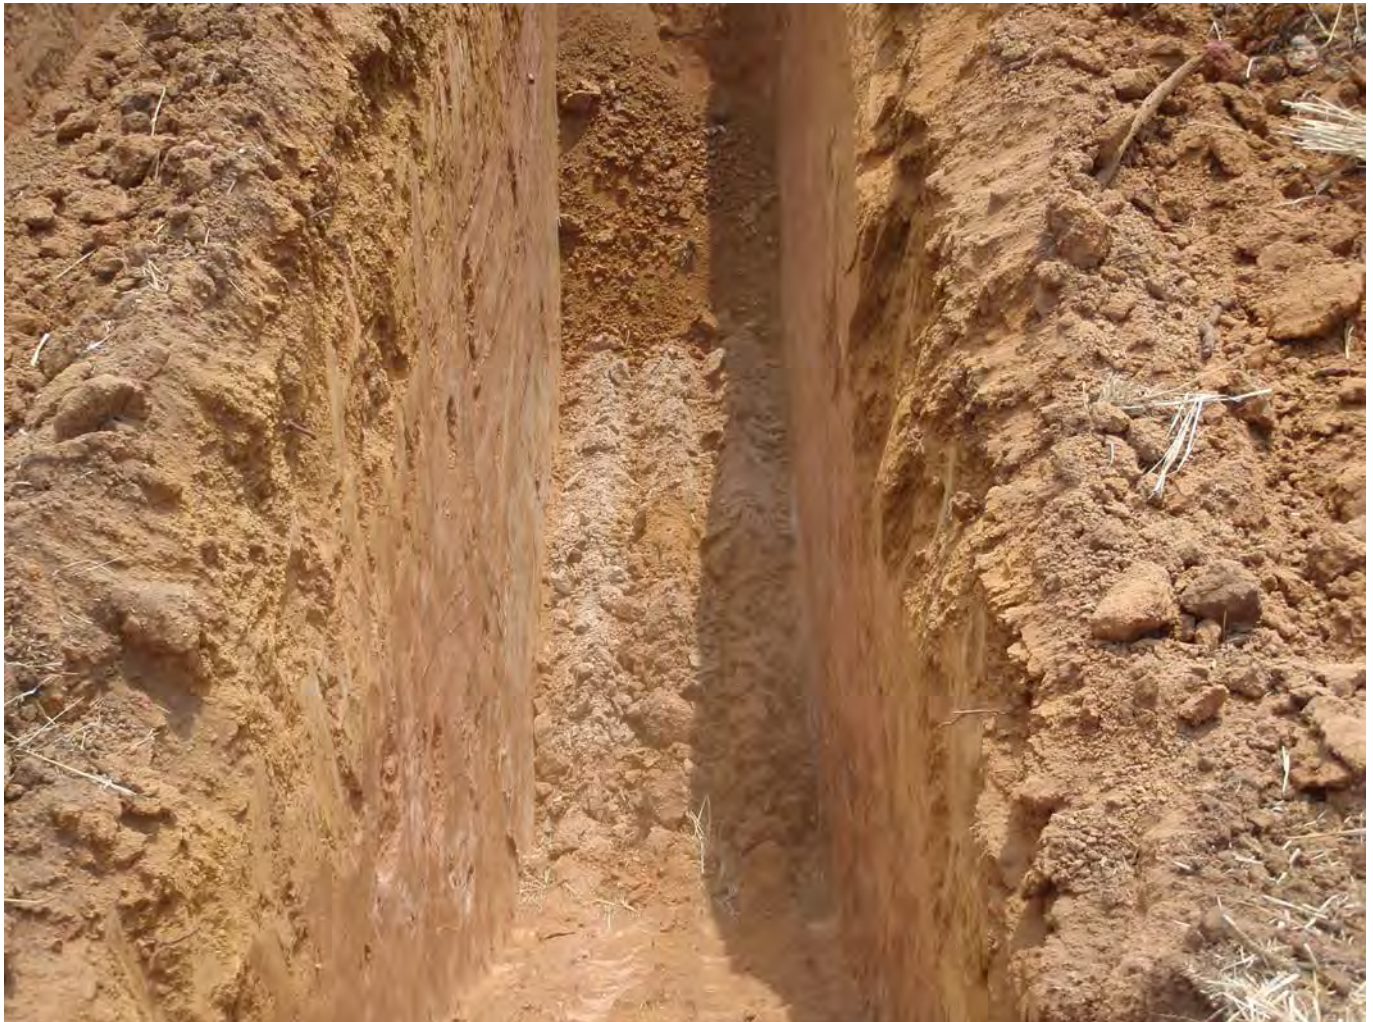
0.20							
			0.50				GC	Clayey GRAVEL fine to medium grained gravel, rounded to sub-rounded particles, pale brown, with low plasticity fines, with some roots and rootlets.	D - M L	
			1				SC	Clayey SAND fine to coarse grained sand, yellow with white and red staining, medium plasticity fines, with some roots and rootlets.	MD - D	Density inferred from observations. Vertical fissures (possibly due to degraded roots) filled with sand size particles are present throughout the entire test pit depth.

1.20				SC / CI	Silty Clayey SAND to Sandy Silty CLAY fine to coarse grained sand to medium plasticity clay, orange and white with red staining, with gravel, with some roots and rootlets.	M (<PL)	
			2							
			3				SC / CI	Silty Clayey SAND to Sandy Silty CLAY fine to coarse grained sand to medium plasticity clay, white with limited red staining, with gravel, with some roots and rootlets.	M (c PL)

COORDS: 462806 m E 6469851 m N MGA94 50
SURFACE RL: DATUM: AHD
PIT DEPTH: 3.60 m
BUCKET TYPE: 900 mm toothed

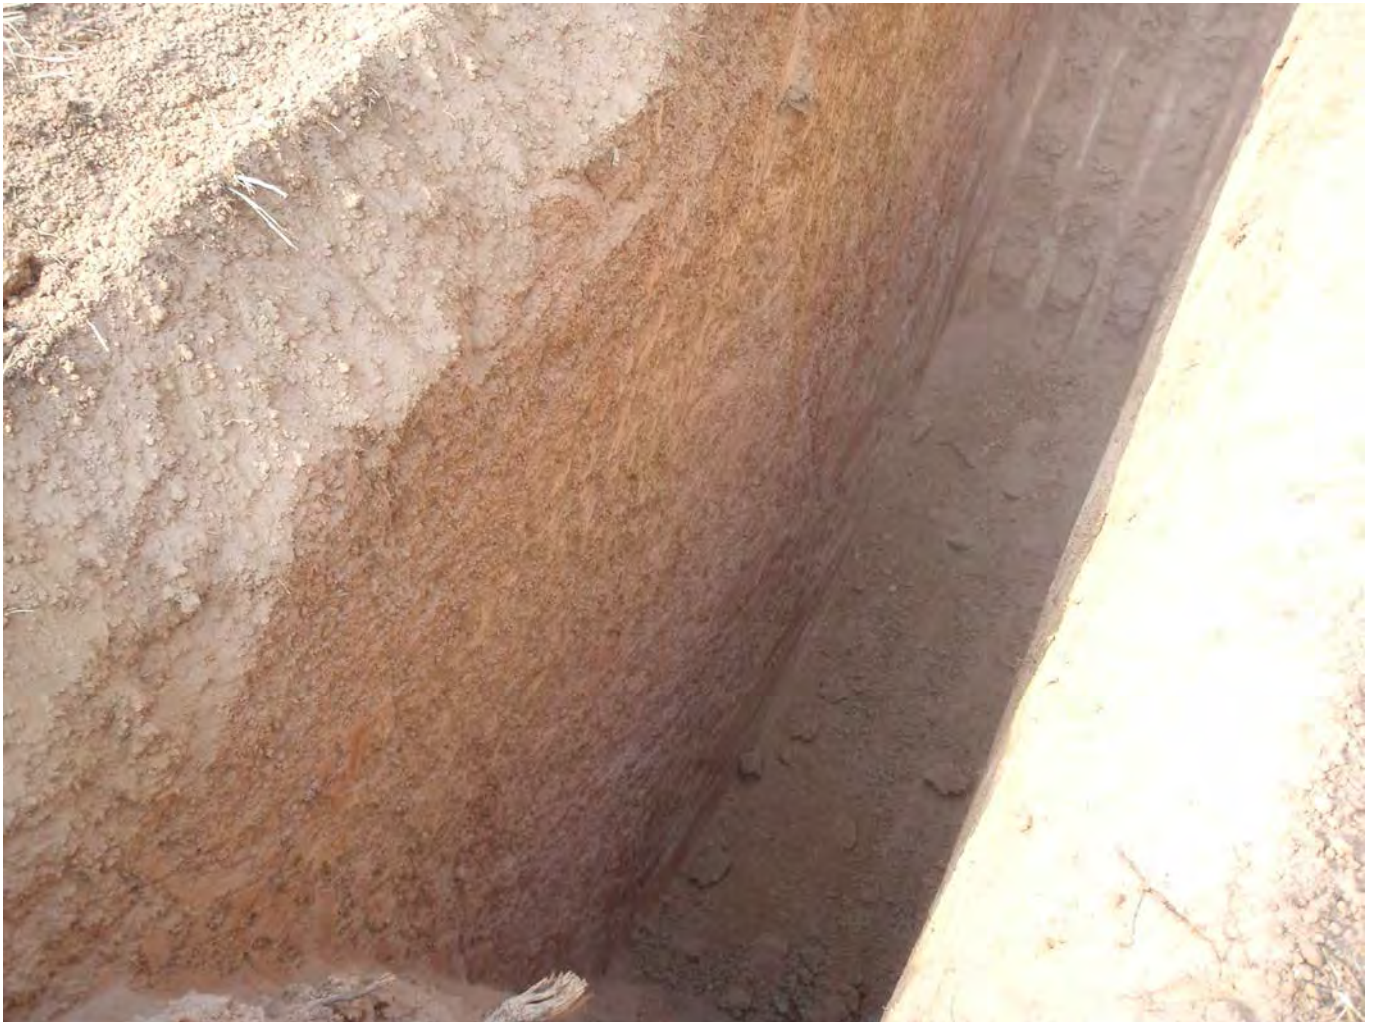
0.20	GP / GC			GRAVEL to Clayey GRAVEL medium to coarse grained gravel, rounded to sub-rounded particles, pale brown, with some low plasticity fines, with some roots and rootlets.	L							
	H		0.80	GC			LATERITE (DURICRUST) fine to coarse grained, rounded to sub-rounded particles, orange, weakly cemented laterite.	D							
			1					VD							
	M-H		1.80	SC / CI			Silty Clayey SAND to Sandy Silty CLAY fine to coarse grained sand to medium plasticity clay, orange and white with red staining reducing at depth, with gravel, with some roots and rootlets.	M (<PL)	VSt	Density inferred from observations. Vertical fissures (possibly due to degraded roots) filled with sand size particles are present throughout the entire test pit depth.					
			2												
	3														
	4														
				5								TEST PIT DISCONTINUED @ 4.80 m TARGET DEPTH GROUNDWATER NOT ENCOUNTERED BACKFILLED

COORDS: 462702 m E 6469755 m N MGA94 50
SURFACE RL: DATUM: AHD
PIT DEPTH: 4.80 m
BUCKET TYPE: 900 mm toothed
