ALLAWUNA FARM LANDFILL

Geotechnical Investigations for Landfill Development

Report Number. 147645033-008-R-Rev0

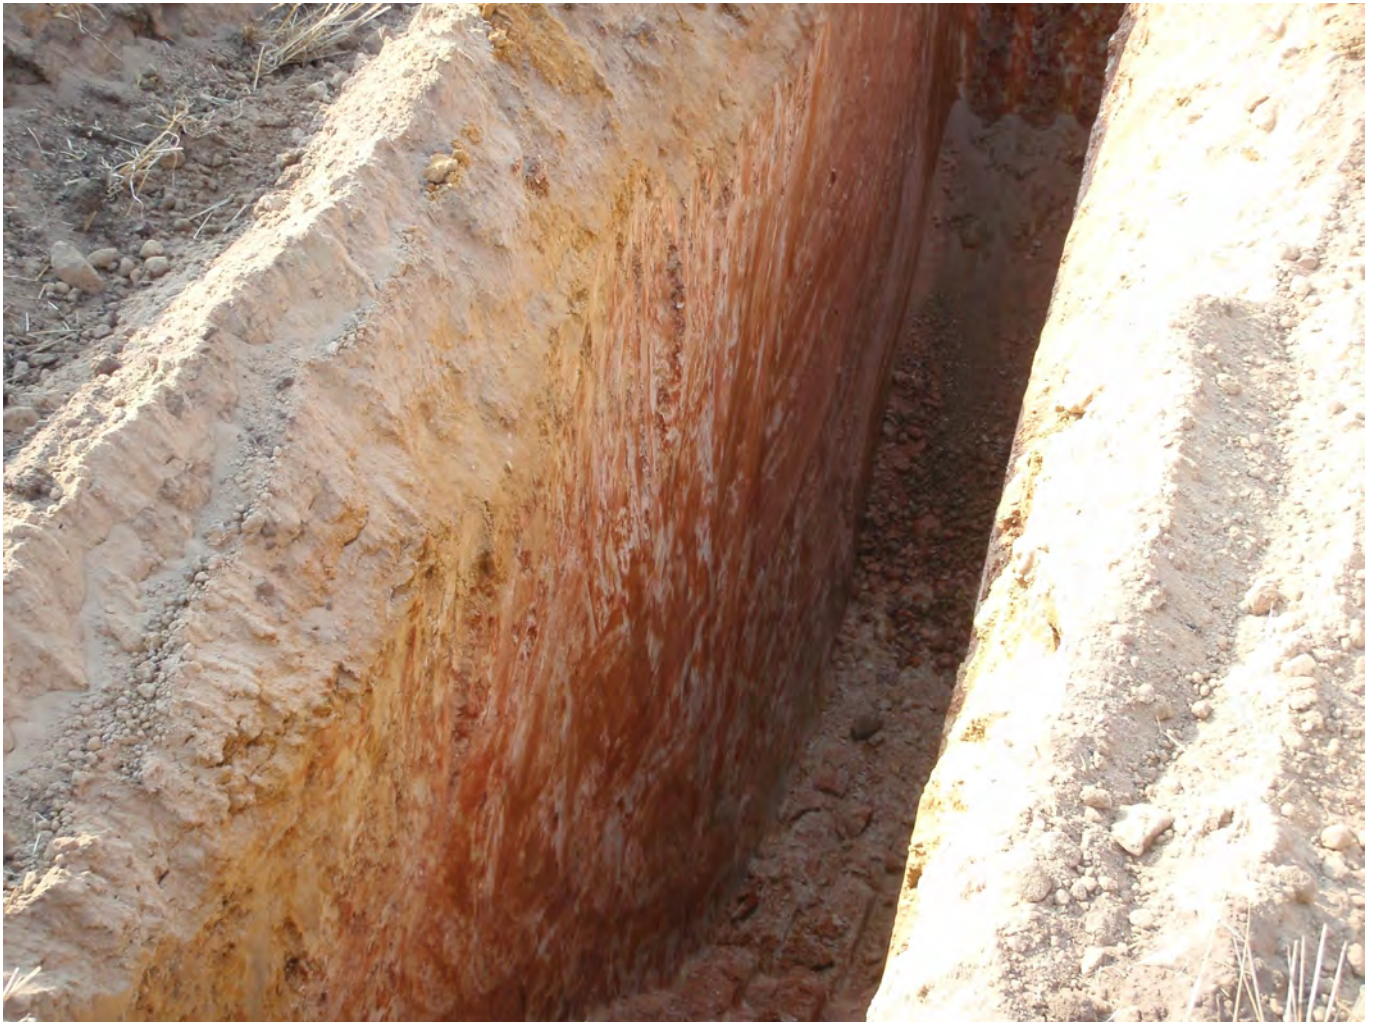
0.70	SC / CI			Silty Clayey SAND to Sandy Silty CLAY fine to coarse grained sand to medium plasticity clay, orange and white with red staining reducing at depth, with gravel, with some roots and rootlets.			Density inferred from observations. Vertical fissures (possibly due to degraded roots) filled with sand size particles are present throughout the entire test pit depth.		
			1									
			2									
	M-H		3						M (<PL)	VSt		
			4									
			5					TEST PIT DISCONTINUED @ 5.00 m TARGET DEPTH GROUNDWATER NOT ENCOUNTERED BACKFILLED

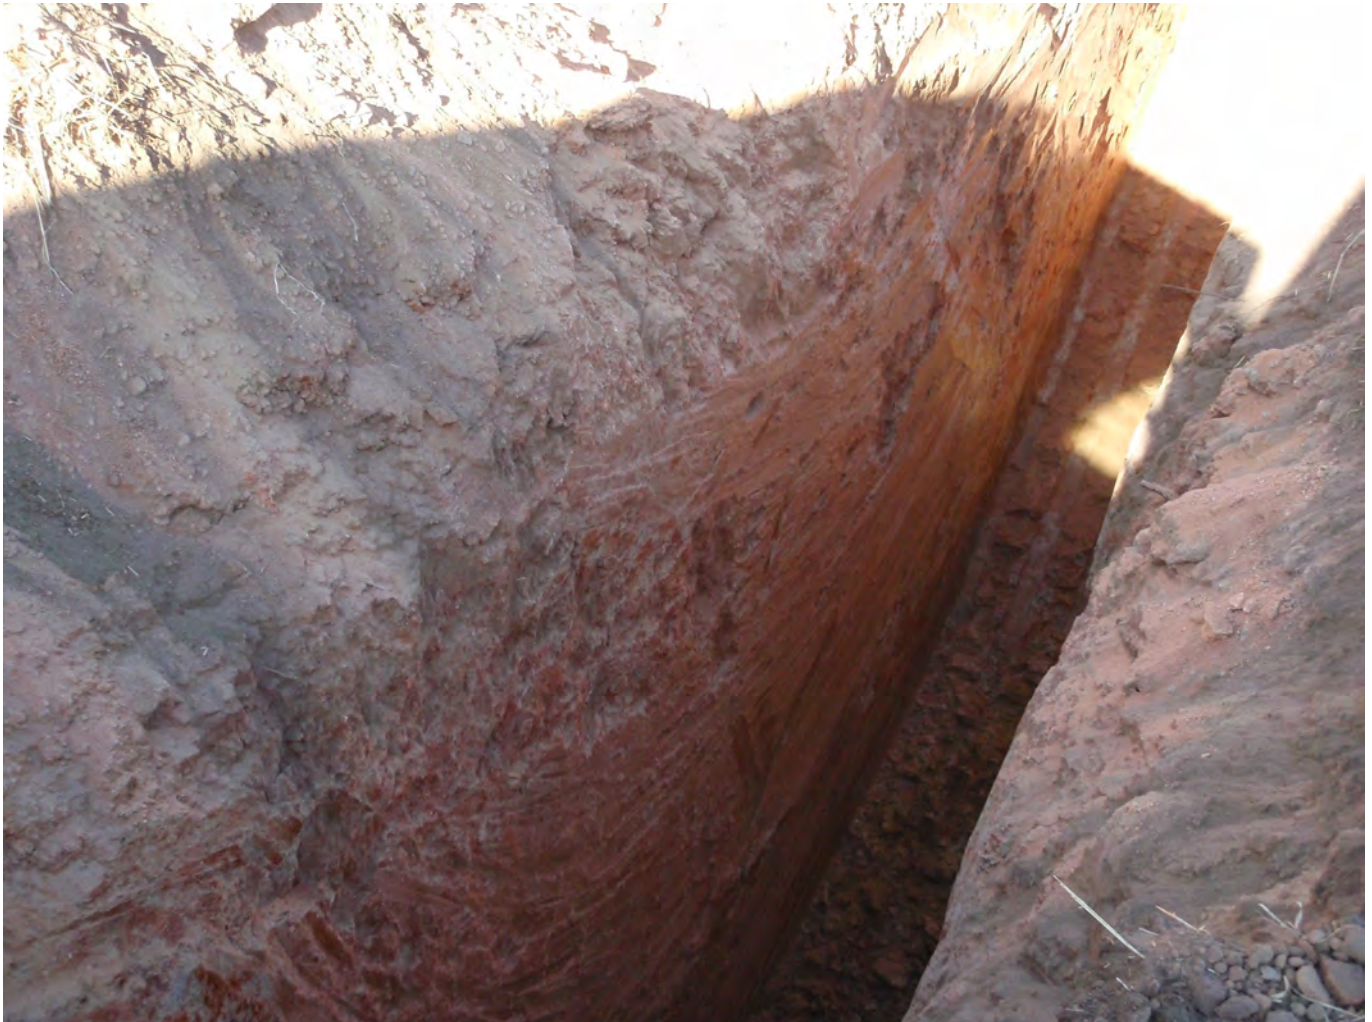
0.60	SC / GC			Clayey SAND to Clayey GRAVEL medium to coarse grained sand with medium to coarse gravel, yellow and white with red staining, with medium plasticity fines.	M			MD	Density inferred from observations. Vertical fissures (possibly due to degraded roots) filled with sand size particles are present throughout the entire test pit depth.	
	1		1.30	SC / CI		Silty Clayey SAND to Sandy Silty CLAY fine to coarse grained sand to medium plasticity clay, orange and white with red staining, with gravel, with some roots and rootlets.	M (<PL)	VSt					
	2		2.90	SC / CI		Silty Clayey SAND to Sandy Silty CLAY fine to coarse grained sand to medium plasticity clay, white with limited red staining, with gravel, with some roots and rootlets.			M (c PL)				
	3												
	M-H		4										
	M		5

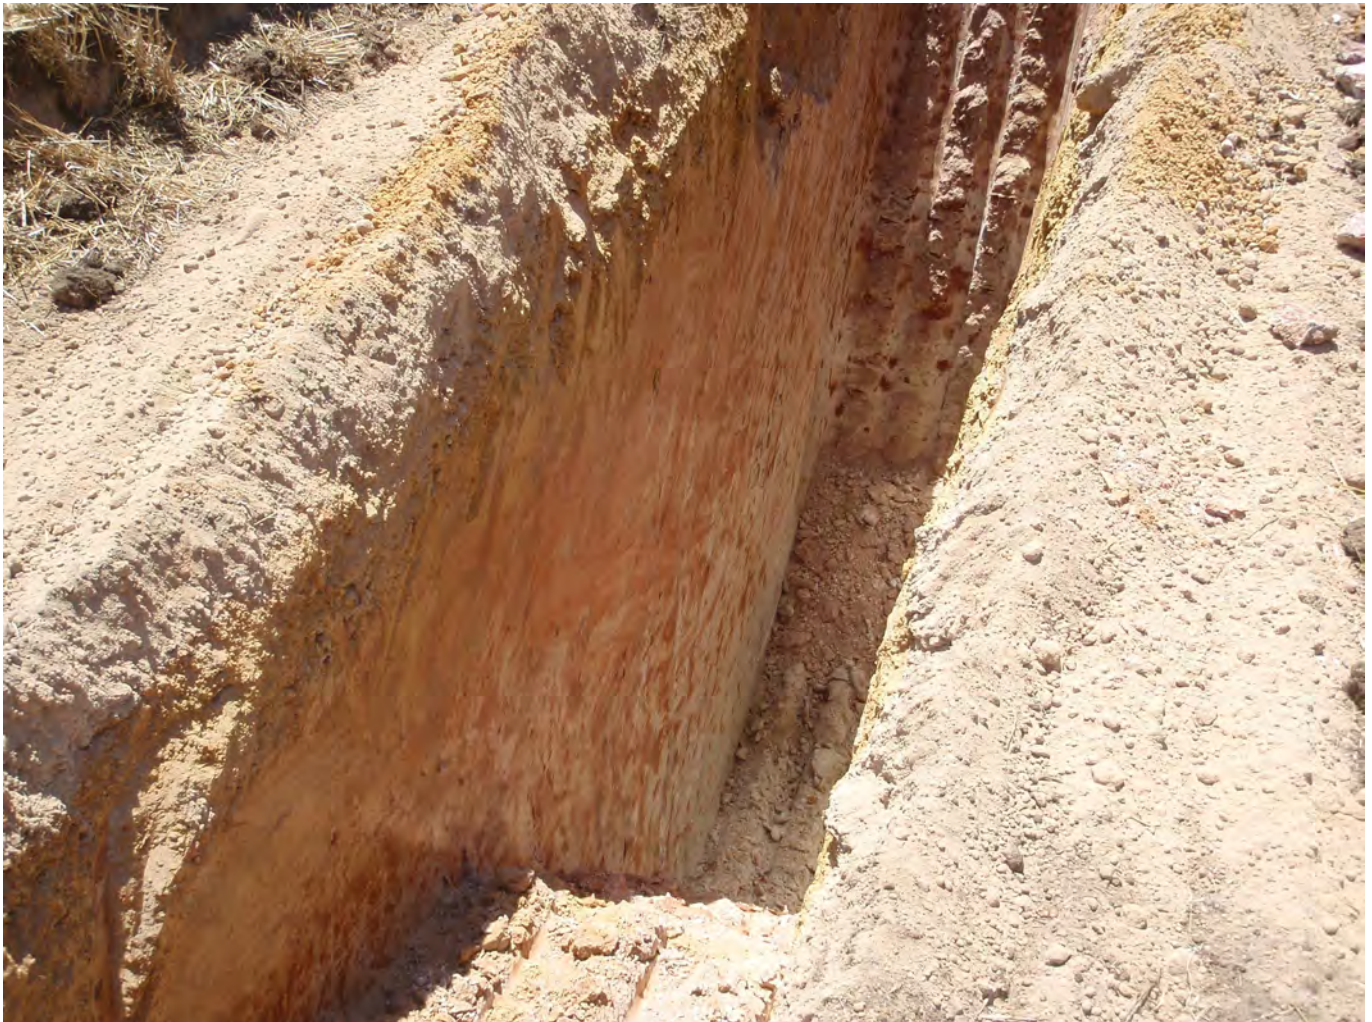
0.50	SC / GC				Clayey SAND to Clayey GRAVEL medium to coarse grained sand with medium to coarse gravel, yellow and white with red staining, with medium plasticity fines.							
			1	SC / CI				Silty Clayey SAND to Sandy Silty CLAY fine to coarse grained sand to medium plasticity clay, orange and white with red staining, with gravel, with some roots and rootlets.							
	H		2		BDS 3.00-3.30 m Rec = 300/300 mm 1 bag				M (<PL)	VSt	Density inferred from observations. Vertical fissures (possibly due to degraded roots) filled with sand size particles are present throughout the entire test pit depth.				
			3												
	M-H		4	4.00					GP	SAPROLITE to SAPROCK. Mixtures of large rock fragments (approximately 60 mm) of low weathered granite embedded in a clayey/silty soil matrix.	M				
			H-R							TEST PIT DISCONTINUED @ 4.20 m GROUNDWATER NOT ENCOUNTERED BACKFILLED REFUSAL ON GRANITE					
					5

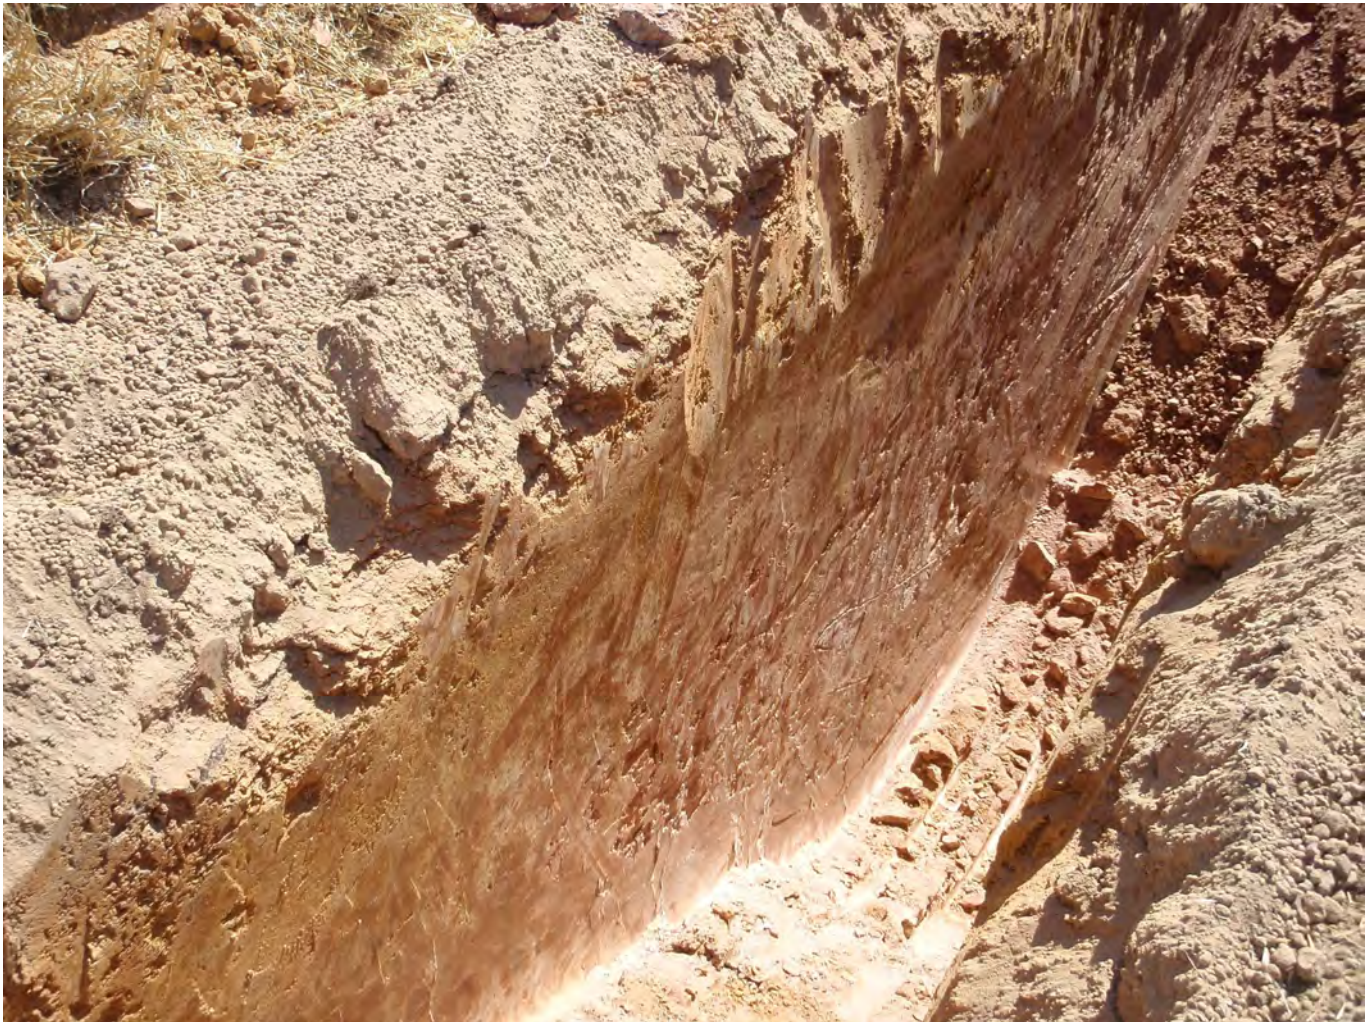
0.40	SC				Clayey SAND fine to coarse grained, yellow, white with red staining, medium plasticity fines.								
	M-H		1	1.10

SC / CI	Silty Clayey SAND to Sandy Silty CLAY fine to coarse grained sand to medium plasticity clay, orange and white with red staining, with gravel, with some roots and rootlets.	M (<PL)	VSt	Density inferred from observations. Vertical fissures (possibly due to degraded roots) filled with sand size particles are present throughout the entire test pit depth.				
			3	3.00				GP	SAPROLITE to SAPROCK. Mixtures of large rock fragments (approximately 60 mm) of low weathered granite embedded in a clayey/silty soil matrix.							
	H-R									TEST PIT DISCONTINUED @ 3.20 m GROUNDWATER NOT ENCOUNTERED BACKFILLED REFUSAL ON GRANITE

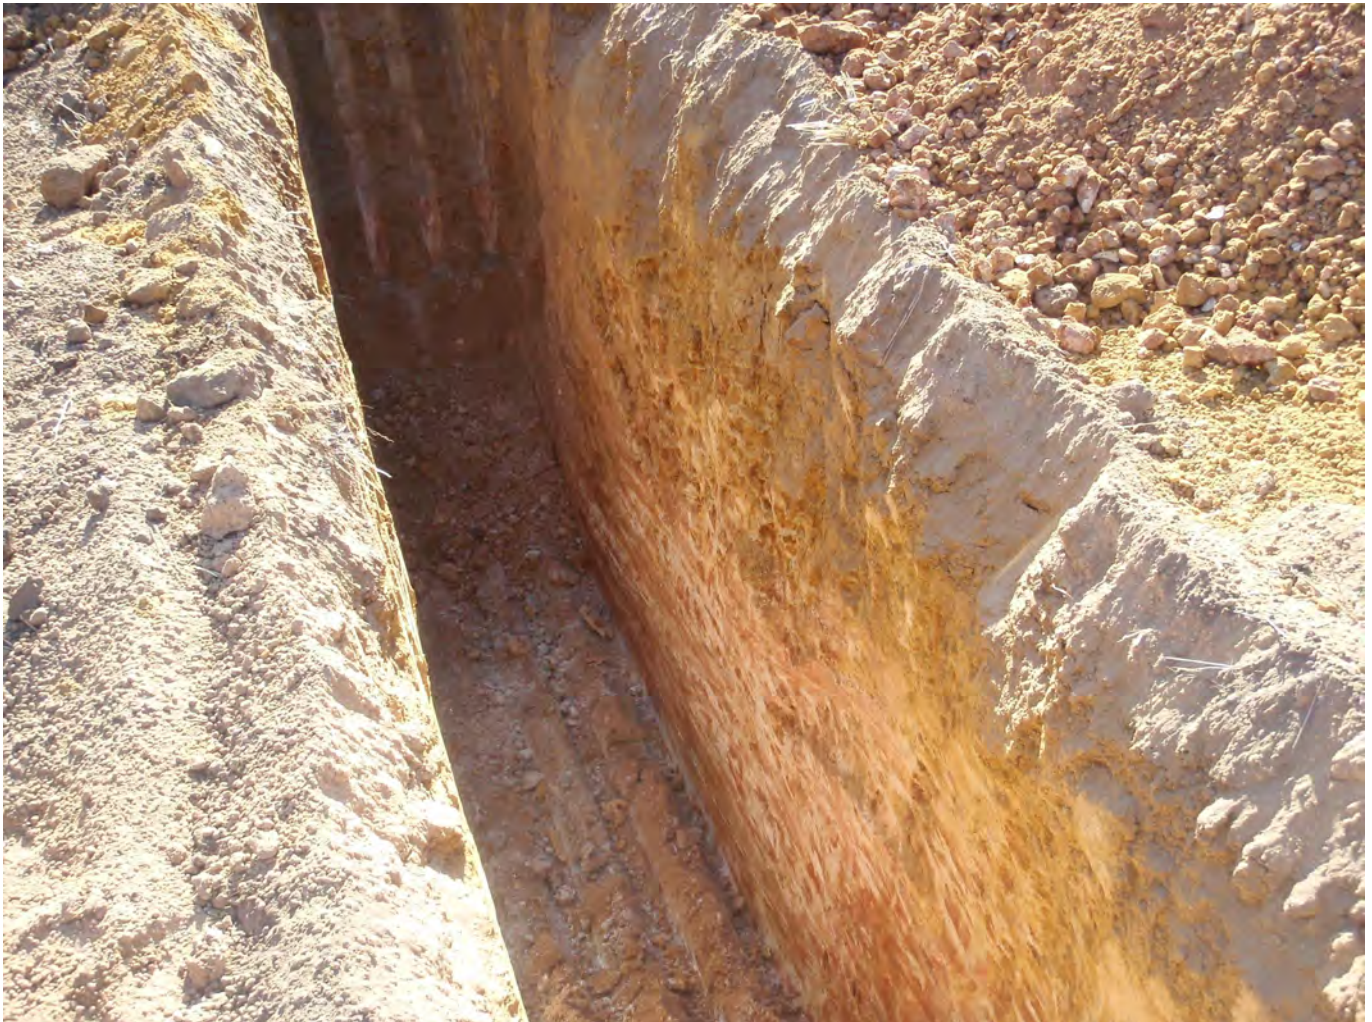
TOPSOIL	D	L	Density inferred from observations. Vertical fissures (possibly due to degraded roots) filled with sand size particles are present throughout the entire test pit depth.

0.50	SC			Clayey SAND fine to coarse grained, yellow, white with red staining, medium plasticity fines.	MD						
	1		SC / CI	Silty Clayey SAND to Sandy Silty CLAY fine to coarse grained sand to medium plasticity clay, orange and white with red staining, with gravel, with some roots and rootlets.			M (<PL)		VSt

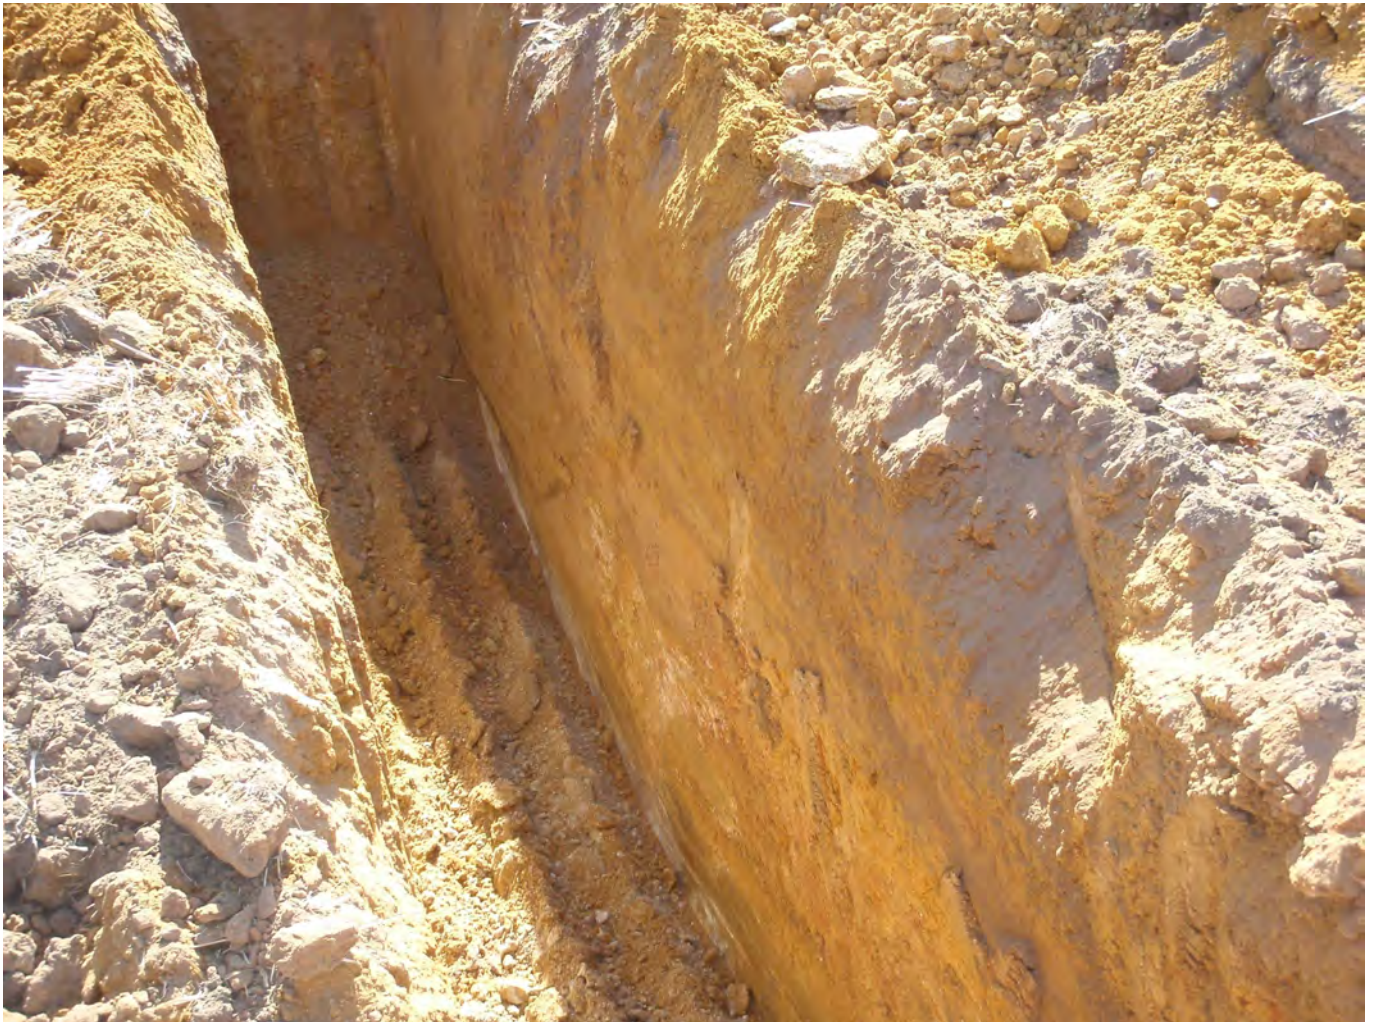
0.60				SC	Clayey SAND fine to coarse grained, yellow, white with red staining, medium plasticity fines.		MD	Density inferred from observations. Vertical fissures (possibly due to degraded roots) filled with sand size particles are present throughout the entire test pit depth.

1.20				SC / CI	Silty Clayey SAND to Sandy Silty CLAY fine to coarse grained sand to medium plasticity clay, light orange and white with red staining, with gravel, with some roots and rootlets.

4.00				SC / CI	Silty Clayey SAND to Sandy Silty CLAY fine to coarse grained sand to medium plasticity clay, white with limited red staining, with gravel, with some roots and rootlets.		M (c PL)	
EX	M				BDS 2.50-2.80 m Rec = 300/300 mm 1 bag				M (<PL)		
					BDS 4.50-4.80 m Rec = 300/300 mm 1 bag						
			5					TEST PIT DISCONTINUED @ 5.00 m TARGET DEPTH GROUNDWATER NOT ENCOUNTERED BACKFILLED			
			6

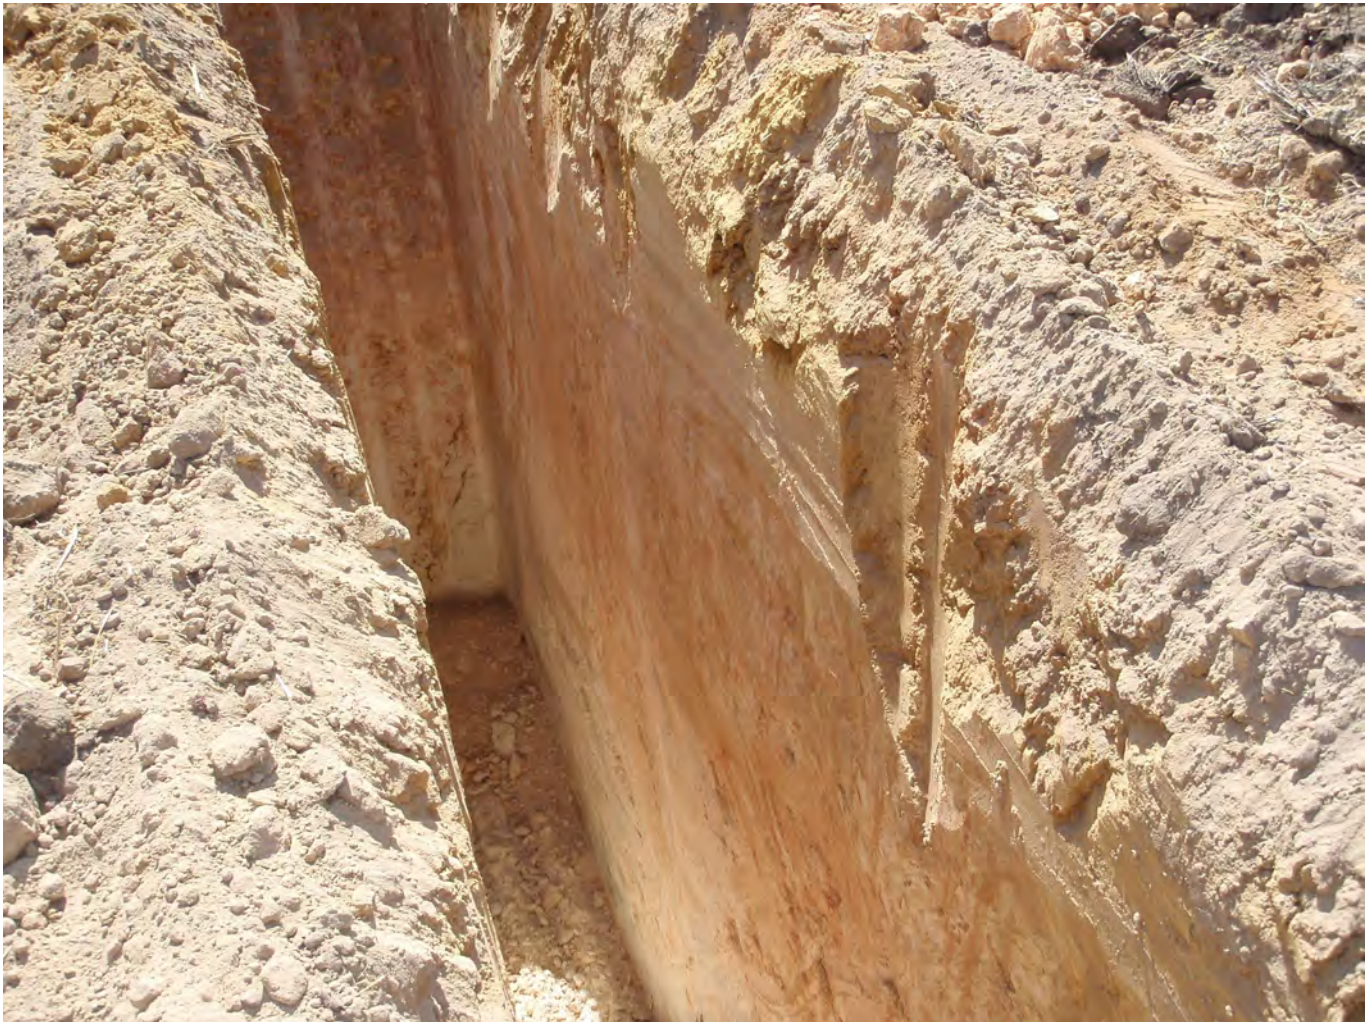
0.60				SC	Clayey SAND fine to coarse grained, yellow, white with red staining, medium plasticity fines.		MD	Density inferred from observations. Vertical fissures (possibly due to degraded roots) filled with sand size particles are present throughout the entire test pit depth.

1.20				SC / CI	Silty Clayey SAND to Sandy Silty CLAY fine to coarse grained sand to medium plasticity clay, light orange and white with red staining, with gravel, with some roots and rootlets.

4.00				SC / CI	Silty Clayey SAND to Sandy Silty CLAY fine to coarse grained sand to medium plasticity clay, white with limited red staining, with gravel, with some roots and rootlets.	M (<PL)	VSt	
			5					TEST PIT DISCONTINUED @ 5.00 m TARGET DEPTH GROUNDWATER NOT ENCOUNTERED BACKFILLED			
			6

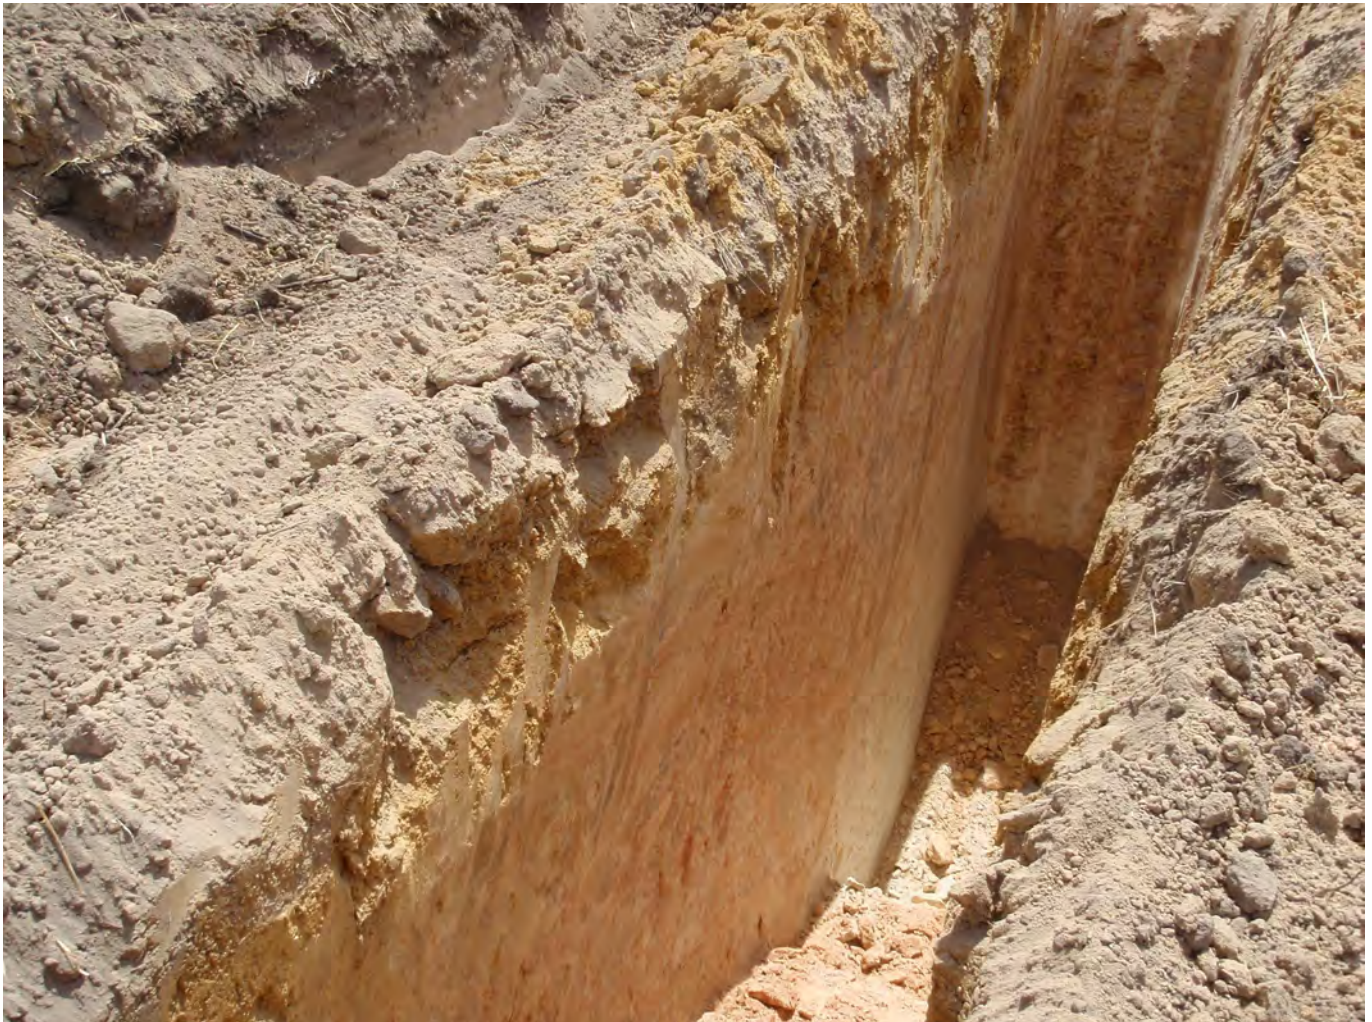
0.20			SC				Clayey SAND fine to coarse grained, yellow, white with red staining, medium plasticity fines.	MD	Vertical fissures (possibly due to degraded roots) filled with sand size particles are present throughout the entire test pit depth.

0.60			SC / CI				Silty Clayey SAND to Sandy Silty CLAY fine to coarse grained sand to medium plasticity clay, light orange and white with red staining, with gravel, with some roots and rootlets.						
	1			M (<PL) - M (c PL)				VSt

1.30													
	2													
	3													
	4													
	5		4.90	SC / CI				Silty Clayey SAND to Sandy Silty CLAY fine to coarse grained sand to medium plasticity clay, white with limited red staining, with gravel, with some roots and rootlets.	M (c PL)					
		TEST PIT DISCONTINUED @ 5.20 m TARGET DEPTH GROUNDWATER NOT ENCOUNTERED BACKFILLED												
6

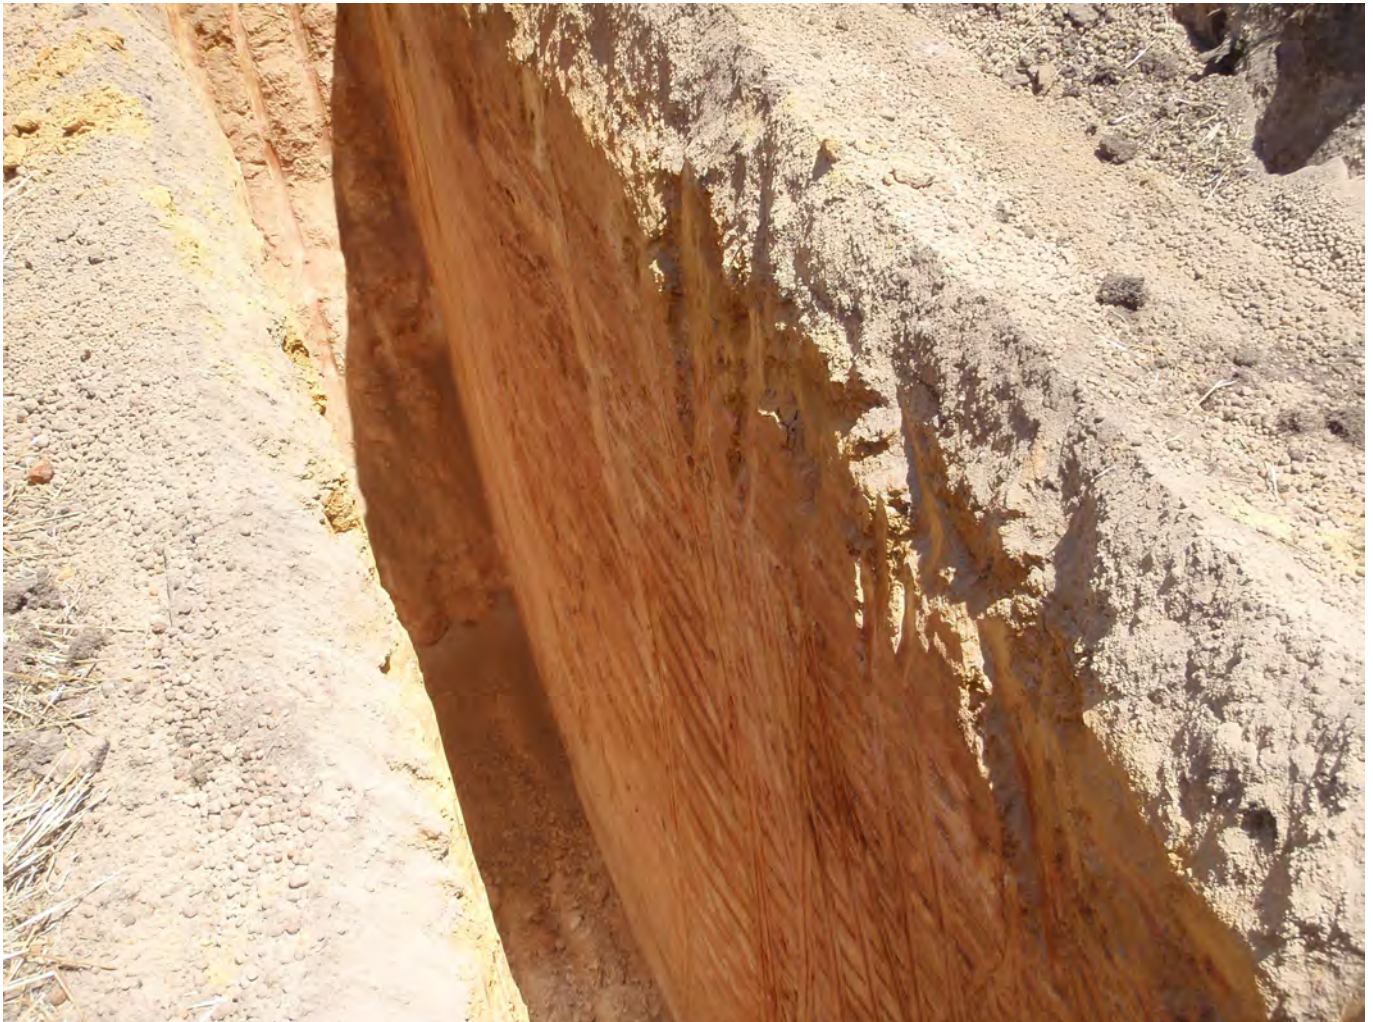
0.60	SC			Clayey SAND fine to coarse grained, yellow, white with red staining, medium plasticity fines.	MD				
	1		SC / CI	Silty Clayey SAND to Sandy Silty CLAY fine to coarse grained sand to medium plasticity clay, light orange and white with red staining, with gravel, with some roots and rootlets.			M (<PL)		VSt

1.80											
M		2										Density inferred from observations. Vertical fissures (possibly due to degraded roots) filled with sand size particles are present throughout the entire test pit depth.
		3										
		4										
		5							TEST PIT DISCONTINUED @ 5.00 m TARGET DEPTH GROUNDWATER NOT ENCOUNTERED BACKFILLED

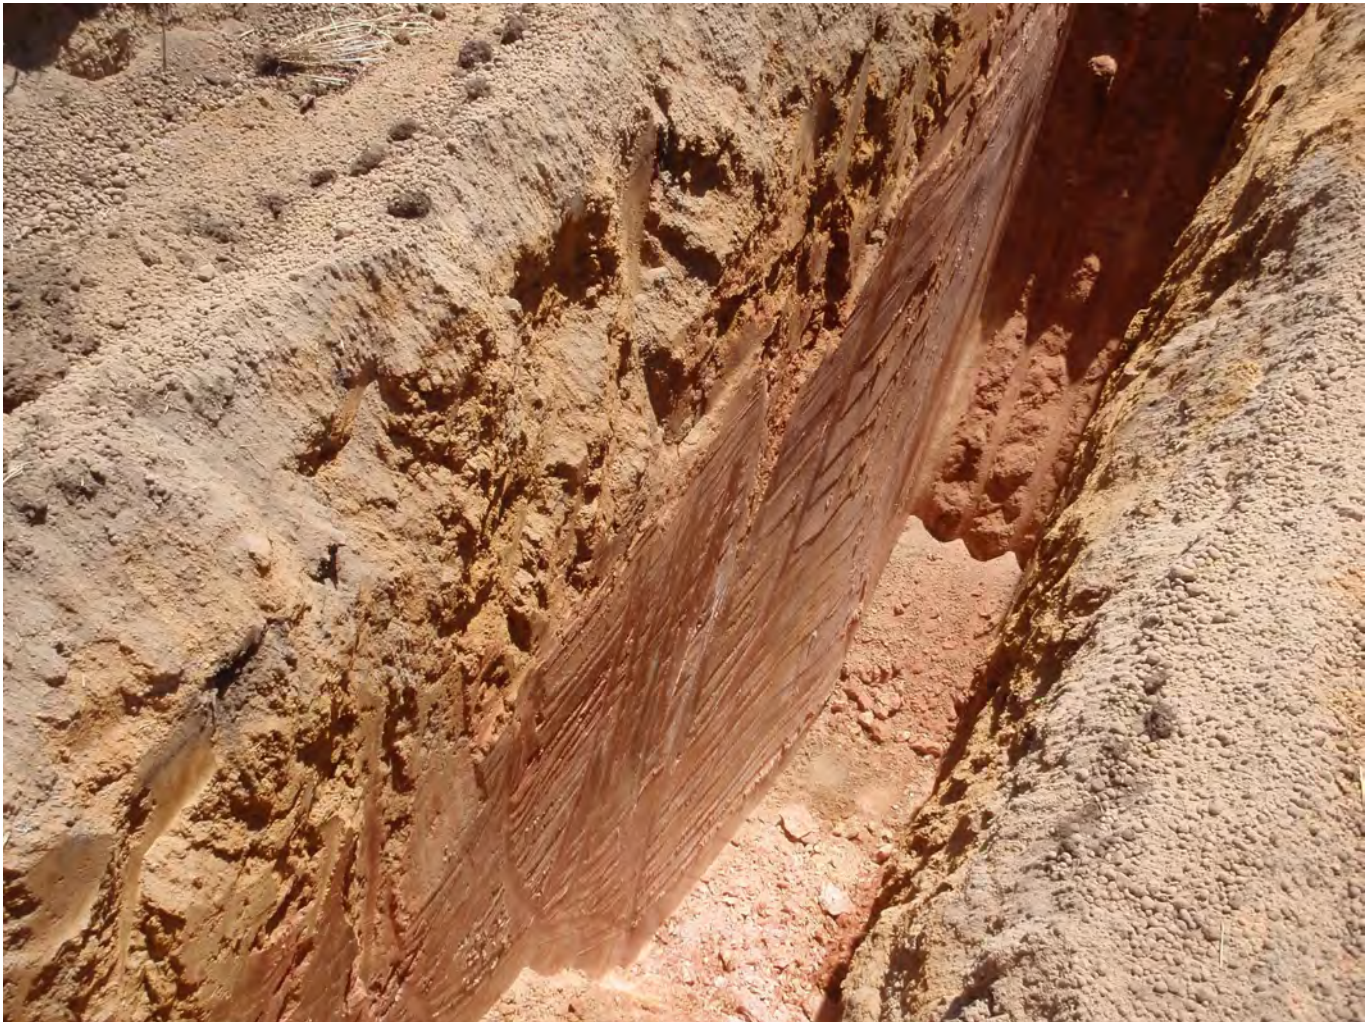
0.50	SC			Clayey SAND fine to coarse grained, yellow, white with red staining, medium plasticity fines.						
			0.70	SC / CI			Silty Clayey SAND to Sandy Silty CLAY fine to coarse grained sand to medium plasticity clay, light orange and white with red staining, trace of gravel, with some roots and rootlets.						
	1												
	2												
	3									M (<PL)	VSt		Density inferred from observations. Vertical fissures (possibly due to degraded roots) filled with sand size particles are present throughout the entire test pit depth.
	4												
	5												
								TEST PIT DISCONTINUED @ 5.00 m TARGET DEPTH GROUNDWATER NOT ENCOUNTERED BACKFILLED

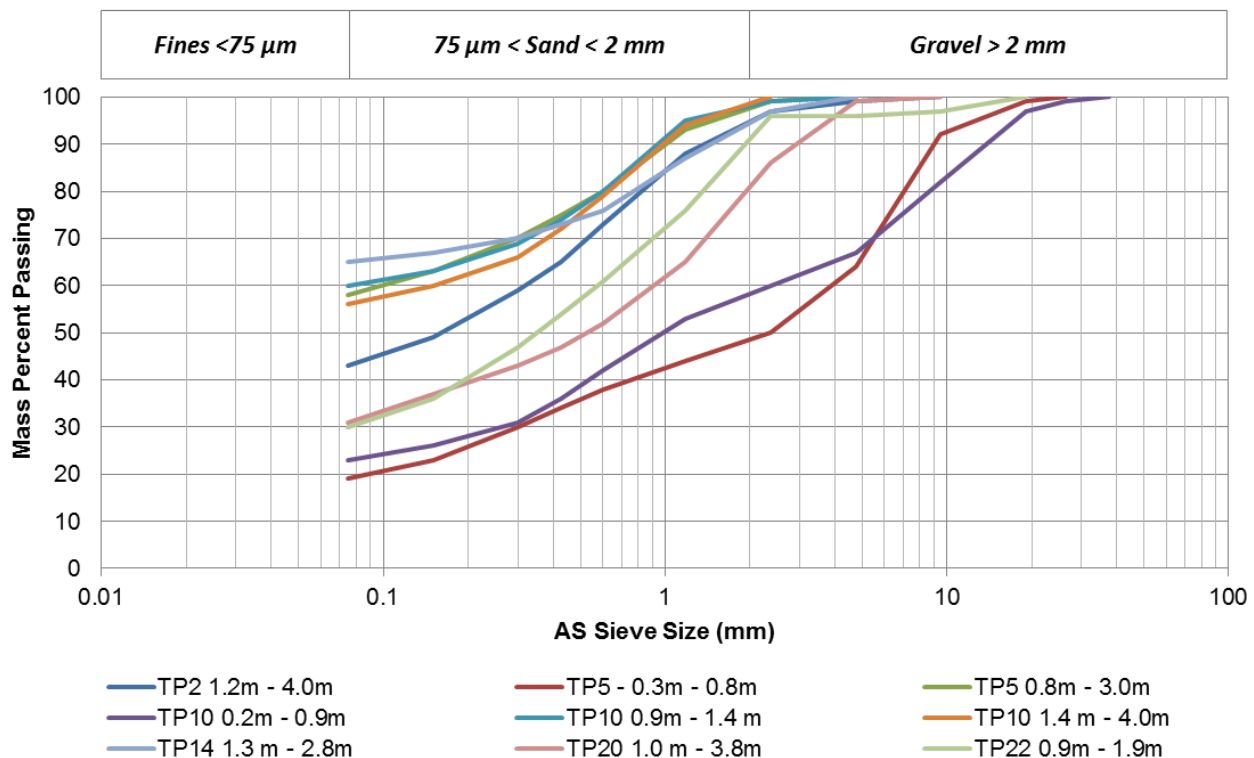
Figure F4: Material PSD by sieve.

Figure F4 to Figure F7 presents the PSD of the materials and Figure F8 to Figure F9 their plasticity index and liquid limit plotted in the plasticity chart.

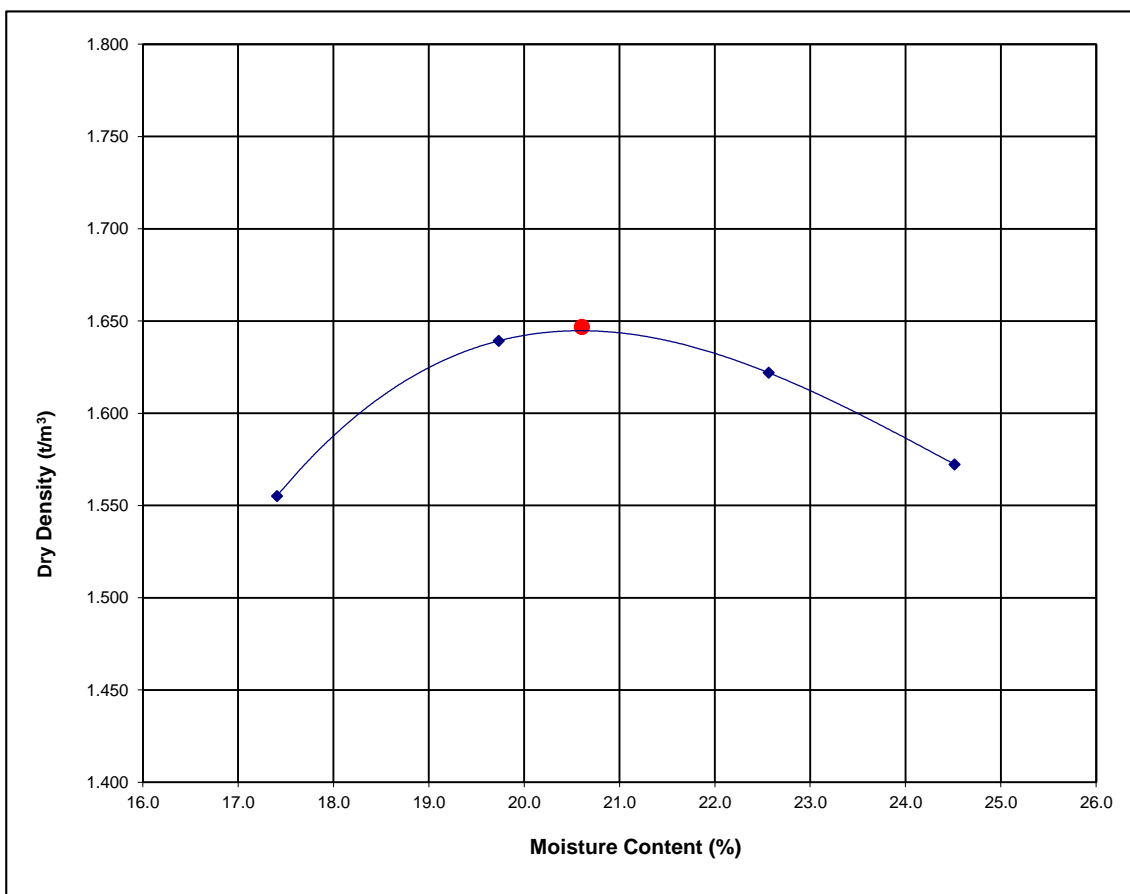
Client	Golder Associates Pty Ltd	Report No.	14080089-MDD
Project	Allawuna Proposed Landfill Site	Test Date	2/09/2014
		Report Date	3/09/2014
Client ID	TP2	Depth (m)	1.2-4.0
Description	CLAYEY SAND- red brown

Maximum Dry Density (t/m³)	1.65	Optimum Moisture Content (%)	20.5
Moisture Content (%)	19.5	Percentage of Oversize/Sieve Size (mm)	0/19

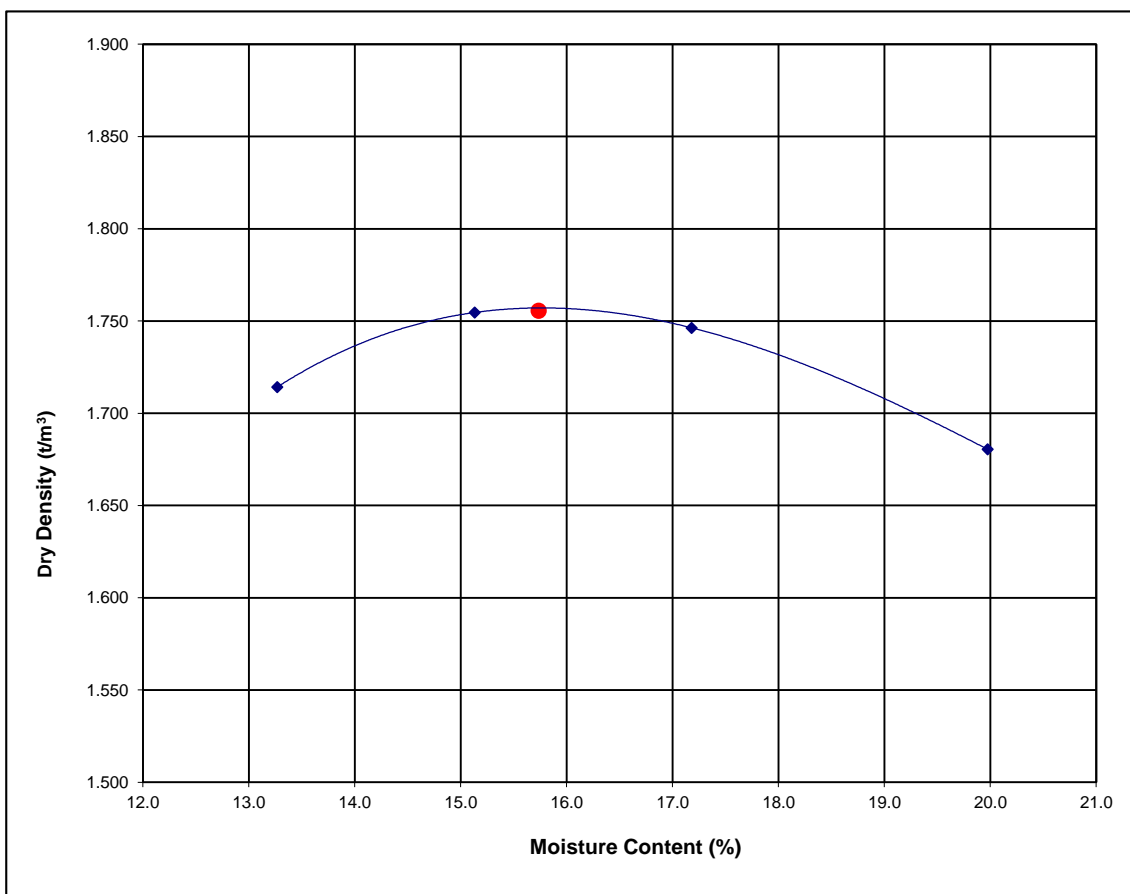
Client	Golder Associates Pty Ltd	Report No.	14080094-MDD
Project	Allawuna Proposed Landfill Site	Test Date	2/09/2014
		Report Date	3/09/2014
Client ID	TP10	Depth (m)	1.4-4.0
Description	SANDY CLAY- white

Maximum Dry Density (t/m³)	1.76	Optimum Moisture Content (%)	15.5
Moisture Content (%)	17.3	Percentage of Oversize/Sieve Size (mm)	0/19

- Based on the results of the standard compaction testing, the standard maximum dry density (SMDD) and optimum moisture content (OMC) of TP10, TP14 and TP116 are similar, approximately 1.75 t/m^3 and 16% to 17% respectively. The material sampled from TP2 presents the lowest SMDD (1.65 t/m^3) and highest OMC (20%). The material from TP86 and TP102 presents the highest SMDD (1.9 t/m^3) and lowest OMC (12%), which is typical of gravel and sand material.

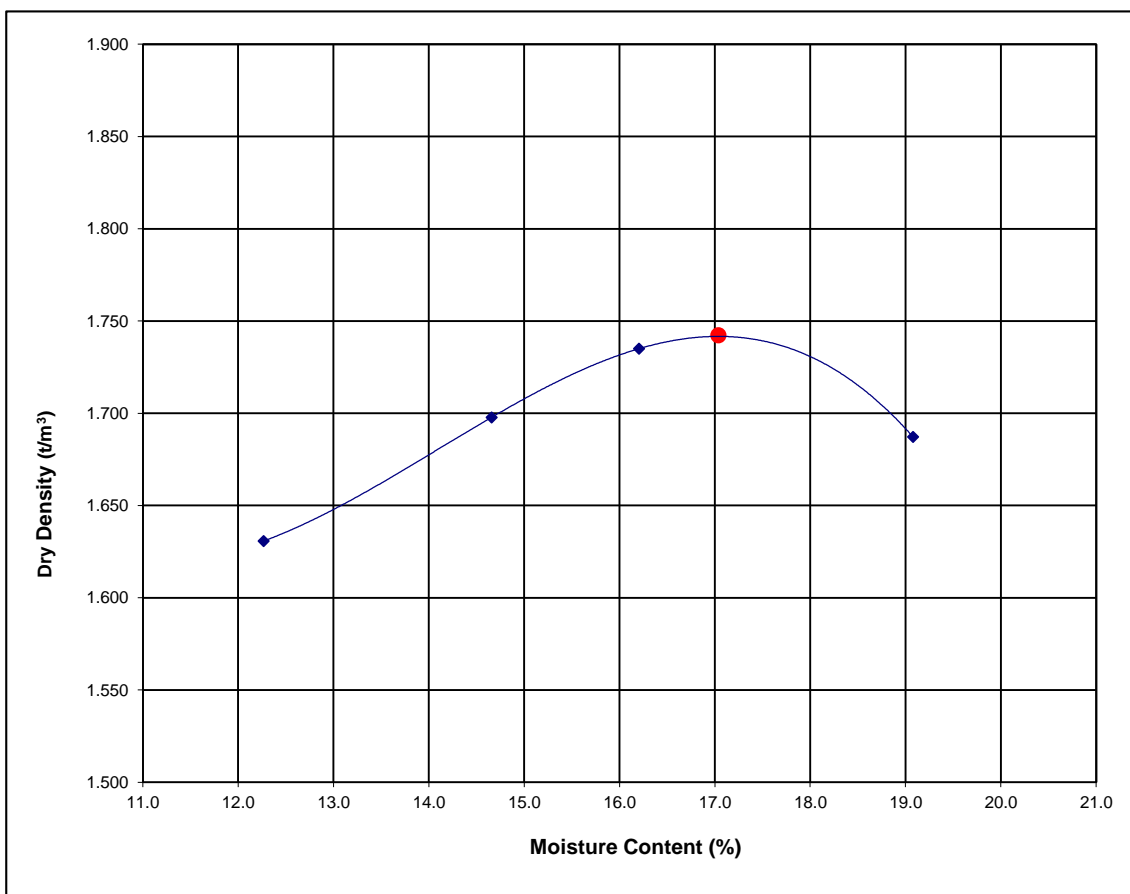
Client	Golder Associates Pty Ltd	Report No.	14080095-MDD
Project	Allawuna Proposed Landfill Site	Test Date	1/09/2014
		Report Date	3/09/2014
Client ID	TP14	Depth (m)	1.3-2.8
Description	SANDY CLAY-grey red

Maximum Dry Density (t/m³)	1.74	Optimum Moisture Content (%)	17.0
Moisture Content (%)	14.7	Percentage of Oversize/Sieve Size (mm)	0/19

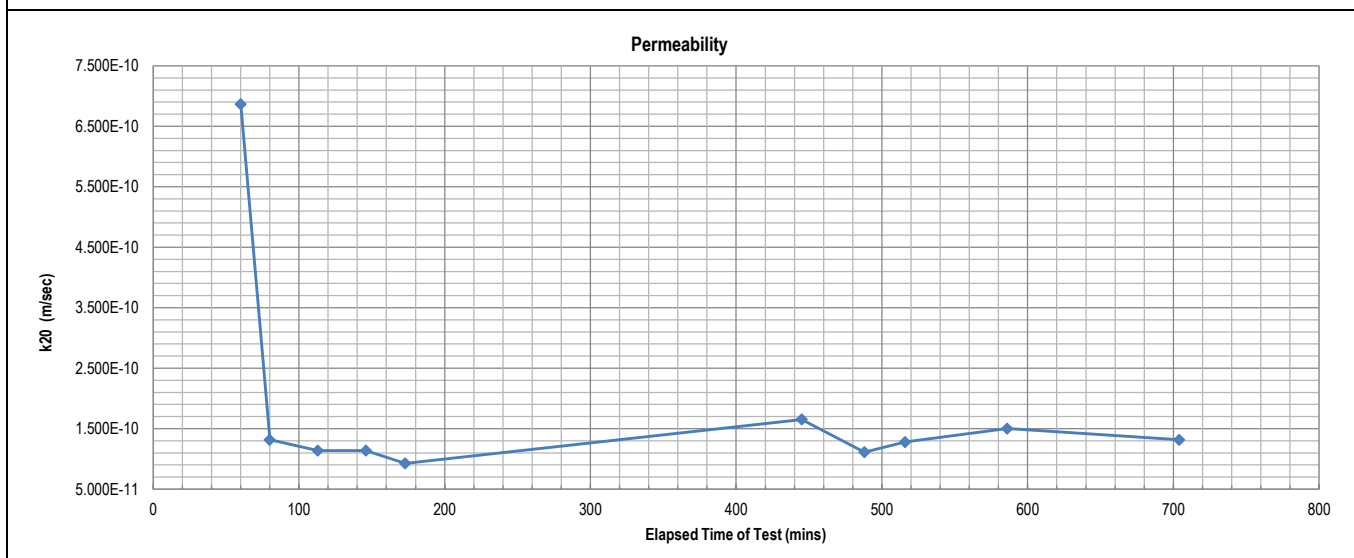
PERMEABILITY $k_{(20)} = 1.37E-10$ (m/sec)

Remarks: The above specimen was remoulded to a target of 95% of Standard Dry Density and at Optimum Moisture Content.

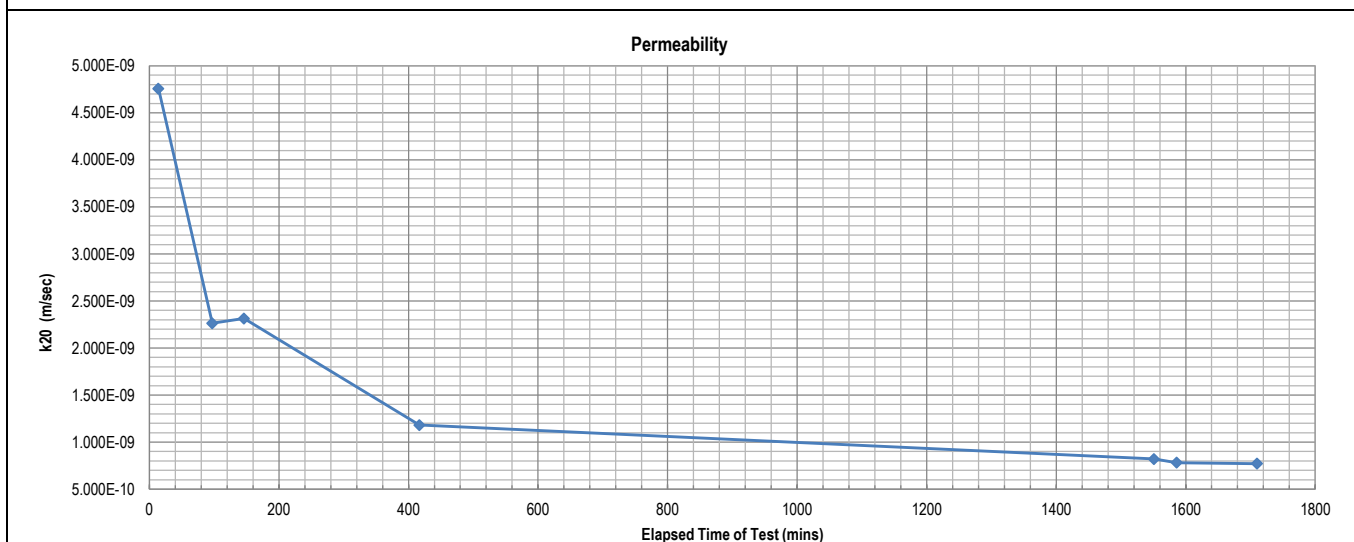
PERMEABILITY $k_{(20)} = 7.91E-10$ (m/sec)

Remarks: The above specimen was remoulded to a target of 95% of Standard Dry Density and at Optimum Moisture Content.

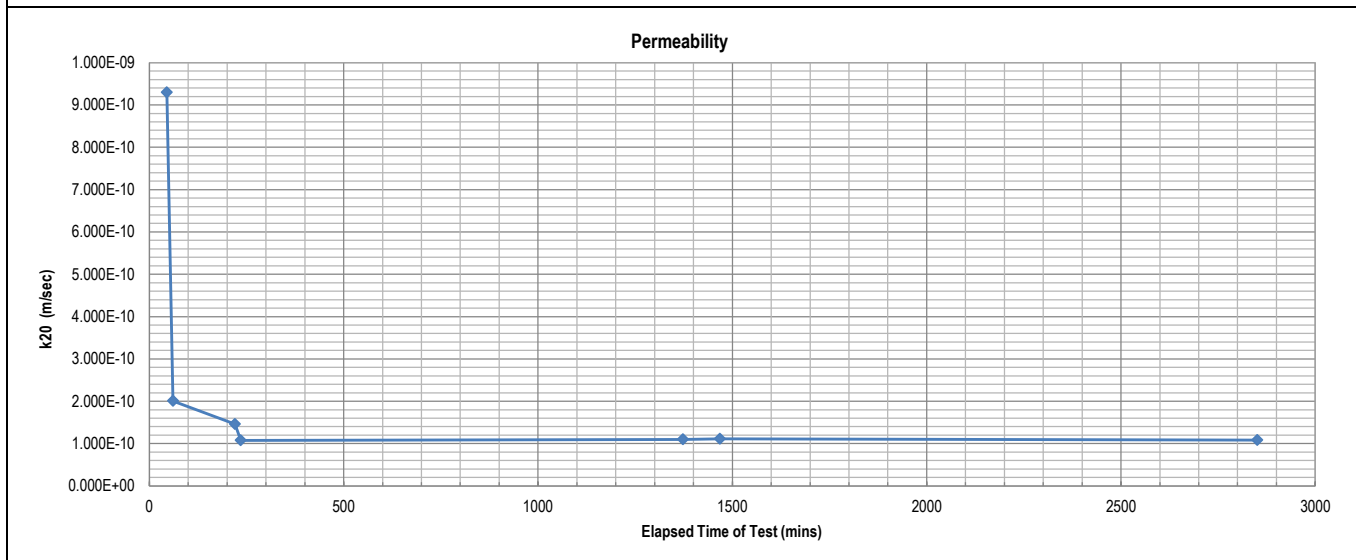
PERMEABILITY $k_{(20)} = 1.08E-10$ (m/sec)

Remarks: The above specimen was remoulded to a target of 95% of Standard Dry Density and at Optimum Moisture Content.
