ALLAWUNA FARM LANDFILL

Geotechnical Investigations for Landfill Development

Report Number. 147645033-008-R-Rev0

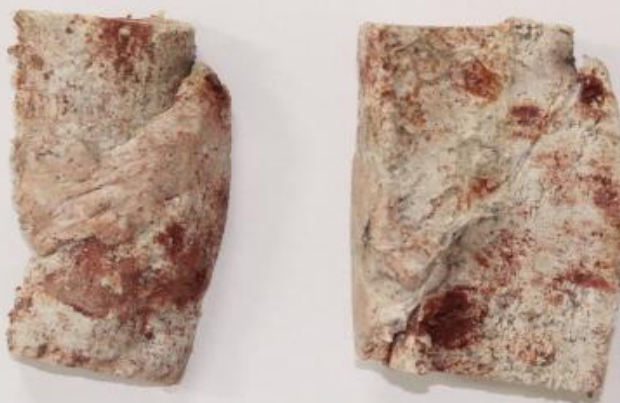
Client: Golder Associates Pty Ltd	Report No.: 14090089 - CU 100 kPa
Project: Allawuna Proposed Landfill Site	Test Date: 4/09/2014 Report Date: 10/09/2014
Client Id.: TP14 Bulk Sample	Depth (m): 1.30-2.80
Description: SANDY CLAY- mottled pale grey and red brown

CLIENT:	Golder Associates Pty Ltd	
PROJECT:	Allawuna Proposed Landfill Site	AFTER TEST
LAB SAMPLE No.	14090089	DATE: 09-09-14
BOREHOLE:	TP14 Bulk Sample	DEPTH: 1.30-2.80

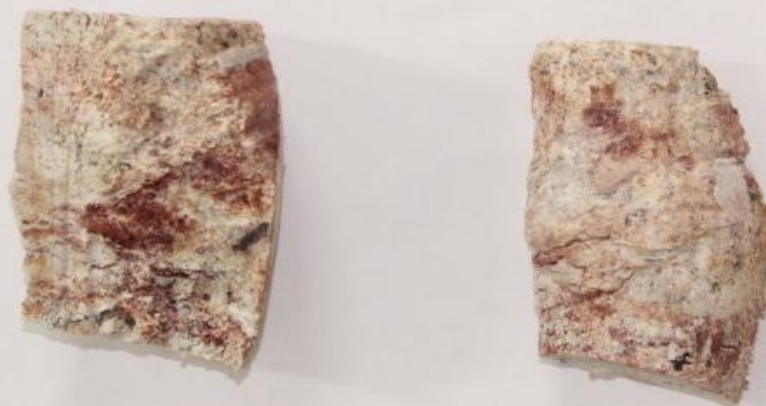
Client: Golder Associates Pty Ltd	Report No.: 14090089 - CU 250 kPa
Project: Allawuna Proposed Landfill Site	Test Date: 4/09/2014 Report Date: 10/09/2014
Client Id.: TP14 Bulk Sample	Depth (m): 1.30-2.80
Description: SANDY CLAY- mottled pale grey and red brown

CLIENT:	Golder Associates Pty Ltd	
PROJECT:	Allawuna Proposed Landfill Site	AFTER TEST
LAB SAMPLE No.	14090089	DATE: 09.09.14
BOREHOLE:	TP14 Bulk Sample	DEPTH: 1.30-2.80

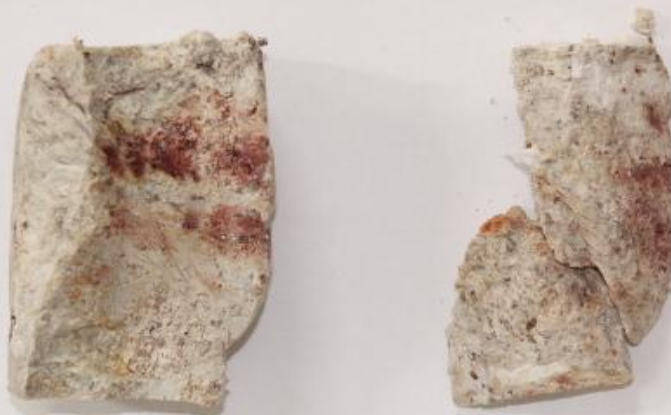
Client: Golder Associates Pty Ltd	Report No.: 14090089 - CU 500kPa
Project: Allawuna Proposed Landfill Site	Test Date: 4/09/2014 Report Date: 10/09/2014
Client Id.: TP14 Bulk Sample	Depth (m): 1.30-2.80
Description: SANDY CLAY- mottled pale grey and red brown

CLIENT:	Golder Associates Pty Ltd	
PROJECT:	Allawuna Proposed Landfill Site	AFTER TEST
LAB SAMPLE No.	14090089	DATE: 09/09/14
BOREHOLE:	TP14 Bulk Sample	DEPTH: 1.30-2.80

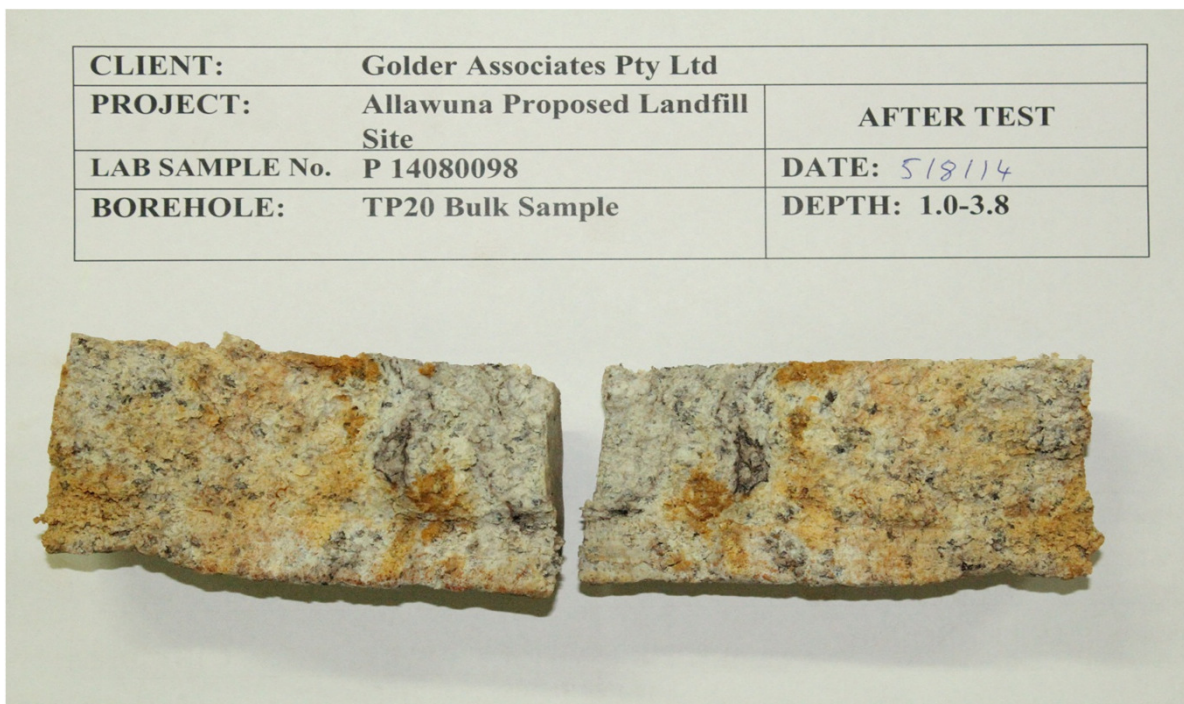
Client: Golder Associates Pty Ltd	Report No.: P 14080098 - CU
Project: Allawuna Proposed Landfill Site	Test Date: 1/09/2014 Report Date: 8/09/2014
Client Id.: TP20 Bulk Sample	Depth (m): 1.0-3.8
Description CLAYEY SAND- mottled grey and yellow brown

CLIENT:	Golder Associates Pty Ltd	
PROJECT:	Allawuna Proposed Landfill Site	AFTER TEST
LAB SAMPLE No.	P 14080098	DATE: 5/8/14
BOREHOLE:	TP20 Bulk Sample	DEPTH: 1.0-3.8

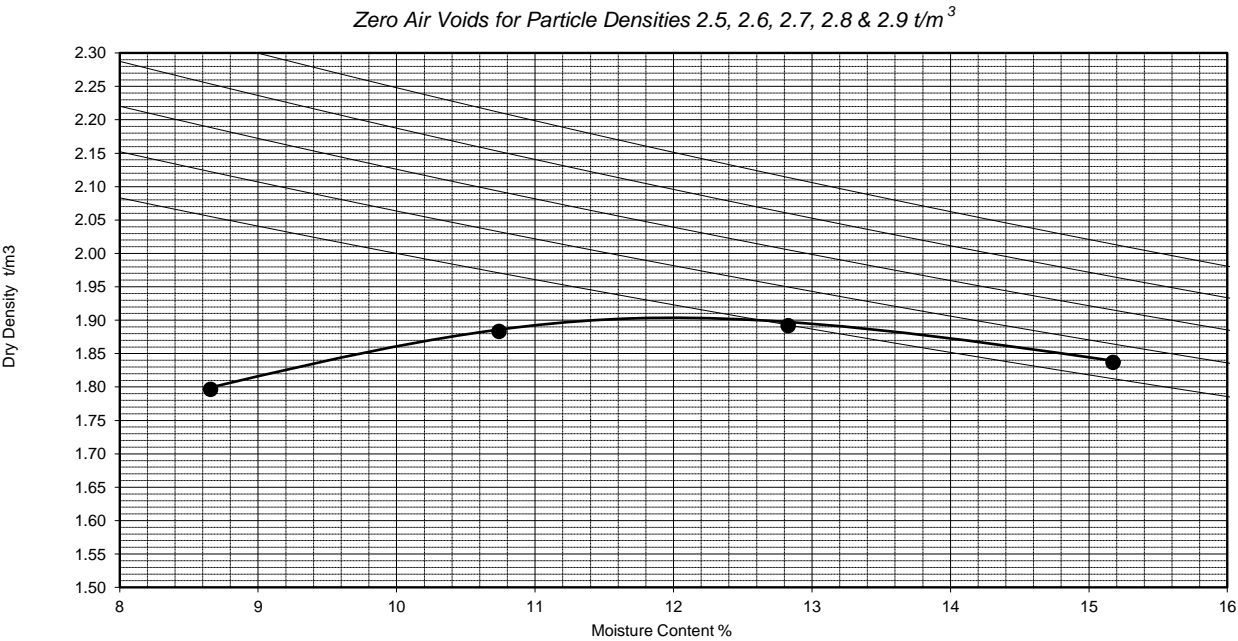
MDD	1.90	t/m ³	Adjusted MDD		t/m ³
OMC	12.0	%	Adjusted OMC		%
			Natural MC		%

- Based on the results of the standard compaction testing, the standard maximum dry density (SMDD) and optimum moisture content (OMC) of TP10, TP14 and TP116 are similar, approximately 1.75 t/m^3 and 16% to 17% respectively. The material sampled from TP2 presents the lowest SMDD (1.65 t/m^3) and highest OMC (20%). The material from TP86 and TP102 presents the highest SMDD (1.9 t/m^3) and lowest OMC (12%), which is typical of gravel and sand material.

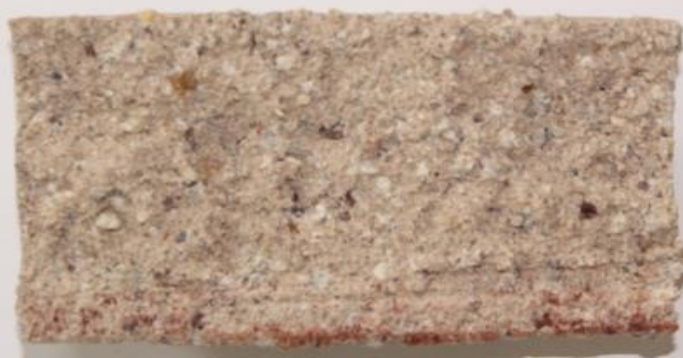
Client: Golder Associates Pty Ltd	Report No.: 14120770 - CU 100kPa
Project: 147645033 Allawuna Proposed Landfill Site	Test Date: 5/01/2015 Report Date: 16/01/2015
Client Id.: TP86 14441784	Depth (m): 2.00-6.00
Description: SILTY SAND- white

CLIENT:	Golder Associates Pty Ltd	
PROJECT:	147645033 Allawuna Proposed Landfill Site	AFTER TEST
LAB SAMPLE No.	14120770	DATE: 09 01 15
BOREHOLE:	TP86 14441784	DEPTH: 2.00-6.00

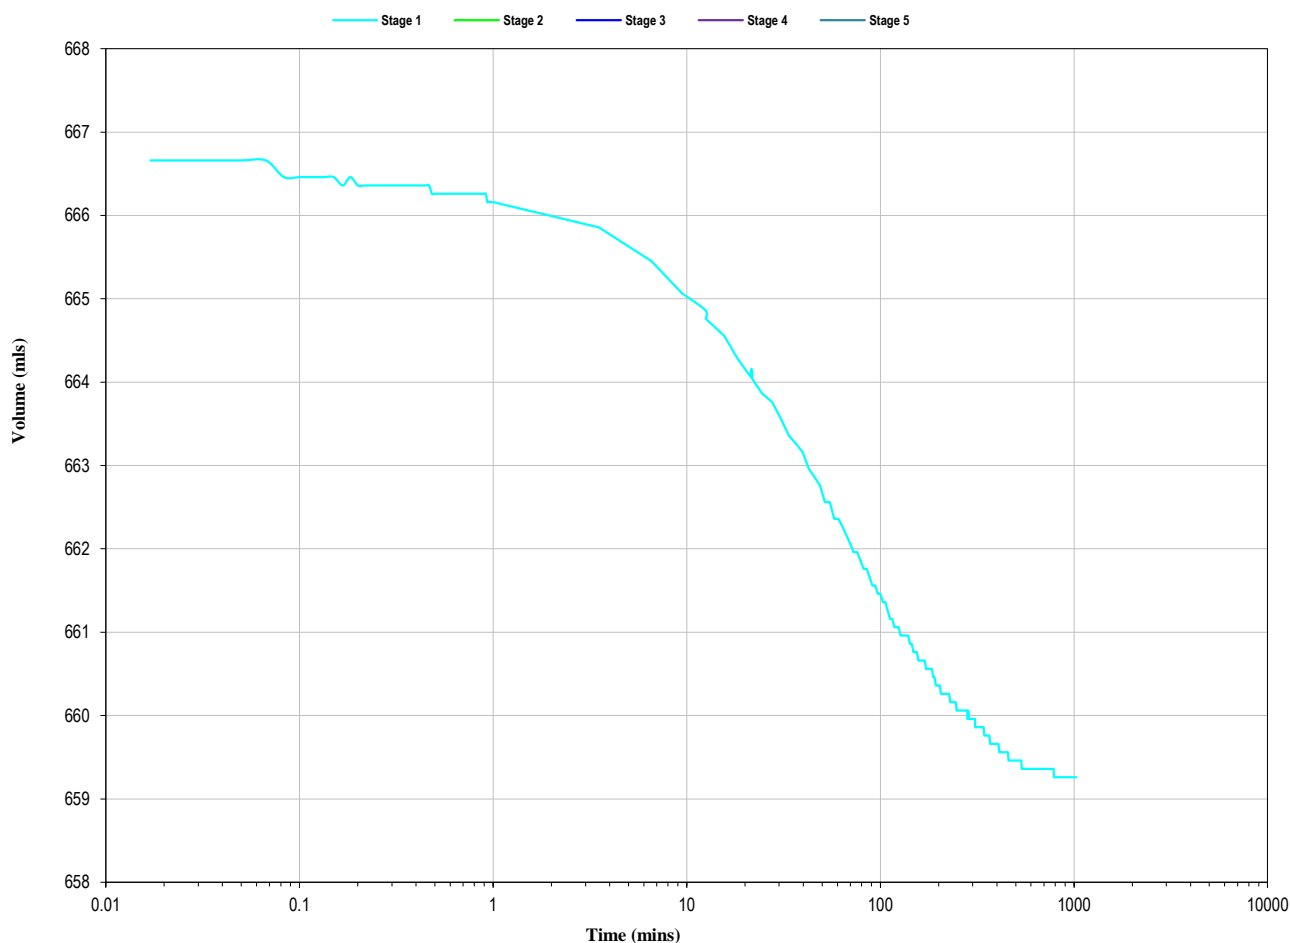
Volume v's Time (Log Scale)

Stage 1
Cv (m²/year) : 0.50
Mv (m²/MN) : 0.105
k (m/s) : 1.63E-11

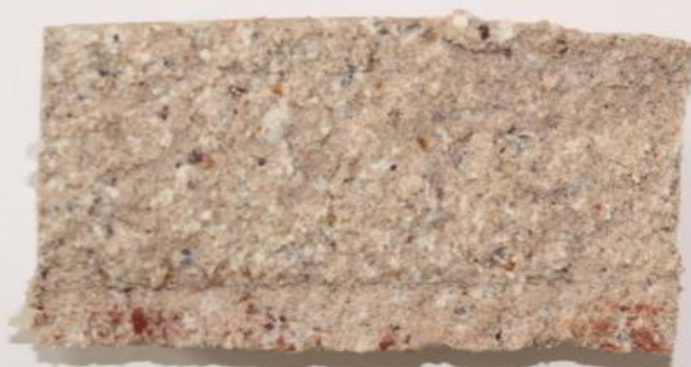
Client: Golder Associates Pty Ltd	Report No.: 14120770 - CU 250kPa
Project: 147645033 Allawuna Proposed Landfill Site	Test Date: 5/01/2015 Report Date: 16/01/2015
Client Id.: TP86 14441784	Depth (m): 2.00-6.00
Description: SILTY CLAY- white

CLIENT:	Golder Associates Pty Ltd	
PROJECT:	147645033 Allawuna Proposed Landfill Site	AFTER TEST
LAB SAMPLE No.	14120770	DATE: 08.01.15
BOREHOLE:	TP86 14441784	DEPTH: 2.00-6.00

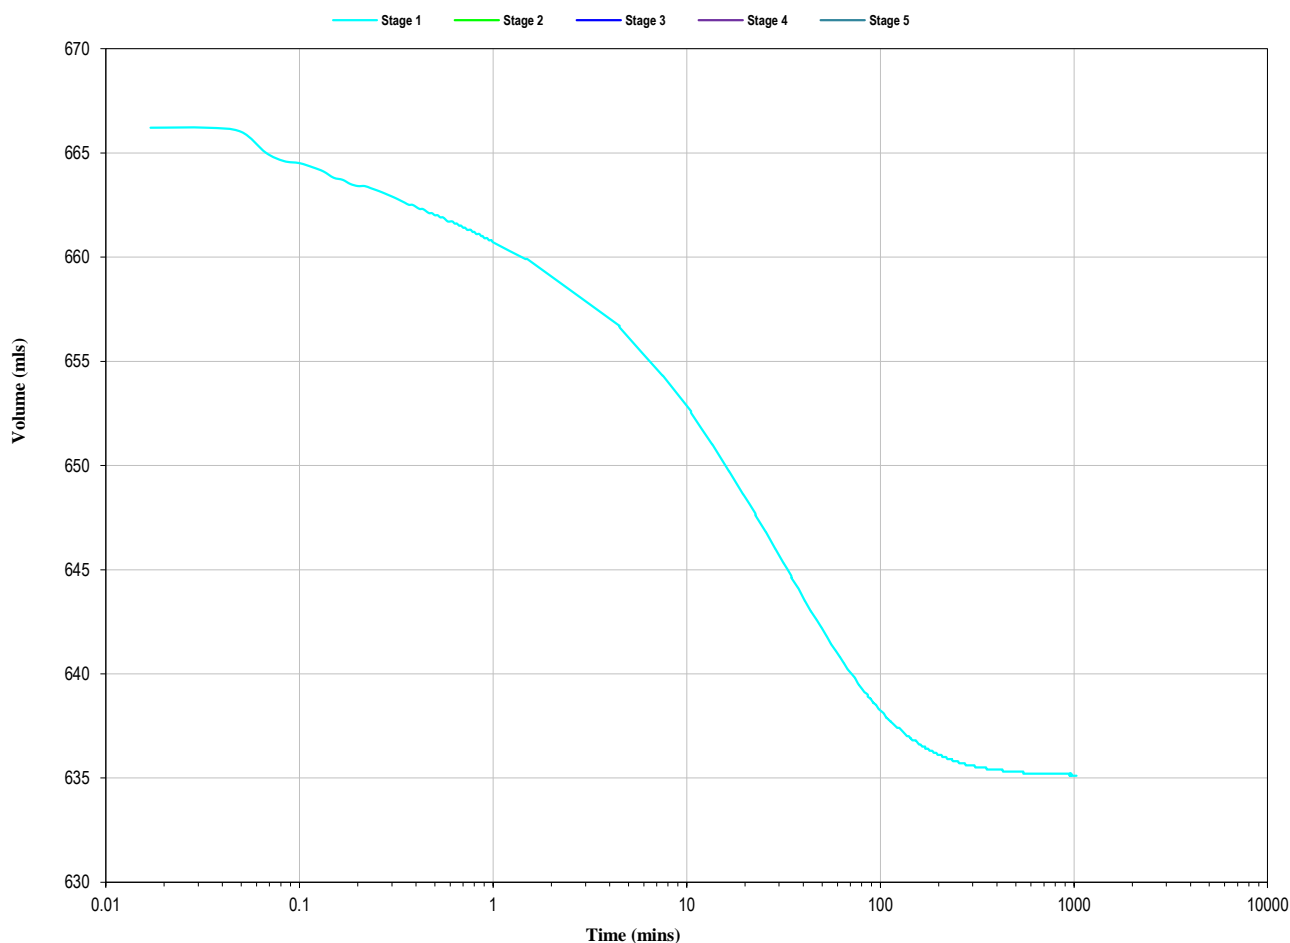
Volume v's Time (Log Scale)

Stage 1
Cv (m²/year) : 1.06
Mv (m²/MN) : 0.189
k (m/s) : 6.21E-11

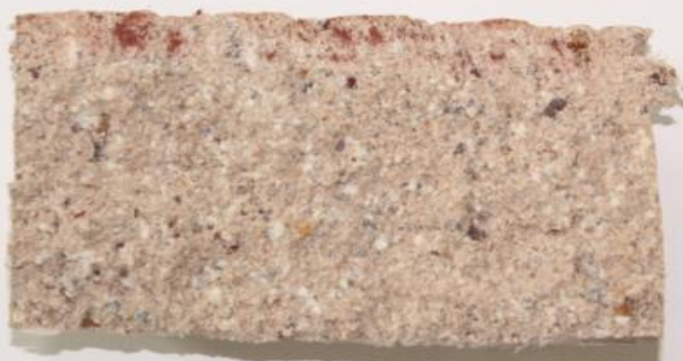
Client: Golder Associates Pty Ltd	Report No.: 14120770 - CU 500kPa
Project: 147645033 Allawuna Proposed Landfill Site	Test Date: 5/01/2015 Report Date: 16/01/2015
Client Id.: TP86 14441784	Depth (m): 2.00-6.00
Description: SILTY SAND- white

CLIENT:	Golder Associates Pty Ltd	
PROJECT:	147645033 Allawuna Proposed Landfill Site	AFTER TEST
LAB SAMPLE No.	14120770	DATE: 08.01.15
BOREHOLE:	TP86 14441784	DEPTH: 2.00-6.00

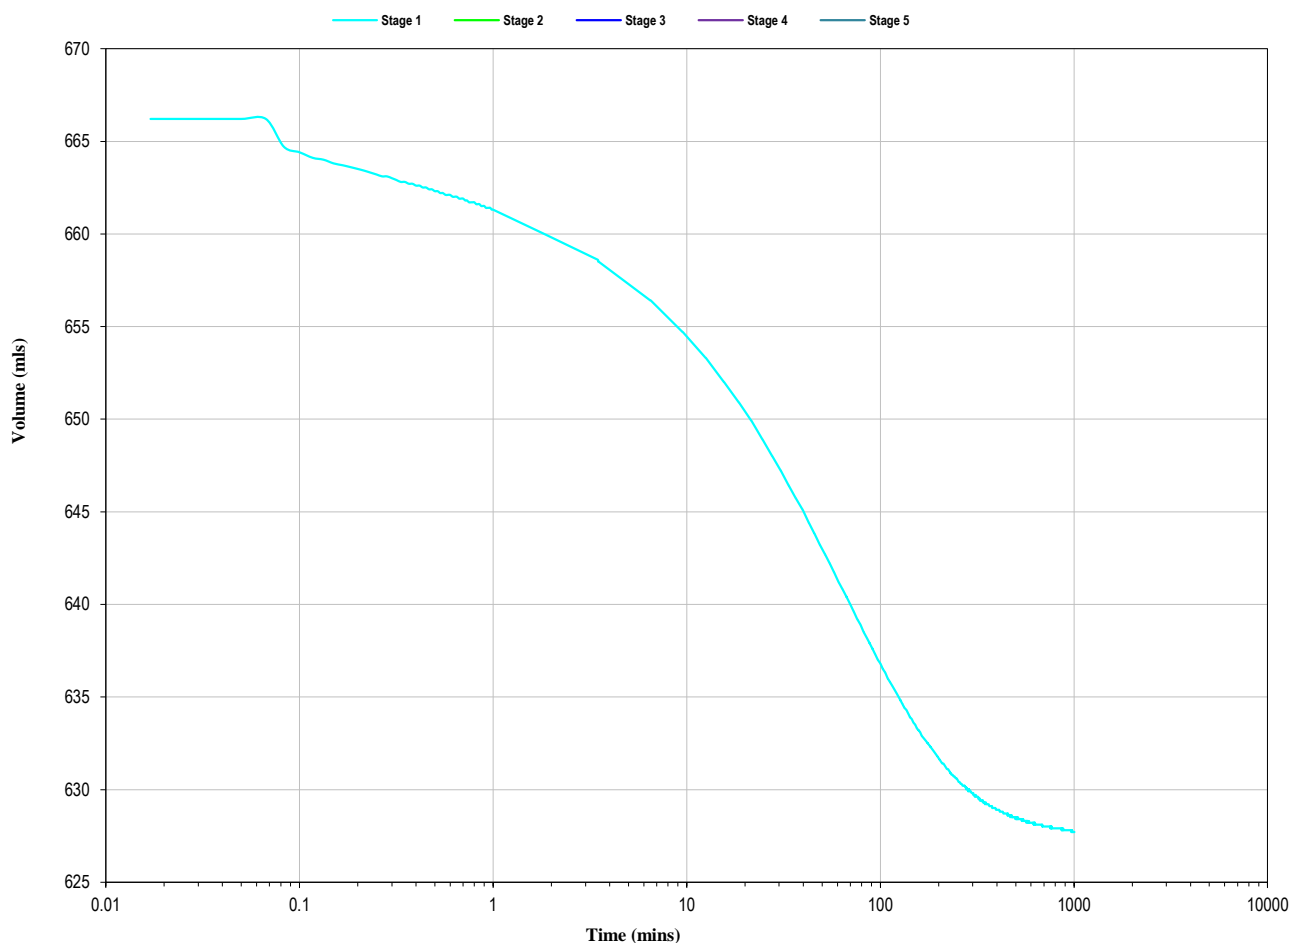
Volume v's Time (Log Scale)

Stage 1
Cv (m²/year) : 0.58
Mv (m²/MN) : 0.112
k (m/s) : 2.02E-11
