**REPORT ON:
GROUND WATER ASSESSMENT,
11 CHITTY ROAD,
TOODYAY, WA
DECEMBER 2014**

REPORT TITLE: **GROUND WATER ASSESSMENT, 11 CHITTY ROAD, TOODYAY,
WA.**

DATE: December 2014

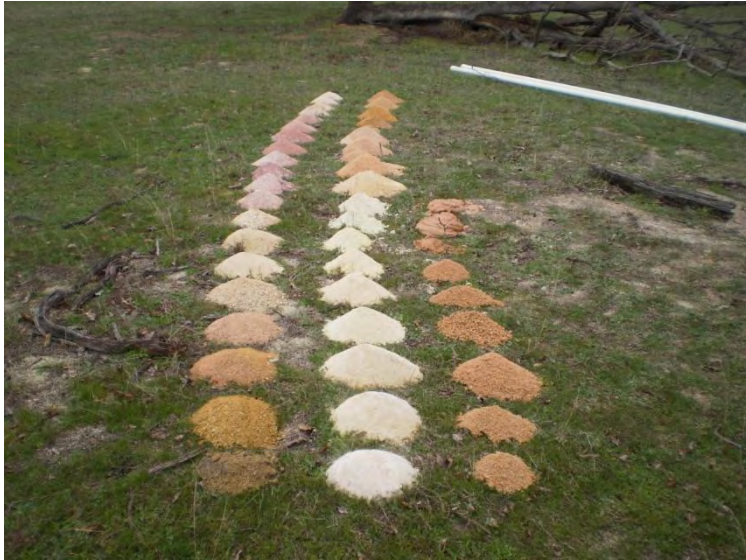
Photo plate 1 - Drill cuttings sampled at 1 m intervals. Water struck at 39 m depth.

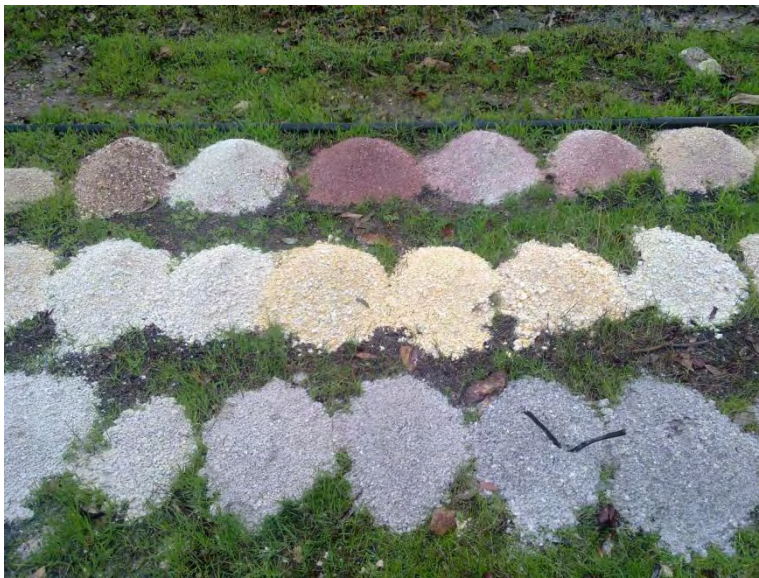
Photo plate 2 - cuttings sampled at 1 m intervals. Water struck at 44 m depth.

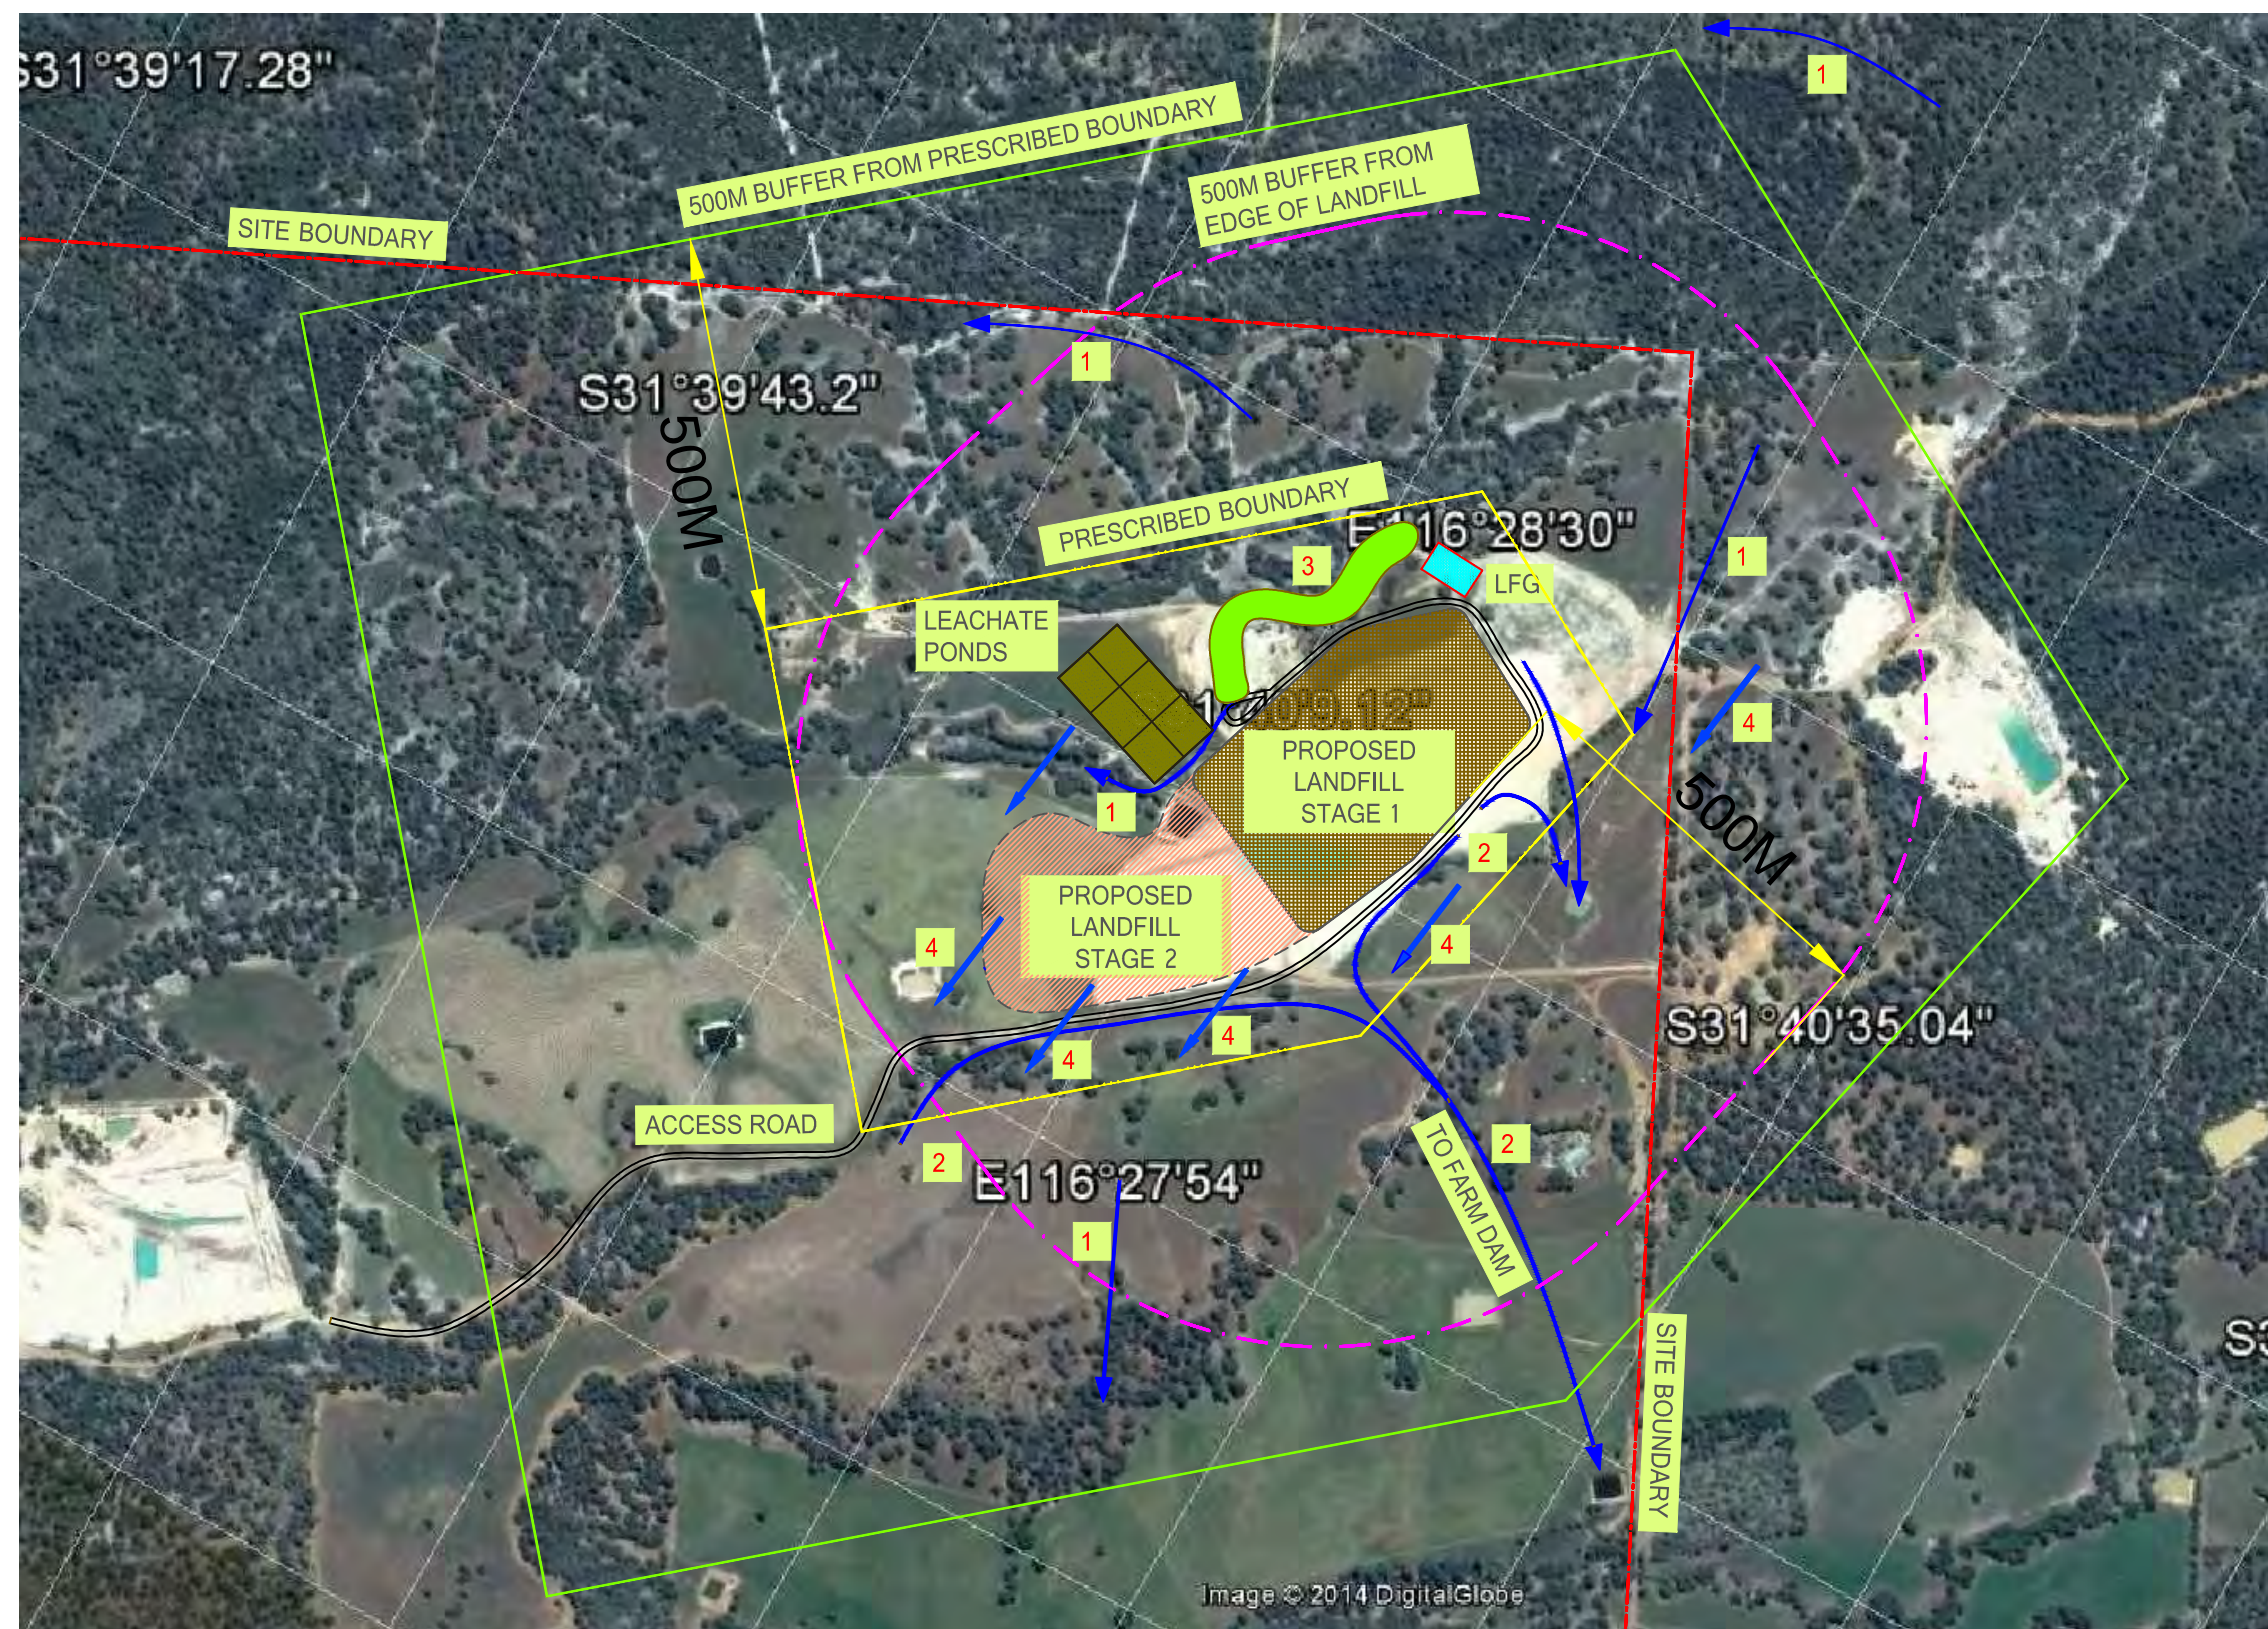
- 1 DENOTES SURFACE WATER FLOW DIRECTION
- 2 DENOTES SURFACE WATER CHANNELS FLOW DIRECTION
- 3 DENOTES VEGETATED SCREEN
- 4 DENOTES GROUND WATER FLOW DIRECTION

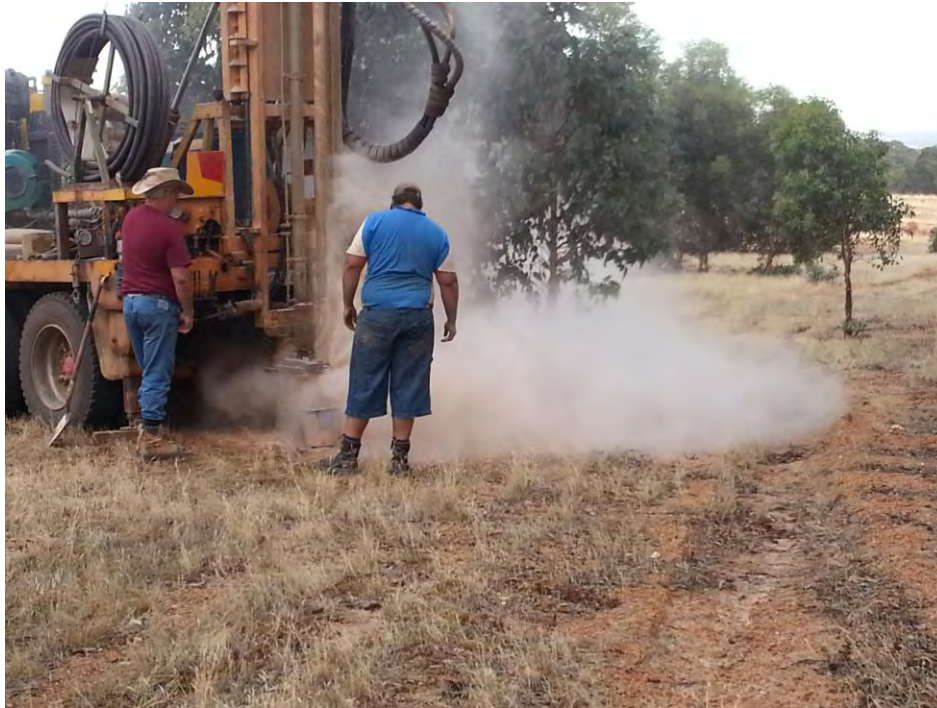
Drilling at depth showing dry conditions

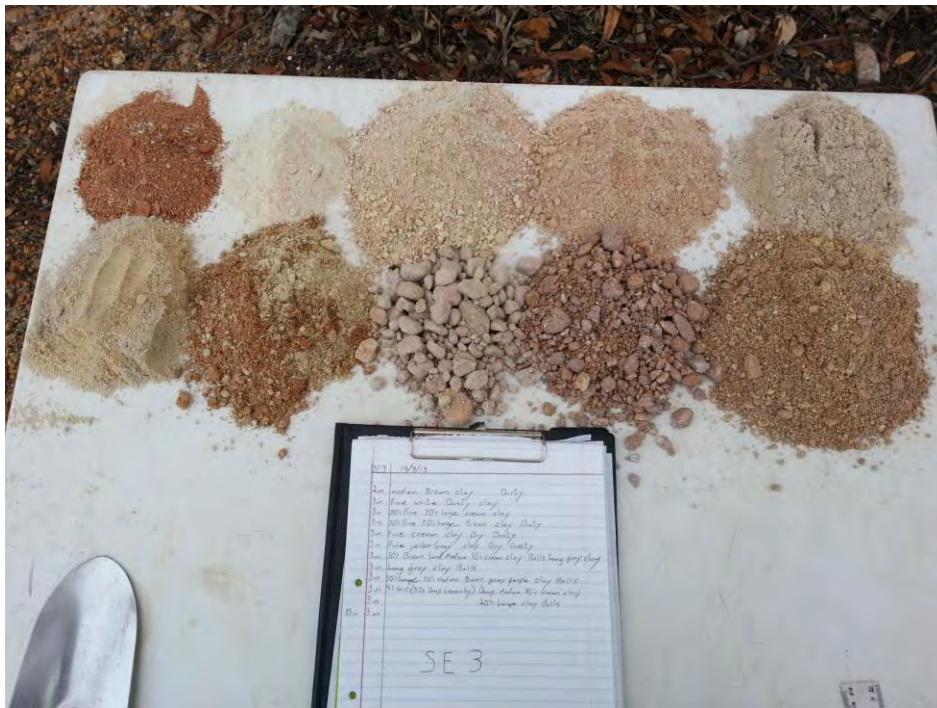
Bore logging

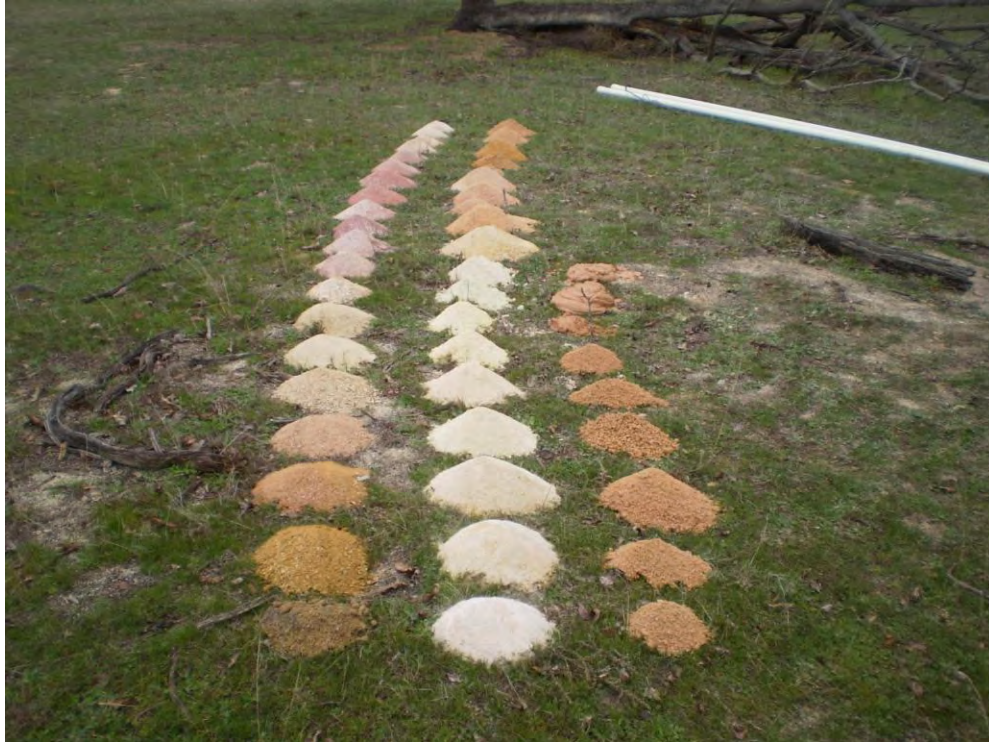
1 m interval sample record showing water intersected at the last 4 samples (46 m below the surface)
