[Document Number]

Revision 1.00

28/03/2025

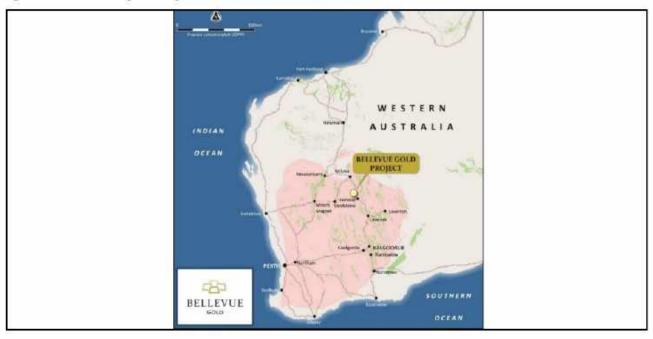
Figure 3: Bellevue Gold Project Locality

The BGP is situated approximately 40 km by road north of the town of Leinster and can be accessed from the Goldfields Highway. The project locality is presented in Figure 3. The proposed IWLTSF Stage 4 North (footprint in red outline) and Stage 4 South (footprint in green outline) configuration is presented in Figure 2.

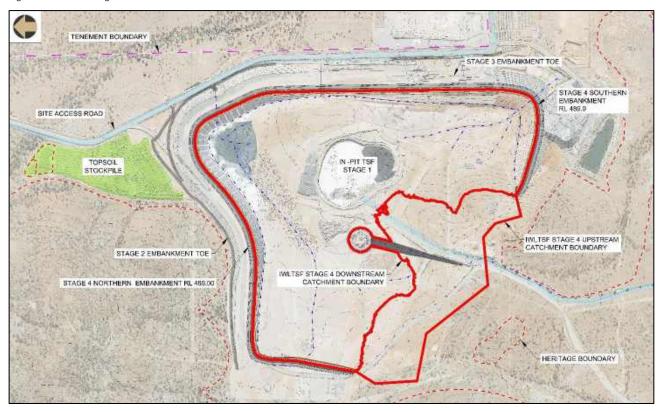
Figure 5: IWLTSF Stage 4 Total Catchment

The project site is sparsely vegetated, strewn with cobbles and gravel and sloping topography. An appropriate rational method runoff coefficient for sparsely vegetated areas with soils such as those observed for the upstream catchment of the IWLTSF would be approximately C = 0.5.

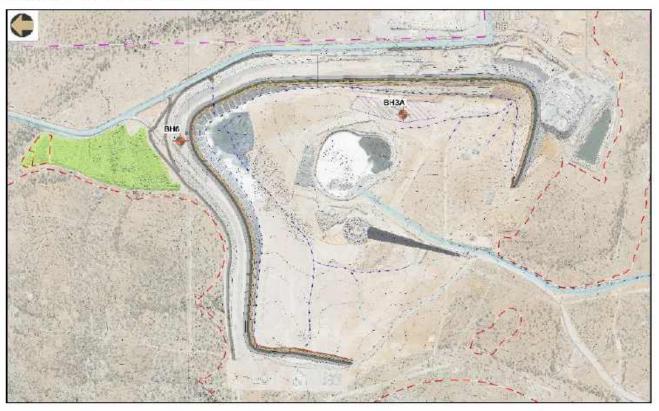
Figure 7: Diamond Core Borehole Locations (January 2021)

The diamond core borehole locations relative to the IWLTSF embankments are presented in Figure 7. A summary of the drilling works is presented in Table 9.

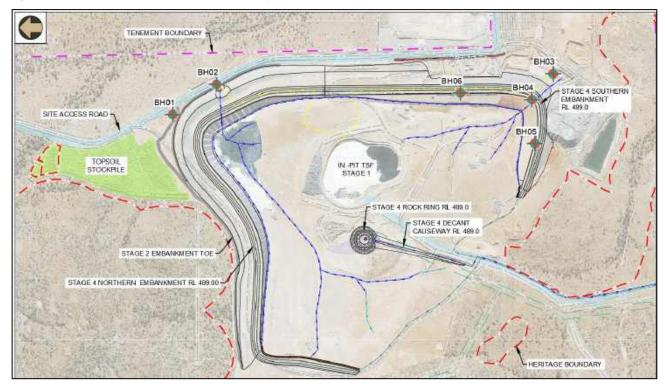
Figure 11: Borehole Locations (November 2024 - February 2025)

Based on the previous GSIs the typical sub-soil stratigraphy across the IWLTSF site is understood to comprises a surficial cover of transported colluvial soils, comprising unconsolidated surficial deposits dominated by sandy, gravelly and silty soil. Across parts of the IWLTSF storage basin, this layer is underlain by a surficial layer of weathered calcrete, occasionally interbedded with basalt. In other areas, the surficial cover of transported colluvial soils is directly underlain by a layer of near surface competent basalt rock formations comprising a mixture of cobbles and boulders.

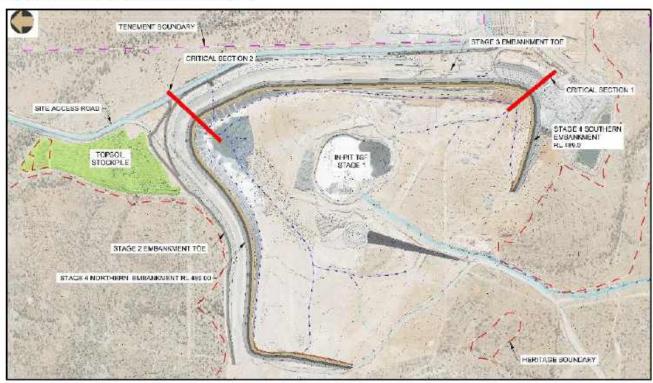
Figure 19: IWLTSF Stage 4 Critical Cross Section (Plan)

Two locations were assessed for seepage conditions on the Northeast and Southeast sides of the embankment, identified as critical sections where the embankment height is greatest. These sections are shown in Figure 19. The maximum embankment heights at the critical cross-sections 1 and 2 for IWLTSF Stage 4 are 27.0 m and 12.0 m, respectively. The selected cross-sections for seepage analysis are based on the geometries outlined in Section 4.7.2.5.

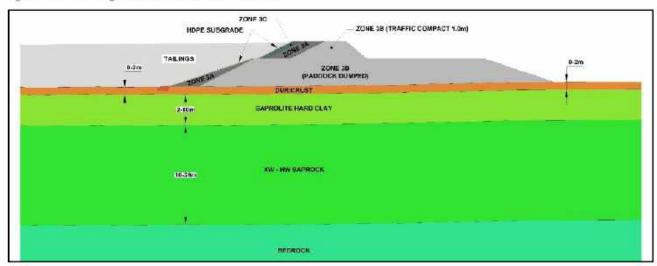
Figure 22: IWLTSF Stage 4 Critical Cross Section - Section 2

The stability model output figures are provided in Appendix G, and the predicted slope stability FoS for each case analysed along with the recommended minimum FoS for Section 1 and 2 are summarised in Table 40 and Table 41 respectively.

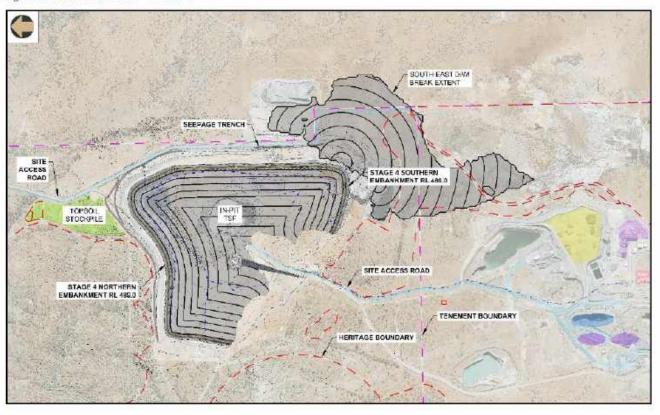
Figure 23: Dam Break Runout - Section 1

It should be noted that the runout distances and heights presented in Table 43 are numerically calculated and assume an uninterrupted flow path which does not take into consideration site specific topography or storage effects. Dam break runout modelling taking into consideration the surrounding topography based on the dam break volumes and calculations is shown in Figure 23 and Figure 24, representing the breach through IWLTSF southeast corner and northeast embankment breach scenarios respectively. The IWLTSF southeast corner dam break runout represents a runout length of 1.0 km at a runout slope of 1.5%. The IWLTSF Stage 4 northeast dam break runout represents a runout length of 800 m at a runout slope of 1.5%

Based on the Linear Method, the IWLTSF Stage 4 (full) during Sunny Day conditions could potentially release tailings which runout between 760 m to 1,180 m and 510 m to 860 from the south-eastern and north-eastern embankment respectively.

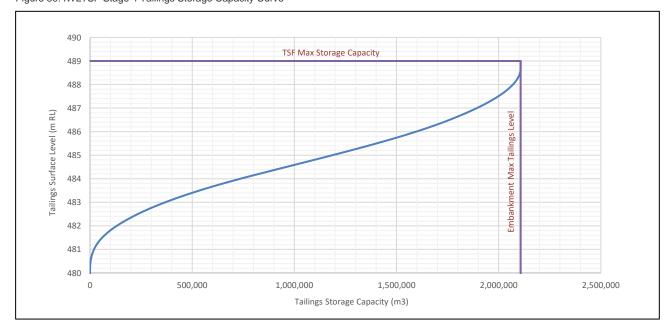
Figure 30: IWLTSF Stage 4 Tailings Storage Capacity Curve

Development (filling) of the IWLTSF Stage 4 is shown graphically on Figure 30 in terms of storage volume and tailings storage elevation.

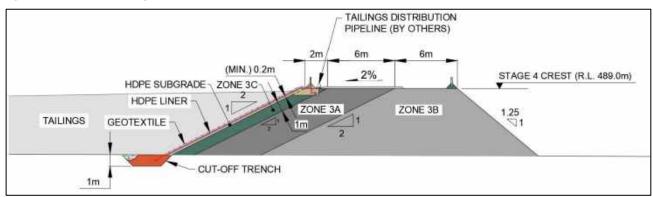
Figure 33: Cut-off Trench Configuration

The conditioning of the ground foundation using local earthy borrow (regolith) materials will help control seepage through the IWLTSF floor. The existing underdrainage network system, including the toe and finger drains, will be extended into Stage 4. This will aid in the consolidation of the deposited tailings, promote early water return, and minimise seepage.

Additionally, the installation of the embankment HDPE liner and underlying subgrade overlayed with a geotextile will mitigate seepage through the embankment. To ensure water-tightness, the Stage 4 HDPE liner will be welded to the Stage 2 and 3 HDPE liners at horizontal benches, creating a continuous embankment surface cover.

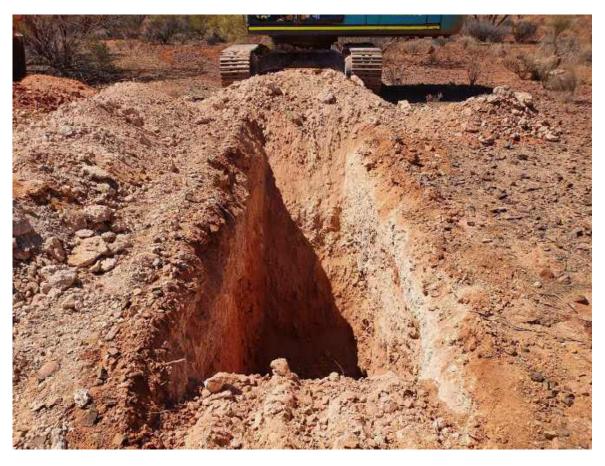
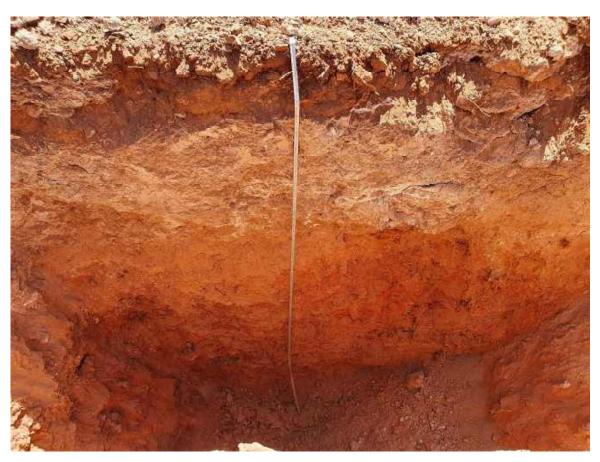
TSF - TP02

TEST PIT	L <mark>O</mark> G		
Job No:	P19-11-PR03	Date Started:	03-12-20
Test Pit ID:	TSF-TP02	Date Finished:	03-12-20
Contractor:	Earth Australia Contracting	Bucket Width:	1.5 m Tiger Toothed
Machine:	Kobelco SK350 LC 35-tonne Excavator	Essting:	51J 259006
Looned By:	JH .	Northing:	6942910

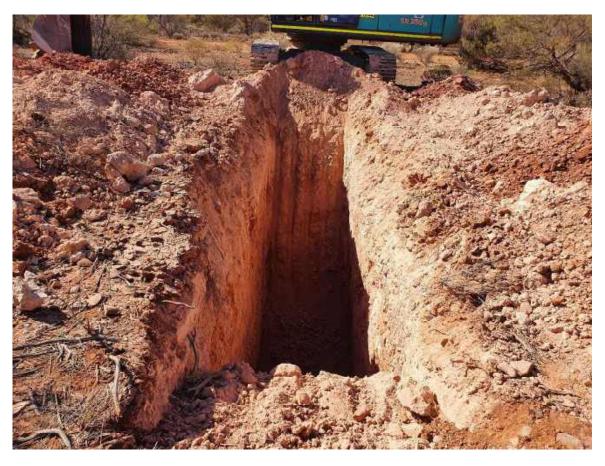
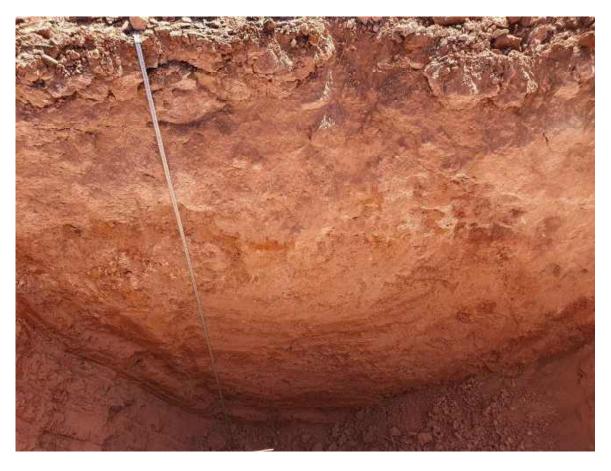
TSF - TP03

TEST PIT	L <mark>0</mark> G		
Job No:	P19-11-PR03	Date Started:	03-12-20
Test Pit ID:	TSF-TP03	Date Finished:	03-12-20
Contractor:	Earth Australia Contracting	Bucket Width:	1.5 m Tiger Toothed
Machine:	Kobelco SK350 LC 35-tonne Excavator	Easting:	51J 259184
Looned By:	JH .	Northing:	6942911

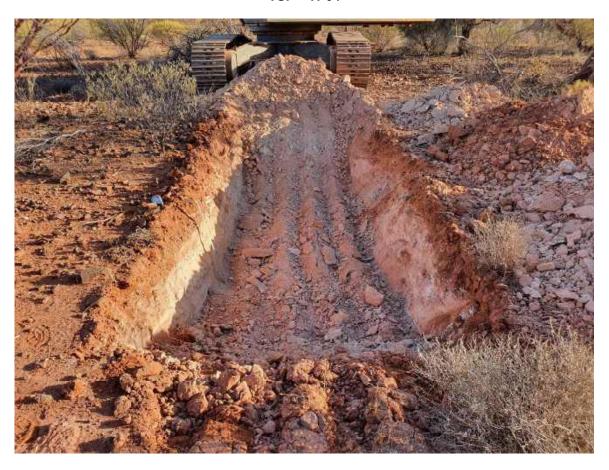
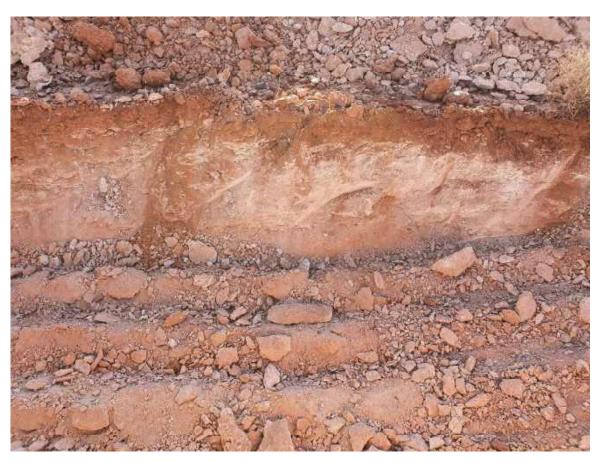
TSF - TP04

TEST PIT	L <mark>0</mark> G			
Job No:	P19-11-PR03	Date Started:	02-12-20	
Test Pit ID:	TSF-TP04	Date Finished:	02-12-20	
Contractor:	Earth Australia Contracting	Bucket Width:	1.5 m Tiger Toothed	
Machine:	Kobelco SK350 LC 35-tonne Excavator	Easting:	51J 259353	\Box
Loaned Day		Morthing	E043000	T

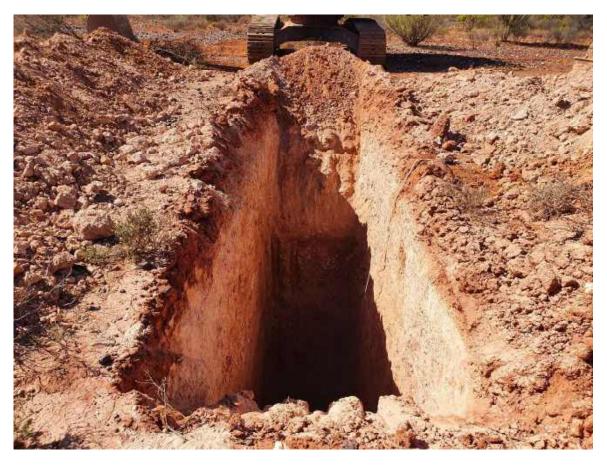
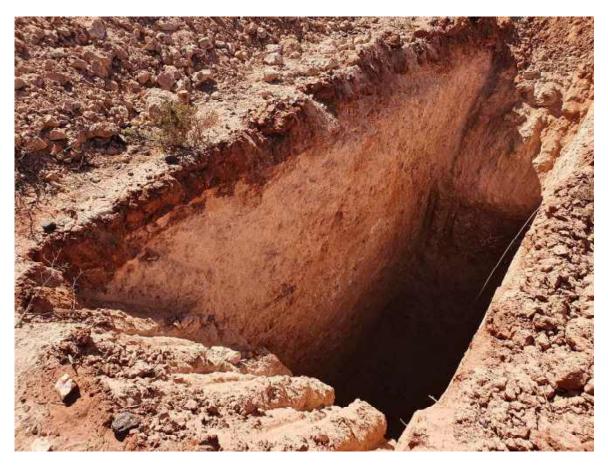
TSF - TP05

TEST PIT	L <mark>0</mark> G		
Job No:	P19-11-PR03	Date Started:	04-12-20
Test Pit ID:	TSF-TP05	Date Finished:	04-12-20
Contractor:	Earth Australia Contracting	Bucket Width:	1.5 m Tiger Toothed
Machine:	Kobelco SK350 LC 35-tonne Excavator	Easting:	51J 259618
Logged By:	JB	Northing:	6942876

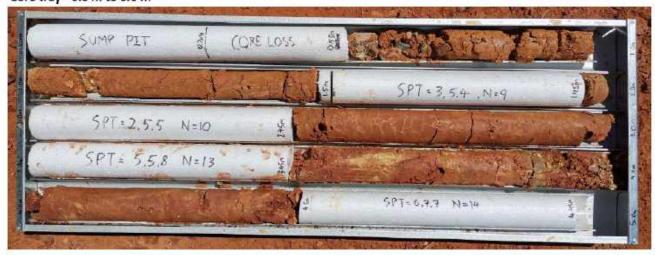
Core tray - 0.0 m to 5.0 m

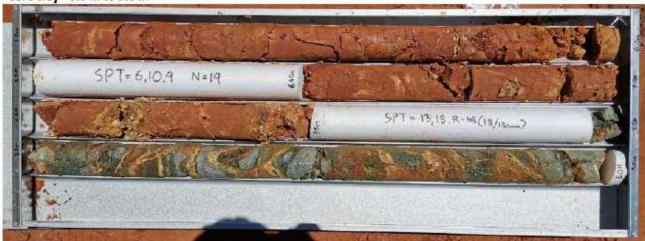
Core tray - 5.0 m to 9.0 m

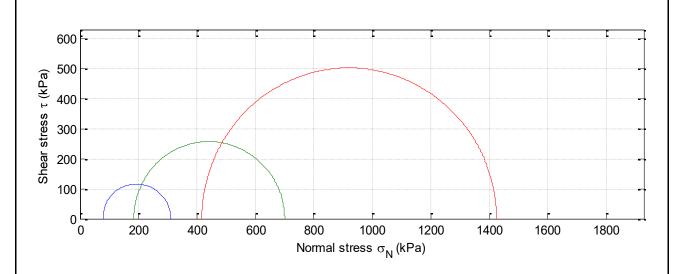
Mohr Circle Diagram

Interpretation from Mohr Circle:	Stages 1 / 2	Stages 1/3	Stage 2/3
Cohesion C' (kPa):	6.46	15.15	36.38
Angle of Shear Resistance Φ' (Degrees):	34.99	32.21	30.96

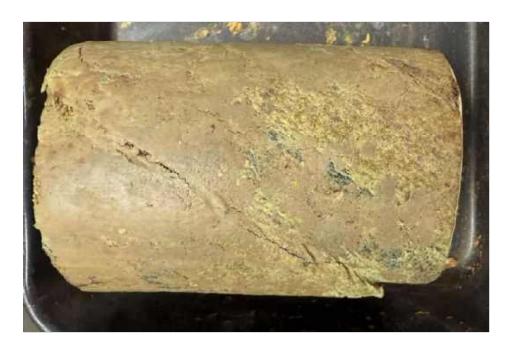
Lab ID:
 BH01-CB1_CU3
 Date Tested:
 05/02/2025

Failure Mode: Intact Shear 32.6 °

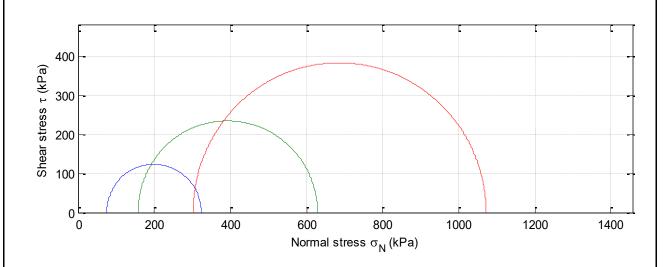
Mohr Circle Diagram

Interpretation from Mohr Circle:	Stages 1 / 2	Stages 1/3	Stage 2 / 3
Cohesion C' (kPa):	11.68	21.17	42.72
Angle of Shear Resistance Φ' (Degrees):	35.37	32.21	30.54

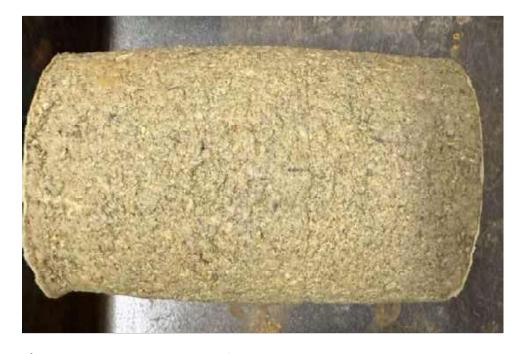
Sample ID:
 BH01-CB3
 Depth (m):
 8.60 - 8.80

Failure Mode: Bulging N/A °

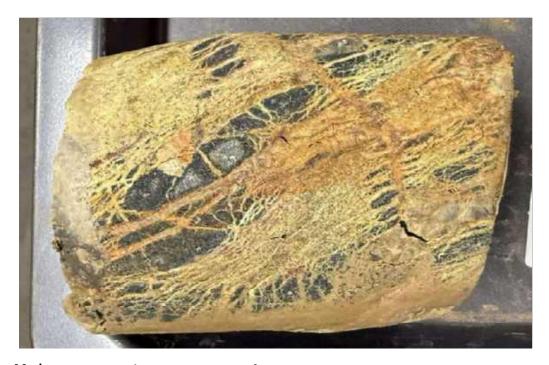
Lab ID:
 BH01-CB5_CU3
 Date Tested:
 05/02/2025

Failure Mode: Intact Shear 38.6 °

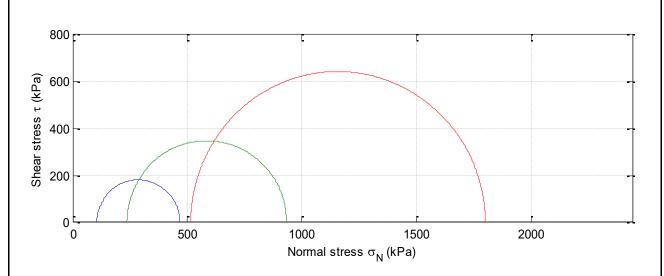
Mohr Circle Diagram

Interpretation from Mohr Circle:	Stages 1 / 2	Stages 1/3	Stage 2 / 3
Cohesion C' (kPa):	24.96	34.13	54.02
Angle of Shear Resistance Φ' (Degrees):	33.82	31.80	30.96

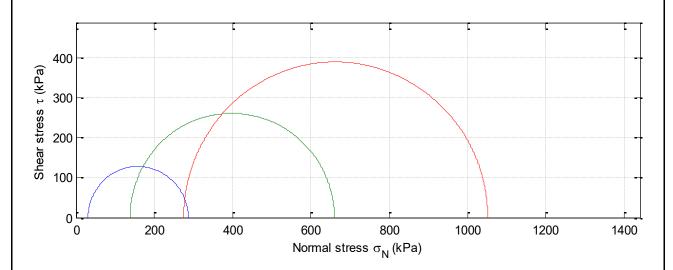
Mohr Circle Diagram

Interpretation from Mohr Circle:	Stages 1 / 2	Stages 1/3	Stage 2/3
Cohesion C' (kPa):	47.92	53.59	78.37
Angle of Shear Resistance Φ' (Degrees):	33.82	30.96	28.81

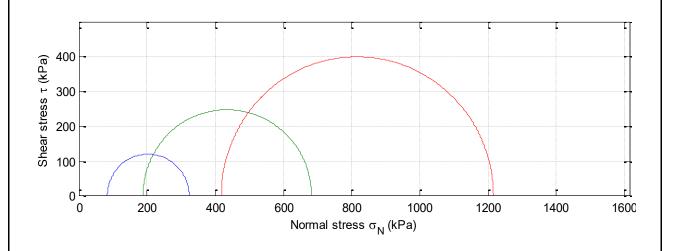
Mohr Circle Diagram

Interpretation from Mohr Circle:	Stages 1 / 2	Stages 1/3	Stage 2 / 3
Cohesion C' (kPa):	9.16	30.49	81.24
Angle of Shear Resistance Φ' (Degrees):	33.42	27.02	23.27

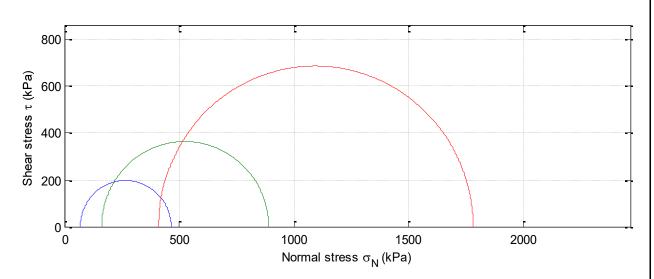
Mohr Circle Diagram

Interpretation from Mohr Circle:	Stages 1 / 2	Stages 1 / 3	Stage 2/3
Cohesion C' (kPa):	35.24	50.83	81.50
Angle of Shear Resistance Φ' (Degrees):	39.69	36.13	34.22

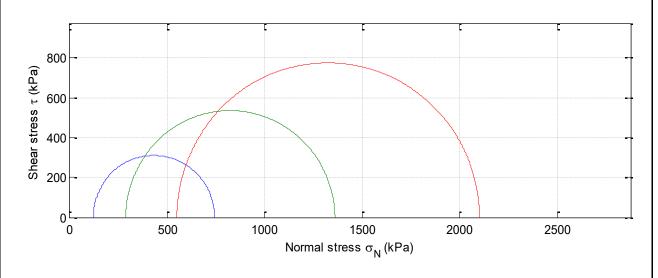
Mohr Circle Diagram

Interpretation from Mohr Circle:	Stages 1 / 2	Stages 1/3	Stage 2/3
Cohesion C' (kPa):	77.49	101.28	161.14
Angle of Shear Resistance Φ' (Degrees):	34.99	31.38	28.37

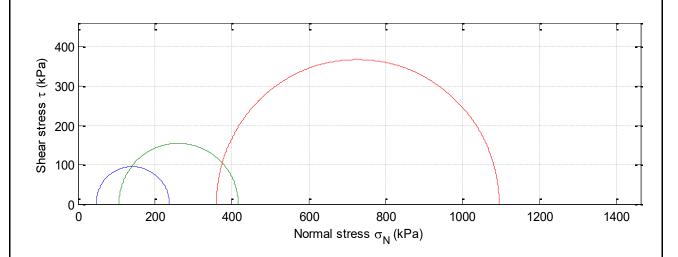
Mohr Circle Diagram

Interpretation from Mohr Circle:	Stages 1 / 2	Stages 1/3	Stage 2/3
Cohesion C' (kPa):	28.31	33.03	39.78
Angle of Shear Resistance Φ' (Degrees):	29.68	27.92	27.02

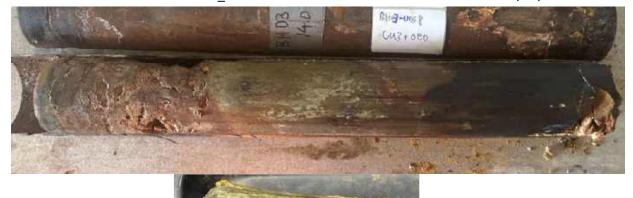
Sample ID:
 BH03-UDS08
 Depth (m):
 14.00 - 14.45

Failure Mode: Intact Shear 42.5 °

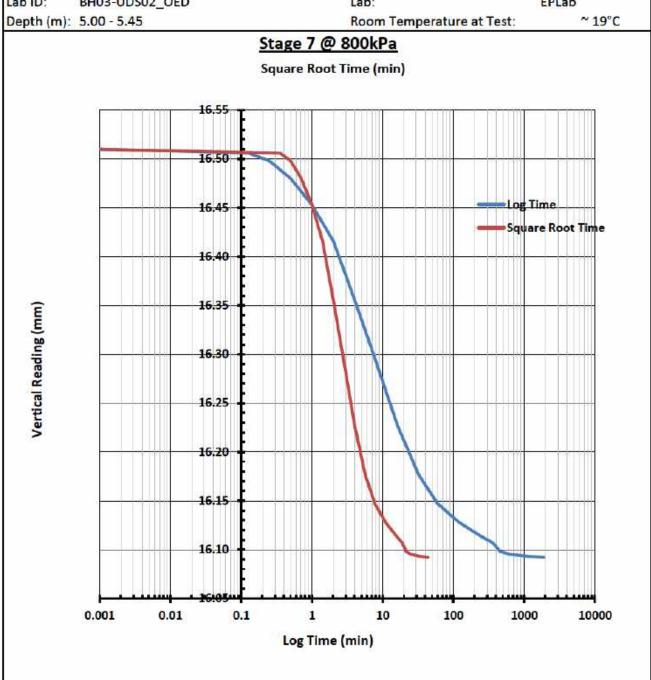
Sample ID: BH03-UDS02

Method: AS1289 6.6.1 / Inhouse Method

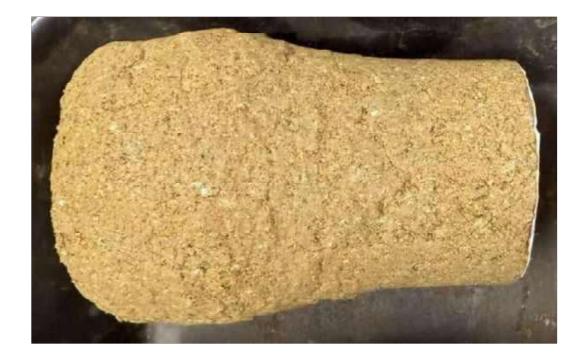
Sample ID:
 BH01-CB1
 Depth (m):
 2.00 - 3.00

Failure Mode: Bulging Failure

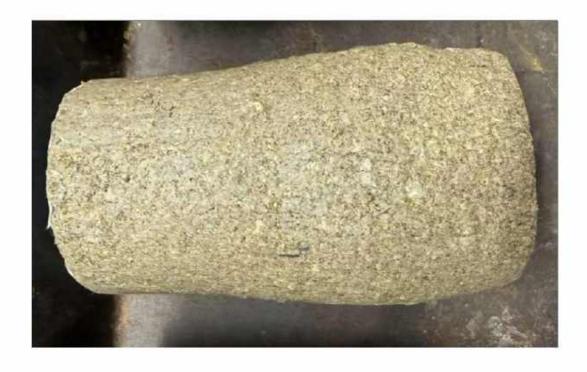
Depth (m): Sample ID: BH01-CB3 8.60 - 8.80 Lab ID: BH01-CB3_UU **Date Tested:** 08/02/2025

Failure Mode: Bulging Failure

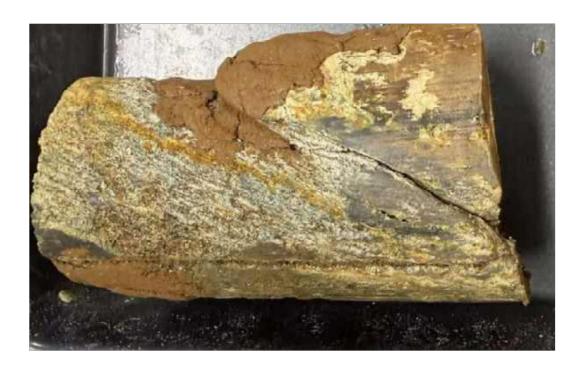
Sample ID:
 BH01-UDS02
 Depth (m):
 4.95 - 5.30

Failure Mode: Intact Shear @ 26.5°

Notes: Sample extruded from Shelby Tube

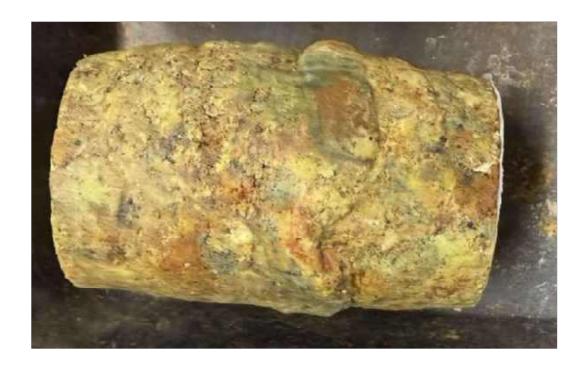
Sample ID:
 BH02-UDS02
 Depth (m):
 9.50 - 9.79

Failure Mode: Intact Shear @ 24.7°

Notes: Sample extruded from Shelby Tube

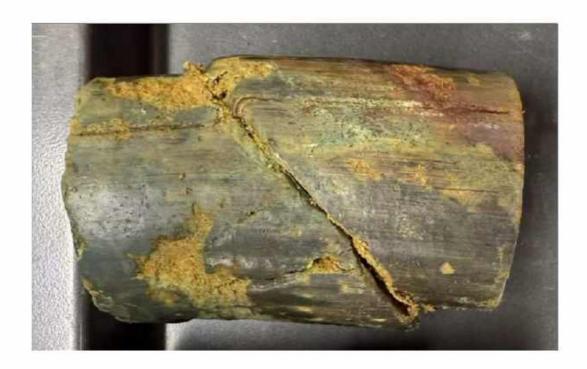
Lab ID:
 BH02-UDS03_UU
 Date Tested:
 08/02/2025

Failure Mode: Intact Shear @ 46.1°

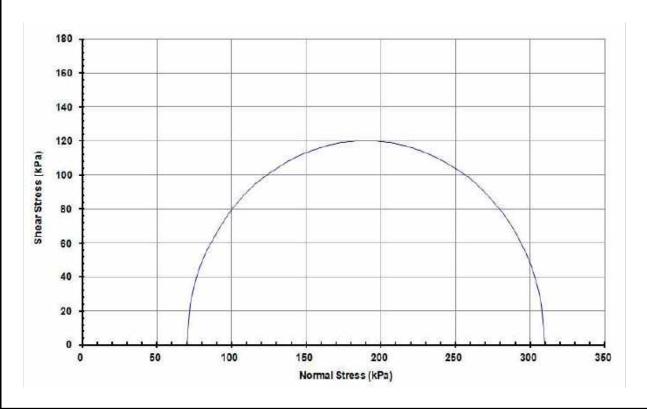
Mohr Circle Diagram (Effective Stress)

Interpretation from Mohr Circle: Stage 1 & 2 Stage 1 & 3 Stage 2 & 3

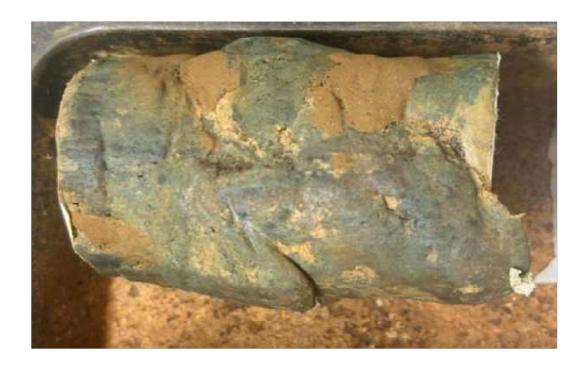
12.50 - 12.95 Sample ID: BH02-UDS04 Depth (m): Lab ID: BH02-UDS04_UU **Date Tested:** 08/02/2025

Failure Mode: Intact Shear @ 29°

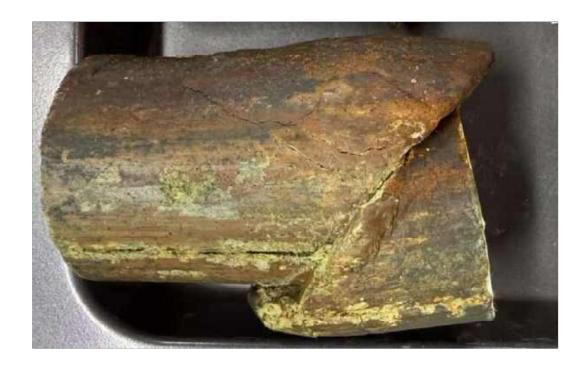
Lab ID:
 BH02-UDS05_UU
 Date Tested:
 08/02/2025

Failure Mode: Intact Shear @ 37.3°

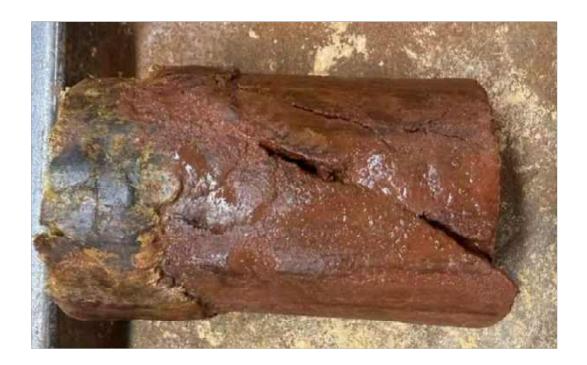
Lab ID:
 BH03-UDS02_UU
 Date Tested:
 12/02/2025

Failure Mode: Intact Shear @ 35.8°

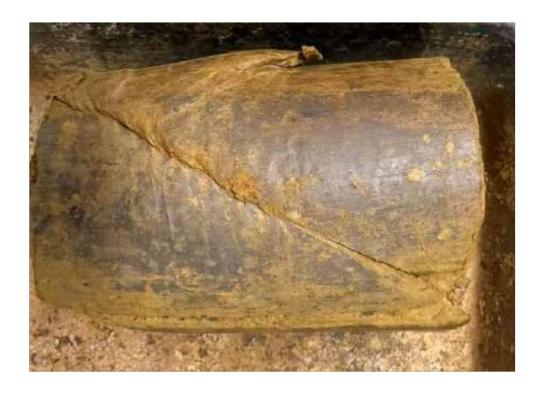
Lab ID:
 BH03-UDS04_UU
 Date Tested:
 12/02/2025

Failure Mode: Intact Shear @ 36.6°

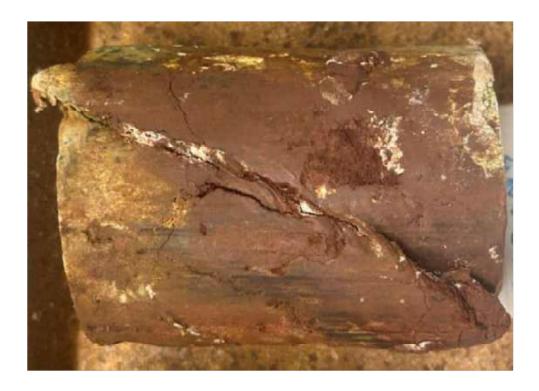
Sample ID: BH03-UDS06 Depth (m): 11.00 - 11.25 Lab ID: BH03-UDS06_UU **Date Tested:** 12/02/2025

Failure Mode: Intact Shear @ 32.5°

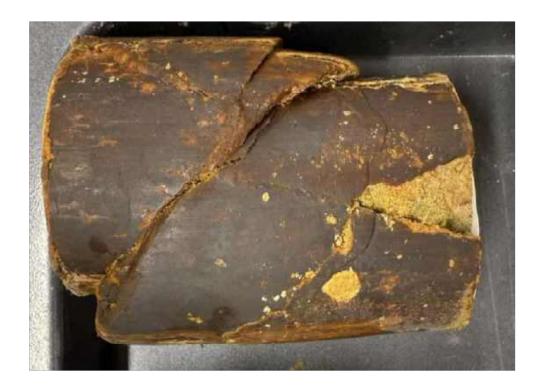
Lab ID:
 BH03-UDS08_UU
 Date Tested:
 12/02/2025

Failure Mode: Intact Shear @ 37.6°
