Siberia Gold Operations

Prescribed Premise Licence Application

Category 6 – Mine Dewatering

Sand King to Palmerston, Bewick and Missouri Open Pits

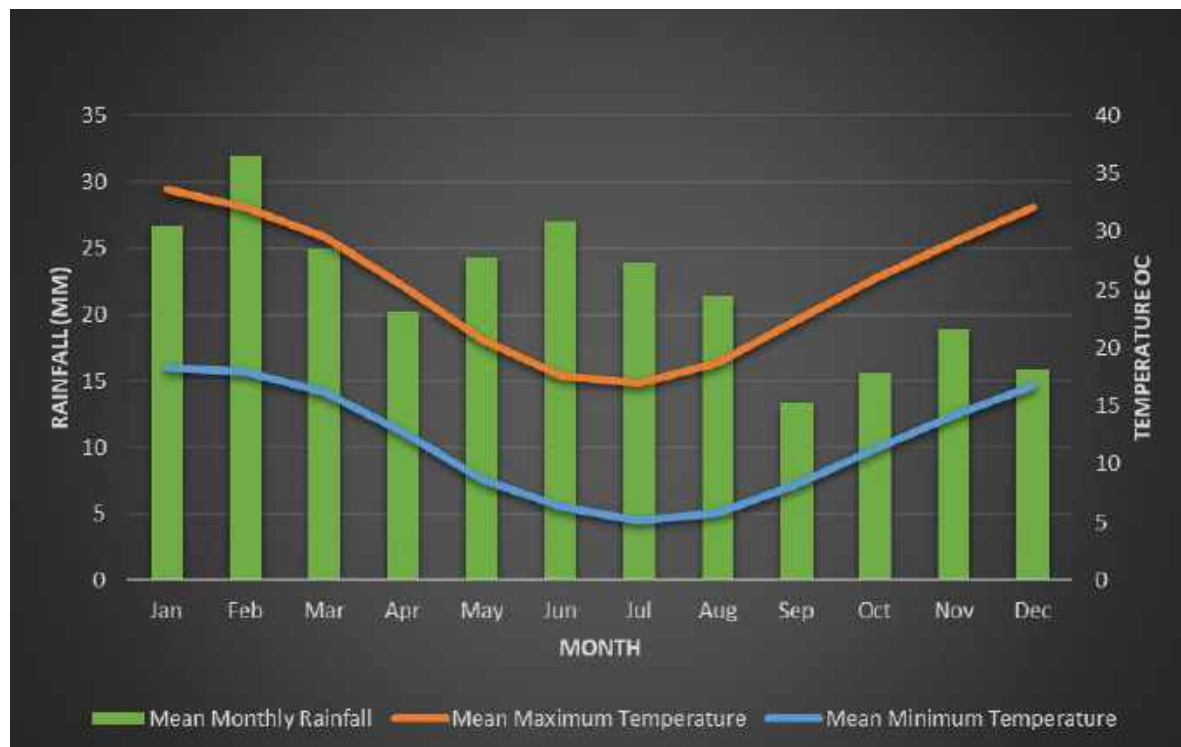
Figure 3: Mean Temperature Range and Rainfall for Kalgoorlie Boulder Airport (BOM 12038) 1939-2023

The driest period of the year is August to December. Semi-arid areas commonly experience dry periods for 4 – 6 months per year. The climatic conditions were drier in 2022 and 2023, with below average rainfall recorded.

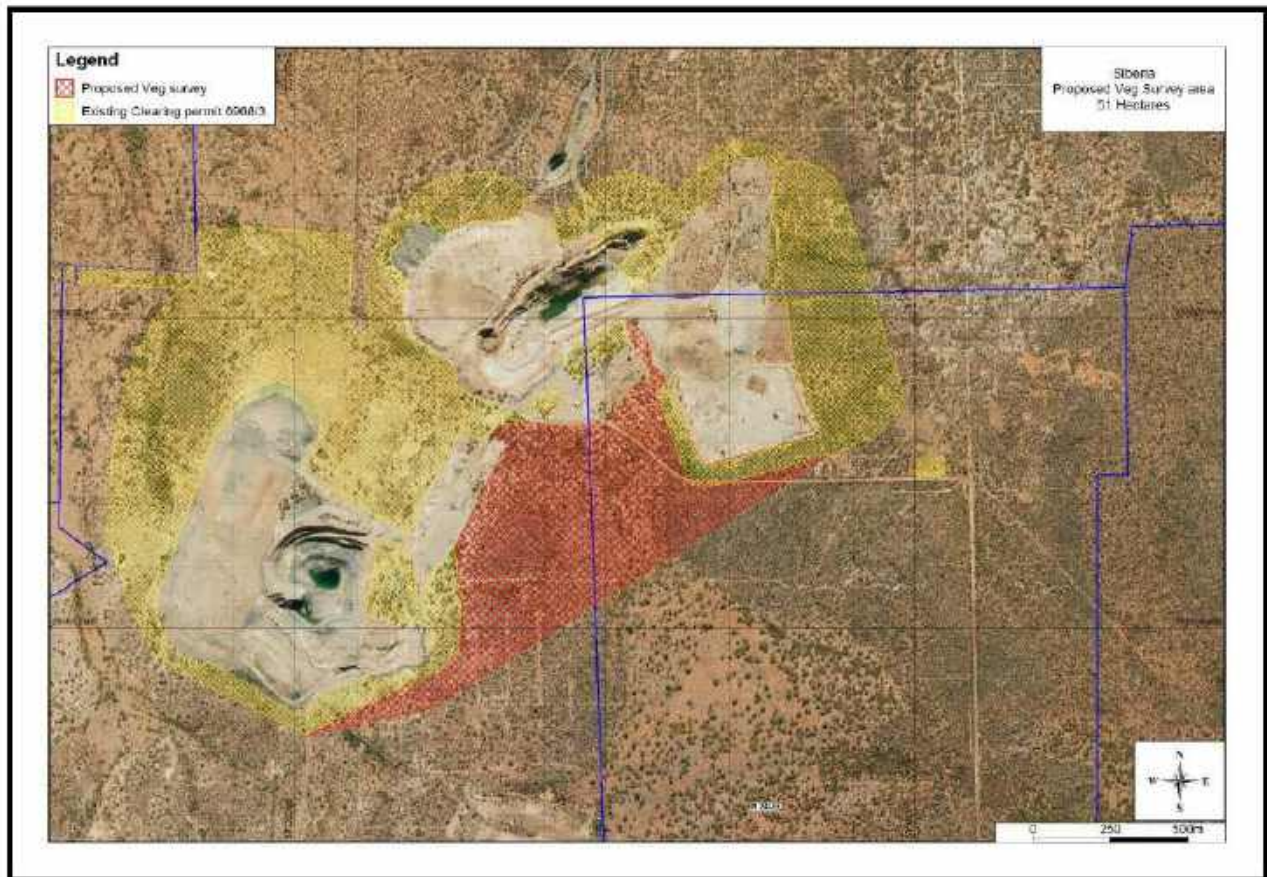
Figure 2: Siberia mining proposal environmental survey area. The Missouri pit is located west of the proposal (red highlighted area) and the Sand King waste dump is located on the NE side.

The mine complex is located 20 km north west of Orabanda, east of the Davyhurst – Orabanda Road (Figures 1 & 2) on unallocated crown land (UCL) within the boundary of Mt Burgess Station. The area to be impacted (the Project Development Area - PDA or Proposal) is mostly located on the south eastern side of the current disturbance area, between Sand King waste dump and Missouri pit and is adjacent to an existing haul road and administration area. Smaller infrastructure areas totalling 4.75 ha (Figure 8) are located around the Camperdown Pit and the proposed Contractor laydown. The Proposal is located within mining tenements M24/ 290, M24/ 39 and L24/224. A flora and vegetation assessment of the site is required for environmental impact assessment (EIA) under Part IV of the *Environmental Protection Act 1986* (EP Act). A Technical Guidance for Flora and Vegetation surveys for EIA was published by the EPA in 2016 under which a targeted survey was deemed appropriate to address the objectives of the survey (EPA 2016). The proposal covers an area of 53 ha, 48.25 ha of which occurs in the environmental survey area (ESA) of 52 ha (Figure 2).

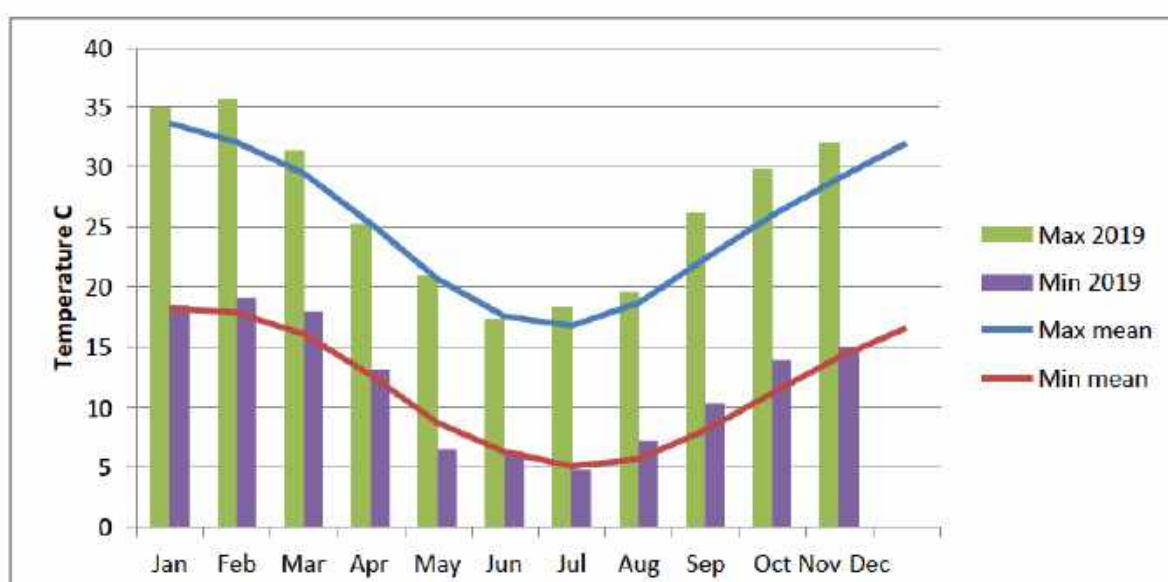
Figure 4: Mean monthly maxima and minima temperatures recorded at Kalgoorlie with the long term means.

The highest maximum temperatures occur during the summer with the long term mean January temperature of 33.7°C (Figure 4). The coolest month is July with a long term mean monthly maximum of 16.8°C. The mean monthly maximum temperatures recorded during January to March 2019 were all above average, followed by a slightly cooler than average autumn and warmer than average winter/spring period. Minimum temperatures have also been above average for much of the year with the exception of May to July. The overall interpretation of the climate in 2019 was warmer and drier than average.

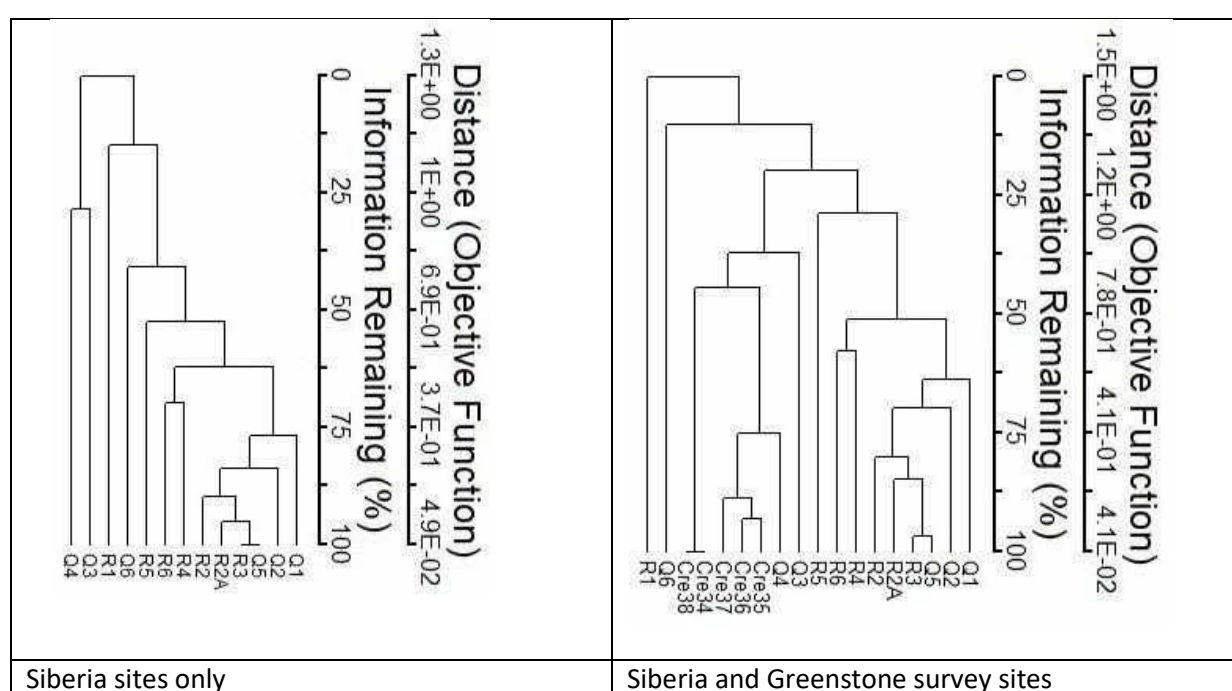
Figure 7: Dendrograms produced from two way Bray-Curtis cluster analysis of the Siberia sites; and the Siberia sites against some of the DPAW Credo Greenstone survey sites. Siberia Q4 was statistically the closest to the Credo surveys.

The Greenstone survey sites (Cre34 – 38) are located 14 to 16 km south west of the proposal with sites 34 and 35 on ultramafic greenstone, and 36, 37 and 38 on mafic greenstone. Siberia Q4 has a similarity within 75 % to Credo sites 35, 36 and 37 (Community 4 - open forests to open woodlands of *Eucalyptus* spp). Due to the high levels of impacts on some of the areas it is likely that some species are absent from the proposal area.

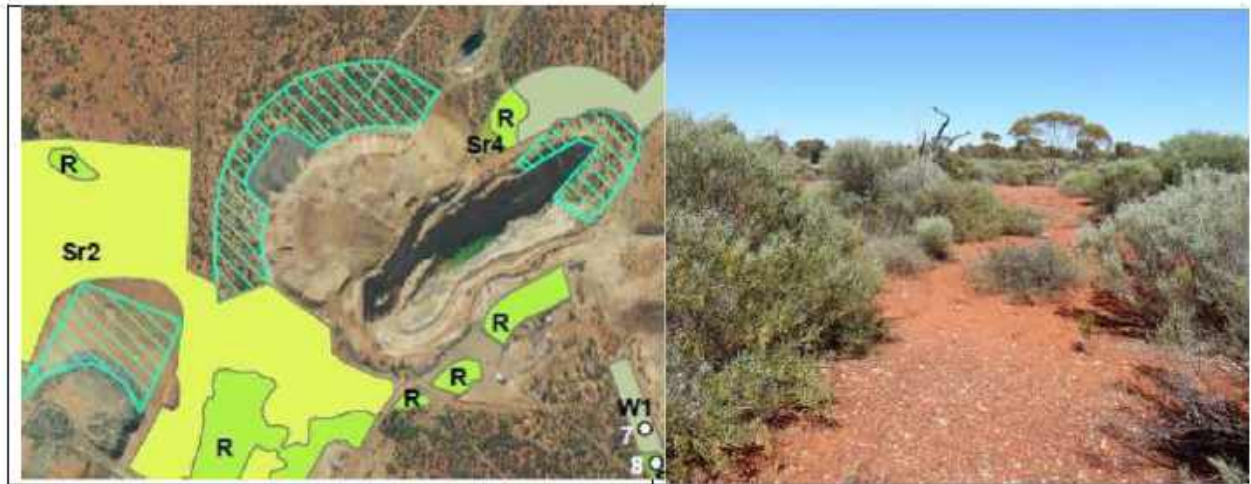
Figure 9: Vegetation mapping undertaken by PLEC in the northern area of the Siberia site. Site A is located adjacent to areas mapped as plant community SR2 and likely to support similar vegetation.

An updated clearing proposal was received from OBM in March 2020 (Figure 8) which proposes to impact 53 ha on the southern side of the mining proposal, which includes 52 ha of the ESA and 1 ha under an existing clearing application CPA 6968/3. Two small areas (A & B) are also proposed on the northern side which were not surveyed. PLEC surveyed areas adjacent to site A which is described as Sr2 – *Acacia hemiteles* open shrubland (Figure 9).

SR2 - Open shrubland of *Acacia hemiteles* with emergent *Casuarina obesa* and scattered groves of *Eucalyptus* spp. over low open shrubland of *Acacia erinacea*, *Eremophila scoparia* and *Senna artemisioides* subsp. *filifolia* which is possibly an impacted community close to VT4 of the current survey.

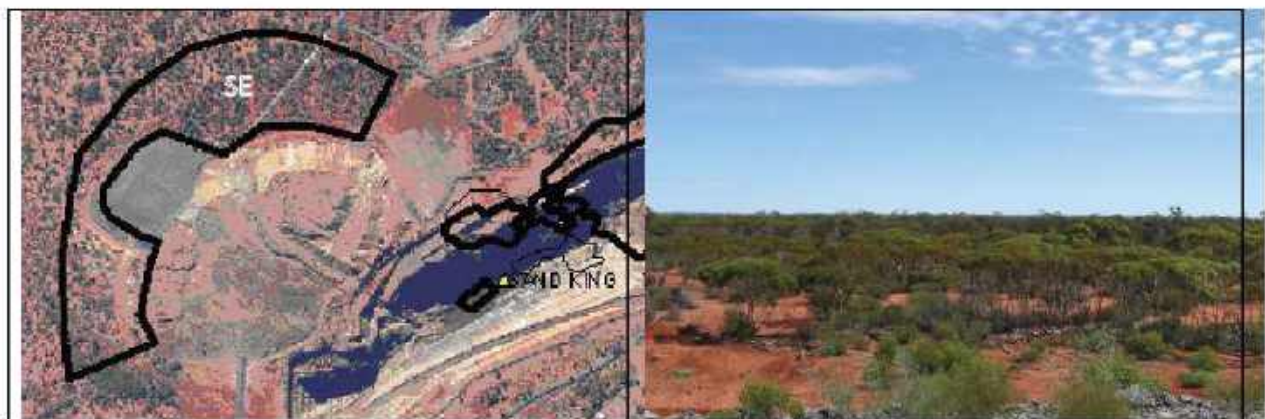
Figure 10: Vegetation mapping undertaken by OES (2007) on the western side of Sand King. Area B is located on the north side of western mapped area SE.

Area B is adjacent to mapping on the western side of Sand King which was surveyed by OES in March 2007 which was mapped as SE – Low *Eucalyptus oleosa* subsp. *oleosa* Woodland over Open Low Scrub A of *Acacia hemiteles*, *Dodonaea viscosa* subsp. *angustissima* and *Eremophila scoparia* over Open Low Scrub B of *Senna artemisioides* subsp. *filifolia* and *Acacia* sp. It is possibly representative of VT4 within the current ESA.

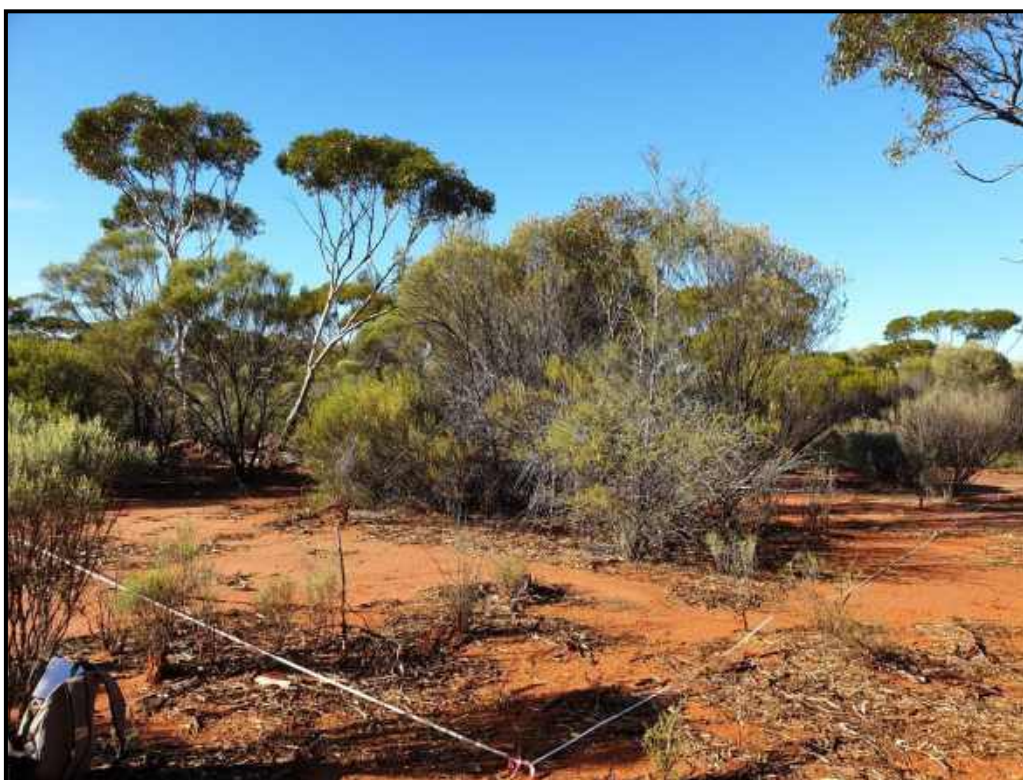
Siberia Quadrat 1 site photo

Eucalyptus griffithsii low open woodland over *Acacia caesaneura*, *Acacia hemiteles*, *Acacia colletioides*, *Grevillea nematophylla* subsp. *nematophylla*, *Acacia burkittii* tall open shrubland over *Acacia hemiteles*, *Acacia burkittii*, *Senna artemisioides* subsp. *filifolia*, *A. ramulosa* var. *ramulosa*, *Eremophila scoparia* open shrubland over *Acacia hemiteles*, *A. ramulosa* var. *ramulosa*, *Scaevola spinescens*, *Eremophila scoparia*, *A. colletioides* low opens shrubland over *Triodia scariosa* low isolated tussock grasses

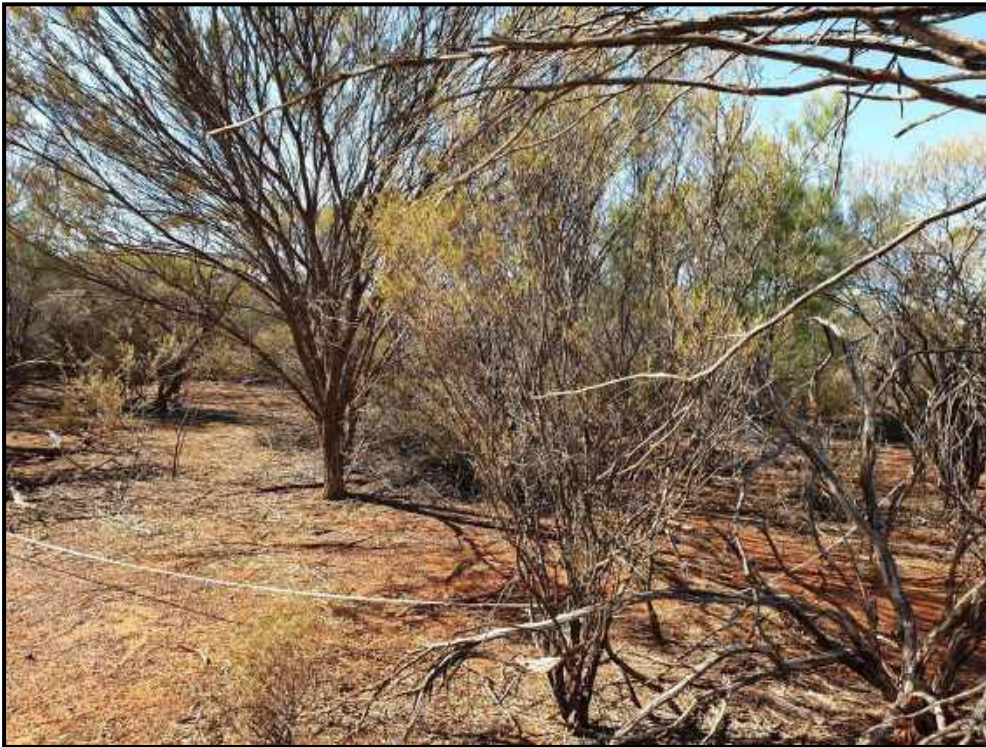
Siberia Quadrat 2 site photo (NW)

Eucalyptus oleosa subsp. *oleosa* isolated mallee trees over *Acacia ramulosa* var. *ramulosa*, *A. caesaneura*, *A. incurvaneura*, *Grevillea nematophylla* subsp. *nematophylla*, *A. burkittii* tall shrubland over *Eremophila granitica*, *E. eriocalyx*, *Prostanthera grylloana*, *Grevillea nematophylla* subsp. *nematophylla* open shrubland over *Eremophila granitica*, *E. eriocalyx*, *Prostanthera grylloana*, *Acacia ramulosa* var. *ramulosa* low sparse shrubland over *Waitzia acuminata* low isolated forbs

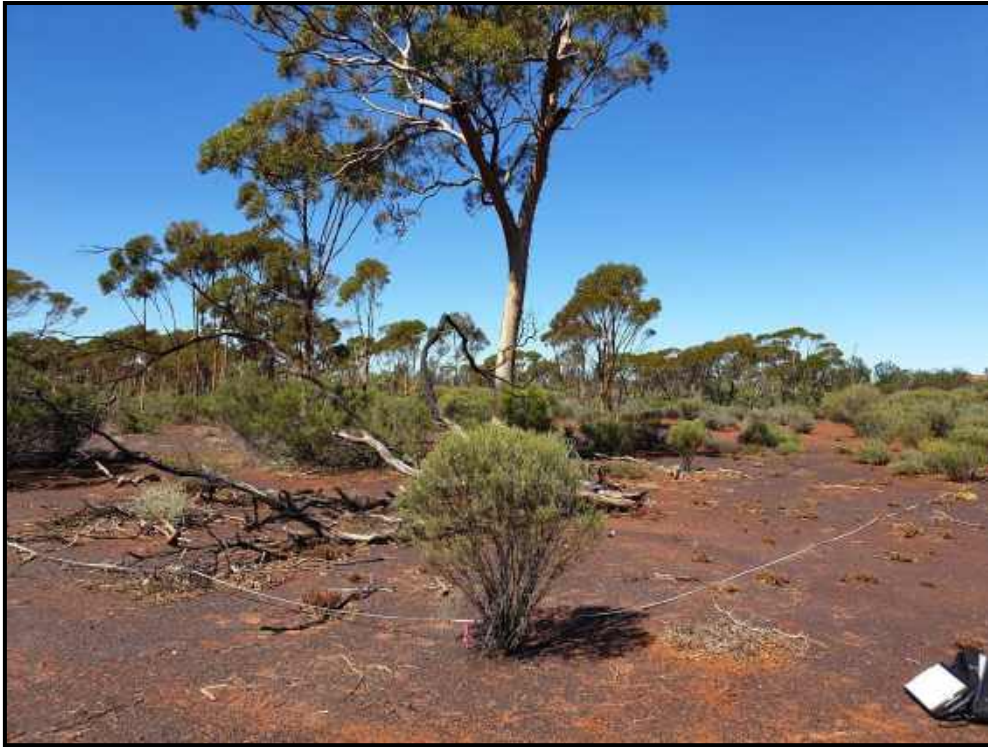
Siberia Quadrat 3 site photo

Eucalyptus salmonophloia open woodland over *Eremophila interstans* subsp. *interstans* tall sparse shrubland over *Eremophila interstans* subsp. *interstans*, *Exocarpos aphyllus*, *Eremophila scoparia*, *Acacia hemiteles* sparse shrubland over *Acacia erinacea*, *Sclerolaena cuneata*, *Scaevola spinescens*, *Dissocarpus paradoxus*, *Sclerolaena diacantha* low sparse shrubland over *Roepera ovata* low isolated forbs

<p>North side of quadrat > east</p>	<p><i>Dissocarpus paradoxus</i> growing near fallen timber.</p>

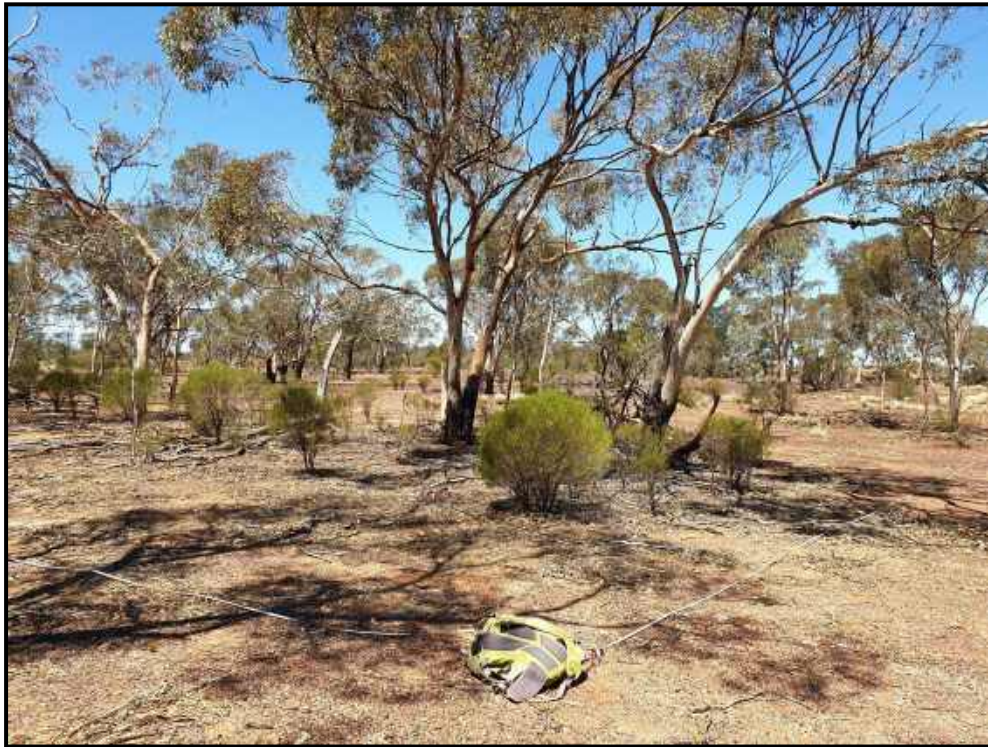
Siberia Quadrat 4 (NW)

Eucalyptus clelandiorum woodland over *Eremophila* sp. Mt Jackson, *Dodonaea lobulata*, *Senna artemisioides* subsp. *filifolia*, *Casuarina pauper*, *Exocarpos aphyllus*, *Acacia effusifolia* open shrubland over *Eremophila* sp. Mt Jackson, *Casuarina pauper*, *Olearia muelleri*, *Scaevola spinescens*, *Dodonaea lobulata*, *Ptilotus obovatus* low open shrubland over *Austrostipa nitida*, *Roepera aurantiaca* low isolated grass tussocks and forbs

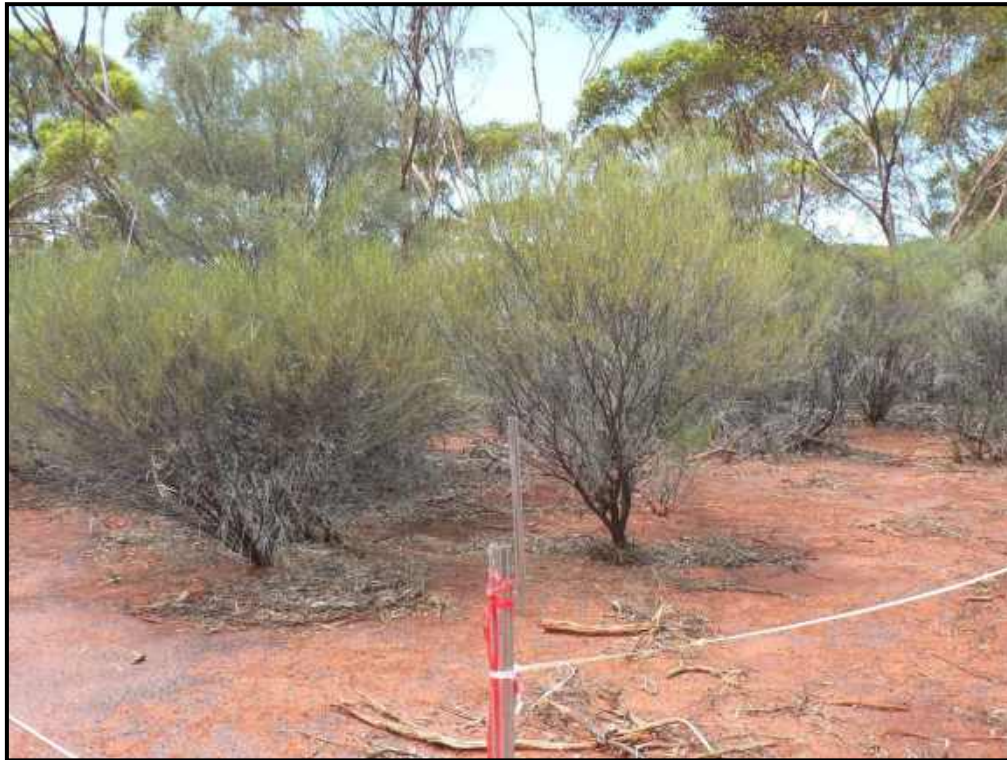
Siberia Quadrat 5 site photo

Eucalyptus griffithsii and *Casuarina pauper* low open forest over *Acacia burkittii*, *A. incurvaneura*, *Grevillea nematophylla* subsp. *nematophylla*, *Acacia ramulosa* var. *ramulosa*, *Acacia tetragonophylla* tall open shrubland over *Acacia ramulosa* var. *ramulosa*, *A. tetragonophylla*, *Dodonaea rigida*, *Senna artemisioides* subsp. *filifolia*, *Acacia burkittii*, *Dodonaea lobulata* open shrubland over *Dodonaea rigida*, *Acacia tetragonophylla*, *Acacia ramulosa* var. *ramulosa*, *Senna artemisioides* subsp. *filifolia* low isolated shrubs over *Austrostipa elegantissima* low isolated tussock grasses

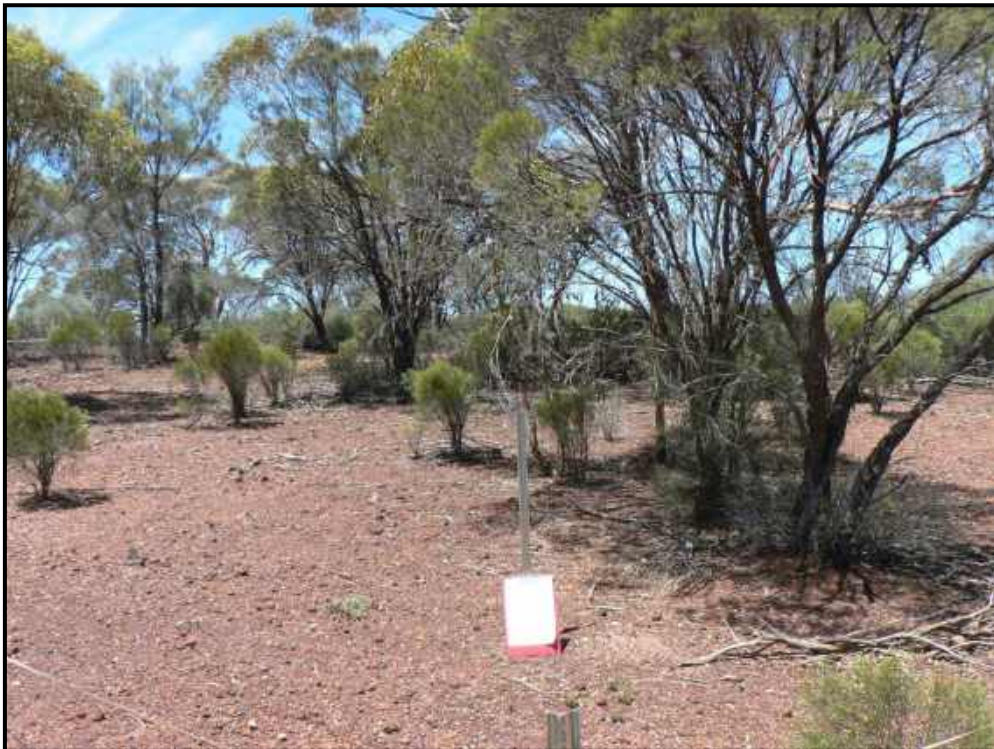
Siberia Quadrat 6 site photo

Eucalyptus griffithsii, *Allocasuarina acutivalvis* subsp. *acutivalvis*, *Eucalyptus salubris* mallee woodland over *Eremophila scoparia*, *Alectryon oleifolius* subsp. *canescens*, *Acacia tetragonophylla*, *A. burkittii* tall sparse shrubland over *Dodonaea lobulata*, *Acacia tetragonophylla*, *Eremophila scoparia*, *Scaevola spinescens*, *Allocasuarina acutivalvis* subsp. *acutivalvis* sparse shrubland over *Eremophila scoparia*, *Olearia muelleri*, *Dodonaea lobulata*, *Acacia tetragonophylla*, *Allocasuarina acutivalvis* subsp. *acutivalvis* low sparse shrubland over *Sclerolaena fusiformis*, *S. diacantha*, *Sida calyxhymenia* low isolated forbs

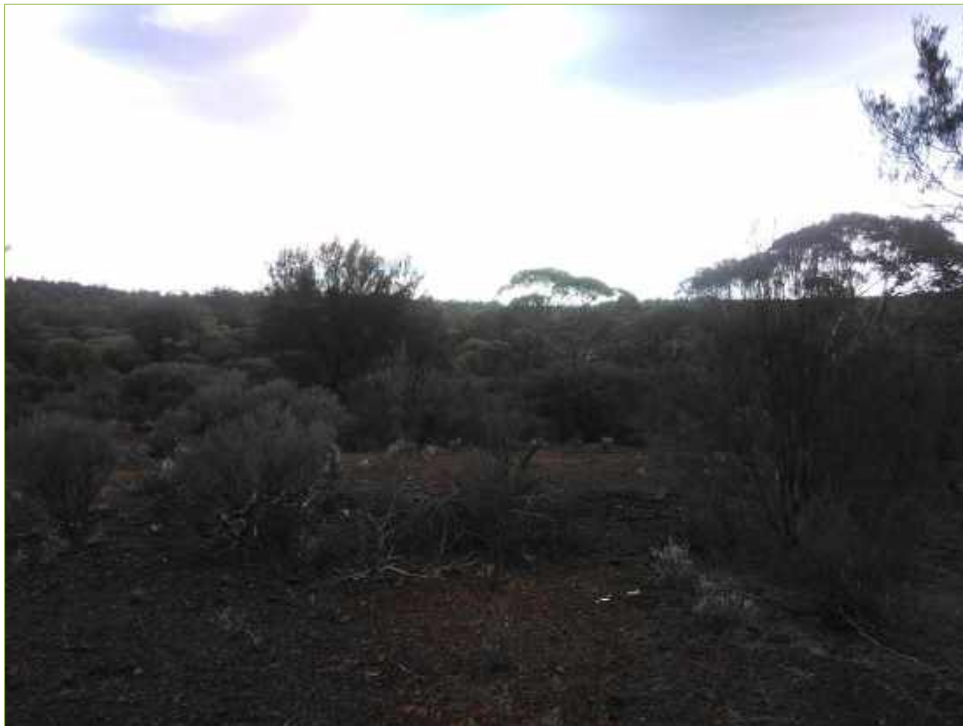
Figure 8 *Degraded habitat showing lack of ground cover and sparse shrubs.*

The areas bounded by the Evanston-Menzies road which include the open mine pit, station homestead and stock yards are degraded, lacking substantial understorey cover and sparse upper storey vegetation (Figure 8). Highly disturbed habitat also occurs around the airstrip at the north-eastern corner of the Riverina site. These degraded areas represent the lowest value to fauna.

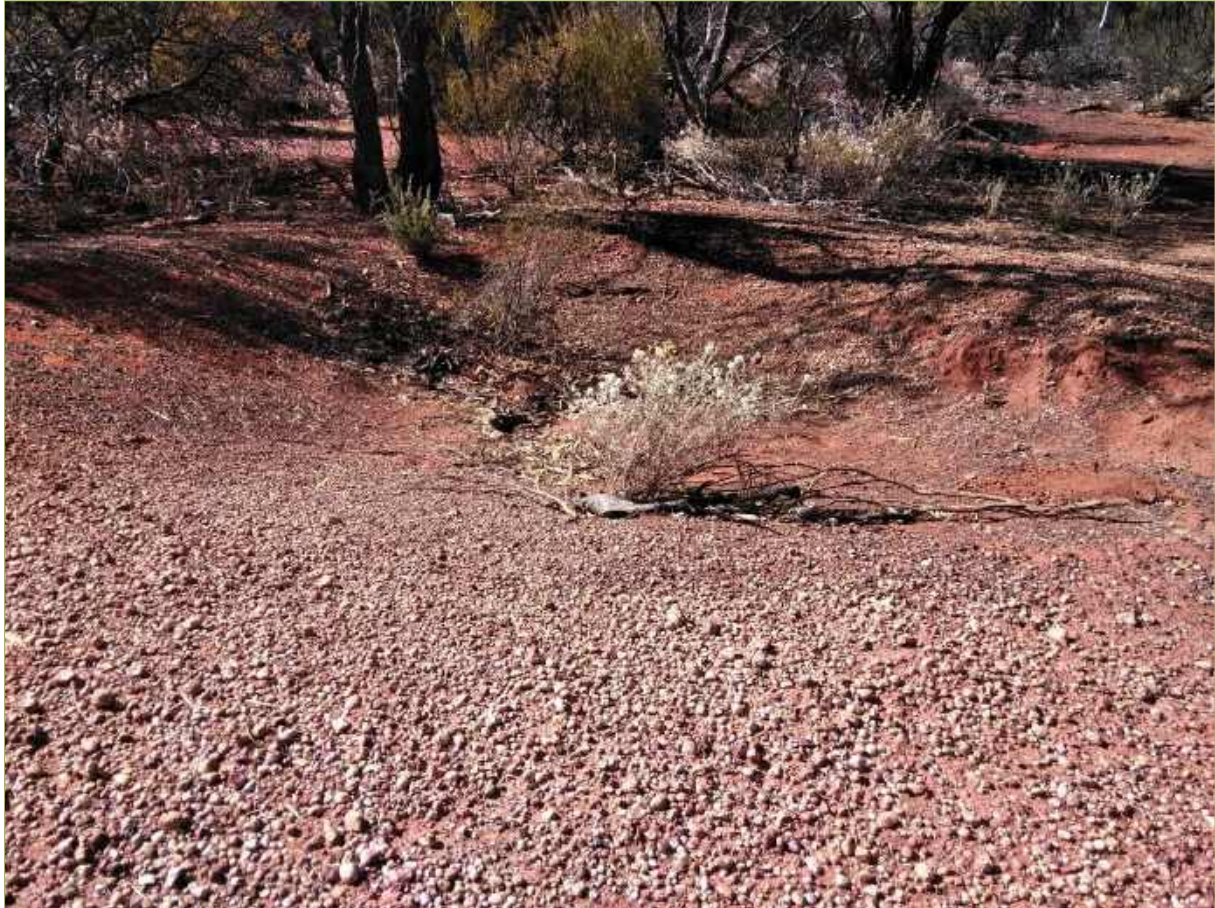
Figure 17 *Old malleefowl mound located at Callion.*

The searches of Davyhurst and Callion did locate nesting mounds (Figure 17) and an individual malleefowl was observed at Davyhurst by one of the mine personnel during the reconnaissance. All the mounds had not been used in the last 20 years and were showing signs of erosion and some were characteristic extinct mounds (i.e., >50 years of age) and had almost eroded completely. Foot searches of Riverina could not be undertaken due to safety concerns for personnel resulting from a persistent overhead lightning storm, however detailed foot searches by the Flora survey team, which included an Arid Ecologist with extensive malleefowl experience did not locate any evidence of their presence.
