MT IDA PROJECT | ENVIRONMENTAL COMMISSIONING PLAN

Revision No: 0
Date: 19/03/2025

File name	DLI_MIG_Environmental Commissioning Plan_Rev0v4
Author	
Project manager	
Client name	Delta Lithium Limited
Project name	Mt Ida Project
Document title	Environmental Commissioning Plan
Revision number	0
Project number	220057

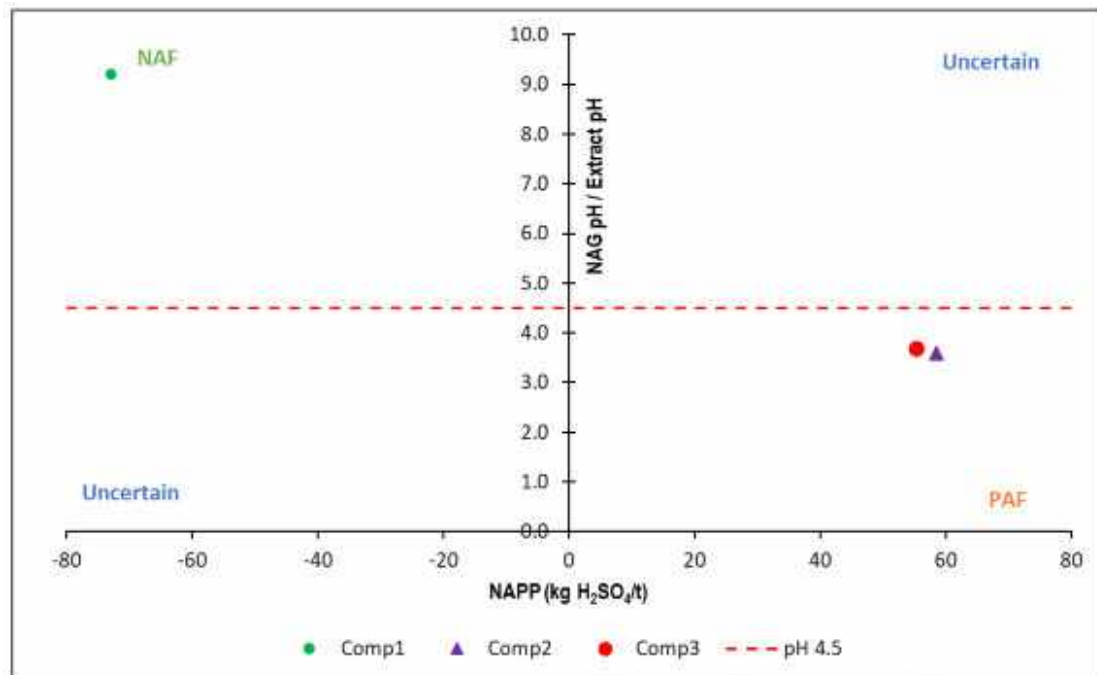
Figure 3-2: Classification of Mt Ida gold tailings (MBS, 2025)

Geochemical properties of gold tailings were assessed in early 2025 (MBS, 2025). Testing was conducted on one composite sample derived from oxide/transitional ore and two composite samples derived from fresh ore. The oxide/transitional sample was classified as non-acid forming (NAF), while both samples derived from fresh ore were classified as potentially acid forming (PAF) (Figure 3-2).

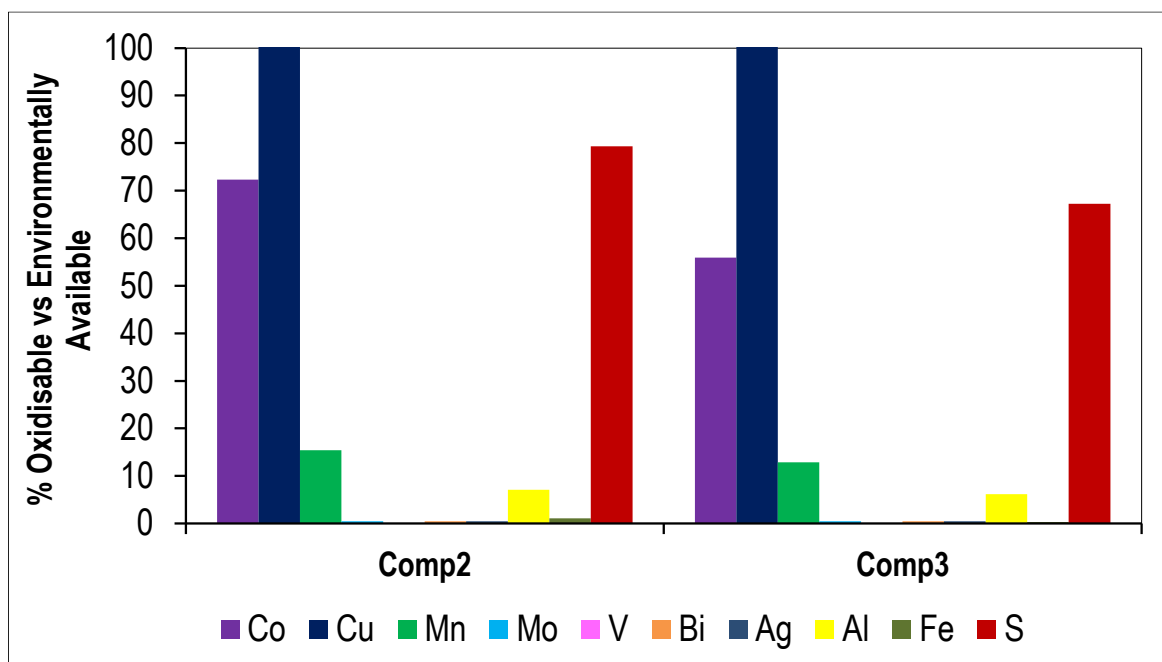
Chart 4: Oxidisable vs Aqua Regia of key Metals/Metalloids

- These results are consistent AMD formation. Iron, copper and sulfur were released from oxidation of the iron sulfide minerals (Section 5.1) generating acidic leachates partially buffered by the presence of rapid-reacting carbonate minerals and formation of salts. However, it should be noted that these results are highly conservative and only indicate that AMD can potentially be generated, since only mildly oxidative conditions are expected to prevail within the IWLTSF with measures (underdrainage and liners) to prevent seepage outflow.

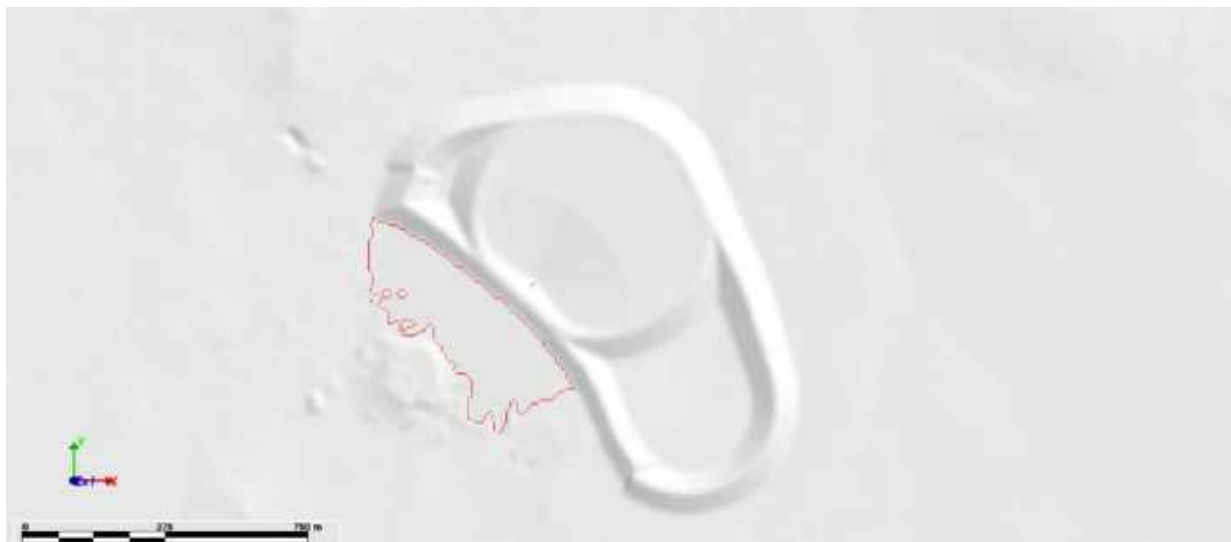
Figure 1: Inundation Plan

A preliminary inundation plan is shown below.

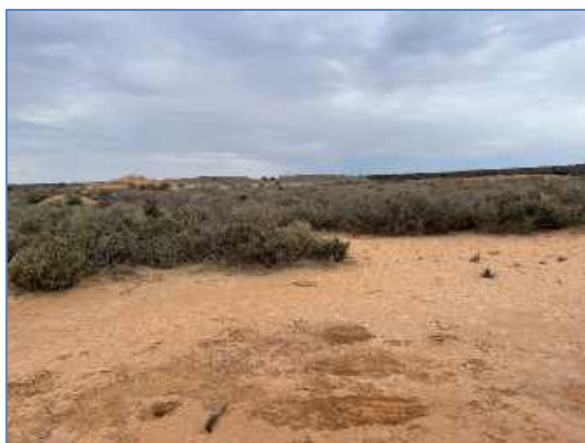
Plate 1 Tailings at site T1

The tailings samples were all identified as Emerson Class 5 (Table 1), indicating that the tailings slake but are not prone to dispersion of the clay fraction in their current state. It should be noted however, that the high salinity of the historic tailings may have a flocculating effect, reducing the propensity for dispersion of the clay fraction. The potential for dispersion may therefore increase if salts are leached from the tailings material.
