Water Management Plan

Lot 101 (no. 752) Wallcliffe Road, Margaret

River

Project No: EP18-128(10)

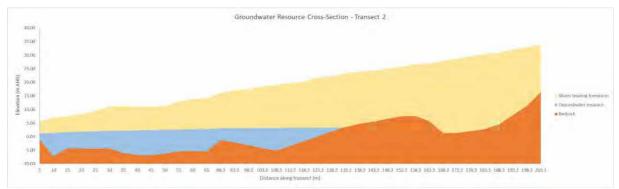
Plate 1: Conceptual model of the ground conditions beneath the site (Emerge Associates 2022)

A conceptual cross section of the measured and anticipated ground conditions beneath the potential infiltration and lower portions of the site, based on the geotechnical and geophysical investigations performed across the site, is shown in **Plate 1**.

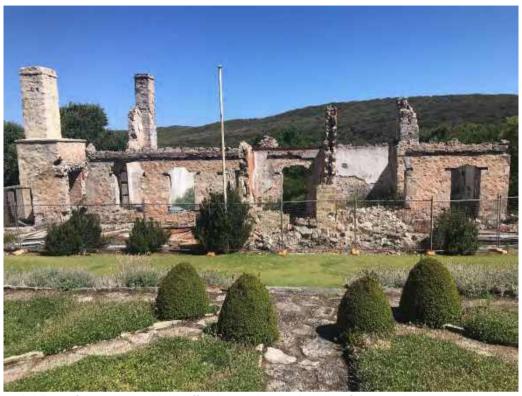
Photo 1: View of the existing Wallcliffe House derelict building from test location 24 looking northwest.

Several retaining walls, including a 5.3 m high limestone block retaining wall (see Photo 3) were observed surrounding the existing Wallcliffe House building and at the south-western corner of the site. Access roads were observed crossing the site along the southern, western and eastern site boundaries and at its centre. A pond feature, pump and boat sheds (see Photo 4) were observed at the north-eastern corner of the site. A concrete hardstand (slab of the former Cliff Wing building and associated driveway, see Photo 5) was also observed at the south-western corner of the site.

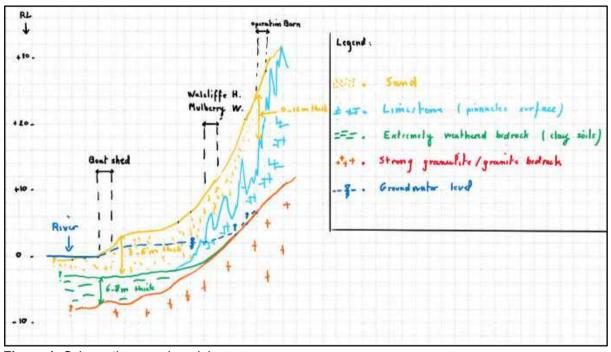
Figure 1: Schematic ground model.

A schematic ground model of the ground conditions anticipated beneath the site is shown in Figure 1 below.

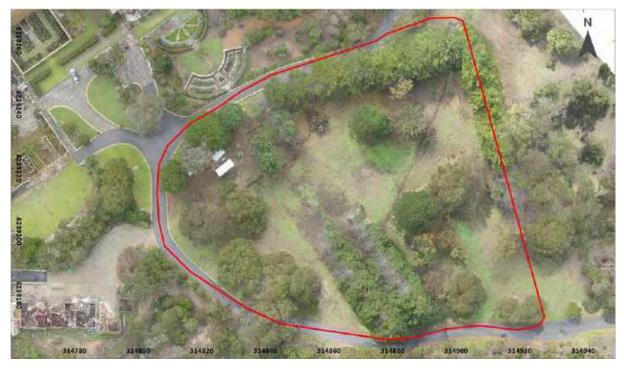
The near surface lithology within the investigation site consists of dry sand overlying limestone rock which was formed on deeper granitic rock.

Figure 1: The extent of geophysical investigation at Wallcliffe House outlined in red. Imagery from MNG Survey flown May 2020.

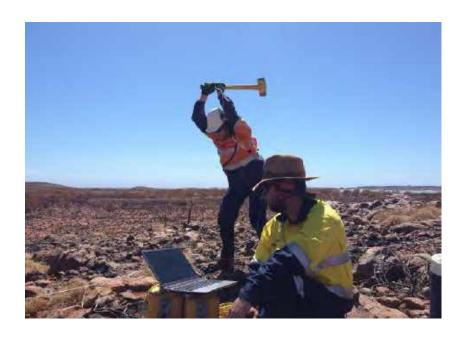
For near surface investigations seismic energy is generated on the surface using a sledge hammer. More powerful sources such as accelerated drop weight, down-hole airguns, or explosives are required for deeper investigations. The generated seismic waves propagate through the subsurface at a certain velocity. On reaching a geological boundary marked by an increase in seismic velocity, at a specific angle the wave is critically refracted and travels along the top of the lower layer at a greater velocity. This generates head waves in the upper layer which return to the surface where it is detected as vibrations by a linear array of geophones spaced at regular intervals.

By measuring the travel times of these refracted waves from multiple source points to multiple receivers, the seismic refraction method can resolve lateral changes in the depth to the top of a refracting interface as well as the seismic velocity within it. Furthermore being related to elastic strength and density, the velocities calculated from a seismic refraction survey can be a useful guide to the rippability of a rock for excavation.

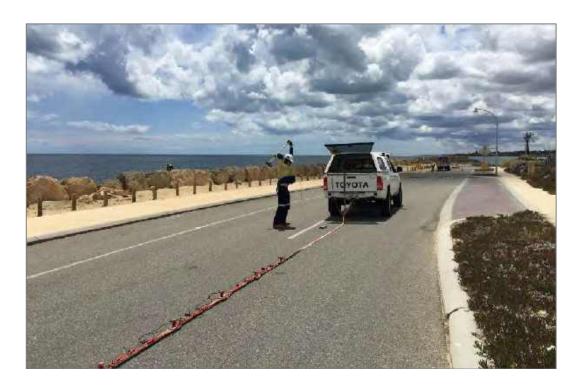
MASW uses an active seismic source such as a hammer or weight drop impact to produce seismic energy consisting predominantly of Pressure (P-) waves and Shear (S-) waves. MASW uses the S-wave dispersion component to provide information on the shear velocity to a depth determined by frequency range of the energy source and array configuration.

Seismic surface waves have dispersion properties that traditionally utilized body waves lack. Differing wavelengths/frequencies have different depth of penetration, and therefore propagates with different phase velocity, with an increase in wavelength being proportional to increased depth of penetration. As the surface wave is the dominant wave generated from any seismic source, MASW data quality (signal to noise) tends to be higher than other seismic methods such as seismic reflection or refraction.

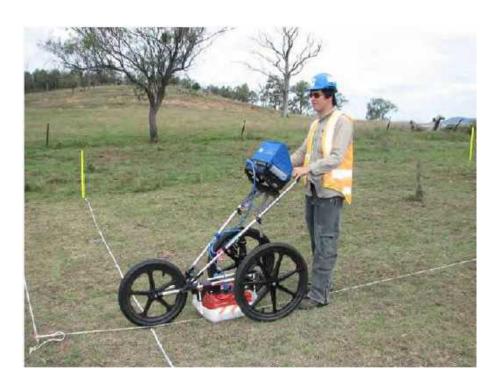
Ground Penetrating Radar (GPR) is a non-destructive and non-invasive geophysical technique for rapidly imaging the shallow subsurface and producing high-resolution colour sections in real time. The method works by transmitting electromagnetic energy into the material being tested (most usual the ground). Typically 100,000 impulses per second are transmitted which are of very short duration and contain a wide spectrum of frequencies.

The transmitted electromagnetic energy propagates through the subsurface as a function of the subsurface material's electrical properties, which are in turn dependent on its physical and chemical properties. Reflection of radar energy occurs at boundaries between differing stratigraphic layers or inclusions which have contrasting electrical properties. Conversely, no reflections occur from a homogenous material where there are no internal reflectors. The reflections are detected by the receiving antenna placed adjacent to the transmitter. The depth to the target is proportional to the time (in nanoseconds) taken for the signal to travel from the transmitting antenna at the surface to the target and back to the receiver.

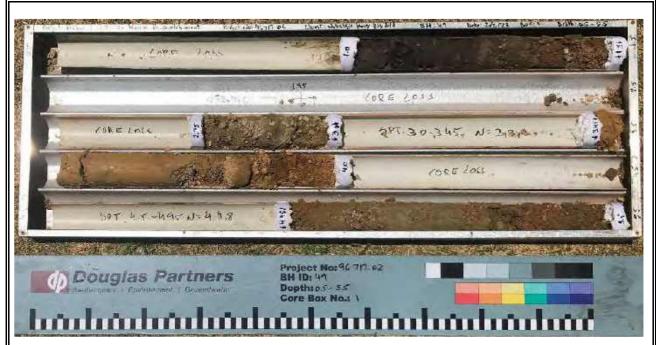
Photo 1 - Box 1: 0.5 m to 5.5 m

Core Photographs - Boxes 1 and 2	PROJECT:	96717.02
Douglas Partners	Proposed Wallcliffe House Re-development	PLATE:	1
Geotechnics Environment Groundwater	Test Location 49	REV:	Α
	CLIENT: Wallcliffe House Pty Ltd	DATE:	4 Feb 2022

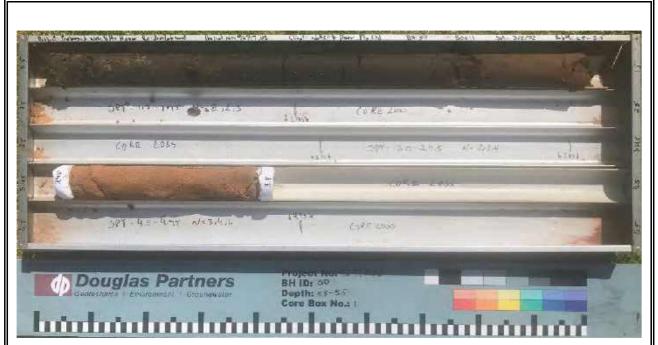
Photo 5 - Box 1: 0.5 m to 5.5 m

Core Photographs - Boxes 1 and 2	PROJECT:	96717.02
Douglas Partners	Proposed Wallcliffe House Re-development	PLATE:	3
Geotechnics Environment Groundwater	Test Location 50	REV:	Α
	CLIENT: Wallcliffe House Pty Ltd	DATE:	4 Feb 2022

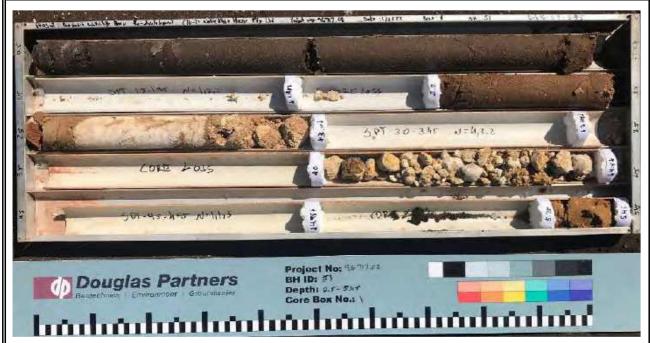
Photo 9 - Box 1: 0.5 m to 5.45 m

Core Photographs - Boxes 1 and 2	PROJECT:	96717.02
Douglas Partners	Proposed Wallcliffe House Re-development	PLATE:	5
Geotechnics Environment Groundwater	Test Location 51	REV:	Α
	CLIENT: Wallcliffe House Pty Ltd	DATE:	4 Feb 2022

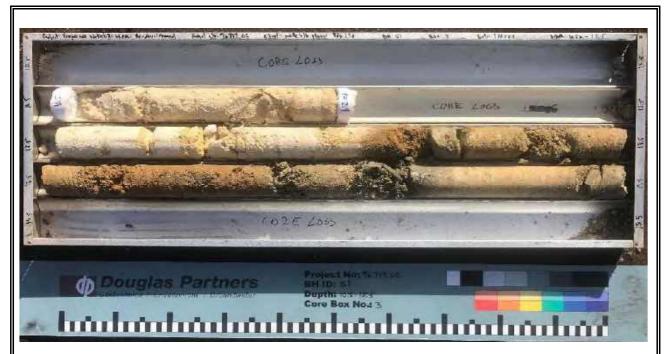
Photo 11 - Box 3: 10.5 m to 15.5 m

Core Photographs - Boxes 3 and 4	PROJECT:	96717.02
Douglas Partners	Proposed Wallcliffe House Re-development	PLATE:	6
Geotechnics Environment Groundwater	Test Location 51	REV:	Α
	CLIENT: Wallcliffe House Pty Ltd	DATE:	4 Feb 2022

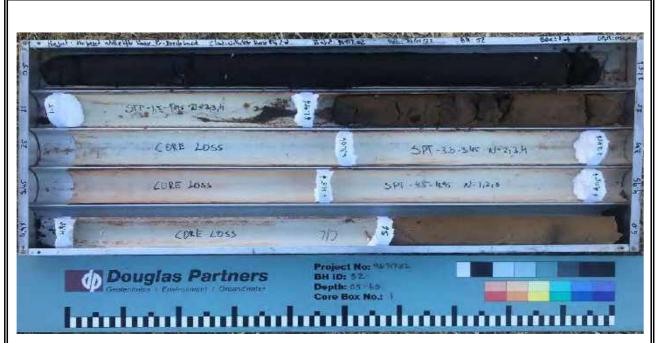
Photo 13 - Box 1: 0.5 m to 6.0 m

Core Photographs - Boxes 1 and 2	PROJECT:	96717.02
Douglas Partners	Proposed Wallcliffe House Re-development	PLATE:	7
Geotechnics Environment Groundwater	Test Location 52	REV:	Α
	CLIENT: Wallcliffe House Pty Ltd	DATE:	4 Feb 2022

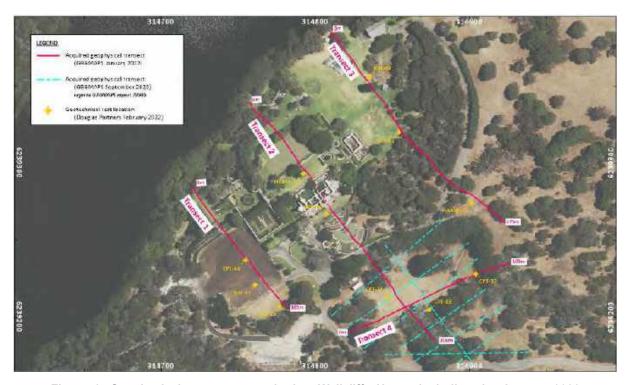
The geophysical investigation was carried out along four (4) transects within the site boundaries as shown in pink lines in Figure 1 below. Transects from the previous geophysical investigation carried out by GBGMAPS in September 2020 are shown in blue.

Figure 1: Geophysical transects acquired at Wallcliffe House including the January 2022 investigation (pink lines) and the September 2020 investigation (blue lines).

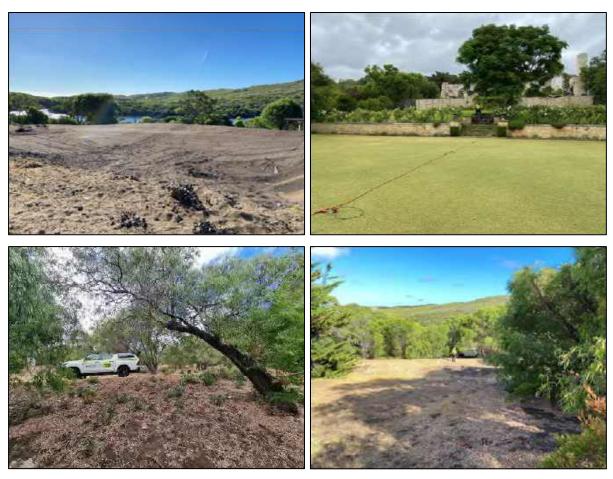
Figure 2: Site conditions during the geophysical investigation at Wallcliffe House including Transect 1 (top left), Transect 2 (top right), Transect 3 (bottom left) and Transect 4 (bottom right).

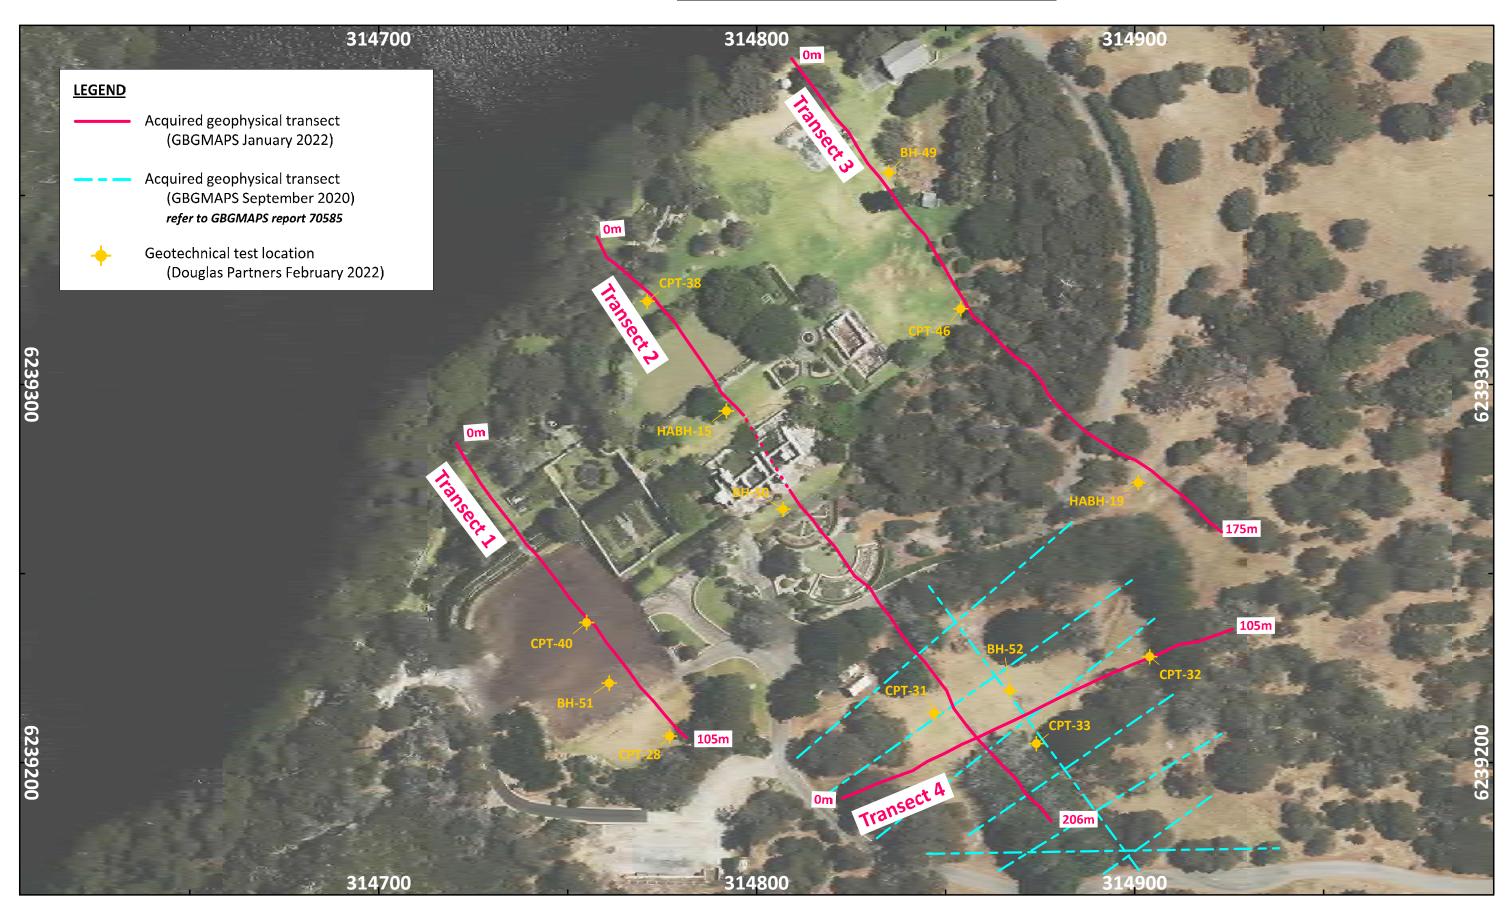
GEOPHYSICAL INVESTIGATION SITE MAP

SEISMIC REFRACTION TESTING

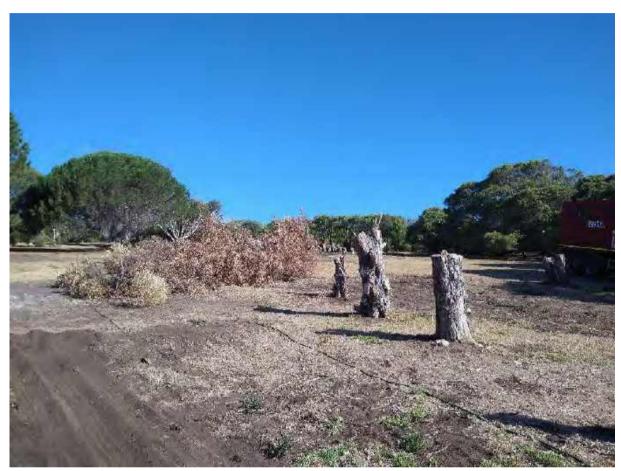
At the time of the investigation, the surface cover across the potential infiltration areas mainly comprised grass and sand, with rows of stumps (previously limbed trees) and groups of trees within or in the vicinity of these areas (see Photo 1 below).

Photo 1: View of the potential infiltration areas from test location 3 looking south.

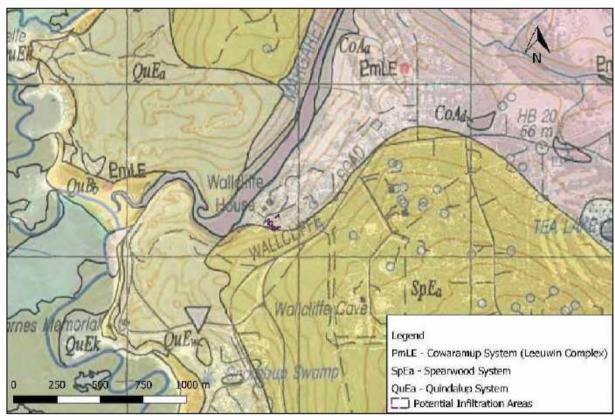
to the south and approximately 250 m to the northwest of the potential infiltration areas. The above geological setting is shown in Figure 1 below.

Figure 1: Geological Setting (Base Map is the Cowaramup-Mentelle 1:50,000 Regolith Landform sheet 1930-III and part of 1830-II).

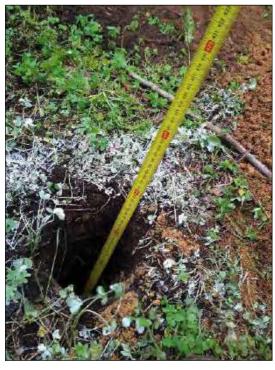
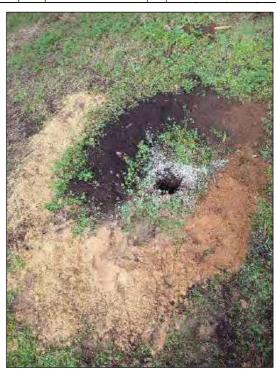
Description	.je		Sam		& In Situ Testing		Dominio Dominio Data		
R		epth n)	of Strata	Graphic Log	Туре	Depth	Sample	Results & Comments	Water	Dynamic Penetrometer Test (blows per 150mm)		
31	-	0.1	FILL/TOPSOIL: SAND SP-SM, fine to medium grained, dark grey, with silt and rootlets, moist.	V) X								
	- - - -		SAND SP: fine to medium grained, dark grey, with rootlets, trace silt, moist, medium dense, residual soil, Spearwood System.									
30	-1 - - -		- becoming dark brown-brown from 1.1 m depth.		D	1.3				-1		
	-		- becoming yellow-brown from 1.5 m depth.			1.7						
29	-2 - -				В	2.3				-2		
	-											
28	- -3 -		- becoming light yellow-brown from 2.8 m depth.							-3 _		
	- - - -		- becoming loose from 3.15 m depth.									
27	- 4 - - -	4.0	Bore discontinued at 4.0m (Target depth)	1						├ ⁴ -दे

TYPE OF BORING: 110 mm diameter hand auger borehole WATER OBSERVATIONS: No free groundwater observed. REMARKS: Location coordinates are in MGA94 Zone 50 J.

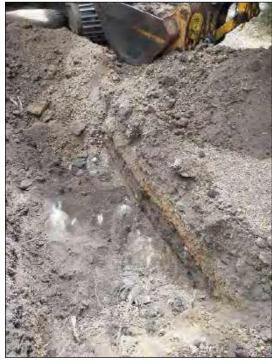
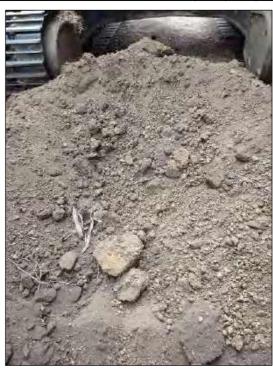
D "	Description	jic _		Sam		& In Situ Testing] <u>,</u>	Dynam	io Dono	tromoto	or Toot	٦
R	Depth (m)	OI	Graphic Log	Туре	Depth	Sample	Results & Comments	Water	Dynamic Penetrometer Test (blows per 150mm)				
8		Strata	0	ŕ	De	Sar	Comments		5	10	15	20	
- "	0.	FILL/Gravelly SAND SP-SM: fine to medium grained, dark grey-brown and grey-brown, fine to coarse sized, with silt, dry to moist, very dense.							-				Þ
	0.	FILL/Gravelly Clayey SAND SC: fine to medium grained, red-brown, fine to coarse sized, low plasticity, dry to moist.											_
22	- 1	FILL/SAND SP-SM: fine to medium grained, dark grey-brown, with silt, trace gravel, moist.											
		Pit discontinued at 0.6m (Hard digging, refusal on limestone rock)											
-21	- 2												
- "									:				
20	-3												
									:				
19	-4												
									:				
H													٦

WATER OBSERVATIONS: No free groundwater observed.

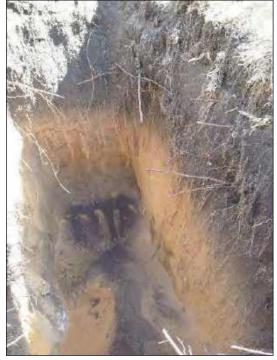
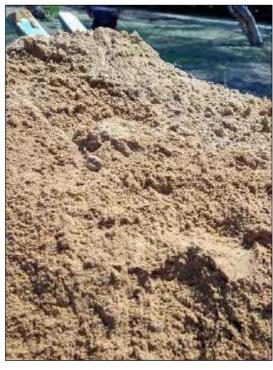
PIT No: 11

Description	je je		Sam		& In Situ Testing		Dominio Dominio Tork
묍	Depth (m)	of Strata	Graphic Log	Туре	Depth	Sample	Results & Comments	Water	Dynamic Penetrometer Test (blows per 150mm)
32	· 0.	FILL/TOPSOIL: SAND SP-SM: fine to medium grained.	<i>YY</i>]	S			5 10 15 20
		SAND SP-SM: fine to medium grained, dark grey-brown, with silt, moist, medium dense to dense. Residual Soil, Spearwood System.							b
31	-1	- becoming yellow-brown, trace silt from 1.1 m depth.							
30	-2	- trace of low to medium strength limestone cobbles and gravel from 2.2 m depth. - high strength limestone boulder or pinnacle observed on the northern side of the pit from 2.4 m depth.							-2 [
29	-3 3.	Pit discontinued at 3.0m (Target depth)	1	<u></u> —D—	 3.0				3
28	- 4 - 4 								
	· 				P		57

WATER OBSERVATIONS: No free groundwater observed.

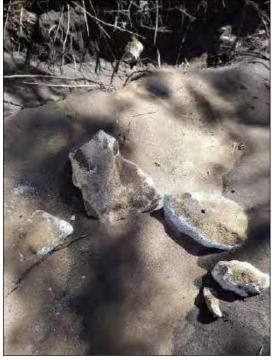
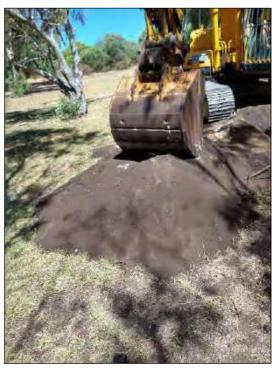
1.4	Pit discontinued at 1.4m (Hard digging, refusal on	<u> :::::</u>										
-2	2												
-3	3												
- 4 - 4	4												
		0.15	Depth (m) Of Strata FILL/TOPSOIL: SAND SP-SM: fine to medium grained, dark grey-brown, with silt, trace rootlets, moist. SAND SP-SM: fine to medium grained, dark grey-brown, with silt, medium dense to dense. Residual Soil, Spearwood System. - limestone boulder observed at 0.9 m depth. - becoming dark brown from 1.2 m depth. Pit discontinued at 1.4m (Hard digging, refusal on limestone rock)	Depth (m) Of Strata O.15 FILL/TOPSOIL: SAND SP-SM: fine to medium grained, dark grey-brown, with silt, trace rootlets, moist. SAND SP-SM: fine to medium grained, dark grey-brown, with silt, medium dense to dense. Residual Soil, Spearwood System. - Iimestone boulder observed at 0.9 m depth. - becoming dark brown from 1.2 m depth. Pit discontinued at 1.4m (Hard digging, refusal on limestone rock)	FILL/TOPSOIL: SAND SP-SM: fine to medium grained, dark grey-brown, with silt, trace rootlets, moist. SAND SP-SM: fine to medium grained, dark grey-brown, with silt, medium dense to dense. Residual Soil, Spearwood System. - limestone boulder observed at 0.9 m depth. - becoming dark brown from 1.2 m depth. Pit discontinued at 1.4m (Hard digging, refusal on limestone rock)	Depth (m) Strata O.15 FILL/TOPSOIL: SAND SP-SM: fine to medium grained, dark grey-brown, with silt, trace rootlets, moist. SAND SP-SM: fine to medium grained, dark grey-brown, with silt, medium dense to dense. Residual Soil, Spearwood System. - Iimestone boulder observed at 0.9 m depth. - becoming dark brown from 1.2 m depth. Pit discontinued at 1.4m (Hard digging, refusal on limestone rock)	Depth (m) Strata O.15 FILL/TOPSOIL: SAND SP-SM: fine to medium grained, dark grey-brown, with silt, trace rootlets, moist. SAND SP-SM: fine to medium grained, dark grey-brown, with silt, medium dense to dense. Residual Soil, Spearwood System. - Iimestone boulder observed at 0.9 m depth. - becoming dark brown from 1.2 m depth. Pit discontinued at 1.4m (Hard digging, refusal on limestone rock)	Depth (m) Strata FILL/TOPSOIL: SAND SP-SM: fine to medium grained, dark grey-brown, with silt, trace rootlets, moist. SAND SP-SM: fine to medium grained, dark grey-brown, with silt, medium dense to dense. Residual Soil, Spearwood System. I becoming dark brown from 1.2 m depth. Pit discontinued at 1.4m (Hard digging, refusal on limestone rock) Pit discontinued at 1.4m (Hard digging, refusal on limestone rock)	Depth (m) of Strata FILL/TOPSOIL: SAND SP-SM: fine to medium grained, dark grey-brown, with silt, trace rootlets, moist. SAND SP-SM: fine to medium grained, dark grey-brown, with silt, medium dense to dense. Residual Soil, Spearwood System. - limestone boulder observed at 0.9 m depth. - becoming dark brown from 1.2 m depth. Pit discontinued at 1.4m (Hard digging, refusal on limestone rock) Results & Comments Pit dis Comments Pit discontinued at 1.4m (Hard digging, refusal on limestone rock)

WATER OBSERVATIONS: No free groundwater observed.

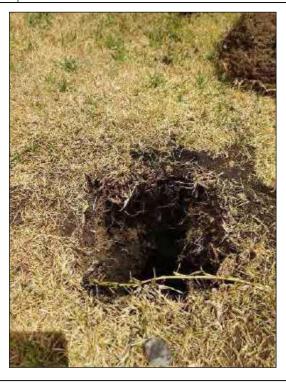
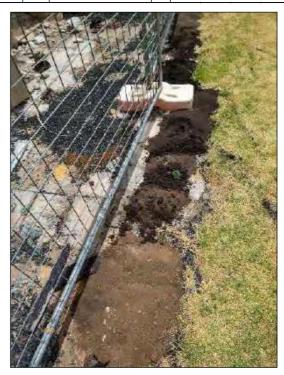
BORE No: 16

Sampling & In Situ Testing Description Graphic Log Dynamic Penetrometer Test Depth 굽 of (blows per 150mm) Sample Results & Comments Strata FILL/SAND SP-SM: fine to medium grained, dark grey-brown and grey-brown, with silt, trace gravel, moist, medium dense. Metal plate, concrete tiles, pieces of ceramic observed within the fill. SAND SP-SM: fine to medium grained, dark grey-brown, with silt, moist, medium dense. Residual Soil, Spearwood System. - becoming medium dense to dense from 1.8 m depth. 2 Bore discontinued at 3.0m (Collapsing conditions)

TYPE OF BORING: 110 mm diameter hand auger borehole WATER OBSERVATIONS: No free groundwater observed.

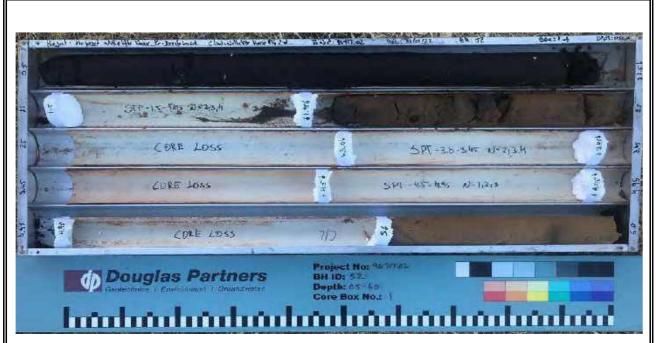
Photo 13 - Box 1: 0.5 m to 6.0 m

Core Photographs - Boxes 1 and 2		PROJECT:	96717.02
Douglas Partners	Proposed Wallcliffe House Re-development	PLATE:	7
Geotechnics Environment Groundwater	Test Location 52	REV:	Α
	CLIENT: Wallcliffe House Pty Ltd	DATE:	4 Feb 2022

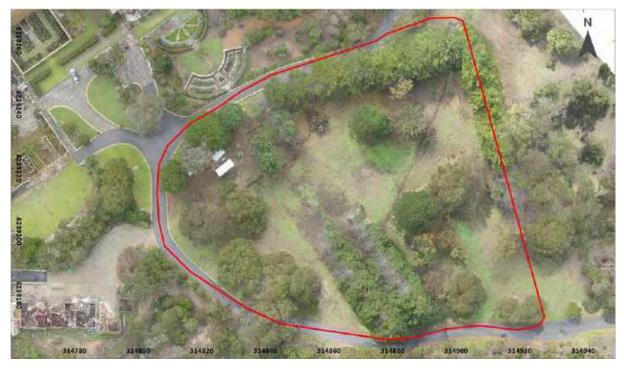
The near surface lithology within the investigation site consists of dry sand overlying limestone rock which was formed on deeper granitic rock.

Figure 1: The extent of geophysical investigation at Wallcliffe House outlined in red. Imagery from MNG Survey flown May 2020.

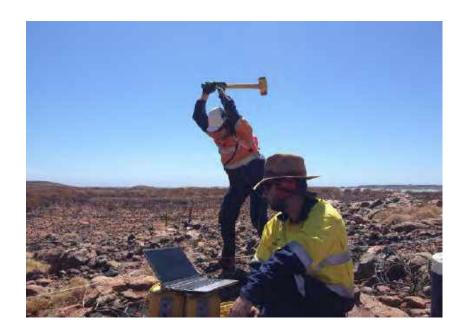
For near surface investigations seismic energy is generated on the surface using a sledge hammer. More powerful sources such as accelerated drop weight, down-hole airguns, or explosives are required for deeper investigations. The generated seismic waves propagate through the subsurface at a certain velocity. On reaching a geological boundary marked by an increase in seismic velocity, at a specific angle the wave is critically refracted and travels along the top of the lower layer at a greater velocity. This generates head waves in the upper layer which return to the surface where it is detected as vibrations by a linear array of geophones spaced at regular intervals.

By measuring the travel times of these refracted waves from multiple source points to multiple receivers, the seismic refraction method can resolve lateral changes in the depth to the top of a refracting interface as well as the seismic velocity within it. Furthermore being related to elastic strength and density, the velocities calculated from a seismic refraction survey can be a useful guide to the rippability of a rock for excavation.

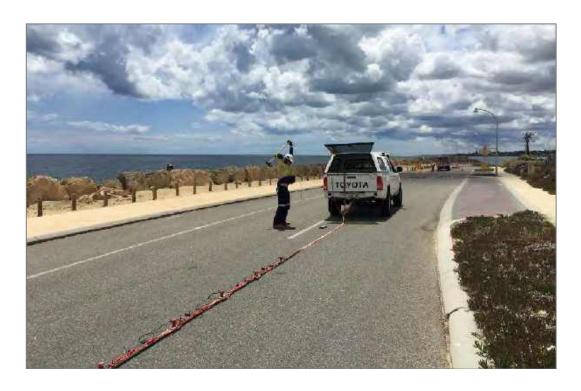
MASW uses an active seismic source such as a hammer or weight drop impact to produce seismic energy consisting predominantly of Pressure (P-) waves and Shear (S-) waves. MASW uses the S-wave dispersion component to provide information on the shear velocity to a depth determined by frequency range of the energy source and array configuration.

Seismic surface waves have dispersion properties that traditionally utilized body waves lack. Differing wavelengths/frequencies have different depth of penetration, and therefore propagates with different phase velocity, with an increase in wavelength being proportional to increased depth of penetration. As the surface wave is the dominant wave generated from any seismic source, MASW data quality (signal to noise) tends to be higher than other seismic methods such as seismic reflection or refraction.

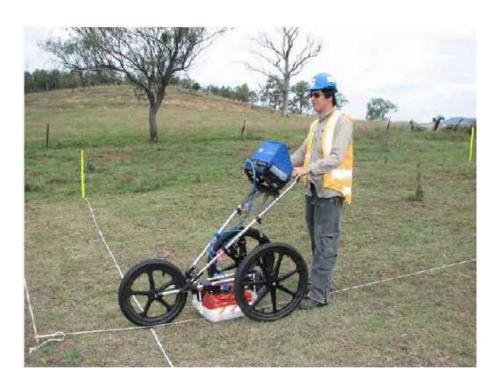
Ground Penetrating Radar (GPR) is a non-destructive and non-invasive geophysical technique for rapidly imaging the shallow subsurface and producing high-resolution colour sections in real time. The method works by transmitting electromagnetic energy into the material being tested (most usual the ground). Typically 100,000 impulses per second are transmitted which are of very short duration and contain a wide spectrum of frequencies.

The transmitted electromagnetic energy propagates through the subsurface as a function of the subsurface material's electrical properties, which are in turn dependent on its physical and chemical properties. Reflection of radar energy occurs at boundaries between differing stratigraphic layers or inclusions which have contrasting electrical properties. Conversely, no reflections occur from a homogenous material where there are no internal reflectors. The reflections are detected by the receiving antenna placed adjacent to the transmitter. The depth to the target is proportional to the time (in nanoseconds) taken for the signal to travel from the transmitting antenna at the surface to the target and back to the receiver.

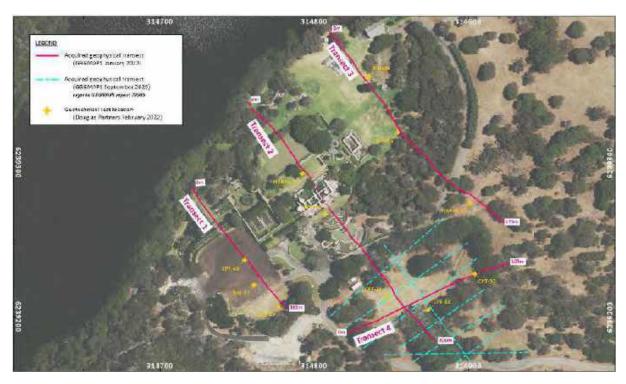
The geophysical investigation was carried out along four (4) transects within the site boundaries as shown in pink lines in Figure 1 below. Transects from the previous geophysical investigation carried out by GBGMAPS in September 2020 are shown in blue.

Figure 1: Geophysical transects acquired at Wallcliffe House including the January 2022 investigation (pink lines) and the September 2020 investigation (blue lines).

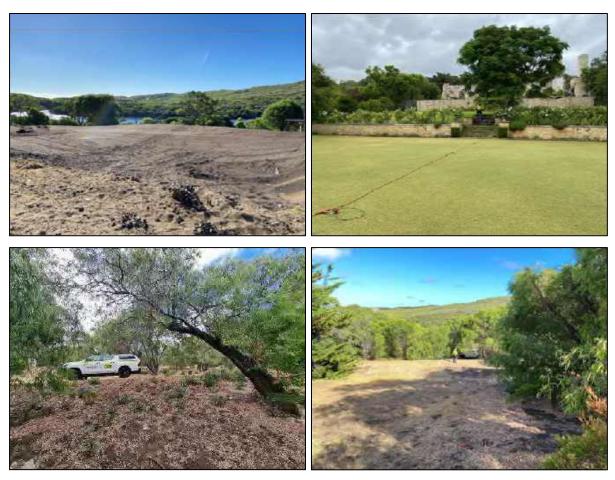
Figure 2: Site conditions during the geophysical investigation at Wallcliffe House including Transect 1 (top left), Transect 2 (top right), Transect 3 (bottom left) and Transect 4 (bottom right).

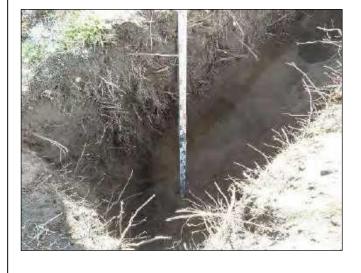
Description	ic		Sam	pling &	& In Situ Testing	L				<u> </u>
묍	Depth (m)	of Strata	Graphic Log	Type	Depth	Sample	Results & Comments	Water	Dynar (k	nic Pene lows pe	etrometo r 150mi	er lest m)
20 20	- 0.15	TOPSOIL/SAND SP-SM: fine to medium grained, dark grey-brown, with silt, roots and rootlets, dry to moist. FILL/SAND SP-SM: fine to medium grained, dark grey-brown, with silt and rootlets, dry to moist, medium dense.		D	0.05	8			-1			
	- 1.4 - - - - - 2 2.0	SAND SP: fine to medium grained, brown, trace silt, moist, medium dense. Residual sand of Spearwood System. - becoming orange-brown from 1.7 m depth.		В	1.8				-			
	- 2.0	Pit discontinued at 2.0m (Target depth)

WATER OBSERVATIONS: No free groundwater observed.

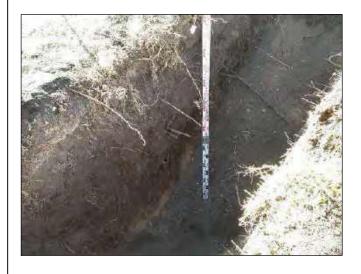
PIT No: 17

Γ			Description	. <u>S</u>		San	npling &	& In Situ Testing	L	
ā	2	Depth (m)	of Strata	Graphic Log	Type	Depth	Sample	Results & Comments	Water	Dynamic Penetrometer Test (blows per 150mm) 5 10 15 20
-	.7	0.15	TOPSOIL/Gravelly SAND SP-SM: fine to medium grained, yellow-brown, fine to coarse sized, with silt, dry to moist.							
	23	1	SAND SP: fine to medium grained, dark grey-brown, trace silt, roots and rootlets, dry to moist, medium dense. Residual sand of Spearwood System.		В	0.5				-1
	-	1.5	SAND SP: fine to medium grained, brown, trace silt, moist. Residual sand of Spearwood System.							
-8	7.7	2 2.0	Pit discontinued at 2.0m (Target depth)	<u> </u>						2

WATER OBSERVATIONS: No free groundwater observed.

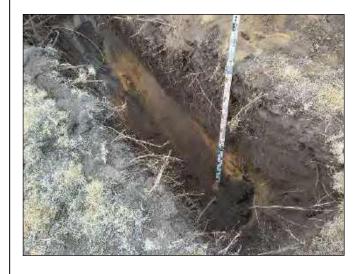
Description	. <u>S</u>		Sam	. •	& In Situ Testing	L.	Dani Bartan ta Tat
7 RL		Depth (m)	of Strata	Graphic Log	Туре	Depth	Sample	Results & Comments	Water	Dynamic Penetrometer Test (blows per 150mm) 5 10 15 20
2	-	0.2	TOPSOIL/SAND SP-SM: fine to medium grained, dark grey-brown, with silt and rootlets, dry to moist.							-
	- - - - -		SAND SP: fine to medium grained, dark grey-brown, with rootlets, trace silt, dry to moist, medium dense. Residual sand of Spearwood System.							-1
	2	1.2	SAND SP: fine to medium grained, brown and orange-brown, trace silt, moist, medium dense. Residual sand of Spearwood System.		В	1.6				
-	-	2.0	Pit discontinued at 2.0m (Target depth)

WATER OBSERVATIONS: No free groundwater observed.

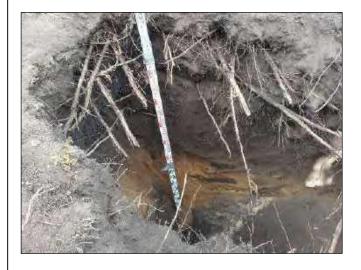
Description	. <u>o</u>		Sam	pling &	& In Situ Testing	L	
R		epth m)	of Strata	Graphic Log	Туре	Depth	Sample	Results & Comments	Water	Dynamic Penetrometer Test (blows per 150mm)
. 34	-		TOPSOIL/SAND SP-SM: fine to medium grained, dark grey-brown, with silt, roots and rootlets, dry to moist.				Ö			5 10 15 20
30	- - - - - -1	0.2	SAND SP: fine to medium grained, dark grey-brown, trace silt, dry to moist, medium dense. Residual sand of Spearwood System.							
	-	1.4	SAND SP: fine to medium grained, orange-brown, trace silt, moist, medium dense. Residual sand of Spearwood System. - becoming pale yellow-brown from 1.8 m depth.							
29	- -2	2.0	Pit discontinued at 2.0m (Target depth)		—В—	-2.0-				2
	-		rit discontinued at 2.011 (Target depth)

WATER OBSERVATIONS: No free groundwater observed.

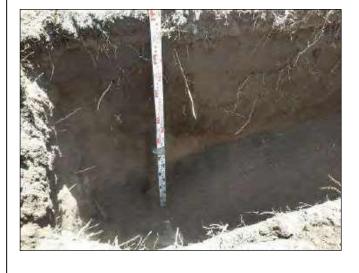
Description	ē		Sam	ipling &	& In Situ Testing	L			 	- .
귐		Depth (m)	of Strata	Graphic Log	Туре	Depth	Sample	Results & Comments	Water	Dyr 5	(blows		er Test n)
। ह	-	0.15	TOPSOIL/SAND SP-SM: fine to medium grained, dark grey-brown, with silt, trace roots and rootlets, dry to moist. FILL/SAND SP: fine to medium grained, dark grey-brown, trace silt, dry to moist, medium dense.		В	0.6	S			-			
- 33	- - - - -	1.3	SAND SP: fine to medium grained, brown, trace silt, moist, medium dense. Residual sand of Spearwood System.		В	1.5				- -1 - - -			
32	- 2	2 2.0	- limestone pinnacle observed from 1.6 m depth. Pit discontinued at 2.0m (Target depth)							2

WATER OBSERVATIONS: No free groundwater observed.

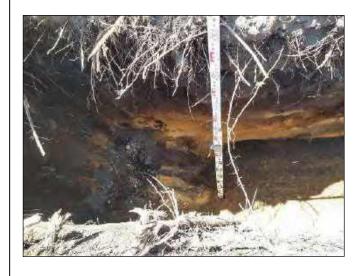
Description	oje.		Sam		& In Situ Testing		Dunamia Danataan T
2 R		Depth (m)	of Strata	Graphic Log	Туре	Depth	Sample	Results & Comments	Water	Dynamic Penetrometer Test (blows per 150mm)
	-		TOPSOIL/SAND SP-SM: fine to medium grained, dark grey-brown, with silt, roots and rootlets, dry to moist.		D	0.05				
21	-	0.2 I 1.1	FILL/SAND SP-SM: fine to medium grained, dark grey-brown, with silt, dry to moist, medium dense.							-1
-	-	1.1	SAND SP: fine to medium grained, orange-brown, trace silt, moist. Residual sand of Spearwood System. - limestone pinnacle observed from 1.6 m depth.							
-	•				В	1.8				
	- 2 - - -	2 2.0	Pit discontinued at 2.0m (Target depth)	•						2

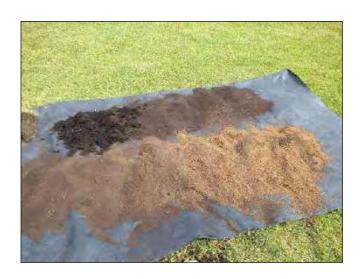
Description	.ie		Sam		& In Situ Testing	۰	D D T
RL		epth m)	of Strata	Graphic Log	Туре	Depth	Sample	Results & Comments	Water	Dynamic Penetrometer Test (blows per 150mm)
3	- - - - - -1	0.15 -	TOPSOIL/SAND SP-SM: fine to medium grained, grey-brown, with silt, dry to moist. SAND SP: fine to medium grained, dark grey-brown, trace silt, dry to moist, medium dense. Residual sand of Spearwood System.							- - - - - - - - - - - - - - -
	- - - - - - - -	2.0 -	silt, moist, medium dense. Residual sand of Spearwood System. Bore discontinued at 2.0m (Target depth)		D	2.0

TYPE OF BORING: 110 mm diameter hand auger borehole WATER OBSERVATIONS: No free groundwater observed.

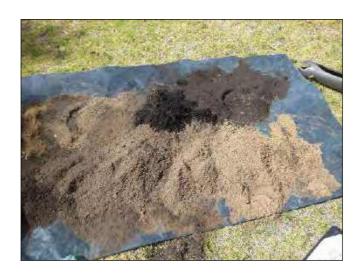
BORE No: 23

Description	.i		Sam	pling &	& In Situ Testing	L	
R	Dept (m)		of Strata	Graphic Log	Туре	Depth	Sample	Results & Comments	Water	Dynamic Penetrometer Test (blows per 150mm)
-	0.	.15	TOPSOIL/SAND SP-SM: fine to medium grained, dark grey-brown, with silt, trace rootlets, dry to moist.							
-	-	0.7	FILL/SAND SP-SM: fine to medium grained, grey-brown and dark grey-brown, with gravel and silt, dry to moist, very dense.							
	- - -1 -		SAND SP: fine to medium grained, dark grey-brown, trace silt, moist, dense. Residual sand of Spearwood System.							-1
-	- - - -	1.3	SAND SP: fine to medium grained, brown, trace silt, moist, medium dense to dense. Residual sand of Spearwood System.							
-9	-2 2	2.0	Bore discontinued at 2.0m (Target depth)	124,724	—В—	 2.0

TYPE OF BORING: 110 mm diameter hand auger borehole WATER OBSERVATIONS: No free groundwater observed.

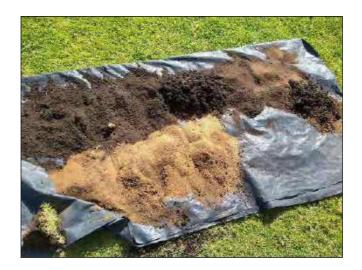
Description	. <u>e</u>		Sam	pling 8	& In Situ Testing	L	
RL	Depth (m)	of Strata	Graphic Log	Туре	Depth	Sample	Results & Comments	Water	Dynamic Penetrometer Test (blows per 150mm) 5 10 15 20
-	- 0.1	TOPSOIL/SAND SP-SM: fine to medium grained, dark grey-brown, with silt, trace rootlets, dry to moist.				U)			- 1
9		SAND SP-SM: fine to medium grained, dark grey-brown, with silt, dry to moist, medium dense. Residual sand of Spearwood System.							-1
	- 1.º	SAND SP: fine to medium grained, brown, trace silt, moist, medium dense. Residual sand of Spearwood System.							
5	-2 2.0 - - -	Bore discontinued at 2.0m (Target depth)	<u> </u>	В	2.0				2

TYPE OF BORING: 110 mm diameter hand auger borehole WATER OBSERVATIONS: No free groundwater observed.

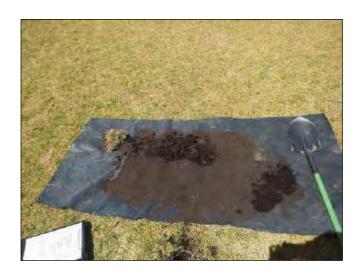
Description	. <u>e</u>		Sam	pling &	& In Situ Testing	L	
R		Depth (m)	of Strata	Graphic Log	Туре	Depth	Sample	Results & Comments	Water	Dynamic Penetrometer Test (blows per 150mm) 5 10 15 20
-	-	0.2	TOPSOIL/SAND SP-SM: fine to medium grained, dark grey-brown, with silt, trace rootlets, dry to moist.							-
- 9		1	SAND SP-SM: fine to medium grained, dark grey-brown, with silt, dry to moist, medium dense. Residual sand of Spearwood System.							
-	- 	2 2.0	Bore discontinued at 2.0m (Target depth)	•	—В—	-2.0-

TYPE OF BORING: 110 mm diameter hand auger borehole WATER OBSERVATIONS: No free groundwater observed.
