Black Cat Syndicate

Bulong Gold Project

Fingals TSF – Geotechnical Design of Dry-Stack Tailings Trial

Project:	Bulong Gold Project
Report Title:	Fingals TSF – Geotechnical Design of Dry-Stack Tailings Trial
Document Number:	148-02-3150C-RR001

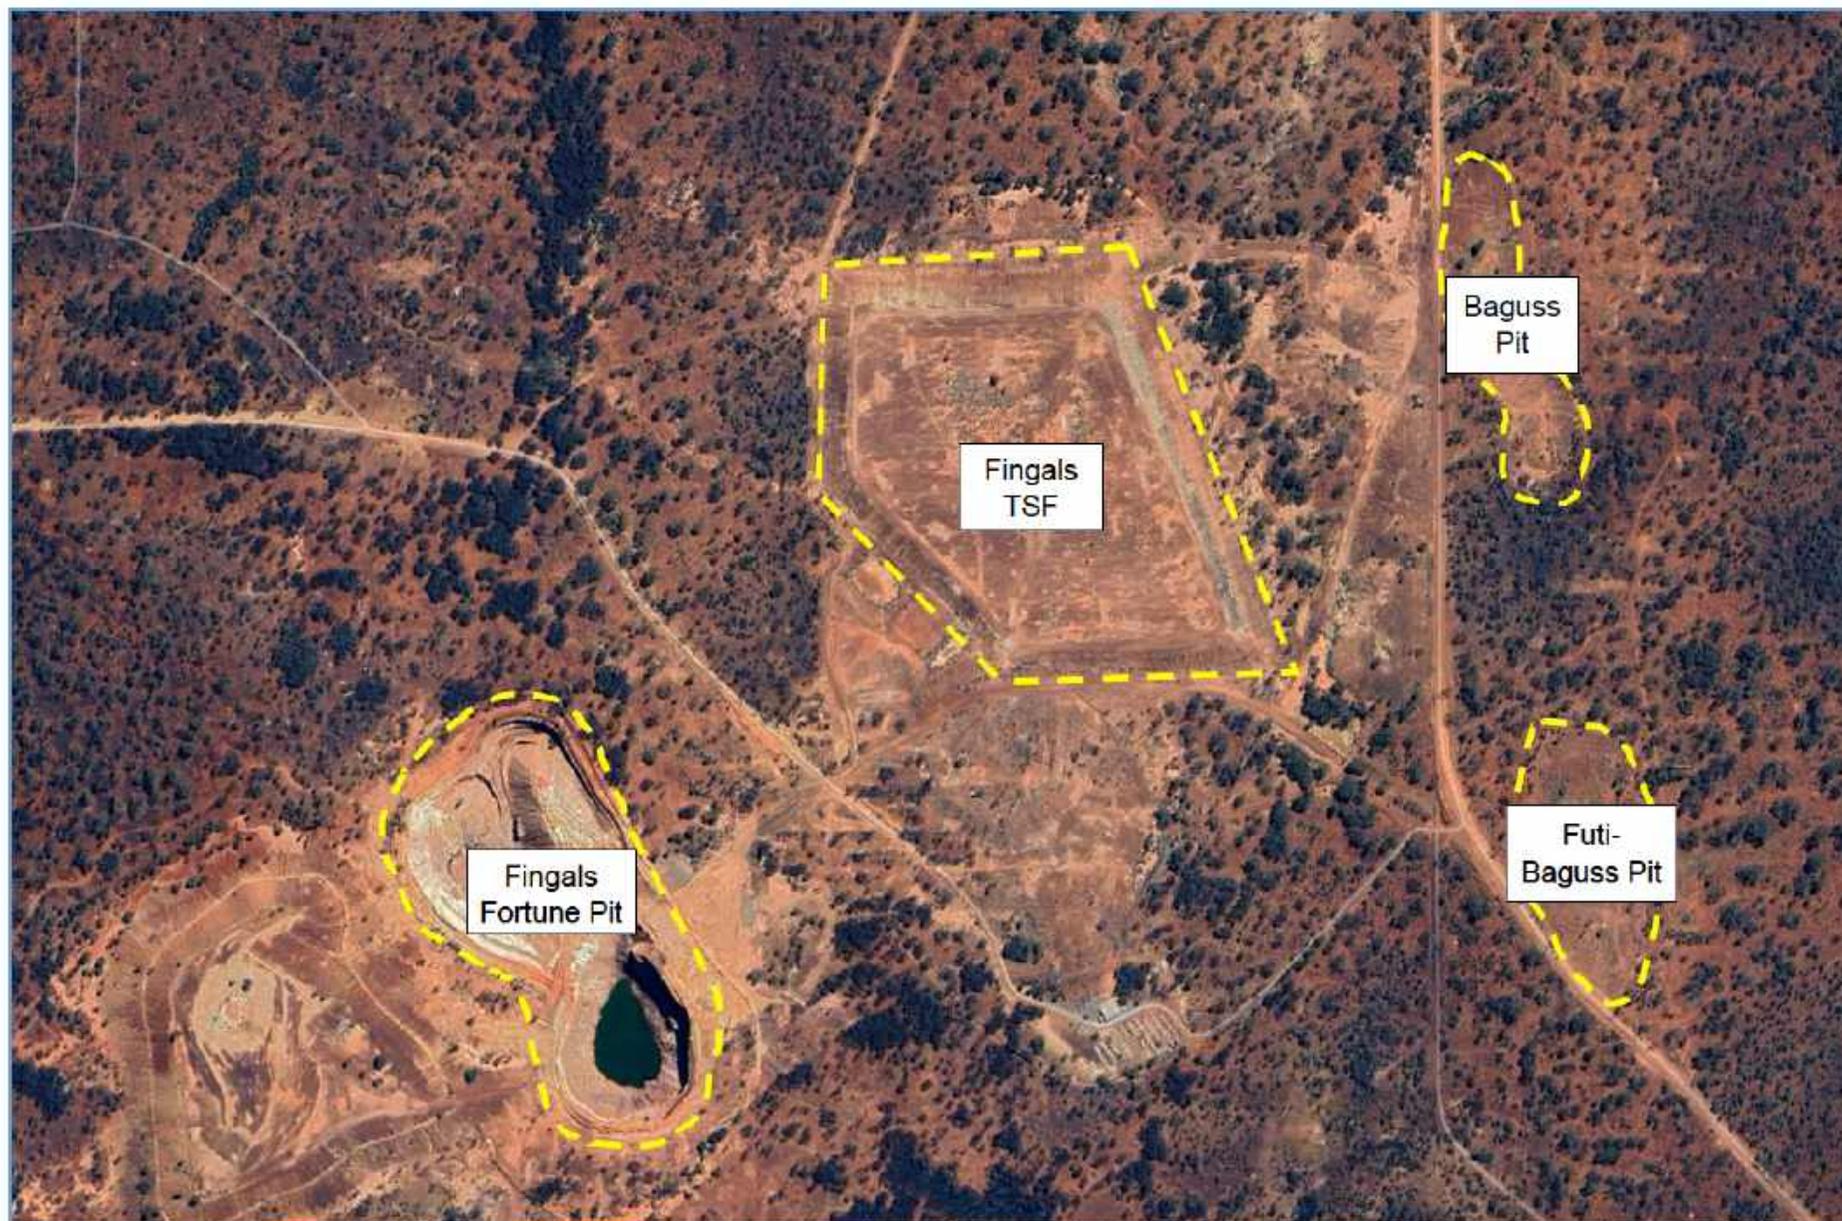
Figure 1-1: General arrangement of Fingals TSF and surrounding open mine pits in-filled with tailings

Black Cat Syndicate (Black Cat) owns the Bulong Gold Project (BGP), located approximately 47 km south-east (approximate location coordinate based on MGA94 datum: 395,150 m Easting, 6,573,770 m Northing) of Kalgoorlie-Boulder, Western Australia comprising the existing Fingals Fortune, Baguss, and Futi Baguss open mine pits that have since being backfilled with tailings. Located adjacent to these pits is the existing above-ground Fingals Tailings Storage Facility (TSF). Black Cat proposes to excavate in-situ tailings from the three (3) surrounding pits and dry-stack the tails onto Fingals TSF. It is understood that the three (3) pits contain up to approximately 750,000 m³ tailings (Baguss: 301,700 m³; Futi-Baguss: 356,200 m³; Fingals Fortune: 115,200 m³). Google satellite imagery illustrating the general arrangement of the pits and Fingals TSF is presented in Figure 1-1 below.

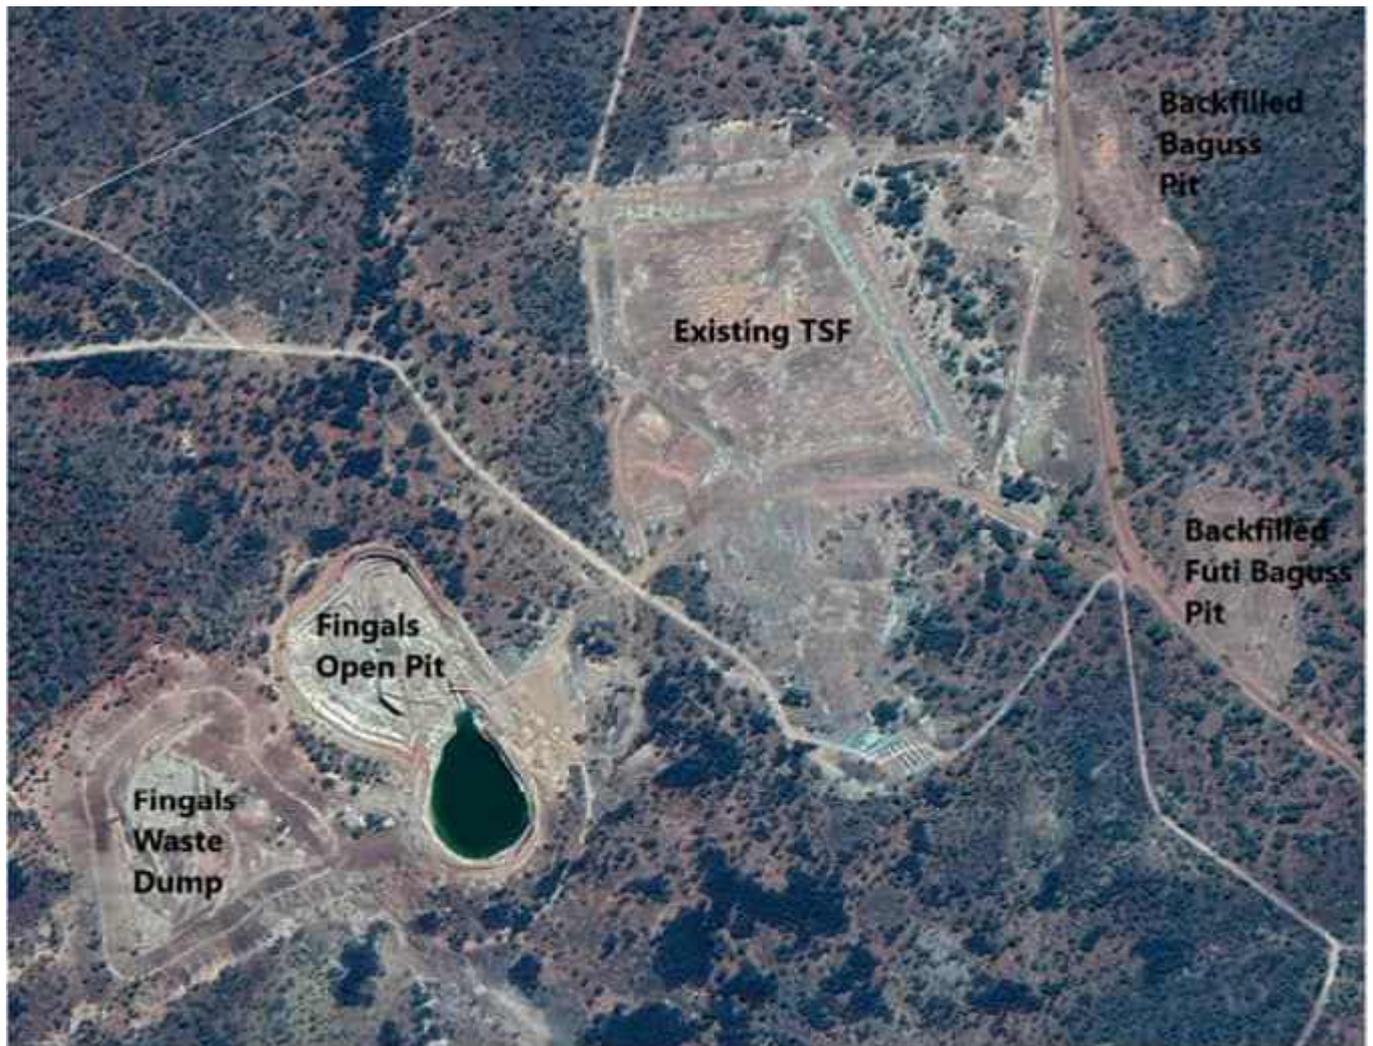
Figure 1: Fingals Open Pit Mine with the existing TSF in the northeast.

A site layout plan is displayed on Figure 1 below:

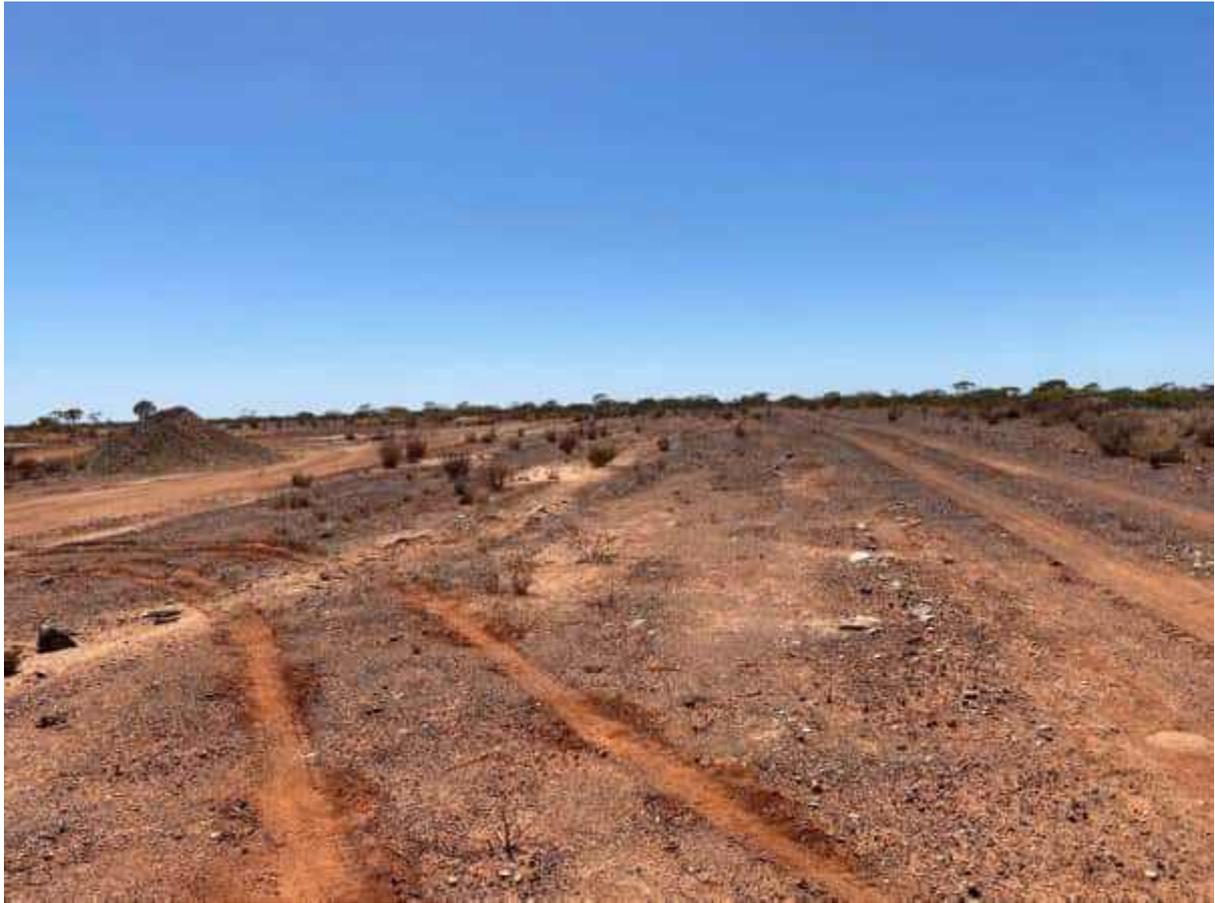
Figure 3: Fingals TSF surface.

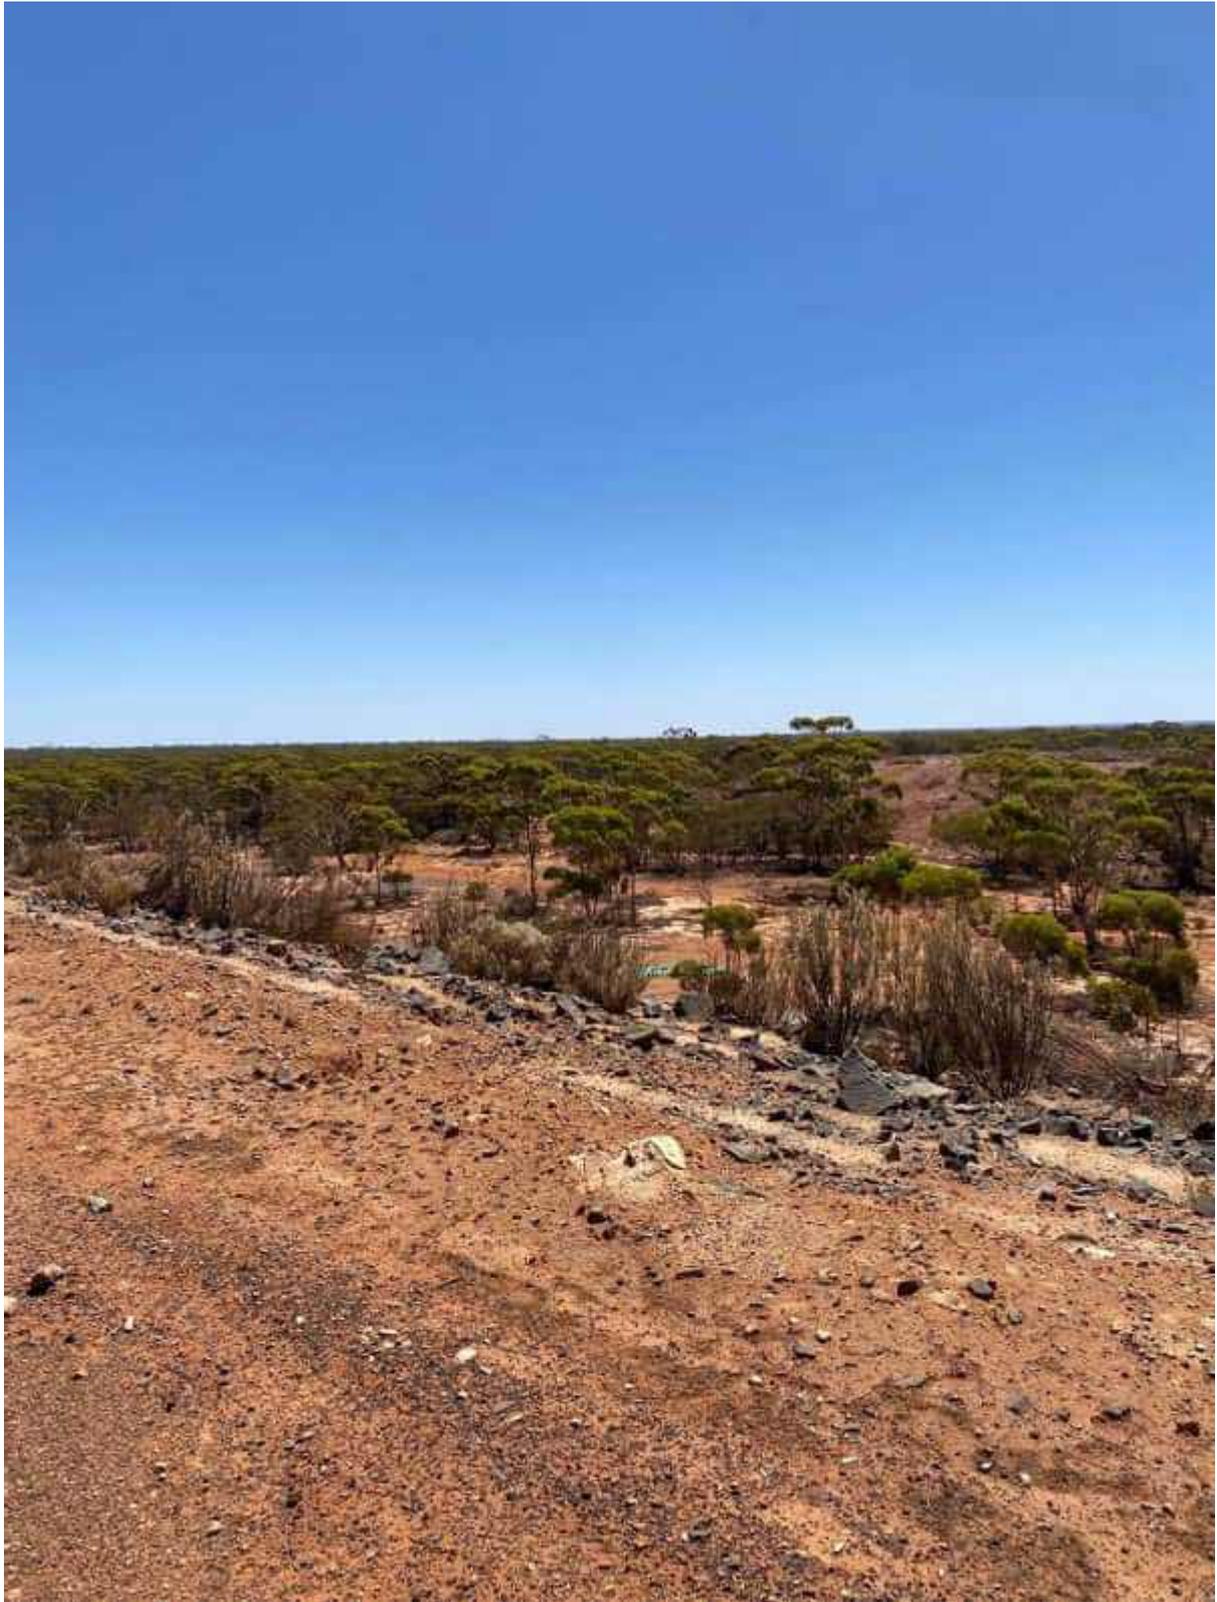
Figure 4: Fingals TSF looking North.

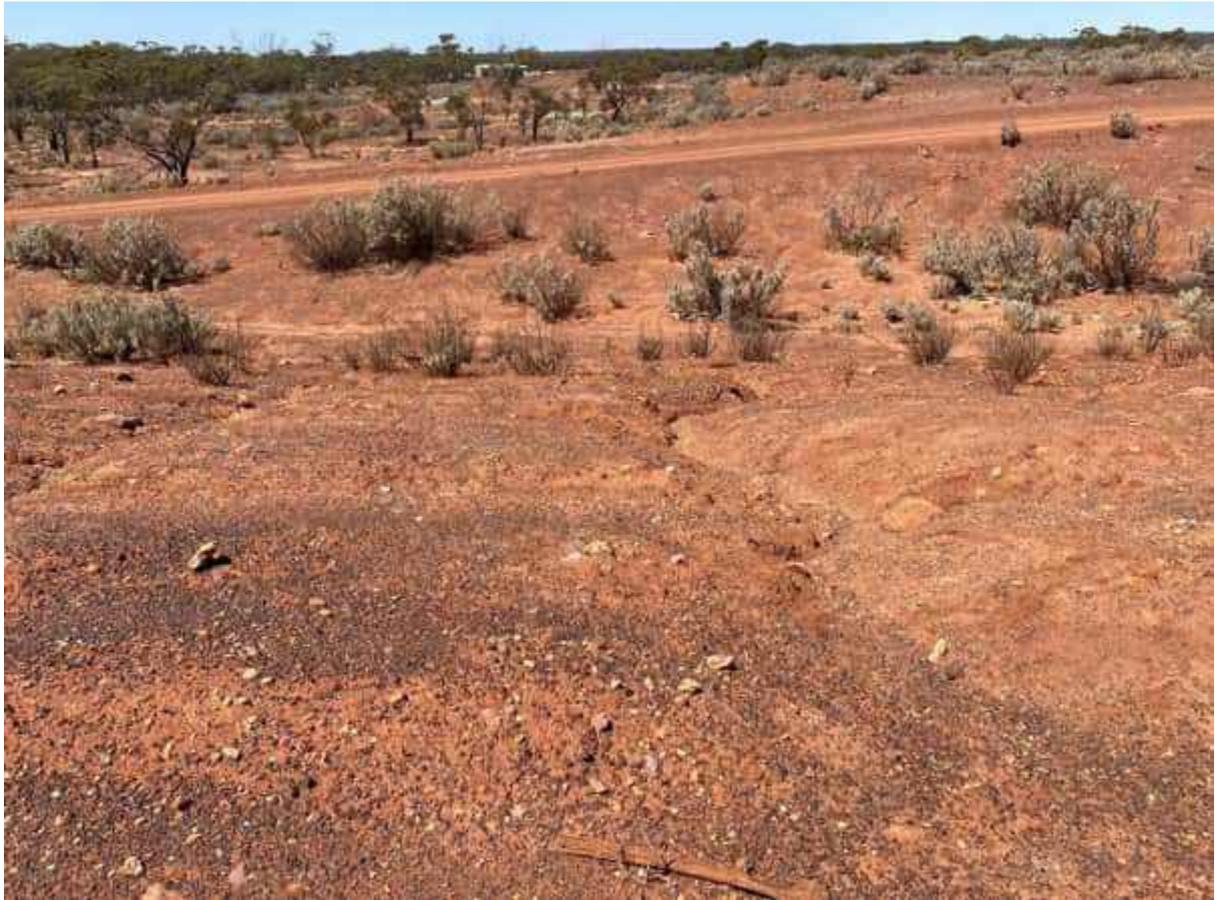
Figure 5: Fingals TSF looking East.

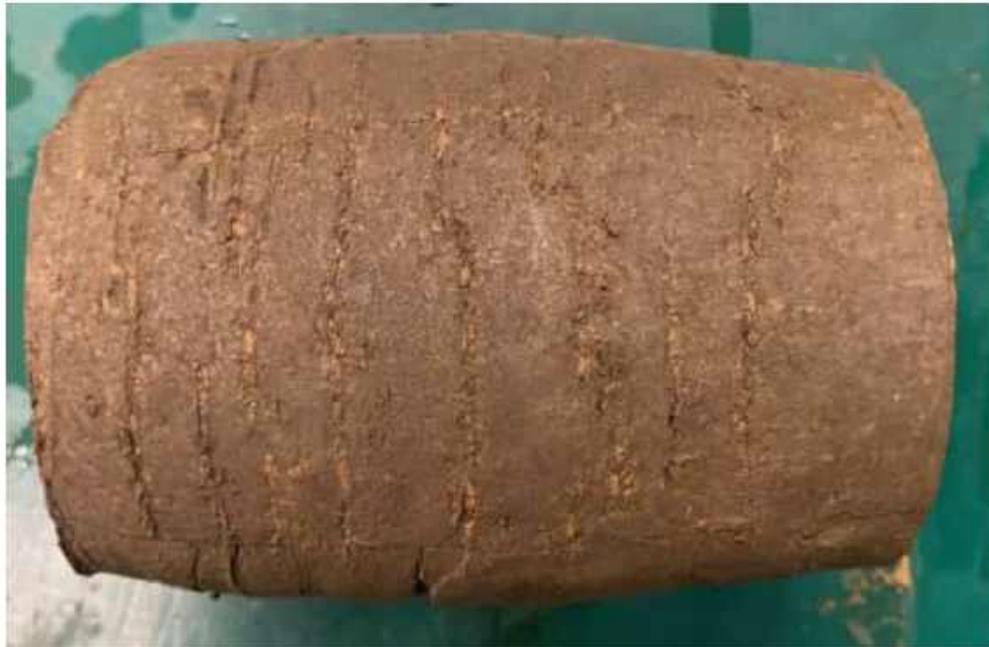
Photo After Test

Sample ID:	TP02	Depth (m):	0.50 - 1.00
Lab ID:	WG22_2634_CU3	Date Tested:	28/02/2022

Failure Mode: Bulging Failure

Notes: Sample remolded to 95% MDD @ OMC

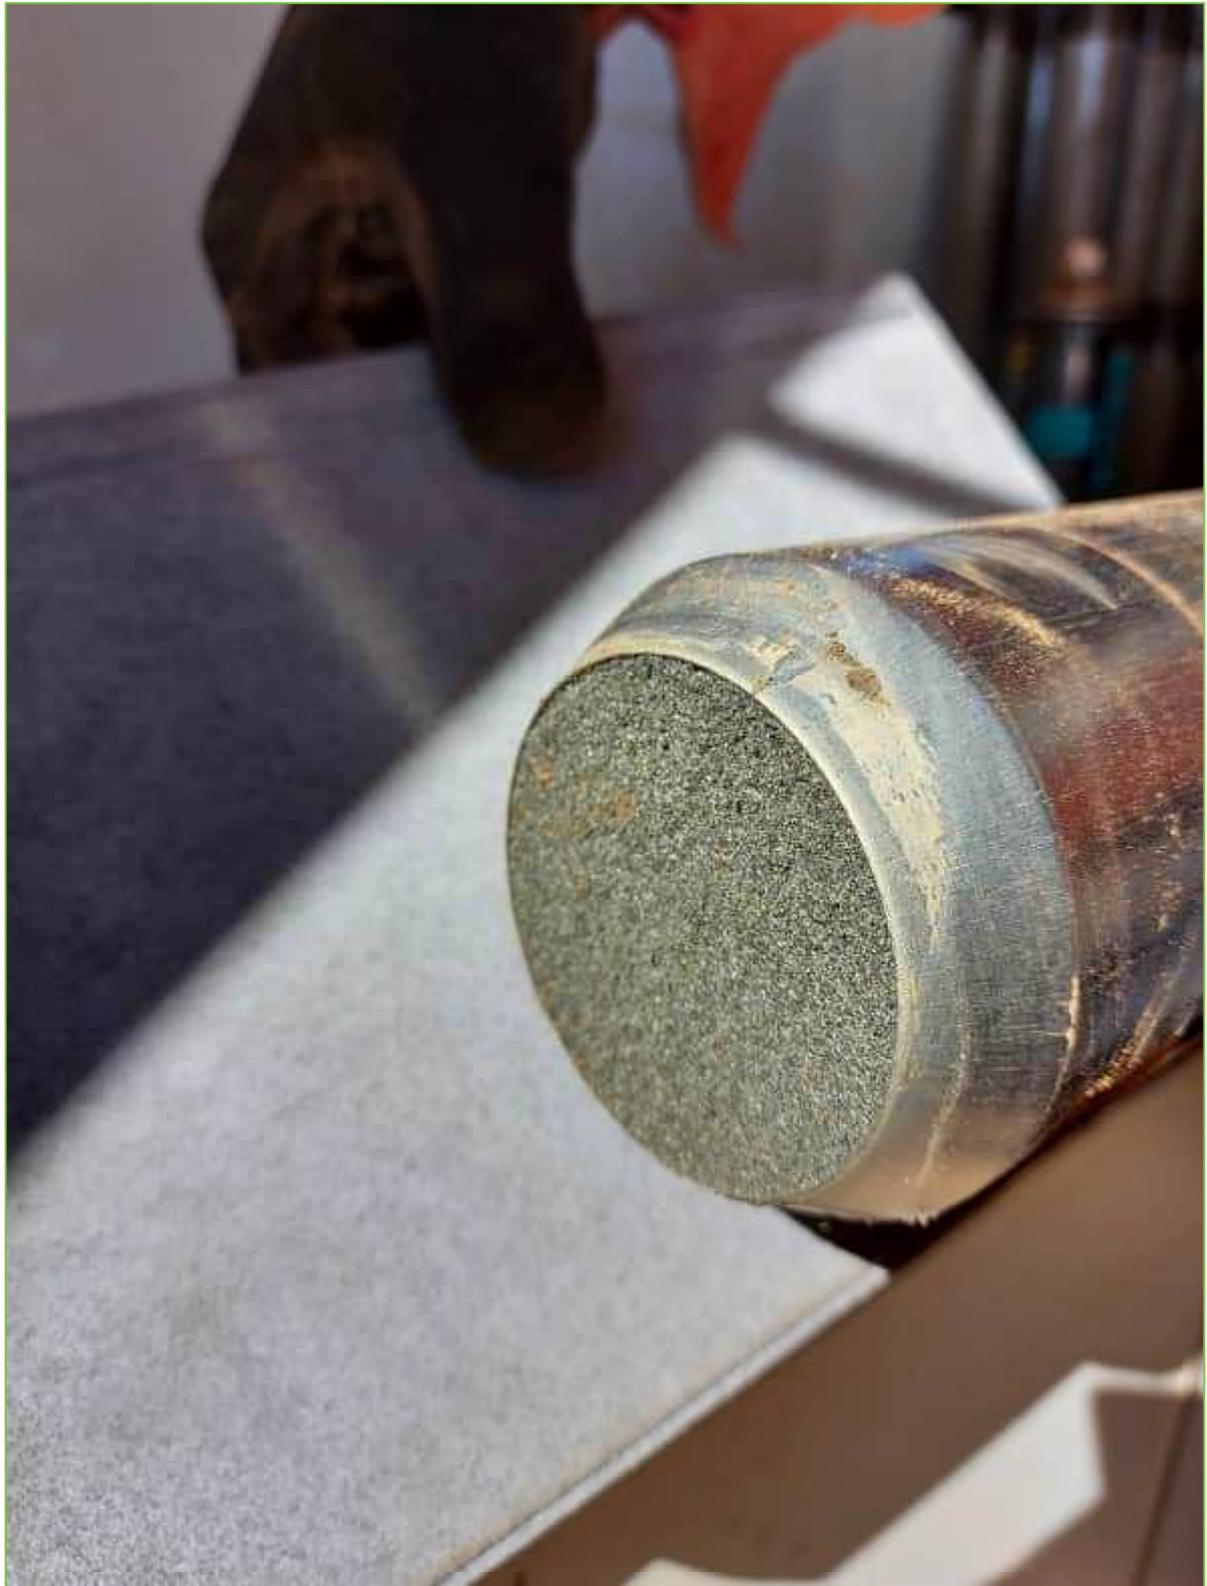
Figure 3-2 Push tube sampler end with extracted undisturbed in-situ Coarse Tailings material

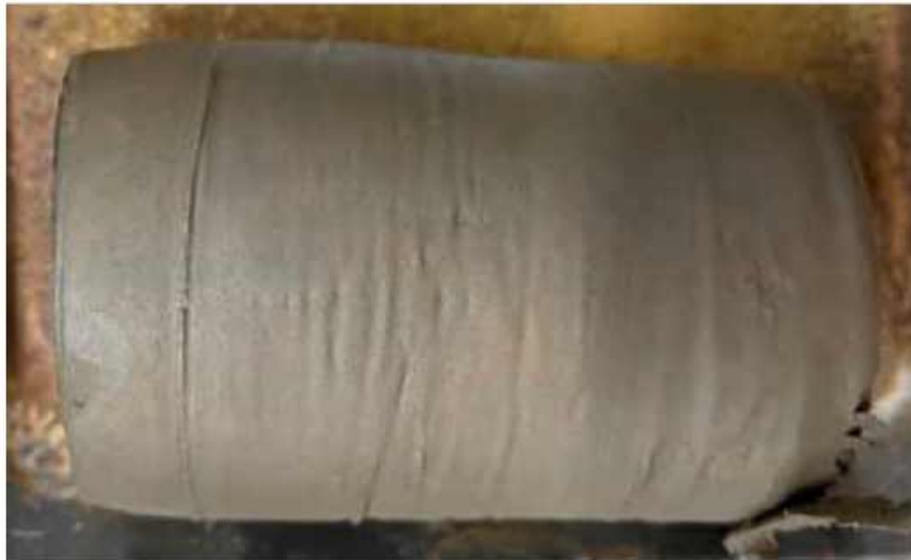
Photo After Test

Sample ID:	CPTU_FB2	Depth (m):	15/01/1900
Lab ID:	CPTU_FB2_15.50_CU3	Date Tested:	01/09/2021

Failure Mode: Bulging Failure

Notes: Sample extruded from tubes

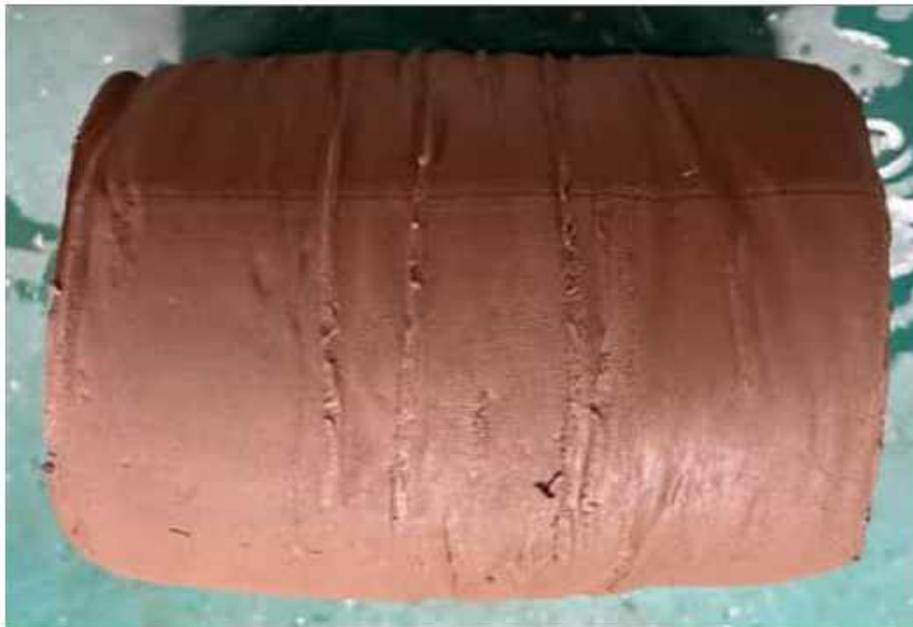
Photo After Test

Sample ID:	CPTU_FB1	Depth (m):	13/01/1900
Lab ID:	CPTU_FB1_13.00_CU3	Date Tested:	01/09/2021

Failure Mode: Bulging Failure

Notes: Sample extruded from tubes
Stored and Tested the Sample as received
Samples supplied by the Client

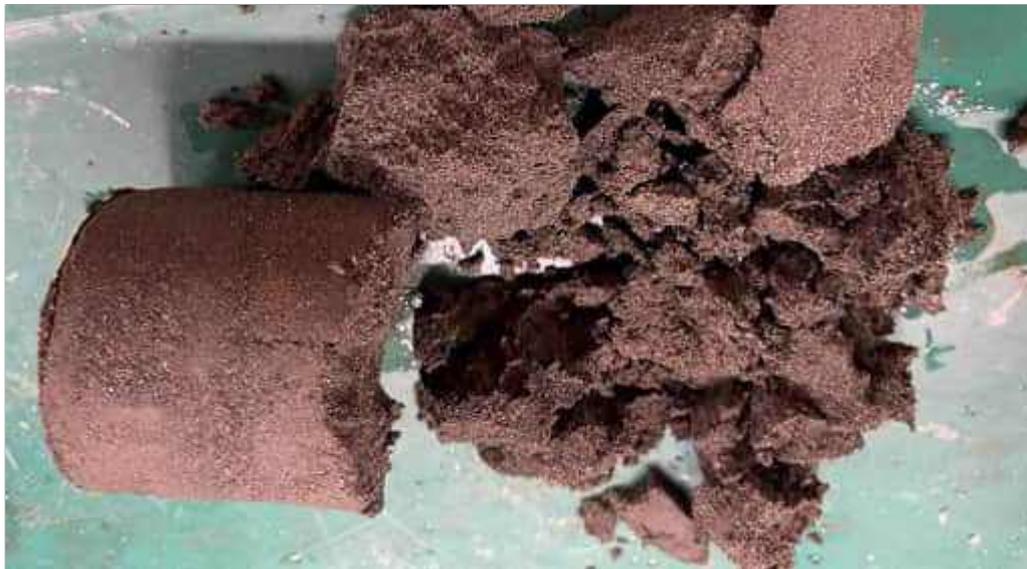
Photo After Test

Client:	Geo Analytica	Date Tested:	02/09/2021
Project:	BC8 Futi Bagus Testing 2021	EP Lab Job Number:	GEO
Sample No:	CPTU_FB1	Lab:	EPLab
Sample ID:	CPTU_FB1_19.00_CD3		
Depth (m):	19	Room Temperature at Test:	~ 18°C

Failure Mode: Bulging Failure

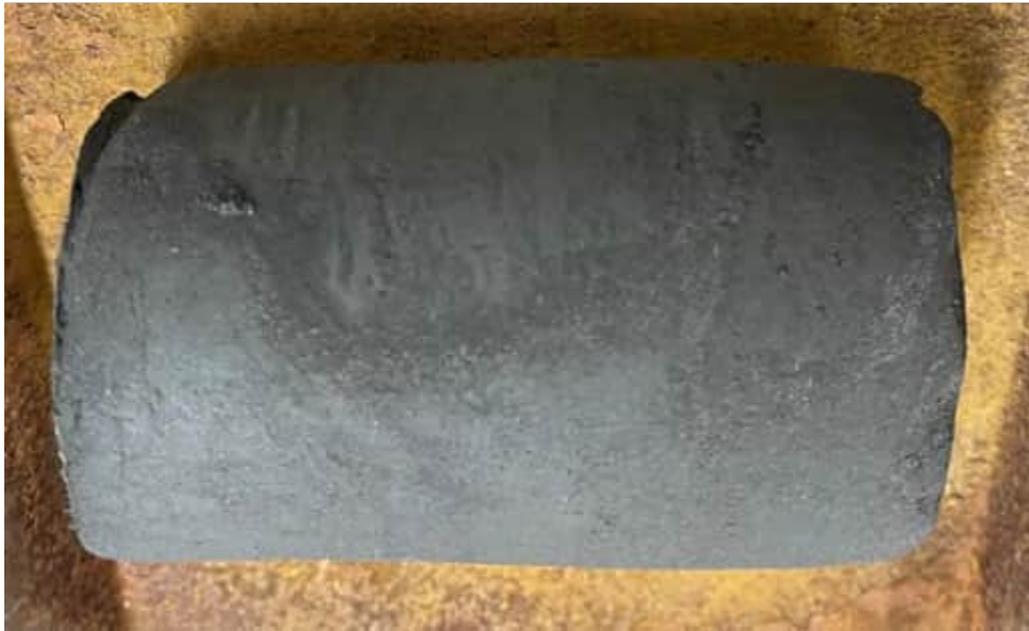
Photo After Test

Client:	Geo Analytica	Date Tested:	02/09/2021
Project:	BC8 Futi Bagus Testing 2021	EP Lab Job Number:	GEO
Sample No:	CPTU_FB2	Lab:	EPLab
Sample ID:	CPTU_FB2_21.00_CU3		
Depth (m):	21	Room Temperature at Test:	~ 18°C

Failure Mode: Bulging Failure

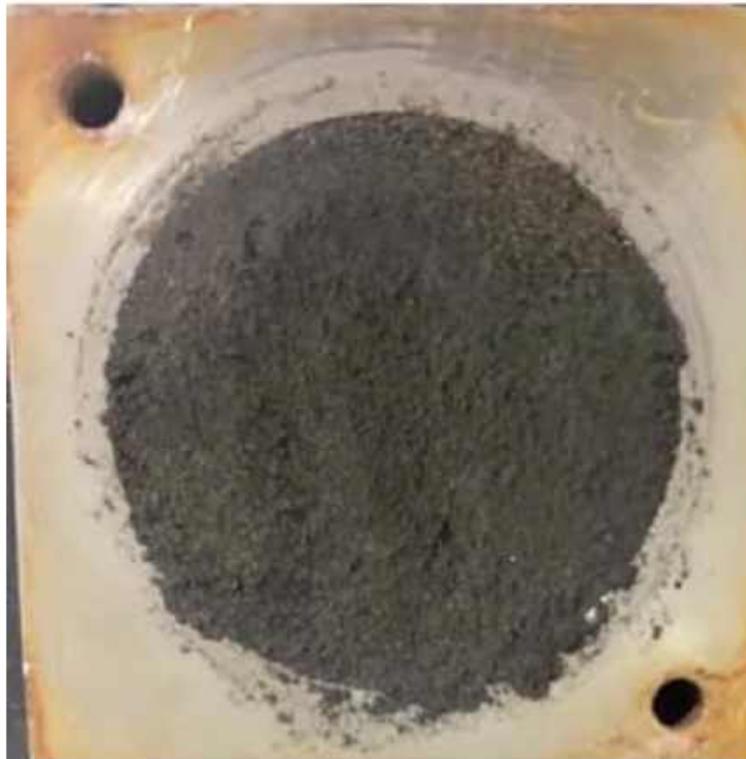
Photo of Sample Post Testing

Client:	Geo Analytica	Date Tested:	02/09/2021
Project:	BC8 Futi Bagus Testing 2021	EP Lab Job Number:	GEO
Sample No:	CPTU_FB1	Lab:	EPLab
Sample ID:	CPTU_FB1_19.00_IDST3		
Depth (m):	19	Room Temperature at Test:	20°

Stored and Tested the Sample as received
Samples supplied by the Client

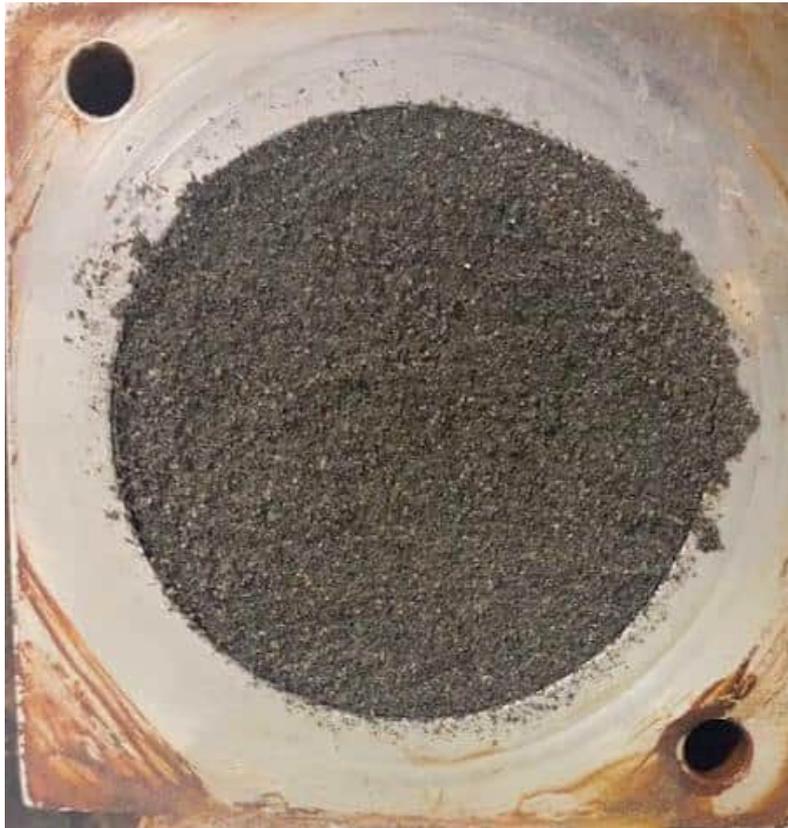
Photo of Sample Post Testing

Client:	Geo Analytica	Date Tested:	02/09/2021
Project:	BC8 Futi Bagus Testing 2021	EP Lab Job Number:	GEO
Sample No:	CPTU_FB3	Lab:	EPLab
Sample ID:	CPTU_FB3_19.00_IDST3		
Depth (m):	19	Room Temperature at Test:	20°

Stored and Tested the Sample as received
Samples supplied by the Client
