17.2 Appendix 2. Tailcon (2025a). TSF3 Detailed Design Report

ROX Resources Limited

Youanmi Gold Project

TSF3 Design Report

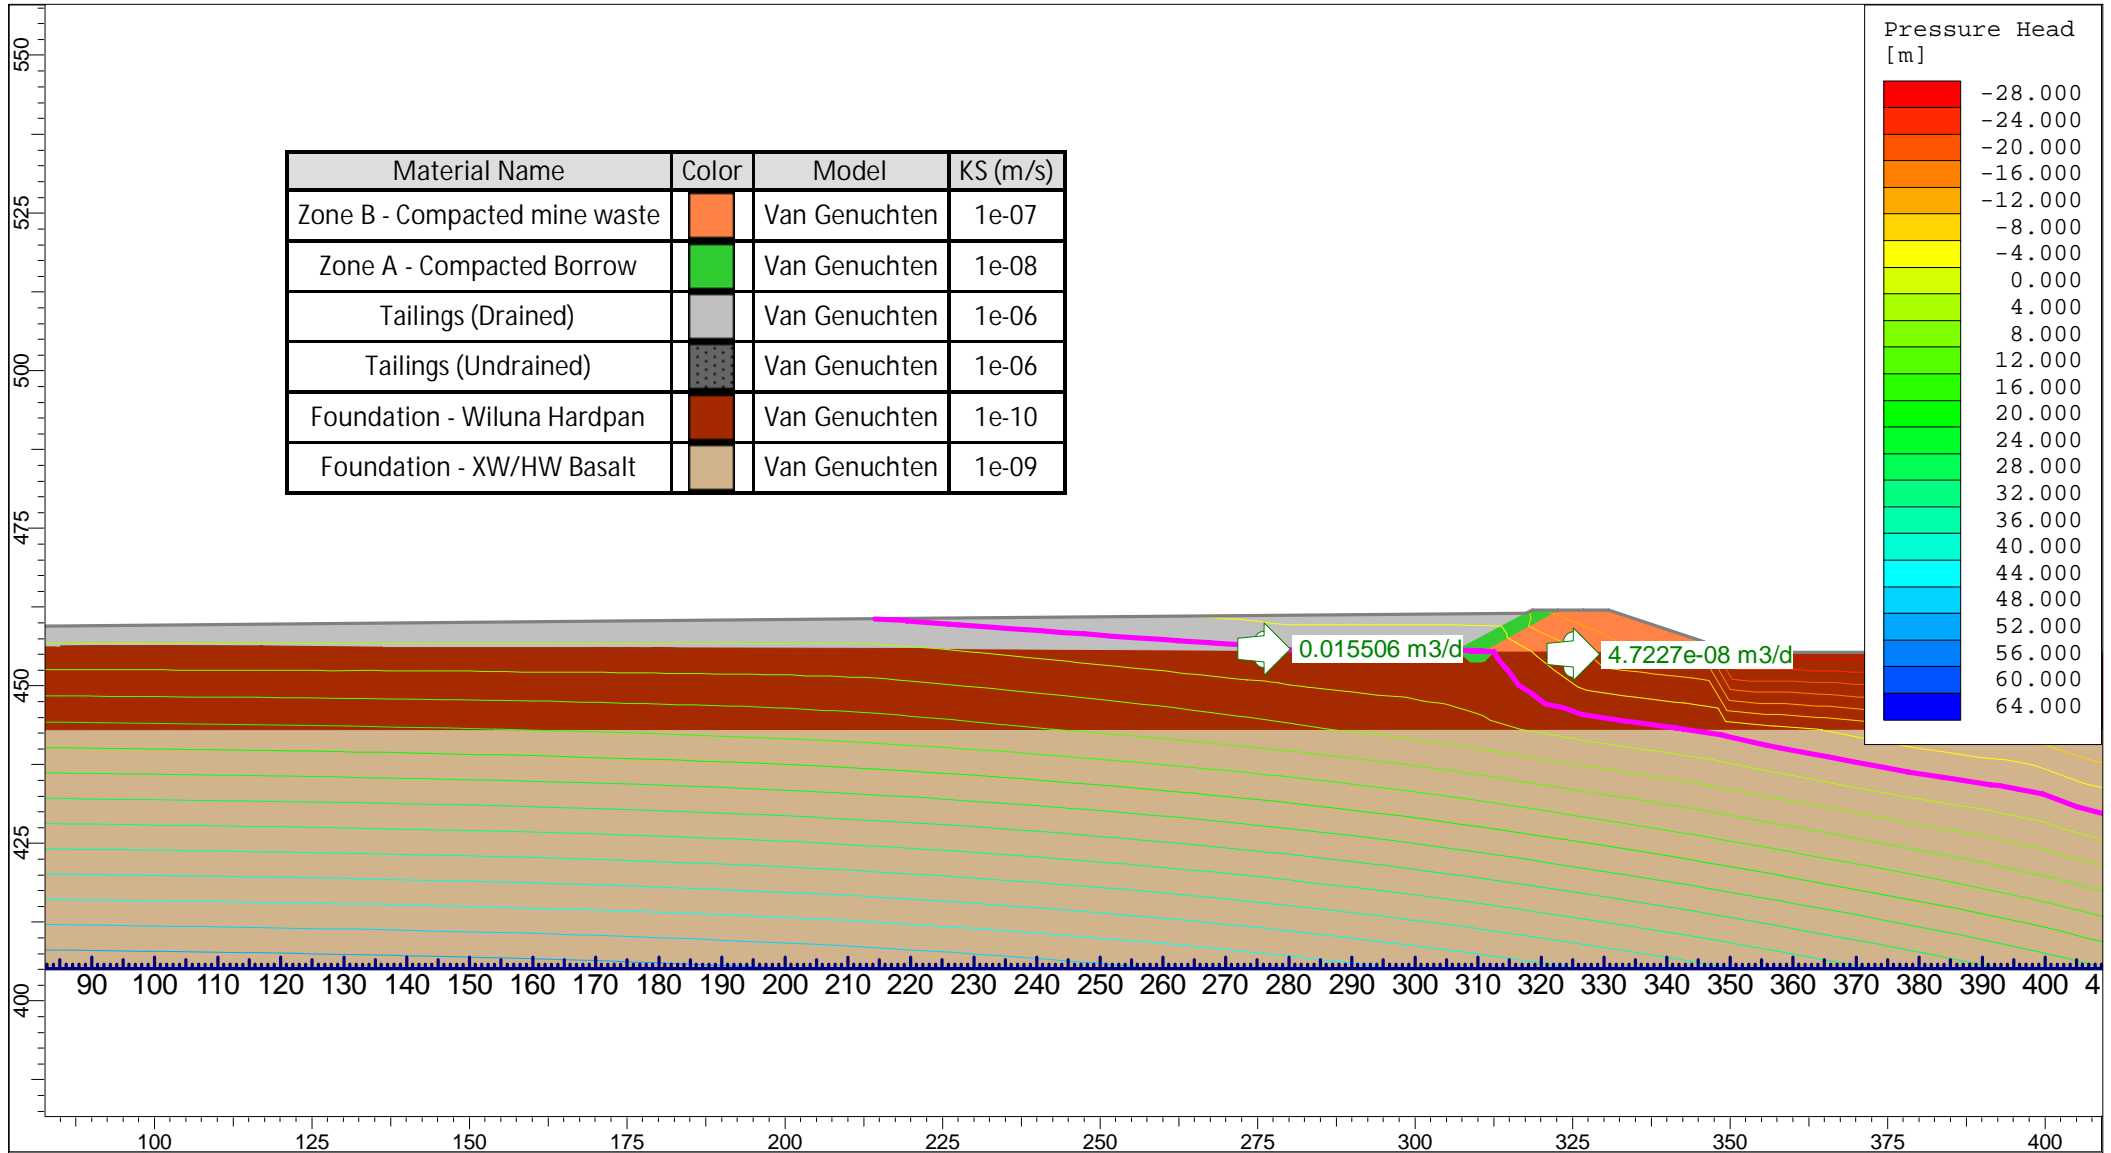
Project				YOUANME TSF3	
	Analysis Description				TSF3 South Section-Starter Wall	
	Drawn By	SW	Scale	1:1200	Paper Size	A4
	Date	24/07/2025		Scenario Name	Seepage Results	
<small>SLIDEINTERPRET 9.038 C:\Users\sonam\TAI\CON PROJECTS\PTY LTD\TailCon Projects - Documents\Design\Slide\YGP\critical section-south embankment.sw.model.rev1.sldm</small>				File Name	critical section-south embankment.sw.model.rev1.sldm

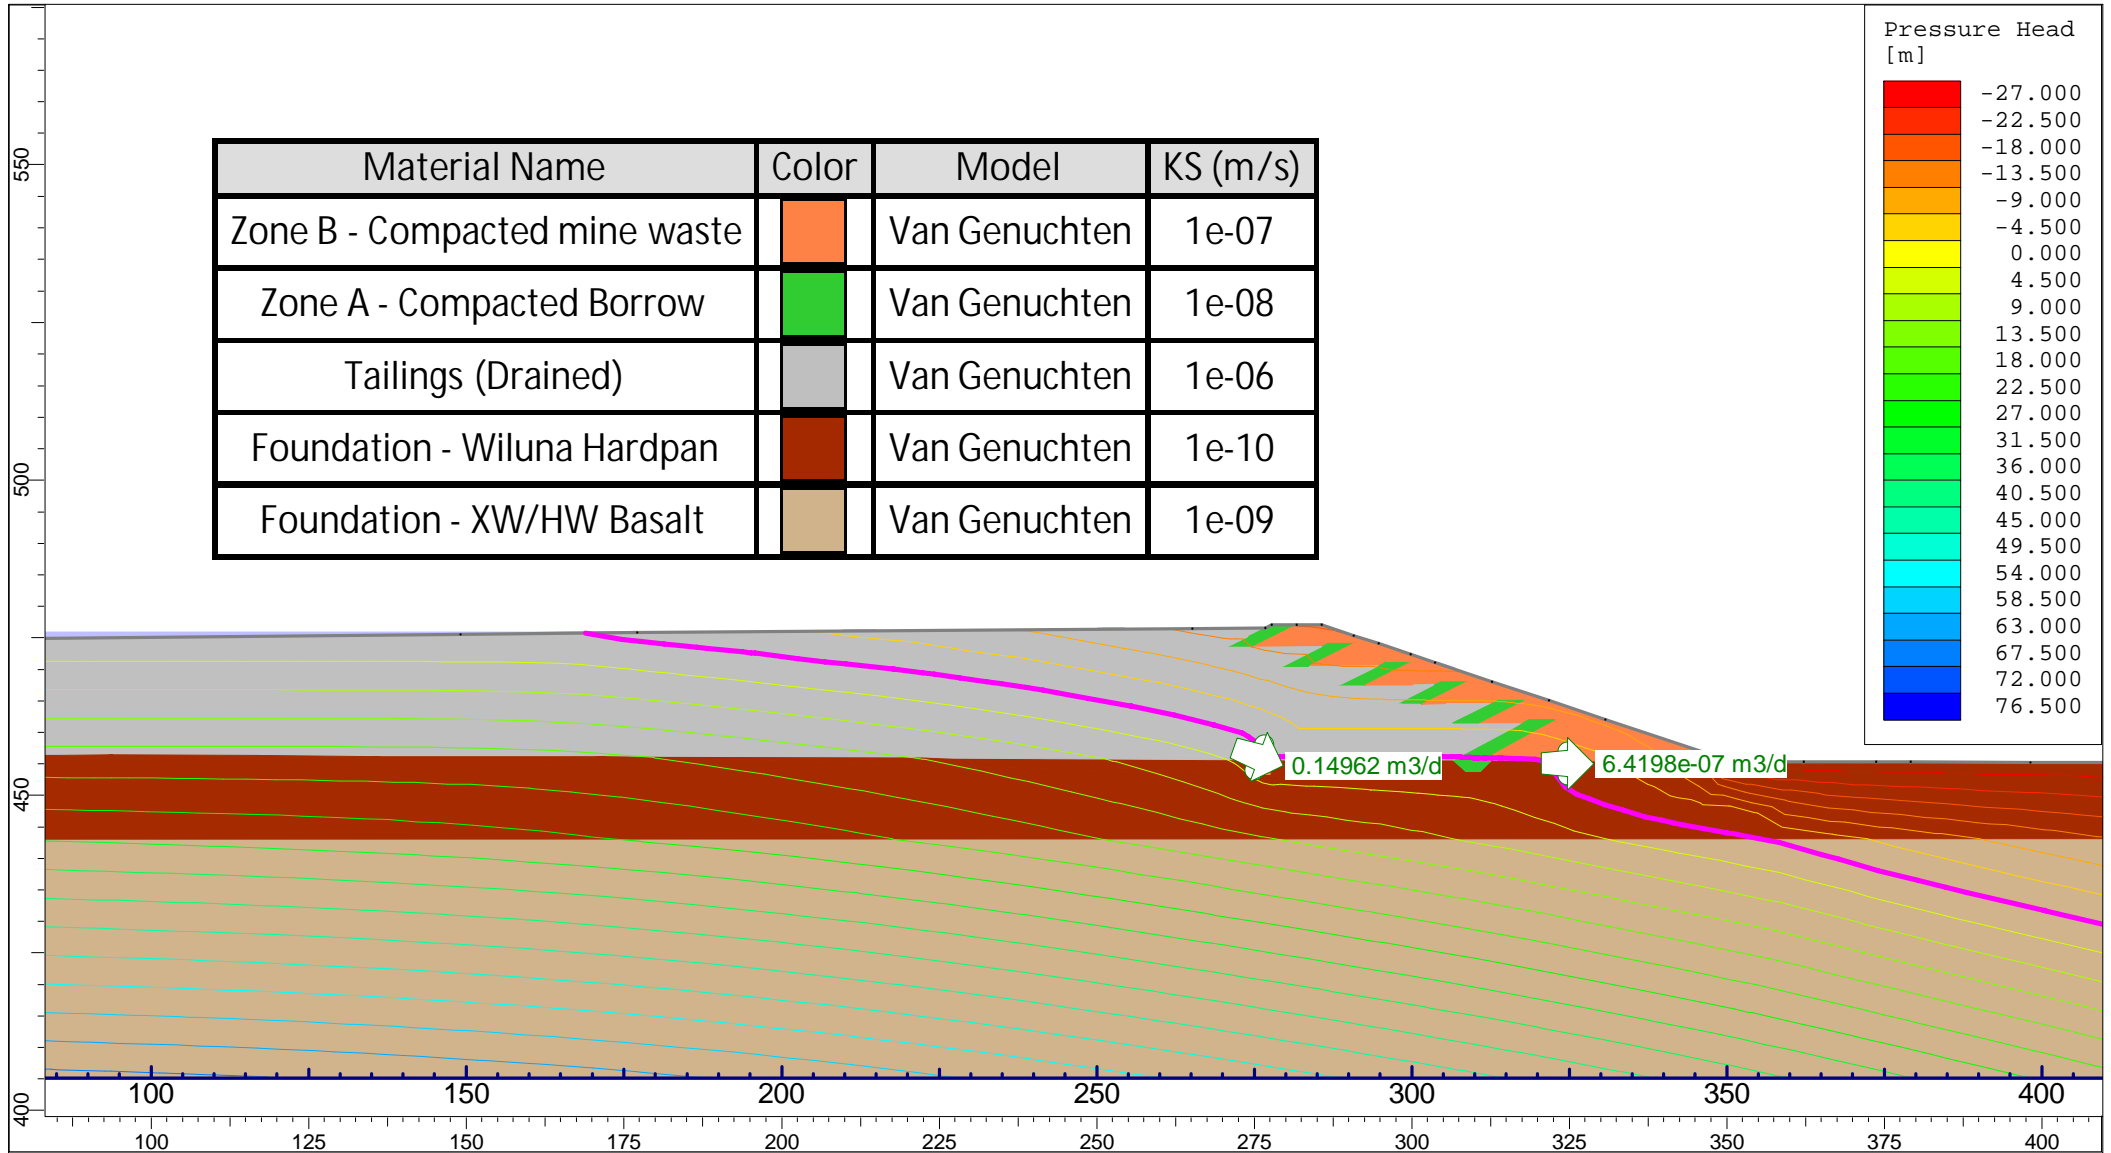
Project				YOUANME TSF3	
	Analysis Description				TSF3 South Section-Final Stg	
	Drawn By	SW	Scale	1:1200	Paper Size	A4
	Date	24/07/2025			Scenario Name	Seepage Results
<small>SLIDEINTERPRET 9.038 C:\Users\sonam\TAI\CON PROJECTS\PTY LTD\TailCon Projects - Documents\Design\Slide2\YGP\critical section-south embankment sw model rev1.sldm</small>				File Name	critical section-south embankment.sw.model.rev1.sldm

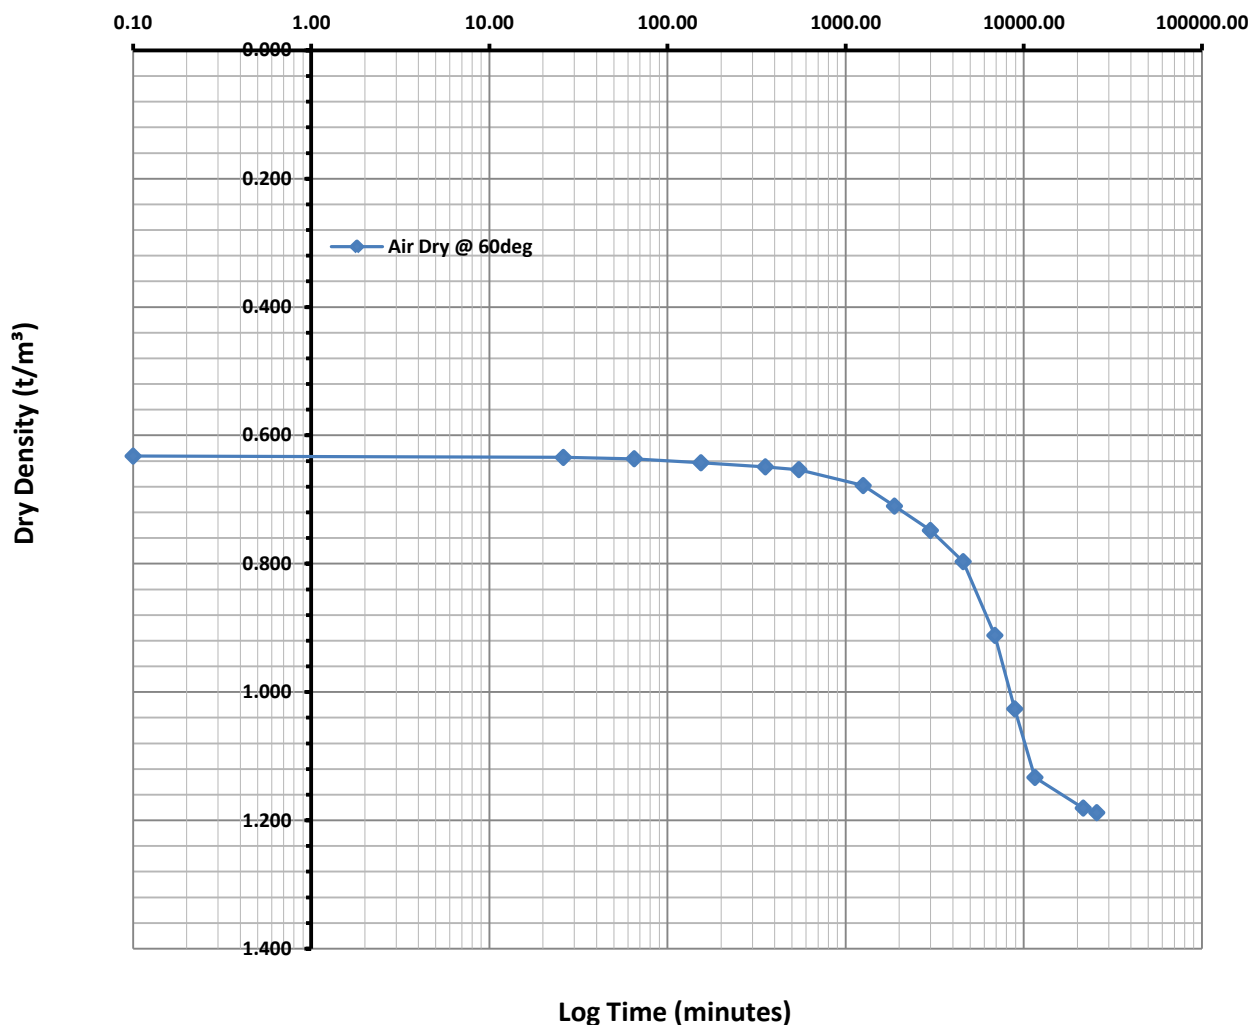
Dry Density (t/m³) Vs Time (minutes)

An air-drying test is carried out on a tailings slurry sample to determine the effect of natural drying on the tailings after initial settlement and removal of supernatant water, thereby simulating conditions expected following sub-aerial deposition. Continuous monitoring of the weight and volume of the specimen is carried out to quantify the relationship between dry density, moisture content, volumetric change, and the degree of saturation of the tailings.

The result indicates that peak dry density can be achieved after approximately 7 days, refer to Appendix D for results. It should be noted that the air-drying results do not account for summer/winter cycles and are conducted at 60° C for the duration of the test.
