Application to amend works approval

Works approval number L9111/2018/1

Applicant City of Kalamunda

Premises Walliston Transfer Station
155 Lawnbrook Road West
Walliston WA 6076

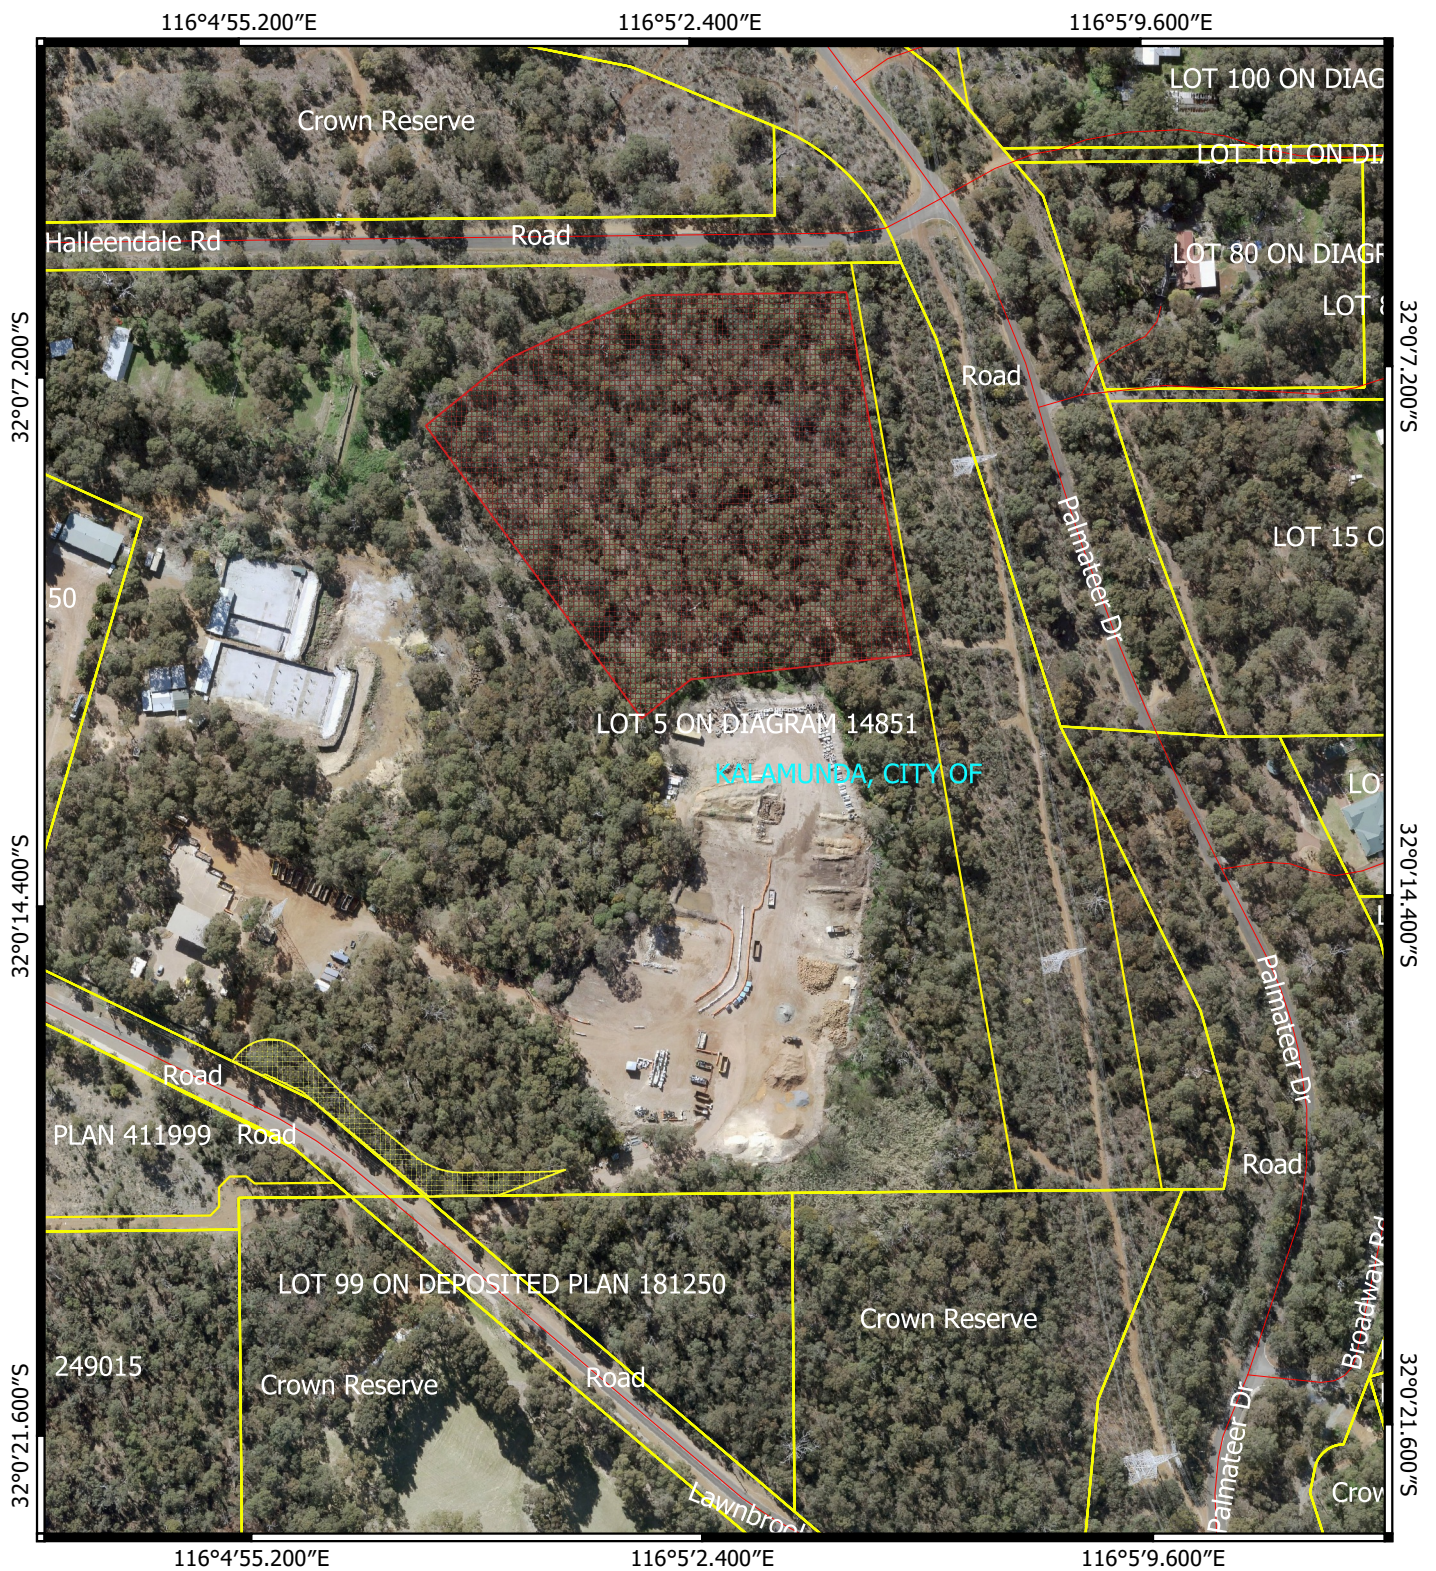
- g) The artificial black cockatoo nest hollow(s) required by condition 5(e) of this Permit must:
 - i. be installed within the area cross-hatched red on attached Plan 8733/1 being a portion of Lot 5 on Deposited Plan 14851;

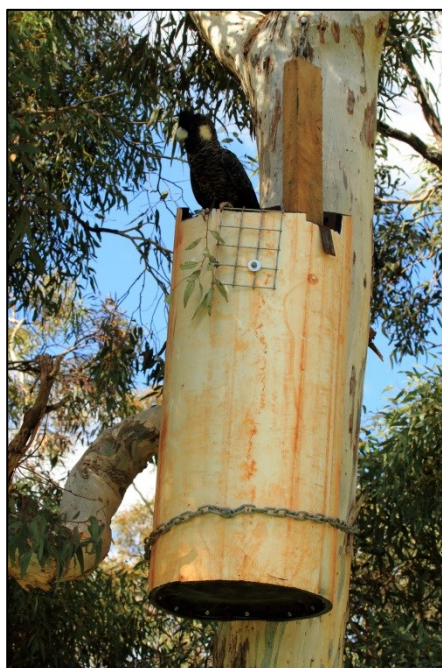
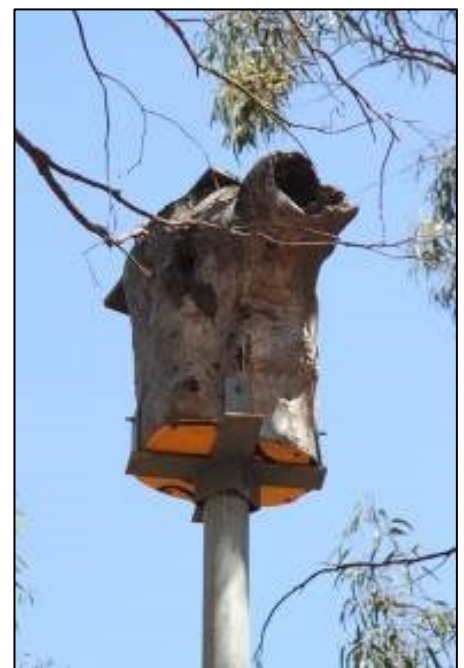
Below are three examples of successful artificial hollows used by Carnaby's cockatoo for nesting. Artificial hollows made from a natural log with cut side entrance (left), white industrial pipe with top entrance (centre) and natural log with natural side entrance (right).

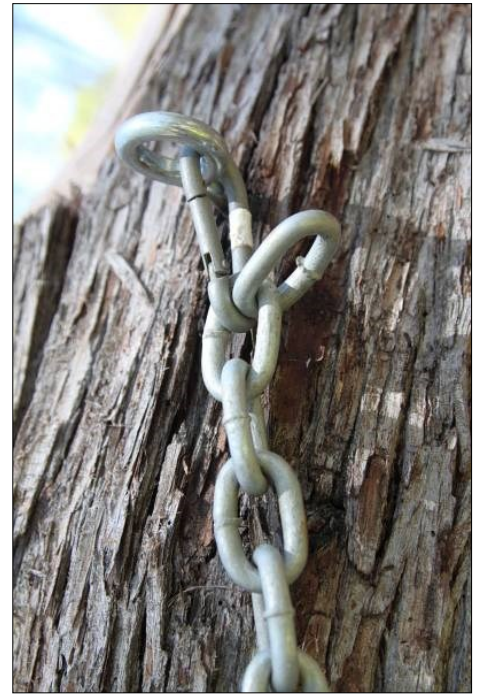
Example fixing for artificial hollow
Photo by Christine Groom
