Decision Report

Application for Licence

Licence Number	L9293/2021/1
Applicant ACN	Silver Lake (Rothsay) Pty Ltd 151 137 450
File Number	DER2021/000158
Premises	Rothsay Gold Project Mining Tenements M59/39, M59/40 and L59/24 PERENJORI WA 6620
	As defined by the Premises maps attached to the issued licence
Date of Report	8 November 2021
Decision	Licence granted

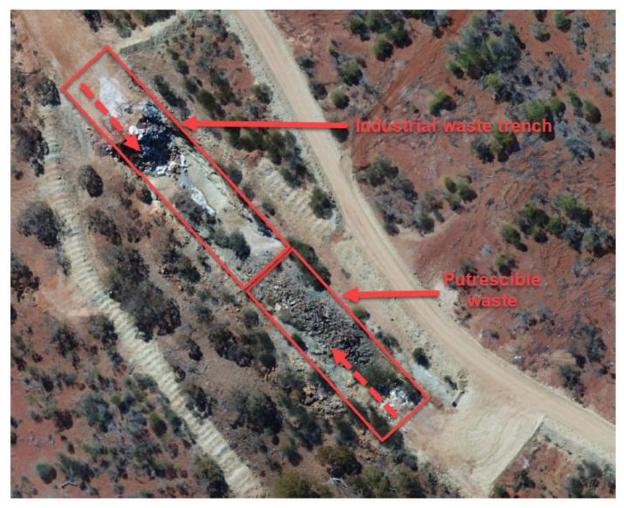
Figure 6: Landfill as constructed

The putrescible landfill was constructed under works approval W6195/2018/1 and Environmental Compliance Report received. It is established in the Woodleys open pits, Woodleys North and Woodleys South pits, for the disposal of up to 500 tonnes per annum of putrescible waste and up to 200 tyres.

Figure 6 shows the landfill as constructed.

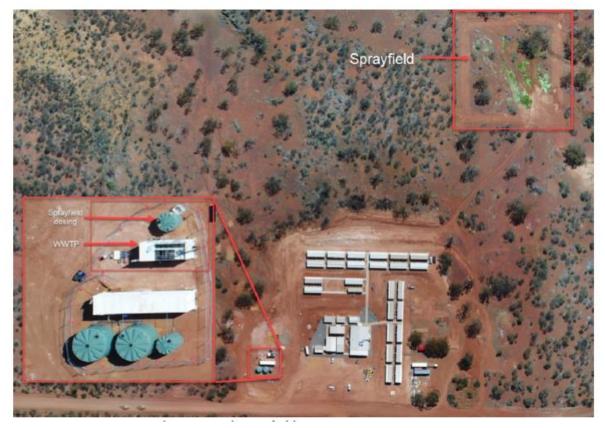
Figure 7: As constructed WWTP and sprayfield aerial view

The WWTP and sprayfield was constructed under works approval W6195/2018/1 and Environmental Compliance Report received. A 25 m³ per day WWTP has been installed that uses an active biological treatment process using a Submerged Aerated Filter (SAF). Biosolids from the sludge tank are pumped out as required by a licensed contractor and disposed of offsite to a licensed facility.

A 0.81ha irrigation spray field has been installed that consists of four sprinkler areas within a designated fenced compound. Treated effluent from the irrigation tank is transferred by a pipeline that runs adjacent to the access road.

Figure 7 shows the as constructed WWTP and sprayfield.
