## Application for Licence

### Part V Division 3 of the *Environmental Protection Act 1986*

<b>Licence Number</b>	L9444/2024/1
<b>Applicant</b>	Matters Enterprises Pty Ltd Trading as RUBBERGEM
<b>ACN</b>	090 053 384
<b>File number</b>	DER2024/000271 & APP-0026144
<b>Premises</b>	Rubbergem 1228 & 1250 Rockingham Road (via Henry Street, off Hope Valley Road)  Legal description Lot 18 and Lot 19 on Diagram 19020 Lot 18 Certificate of Title Volume 1193 Folio 623 Lot 19 Certificate of Title Volume 1838 Folio 629 As defined by the coordinates in Schedule 2 of the licence
<b>Date of report</b>	7 October 2025
<b>Decision</b>	Licence granted

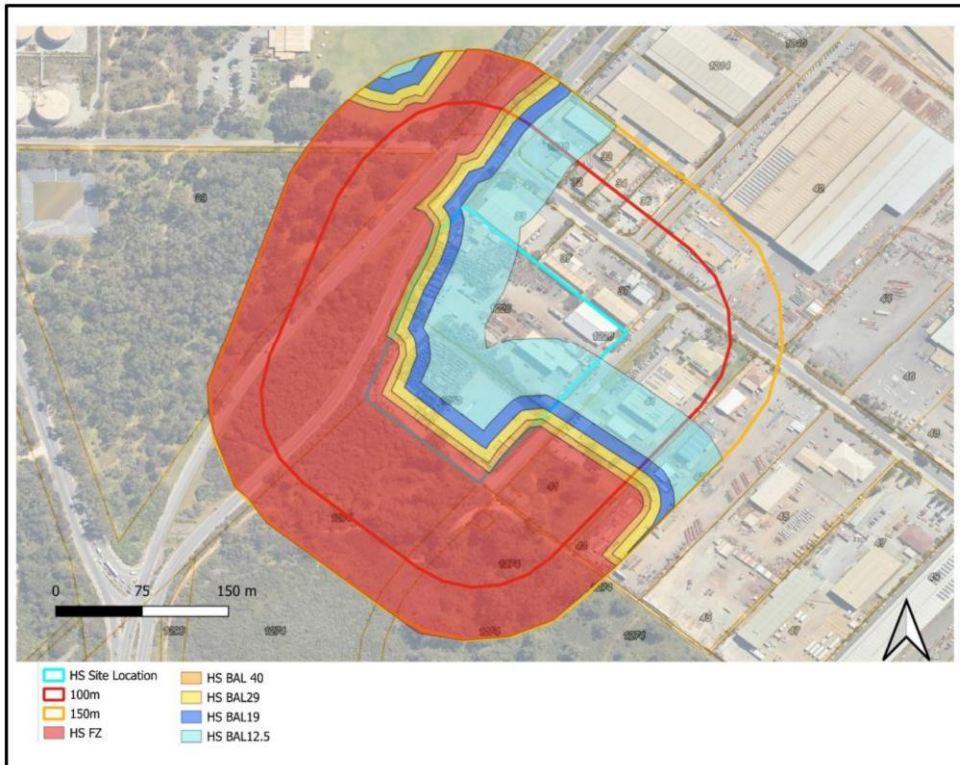
**Figure 4: BAL contour map with the red area denoting BAL-Flame Zone rated bushland.**

As the premises is within a bushfire prone area, a Bushfire Attack Level (BAL) assessment was carried out by TESH Fire Engineering Pty Ltd on behalf of the applicant on 26 July 2024 to determine the overall level of bushfire risk to the premises. An assessment of vegetation, slope and fuel load was conducted by a qualified engineer to determine BAL ratings. BAL ratings range from BAL-Low (the lowest risk) to BAL-Flame Zone (the highest risk) as shown in Figure 3, Figure 4 and Table 4.

The BAL assessment has determined this area to have a BAL Flame Zone (FZ) rating. A BAL Flame Zone (FZ) is required to adhere to *State Planning Policy 3.7* bushfire prone legislation and poses a risk to the premises of ember attack, radiant heat and/or direct flame contact.

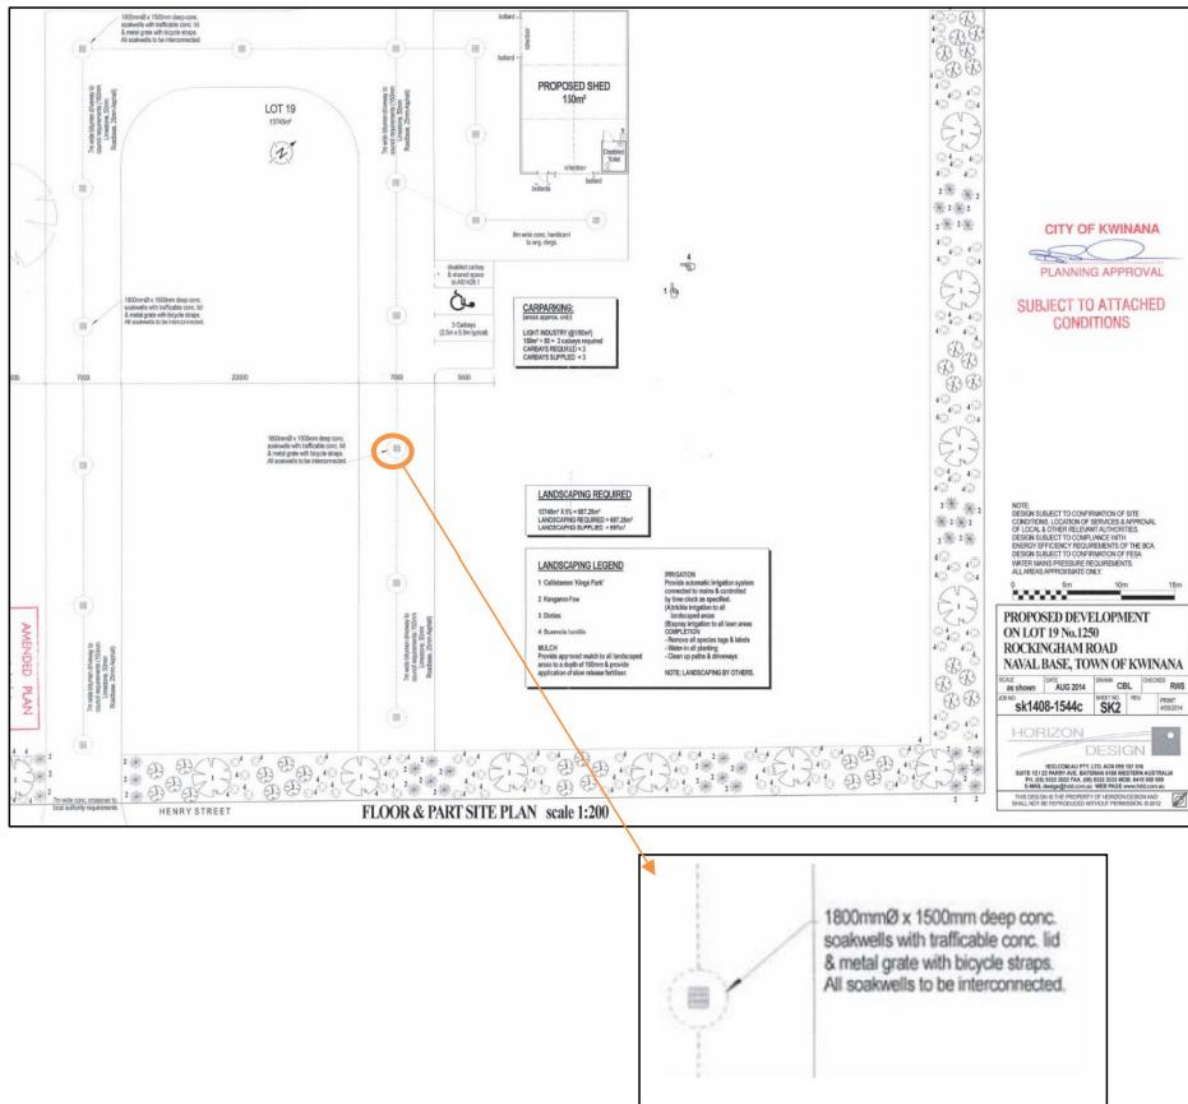
According to the proposed development plan approved by the City of Kwinana for Lot 19 (dated August 2014), the site drainage system consists of 17 interconnected drains (soakwells) each 1800 mm diameter x 1500 mm deep as shown in **Figure 5**.

**Figure 5: Arrangement of interconnected on-site soakwells**

There is no bunding or containment surrounding the on-site hardstand areas. The site slopes downwards in a southerly direction; therefore, firefighting water run-off will move predominately towards unlined sumps and drains within and adjacent to the premises and to the bushland area and wetland adjacent to the southern premises boundary (refer to Figure 6). Given existing site drainage and infrastructure, firefighting water run-off is likely to infiltrate into soil with the potential to seep into groundwater located approximately 10 to 12 mbgl.

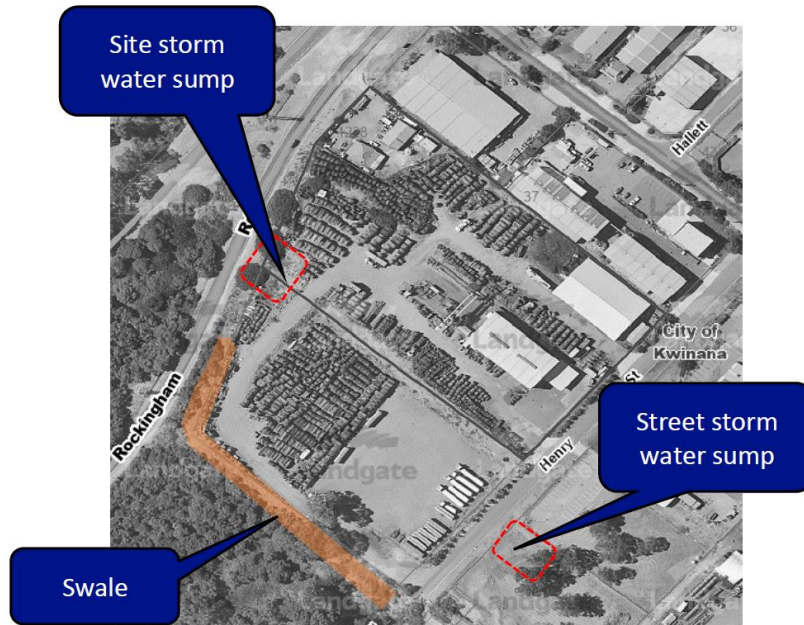
A swale is located adjacent to the southern border of the premises within an area listed as a resource enhancement wetland within the Department of Biodiversity, Conservation and Attractions (DBCA) database. Both compensation basins and on-site soakwells infiltrate to groundwater and therefore provide a pathway for contaminants present in firefighting water to enter the soil and groundwater, with potential to impact sensitive receptors, particularly surrounding wetlands and vegetation.

**Figure 6: Drainage within and adjacent to the premises**

In December 2022, an on-site inspection was conducted at the premises by the department to assess site drainage relating to firefighting water run-off. The assessment noted that there are two compensation basins (stormwater sump and drainage sump) within the premises equating to a total capacity of 1080 m<sup>2</sup>. There is also a 260 m<sup>2</sup> unlined compensation basin (stormwater sump) on Henry St which connects with street stormwater drains. The site drainage does not connect to Cockburn Sound.

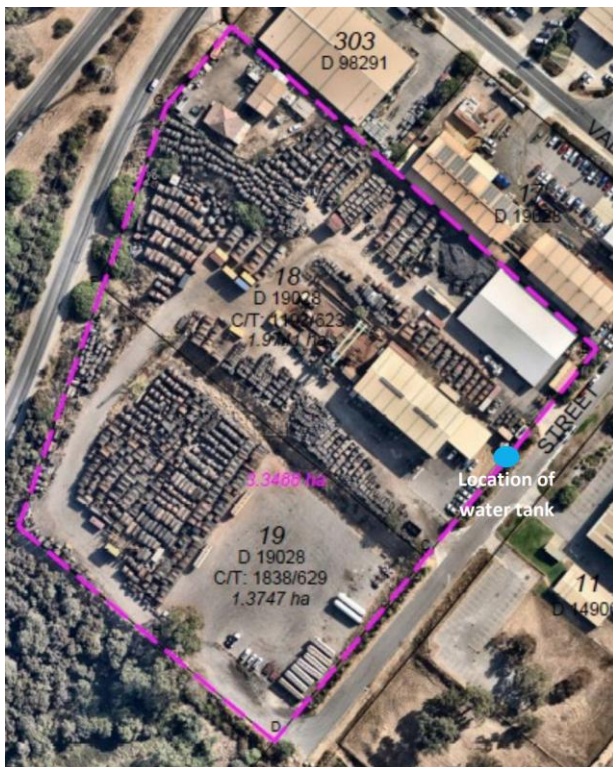
A 25,000 L water tank was installed on the premises, adjacent to the existing rainwater tank (refer to Figure 7) on 10 March 2025 to increase the volume of firefighting water available for firefighting purposes. DFES consulted with TSEG Fire Engineering Pty Ltd (on behalf of Rubbergem) on the 16 October 2024 and advised Rubbergem to install a rainwater tank to provide additional firefighting water during a fire event, as the capacity of the nearby fire hydrant was insufficient. As per *Department of Fire and Emergency Services Built Environment Branch Guideline GL-08* (DFES, 2019), the connectors installed were 125 mm Storz coupling with 100 mm male Camlock coupling, enabling DFES to connect to the water supply in a fire event.

**Figure 7: Location of the installed water tank**

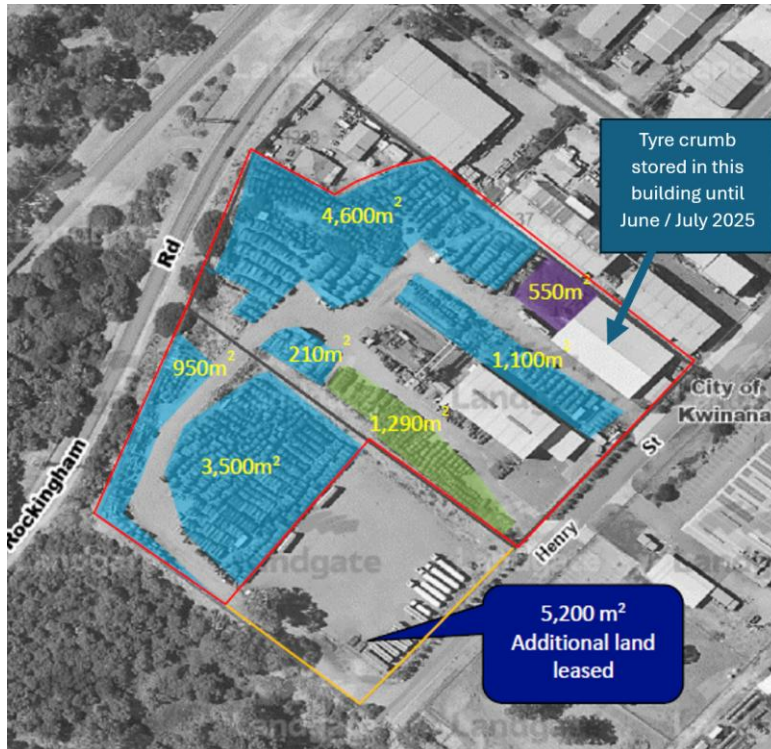
- Store rubber crumb in 1 m<sup>3</sup> bulka bags within the equipment store building as shown in Figure 8. There are approximately 30 bulka bags stored within shipping containers. The applicant aims to move the rubber crumb stored within the equipment store building to Rubbergem's Rockingham facility once the facility is operating under time limited operations. This is expected to occur in July 2025. Rubber crumb will not be stored within the equipment store building at the Henry Street facility after this time.

**Figure 8: Tyre crumb storage area and additional land acquired**
