SUNRISE DAM GOLD MINE PRESCRIBED PREMISES LICENCE – L8579/2011/2 ANNUAL ENVIRONMENTAL REPORT 2025

REPORTING PERIOD 1 JANUARY 2025 – 31 DECEMBER 2025

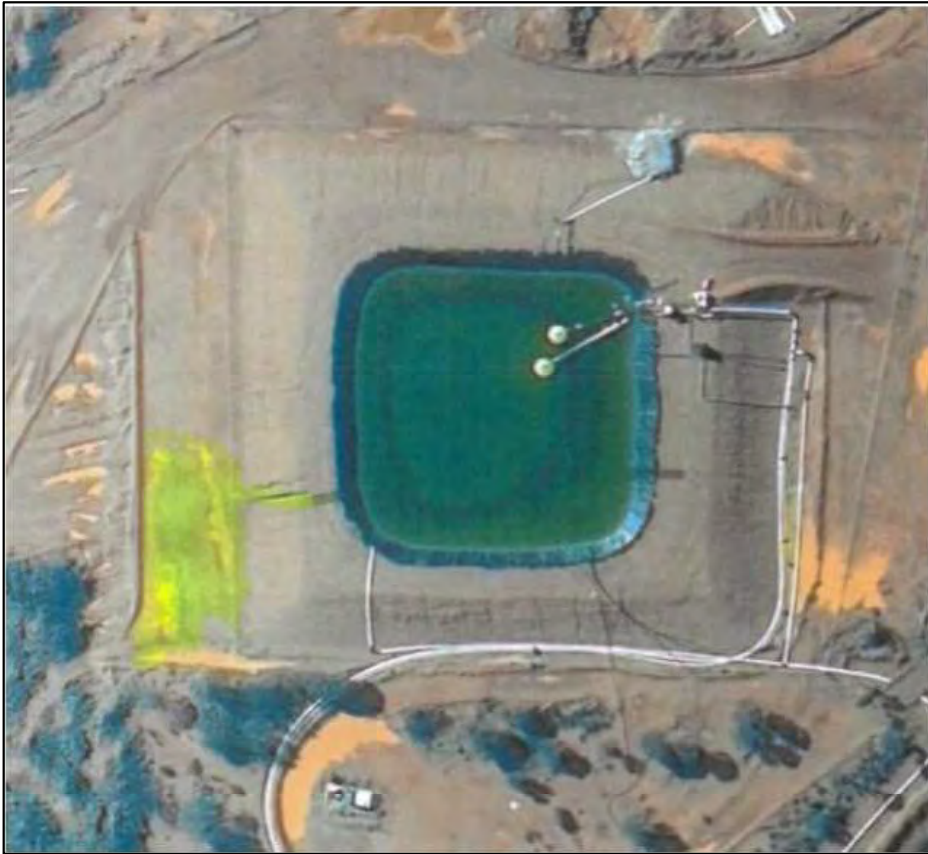
Figure 2: General Layout of the Golden Delicious Turkey Nest within initial flow path in yellow

The affected area is located centrally to the Golden Delicious mining operation, approximately 90 m from the pit edge. The size of the affected area is ~300 m² (0.03 ha) and is bound on three sides by growth media stockpiles, the toe of the Turkey Nest and access road to the adjacent pumping infrastructure (Figure 3). A visual inspection indicated that some shallow rooting shrub species show signs of stress including wilting and drooping of foliage, or partial desiccation with some mortality. The impacted vegetation consists primarily of shallow rooted annual or perennial shrubs i.e. *Solanum centrale*, *Ptilotus* sp. and *Maireana* sp. Approximately 50-100 individual plants are located within the affected area.

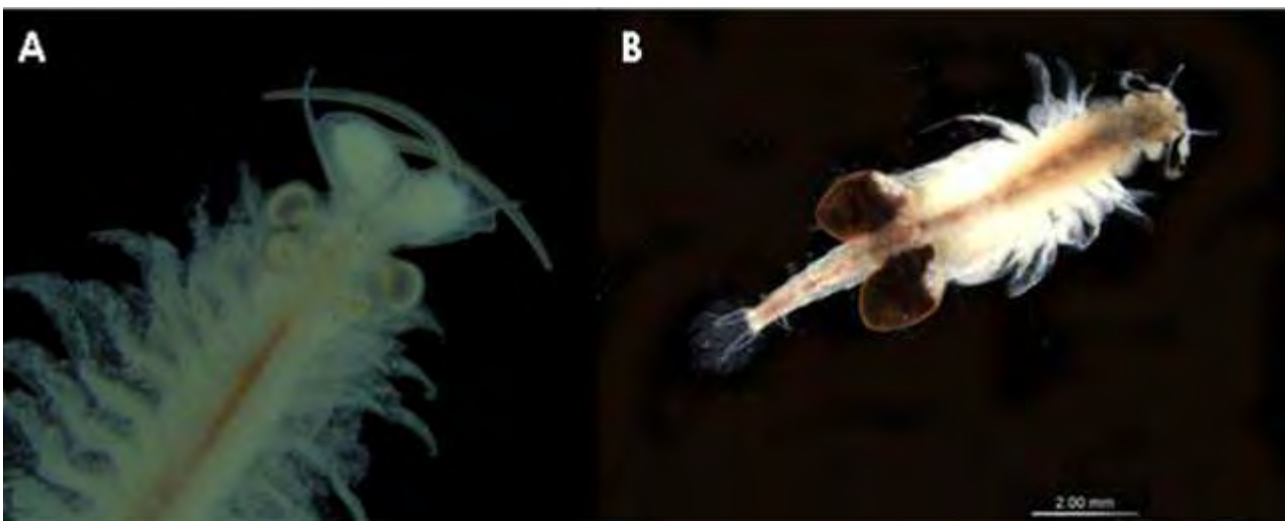
Plate 2-1: Significant or restricted taxa recorded from Lake Carey including: A) *Branchinella simplex* (P1), and B) *Parartemia bicorna* (potentially restricted).

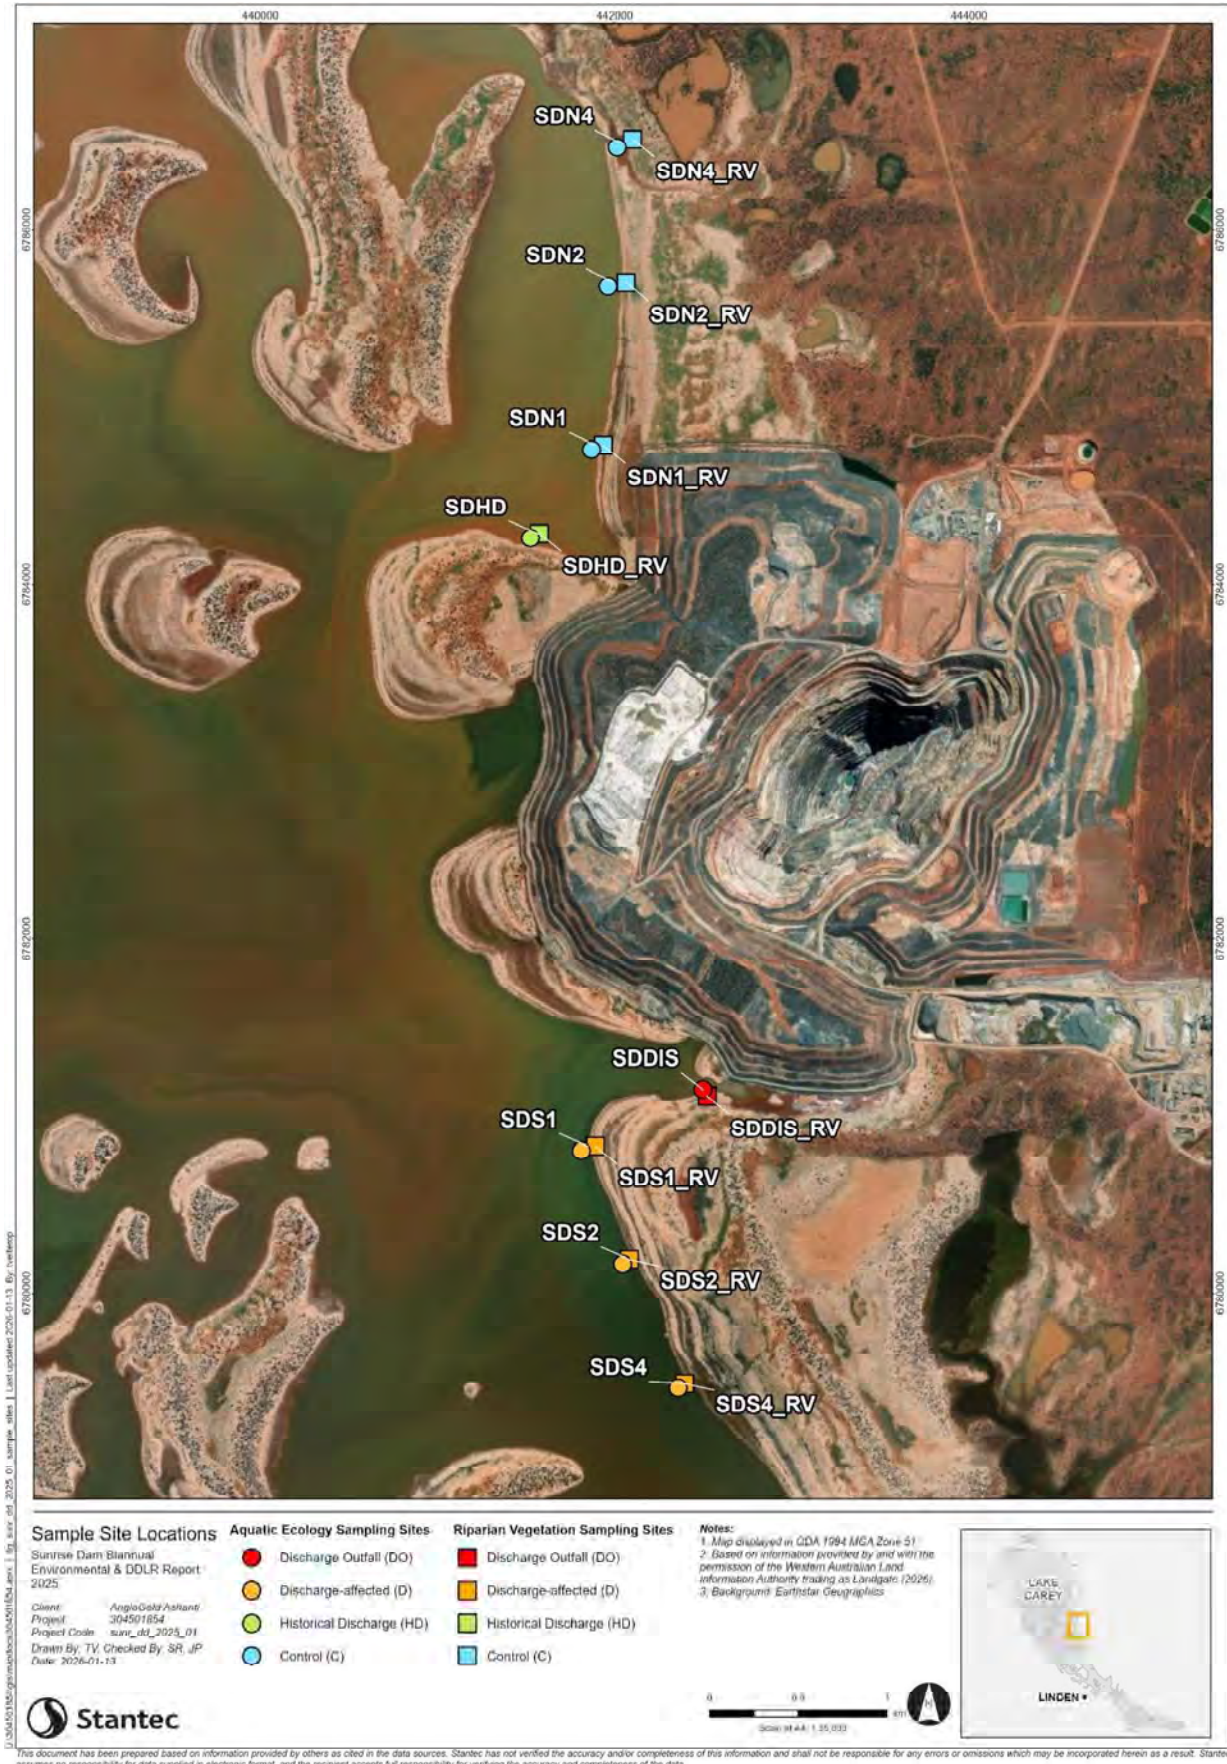
Aquatic ecology sites located on the playa of Lake Carey were classified as discharge outfall (DO; SDDIS), discharge-affected or discharge (D; SDS1, SDS2, SDS4), historical discharge (HD; SDHD) and control (C; SDN1, SDN2, SDN4) (**Figure 3-1, Table 3-1**). The three discharge sites were located within the zone of influence south of the discharge outfall. The historical discharge site was located to the north of the discharge outfall, having received discharge between 1999 to 2001. The control sites were located to the north of the historical discharge and have not been impacted by dewatering discharge. Surface water was only present at one site (SDDIS) during June and September (**Table 3-2**). The riparian vegetation sites were located adjacent to the aquatic ecology sites (**Figure 3-1**). The ecological components sampled are outlined in **Table 3-2**, with detailed methods provided in subsequent sections.

Figure 3-1: Location of aquatic ecology and riparian vegetation sampling sites on Lake Carey, during the 2025 Program.

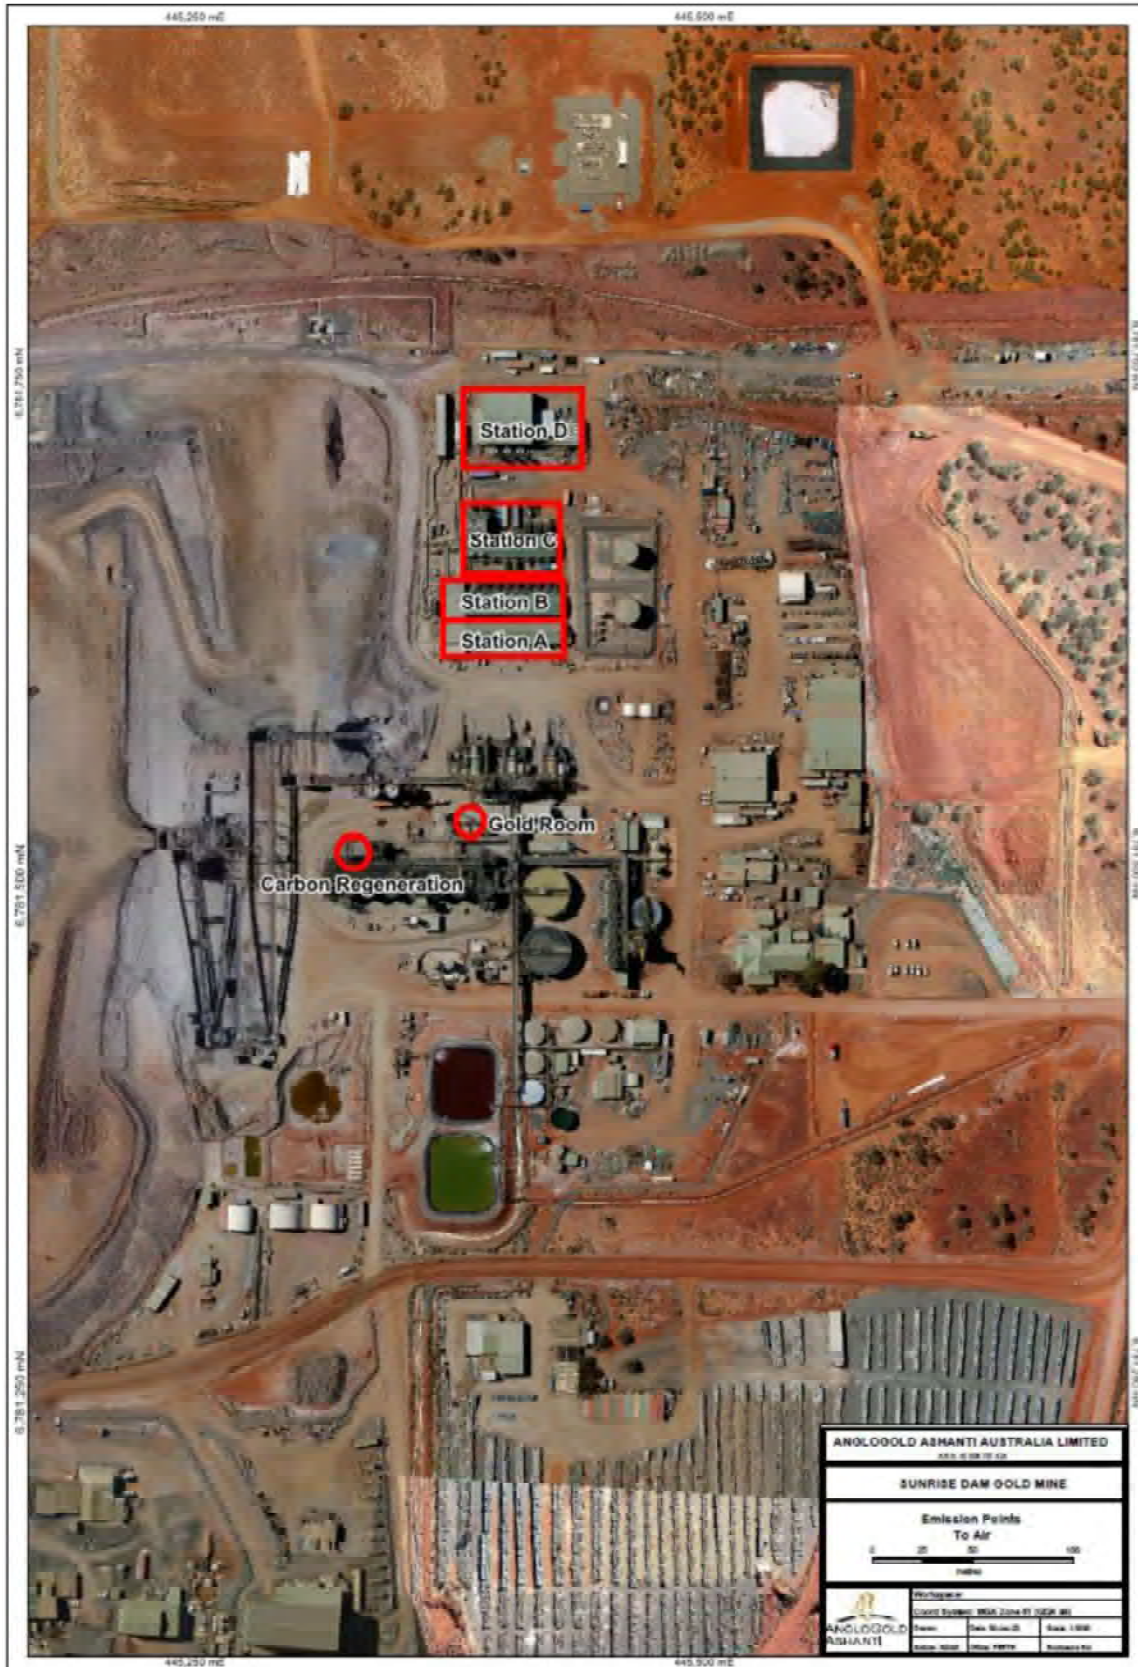
Figure 3: Gold processing air emission points

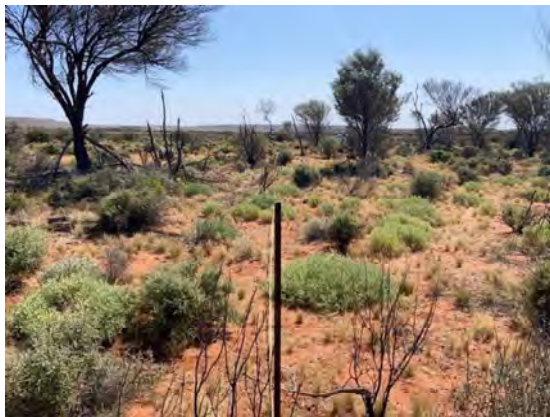
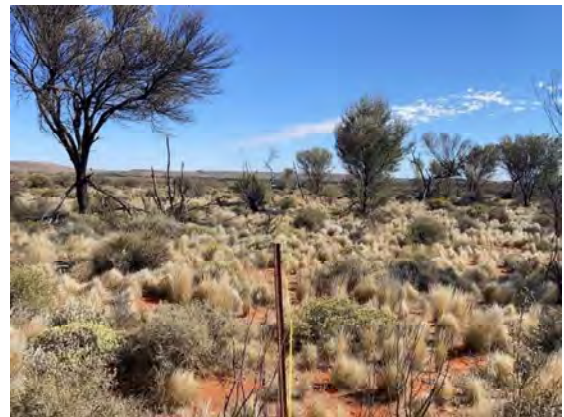
Acacia / Chenopod sparse woodland (CTD06) control transect in 2024 (left) and 2025 (right)

Six control transects were assessed in 2025: CTD06, CTD07, CTD10, CTD11, CTD14 and CTD15 (Figure 4-1, Appendix D). Transect CTD13, which was formerly a control transect, was assessed as an impact transect in 2024 due to continued decline in vegetation cover. In response, transect CTD14 was installed in 2024 and assessed as a new control transect in place of CTD13. The CTD14 control now corresponds to the new impact transects south of the CTD TSF (CTD16 and CTD17). In 2024, control transect CTD15 was installed to the east of the CTD TSF and assessed as the corresponding control for the eastern impact transects.

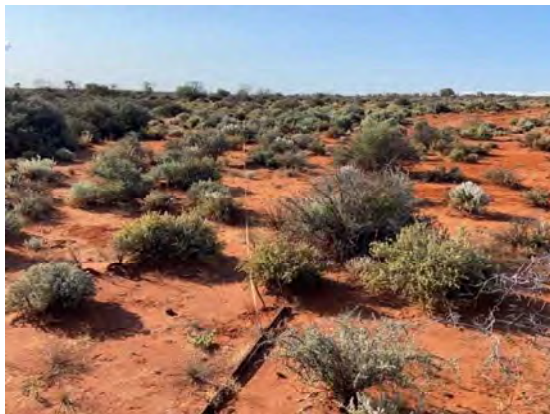
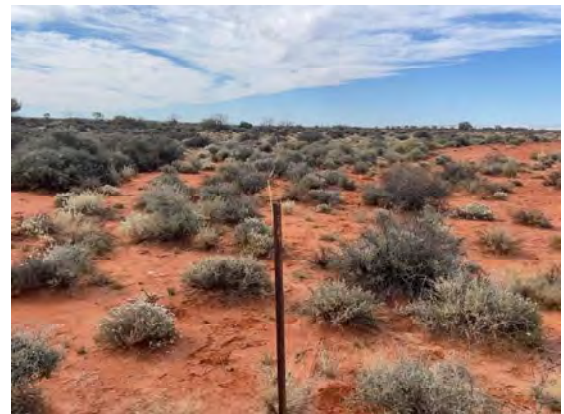
Frankenia / Chenopod shrubland (CTD07) control transect in 2024 (left) and 2025 (right)

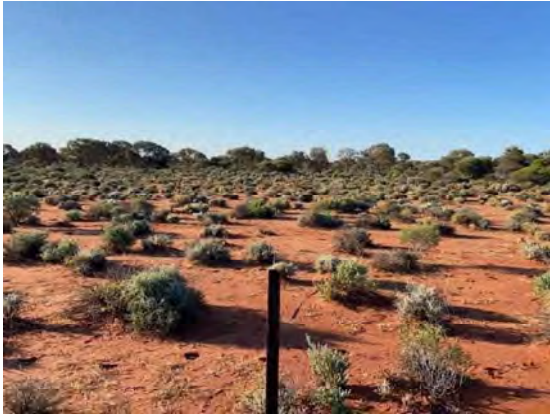
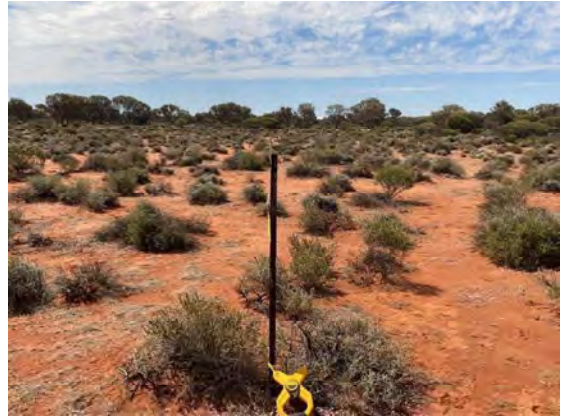
Frankenia / *Chenopod* shrubland (CTD10) control transect in 2024 (left) and 2025 (right)

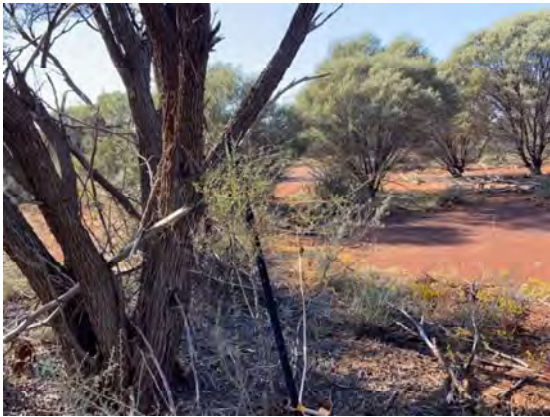
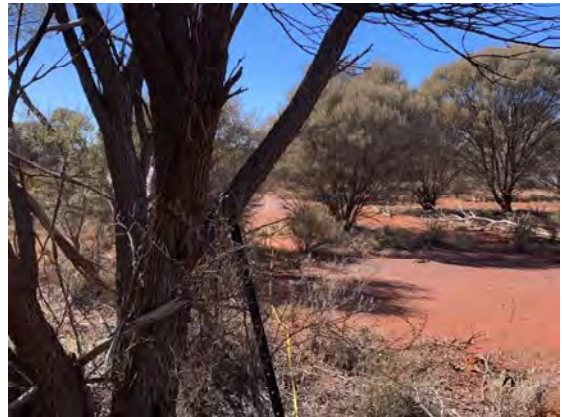
Acacia open shrub / woodland (CTD11) control transect in 2024 (left) and 2025 (right)

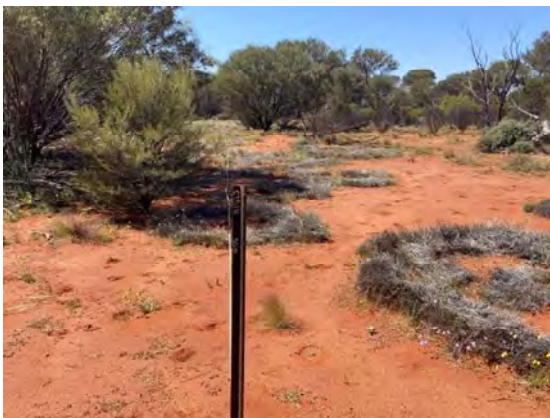
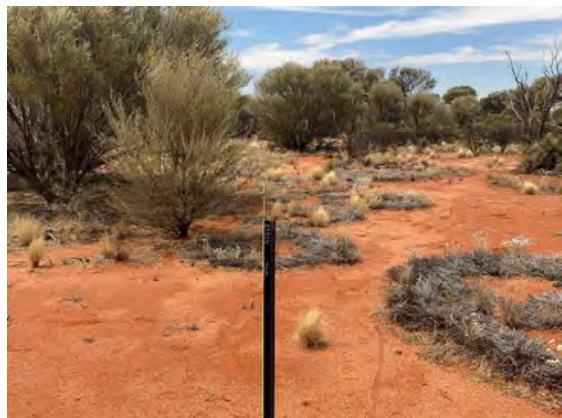
Acacia / *Eucalyptus* low open woodland over a *Triodia* hummock grassland (CTD14) control transect in 2024 (left) and 2025 (right)

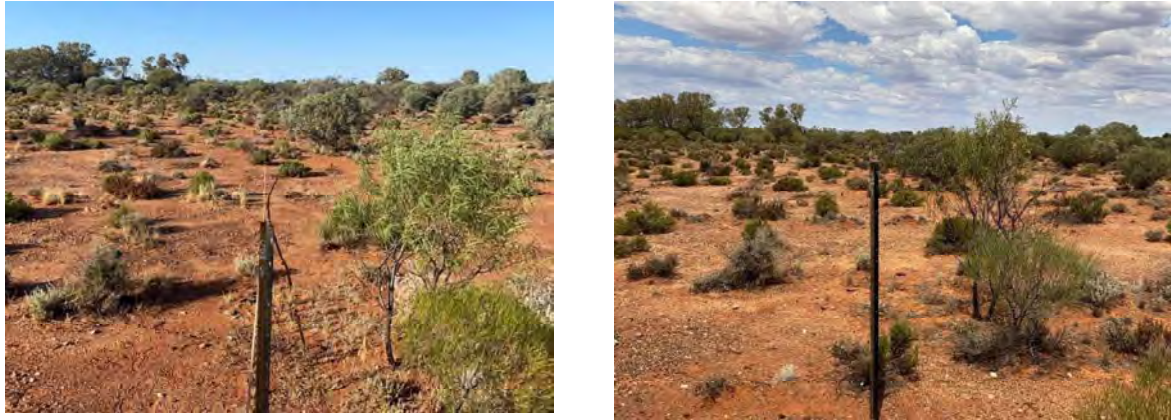
Frankenia / Chenopod shrubland (CTD15) control transect in 2024 (left) and 2025 (right)

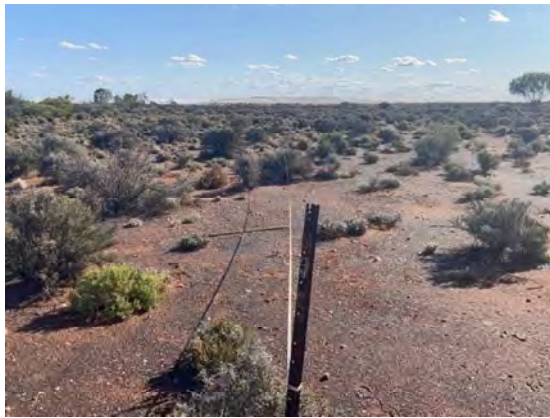
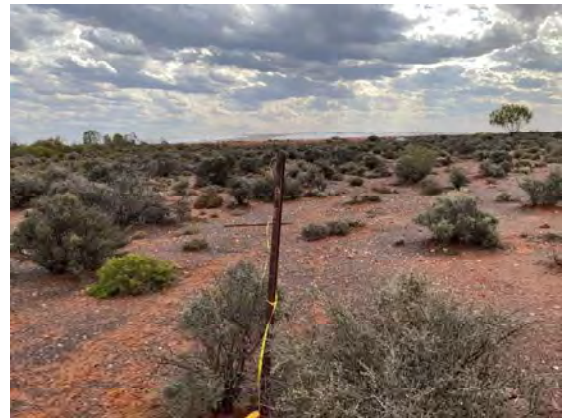
Frankenia/Chenopod shrubland (CTD01) eastern impact transect in 2024 (left) and 2025 (right)

Two impact transects were assessed on the eastern side of the CTD TSF in 2025: CTD01 and CTD02 (Figure 4-4, Appendix D) and were compared to corresponding control transect CTD15. As in previous reports, vegetation monitoring data from CTD01 and CTD02 has been presented as mean values in the following section, due to their proximity to each other (approximately 350 m) and are within similar vegetation communities. Previously, the eastern impact transects were compared to western control transects CTD07 and CTD10 due to similar vegetation types. While CTD15 continues to have *Frankenia*/Chenopod shrubland vegetation type, in 2024 it was installed to the east of the CTD TSF (Figure 3-1) and therefore is subject to more similar environmental influences.

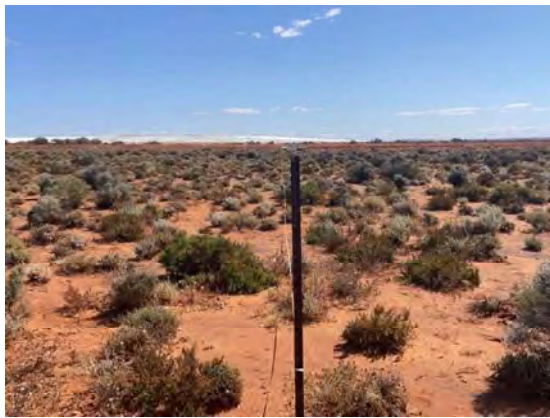
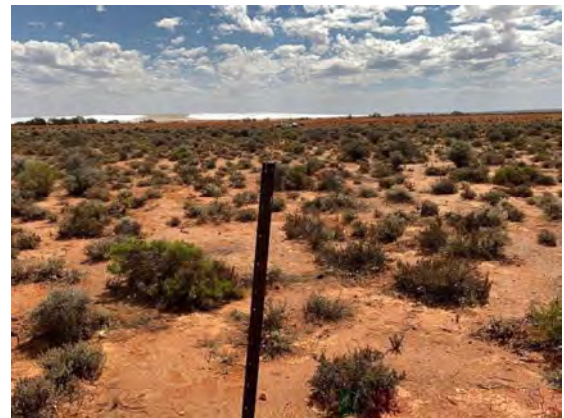
Frankenia/Chenopod shrubland (CTD02) eastern impact transect in 2024 (left) and 2025 (right)

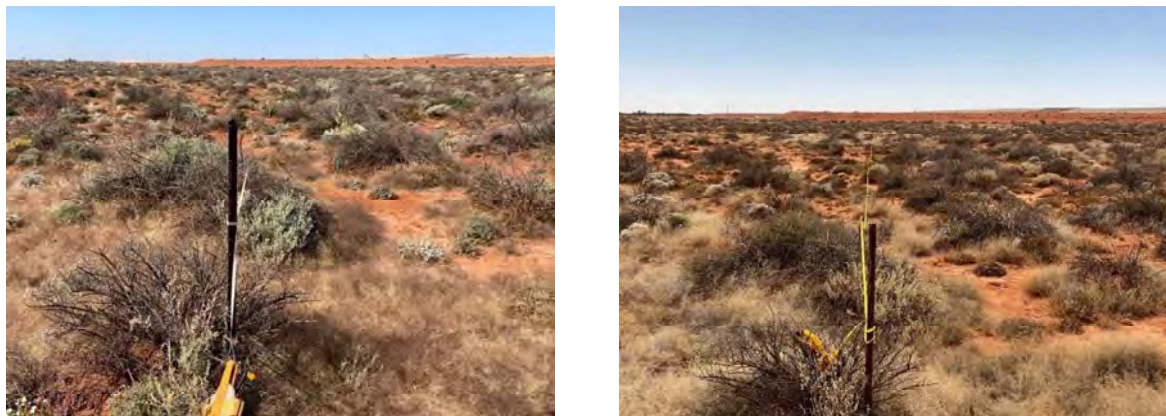
Frankenia shrubland (CTD04) western impact transect in 2024 (left) and 2025 (right)

One impact transect was assessed on the western side of the CTD TSF in 2025: CTD04 (Figure 4-7, Appendix D), and was compared to corresponding control transects CTD06, CTD07 and CTD10.

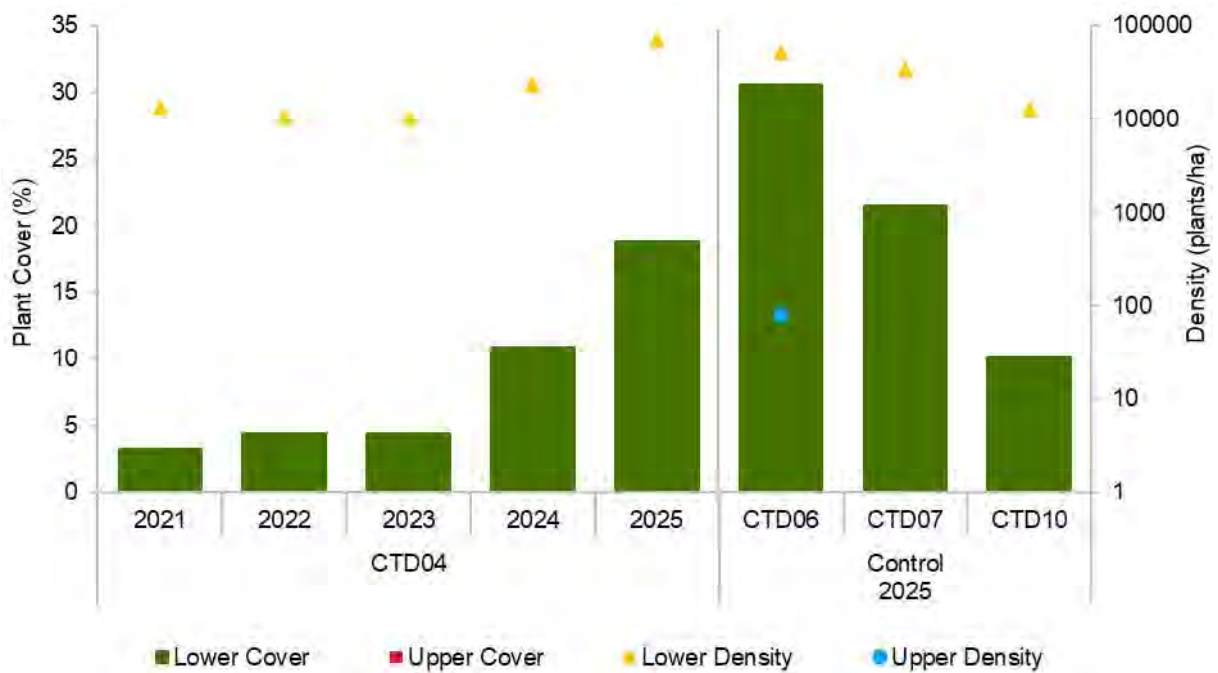
Figure 4-8: Changes in native perennial plant cover (%) and density (plants/ha) over the last five years at the western CTD TSF impact transect in comparison with the corresponding control transects

Field notes from 2025 monitoring indicated that the western impact area contained qualities of a functional ecosystem. These qualities included evidence of reproducing flora, increased annual cover, and perennial seedlings present. Increased vegetation parameters may be related to the above average rainfall that occurred in August 2025, two months prior to the 2025 monitoring event (Figure 2-1). The area around CTD04 noted no weed species but did note scat indicative of cattle visitation, as well as evidence of kangaroo visitation noted within the surrounding area. While the area was noted to have good vegetation cover, it exhibited only moderate overall plant health, due to the presence of dead or dying *Frankenia pauciflora*, *Sclerolaena cuneata* and *Sclerolaena eurotioides*.

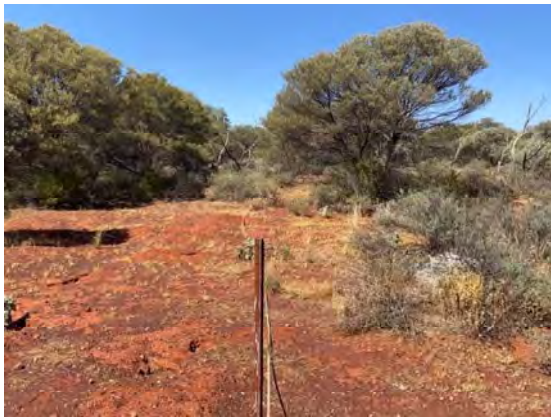
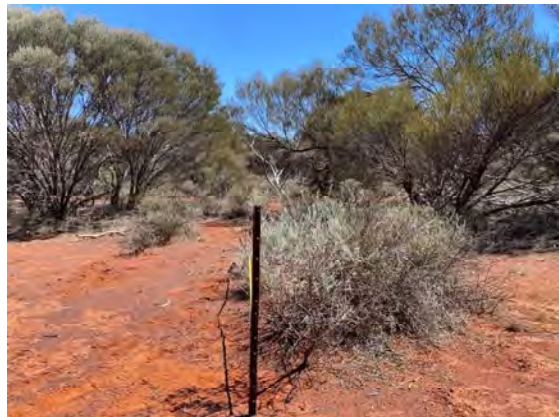
Acacia open shrub/woodland (CTD08) northeastern impact transect in 2024 (left) and 2025 (right)

Two impact transects were assessed on the northeastern side of the CTD TSF in 2025: CTD08 and CTD09 (Figure 4-10, Appendix D) and were compared to corresponding control transect CTD11.

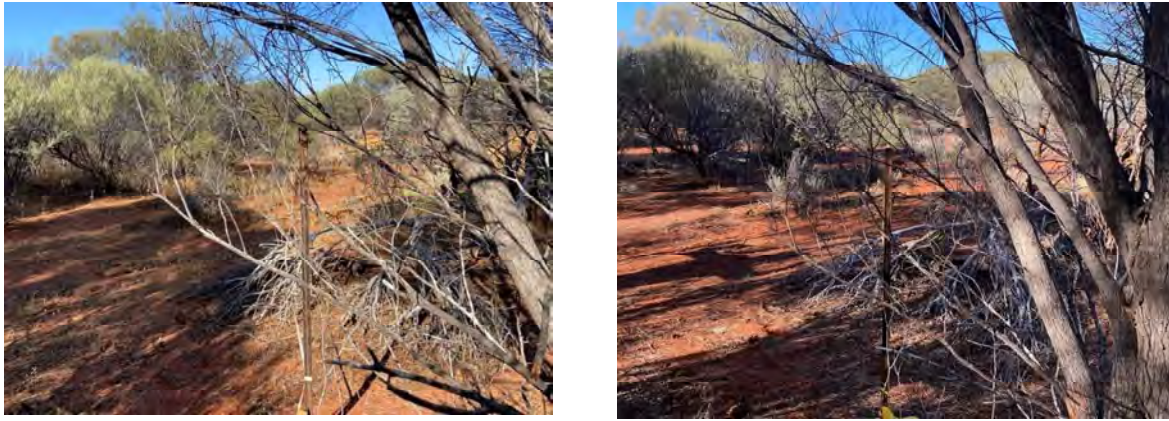
Acacia open shrub/woodland (CTD09) northeastern impact transect in 2024 (left) and 2025 (right)

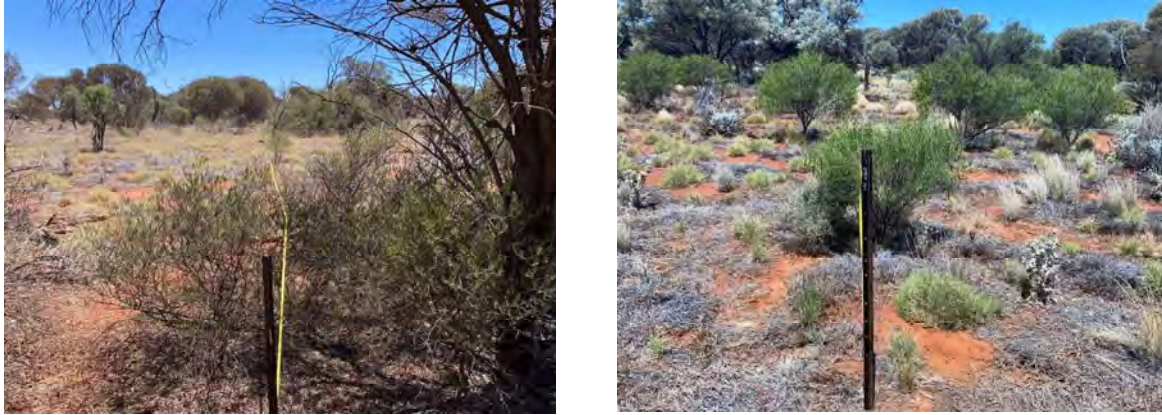
Figure 4-13: Southern impact transects monitored in 2025

Due to tenement access restrictions, in 2025 the former southern impact transects CTD12 and CTD13 were replaced by newly installed transects CTD16 and CTD17. As these transects were monitored for the first time in 2025, direct historical comparisons could not be made. Instead, results were contrasted against the corresponding control transect CTD14, and the 2025 data for CTD16 and CTD17 are treated as baseline conditions for future monitoring.

Acacia/Eucalyptus low open woodland over a *Triodia* hummock grassland CTD16 (left) and CTD17 (right) southern impact transects in 2025

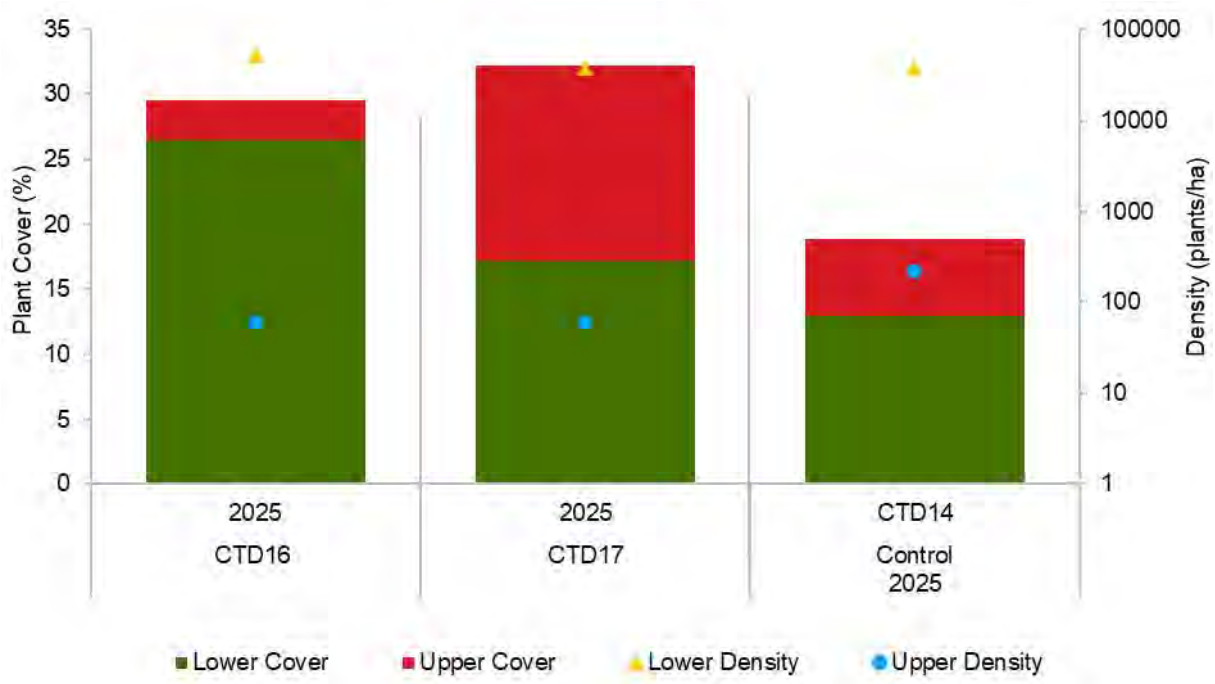
Figure: 4-14: Changes in native perennial plant cover (%) and density (plants/ha) over the last five years at the southern CTD TSF impact transects in comparison with the corresponding control transect

Field notes from 2025 monitoring indicated that the northeastern impact areas contained qualities of a healthy ecosystem. These qualities included evidence of reproducing flora, increased annual cover, a general lack of dead or dying species, and vegetation covering multiple strata. At both impact sites, perennial seedling was evident and overall plant health and vegetation cover was good. At CTD17, evidence of native fauna visitation was observed through various indicators, including scats and burrows, bird calls, egg casings and cocoons, as well as webs and direct sightings of spiders. Additional signs included scats from dingo, rabbit, and wallaby/kangaroo. At CTD16, evidence of invertebrate activity included ants/termites, spiders and various flying insects. Signs of introduced fauna were also noted, such as scat and tracks from cattle. Kangaroo scat was observed, indicating native species presence.

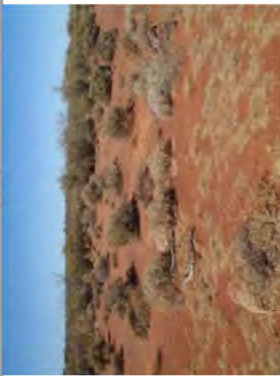
PP03: Facing away from CTD TSF. Extensive shrub deaths - remaining *Maireana* & *Atriplex* shrubs in 'very poor' health. Mid & upper storey vegetation dead. Overall vegetation condition is 'degraded'.

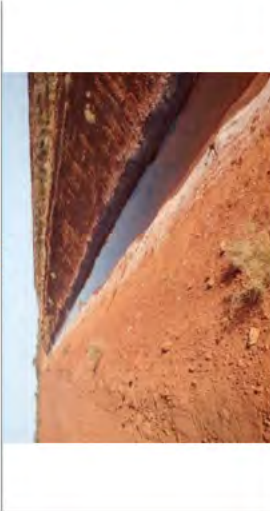
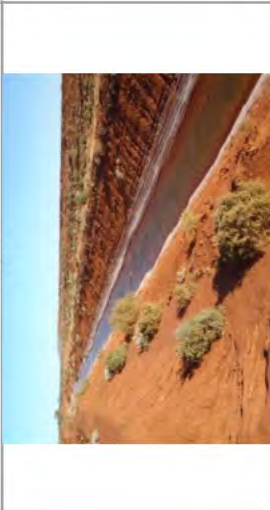
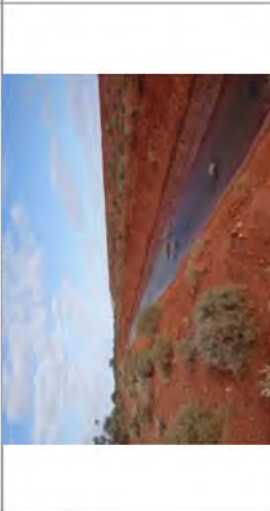
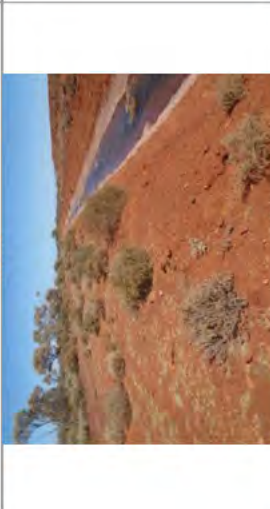
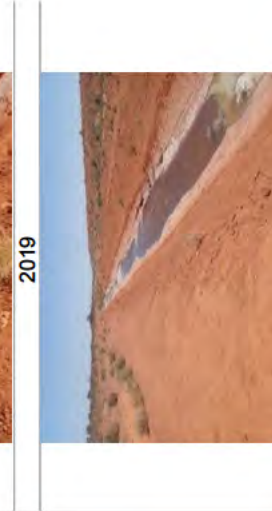
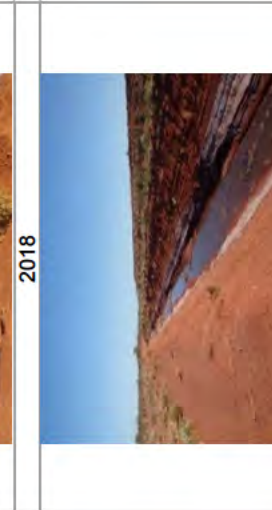
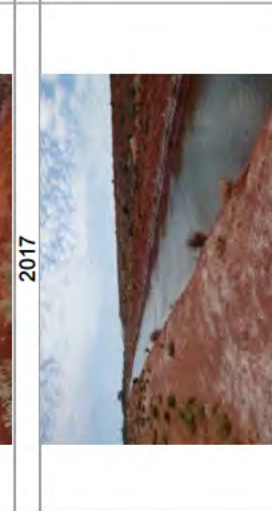
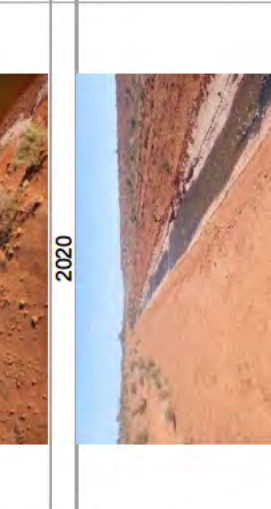
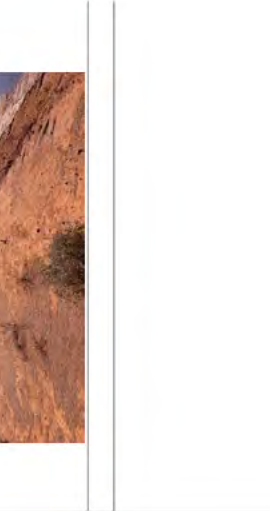
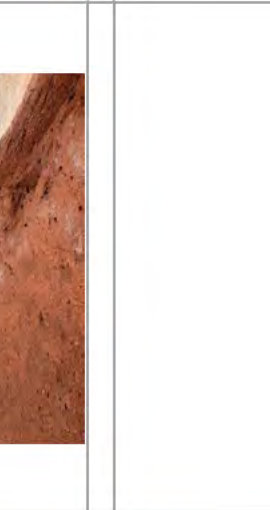
PP04-1: Facing CTD TSF along drain. Salt crusting evident but reduced. Vegetation condition rated as 'degraded'.

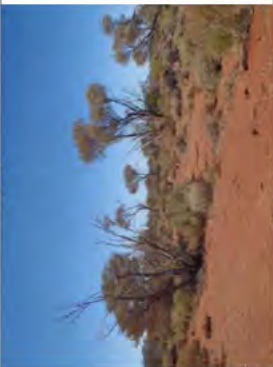
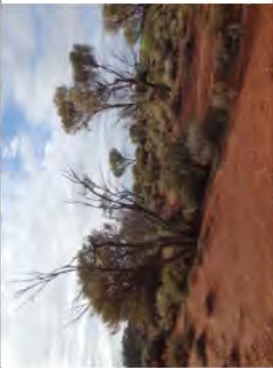
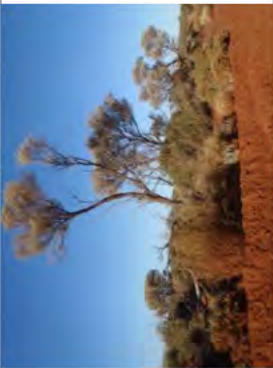
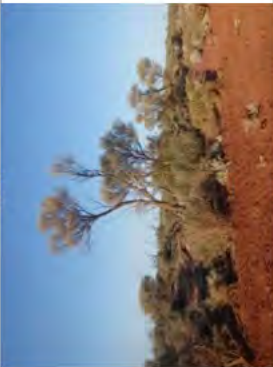
PP05-1: Facing away from CTD TSF. Upper storey dead, & *Maireana* dominant mid storey in 'poor' to 'very poor' health with high number of deaths noted. No salt crusting evident on soil surface. Overall vegetation condition was 'degraded'.

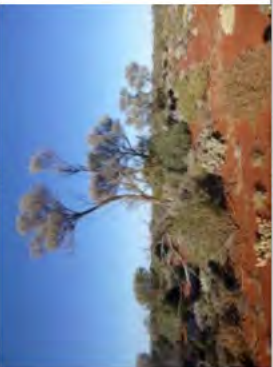
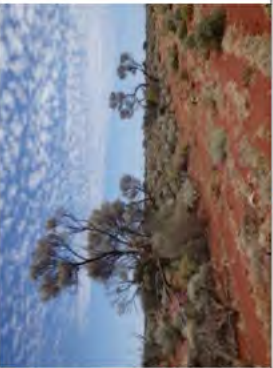
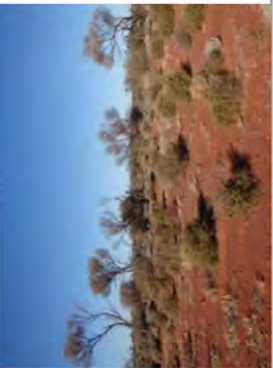
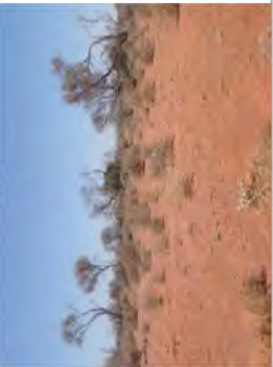
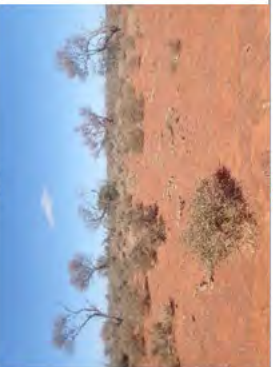
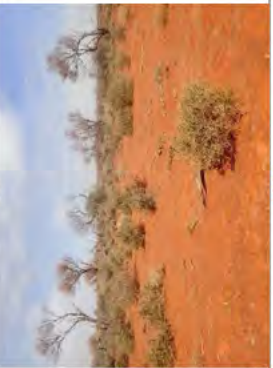
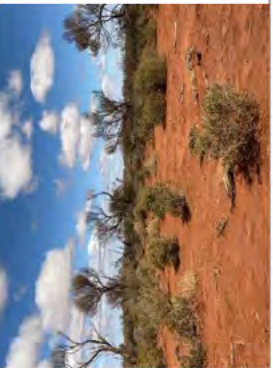
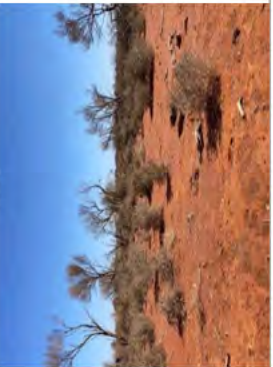
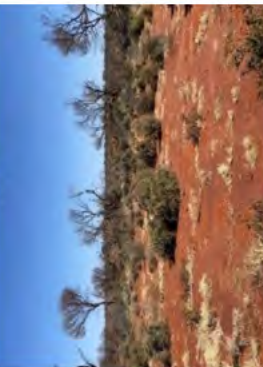
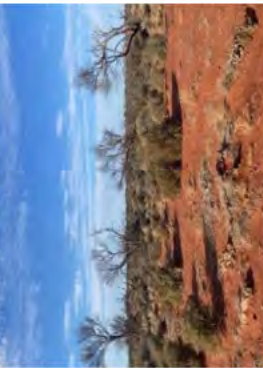
PP06: Facing away from CTD TSF. Basic vegetation structure significantly altered so overall condition is rated as 'degraded'. Health of individual plants rated as 'moderate' to 'poor'. No visible salt crusting.

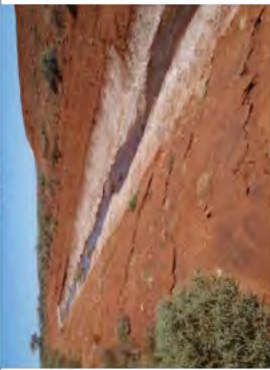
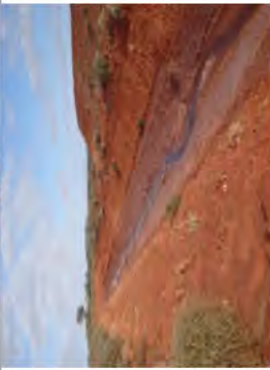
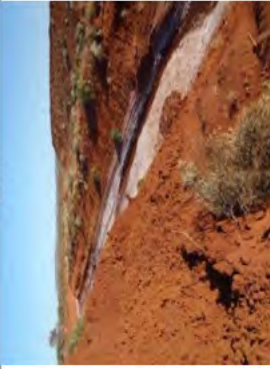
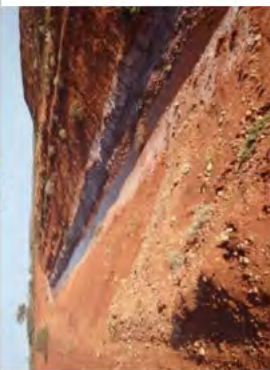
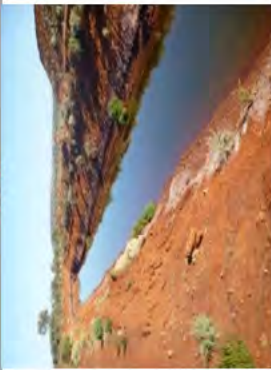
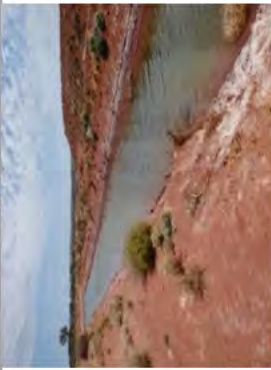
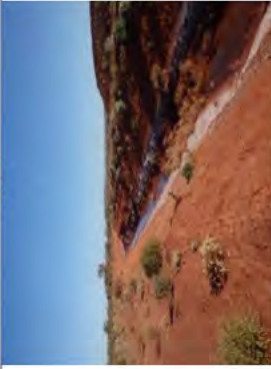
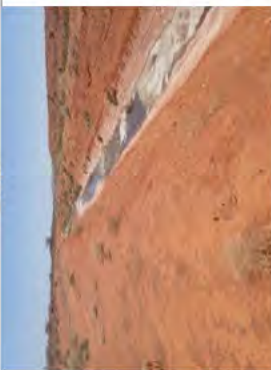
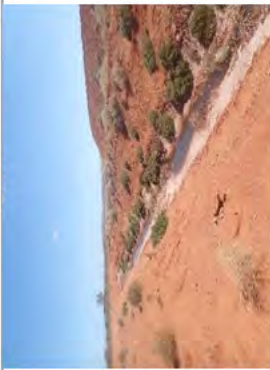
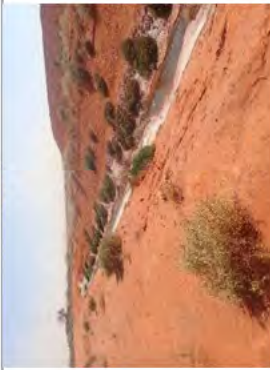
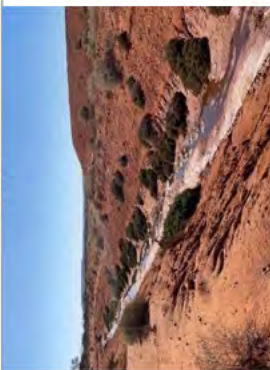
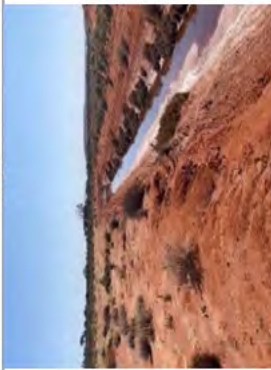
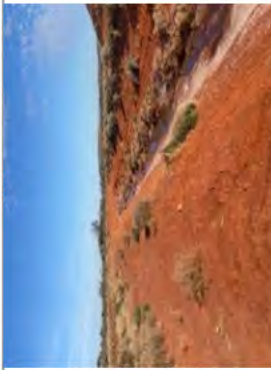
PP06-1: Facing CTD TSF along drain. Salt crusting evident. Plant health stable since 2024. Vegetation condition rated as 'degraded'.

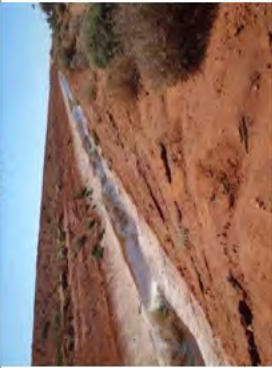
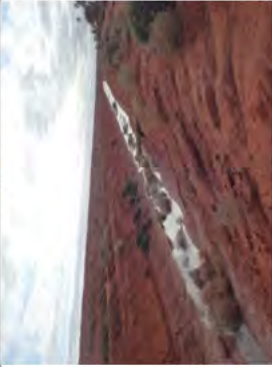
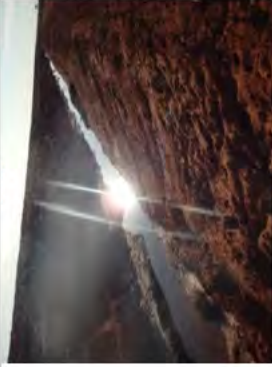
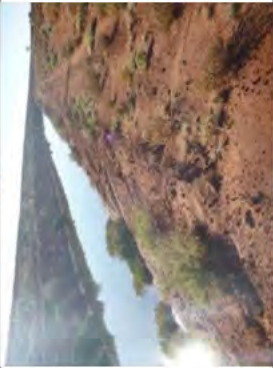
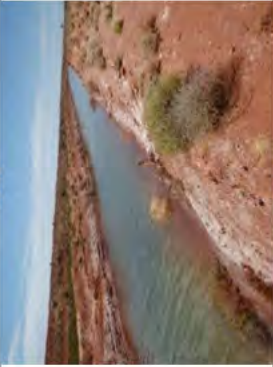
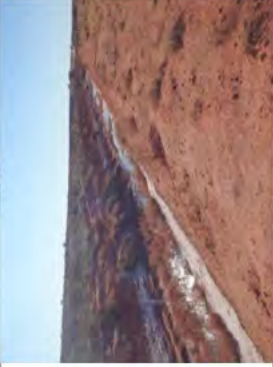
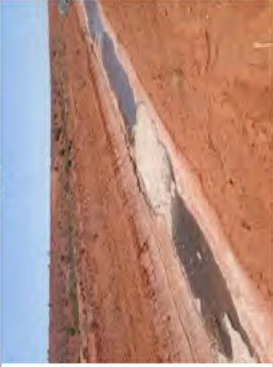
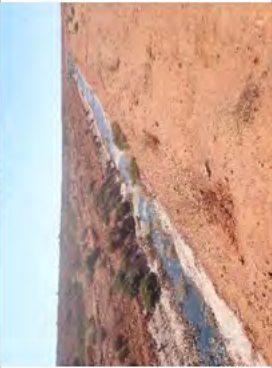
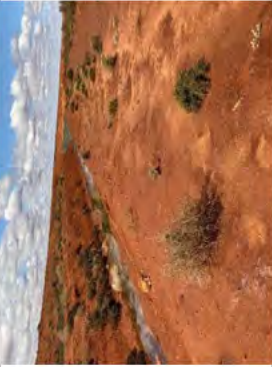
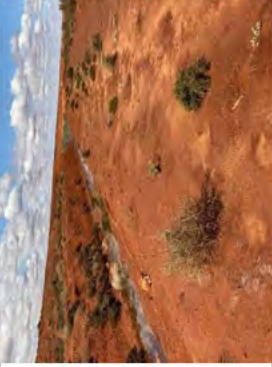
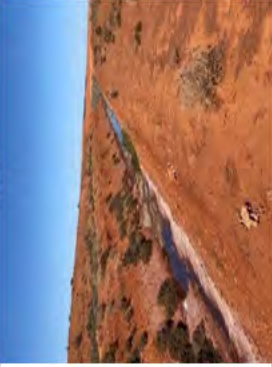
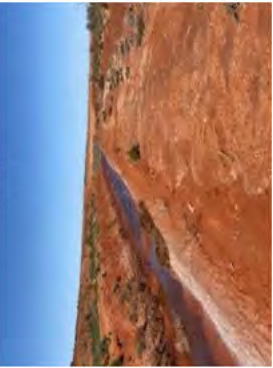
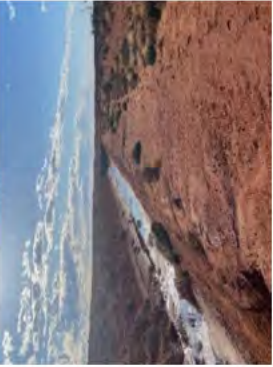
PP06-2: Facing CTD TSF along drain. Salt crusting evident. Plant health stable since 2024. Vegetation condition rated as 'degraded'.

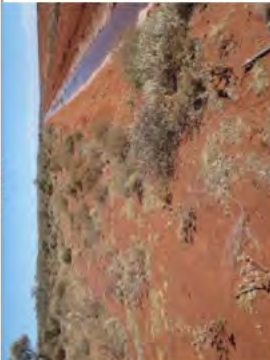
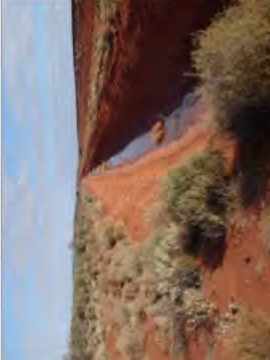
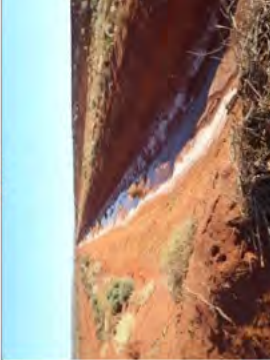
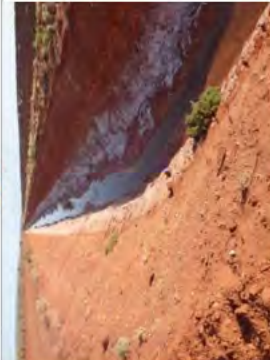
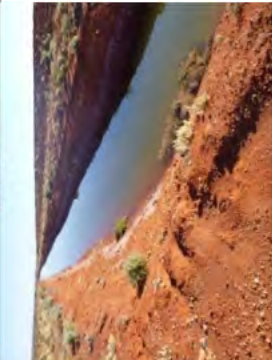
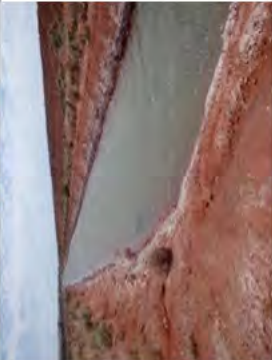
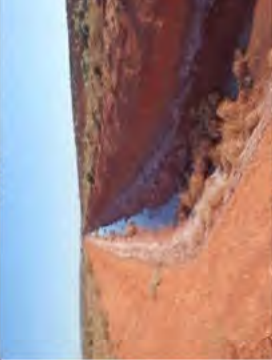
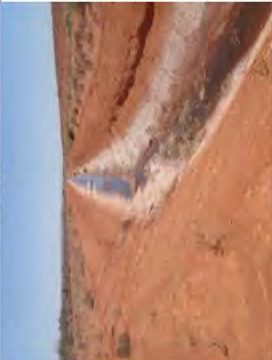
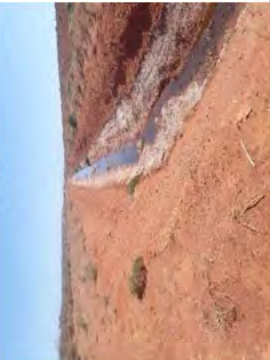
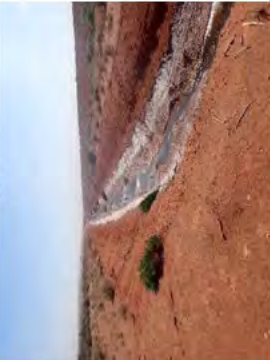
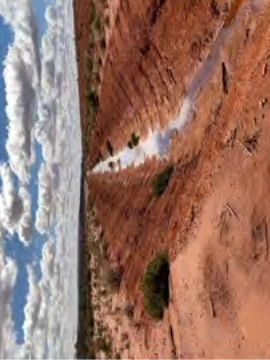
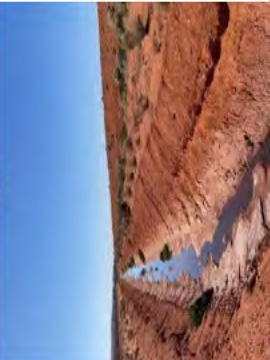
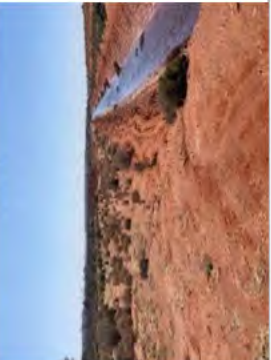
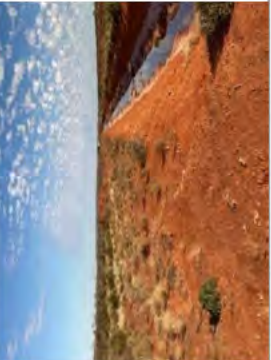
PP07: Facing CTD TSF along drain. Vegetation in 'degraded' condition with plants in 'poor' health, continuing to decline. No salt scalding on soil surface. *Maireana* dominant.
