SUNRISE DAM GOLD MINE PRESCRIBED PREMISES LICENCE – L8579/2011/2 ANNUAL ENVIRONMENTAL REPORT 2025

REPORTING PERIOD 1 JANUARY 2025 – 31 DECEMBER 2025

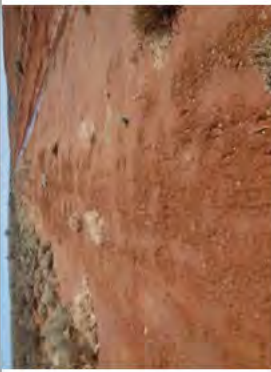
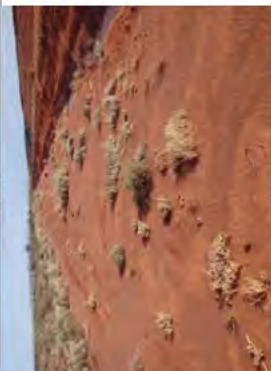
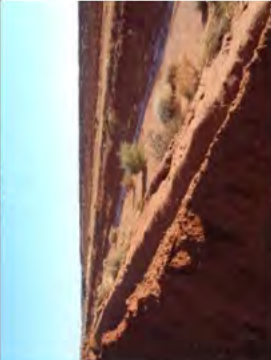
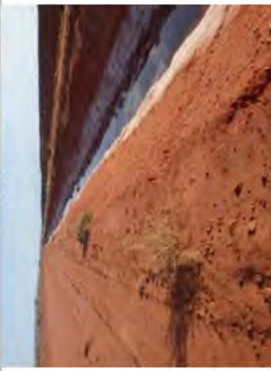
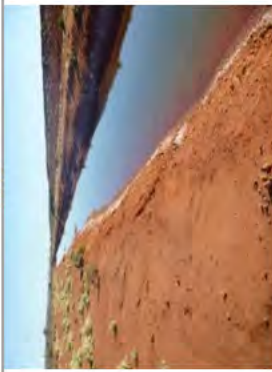
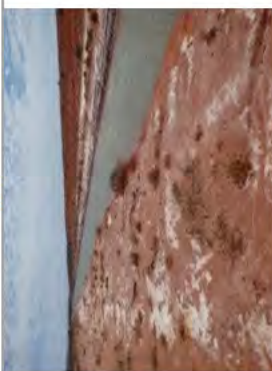
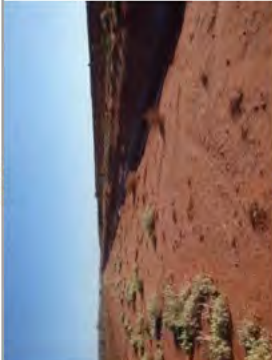
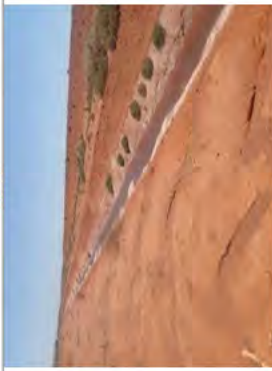
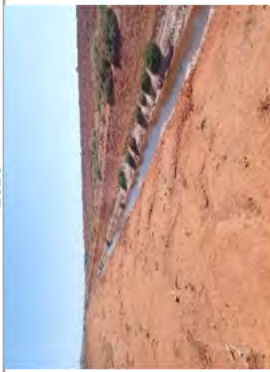
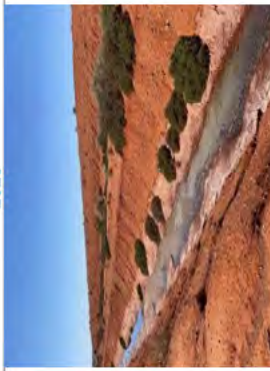
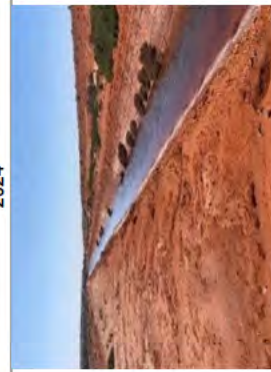
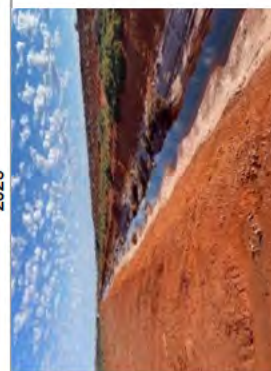
PP08: Facing CTD TFSF along drain. Overall condition of area rated as 'degraded' & health of individual plants on the CTD TFSF side of drain are rated as 'moderate'. Salt crusting & evidence of ponding on soil surface present.

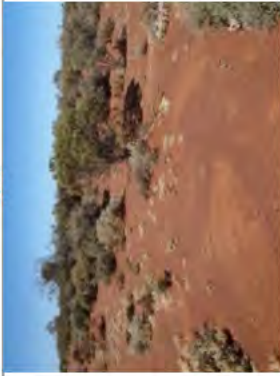
PP08-1: Facing away from CTD TSF. Vegetation in 'degraded' condition, & health of individual plants rated as 'poor'. Visible salt crusting. Some clearing of vegetation had occurred due to activities in the area.

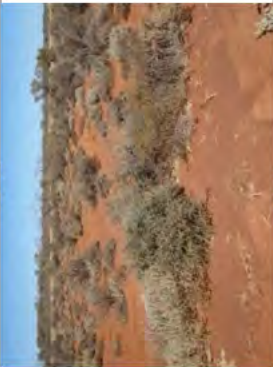
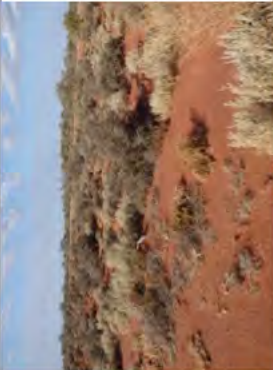
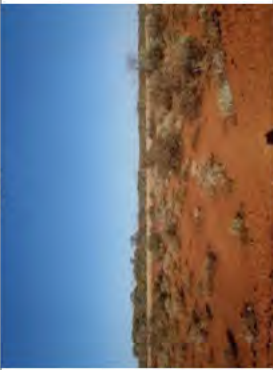
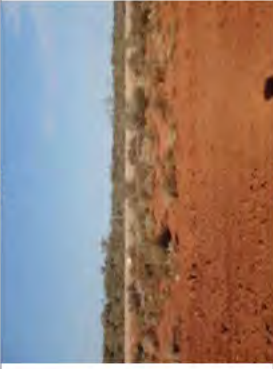
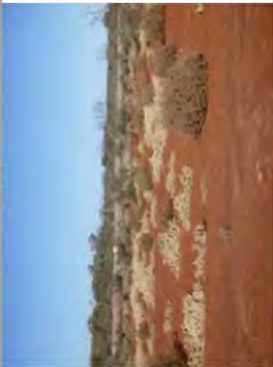
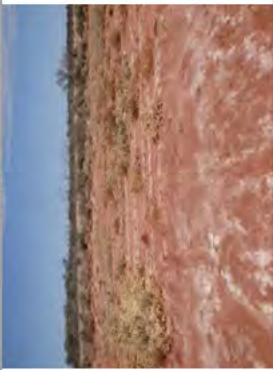
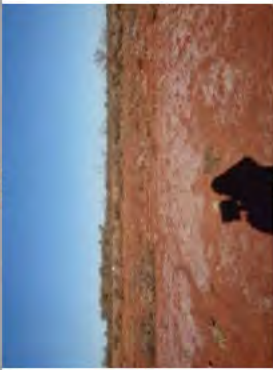
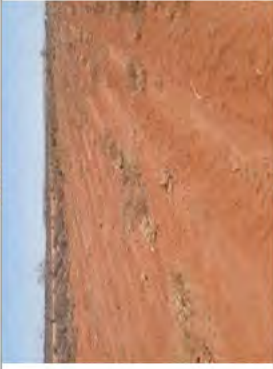
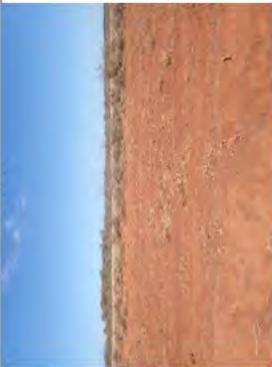
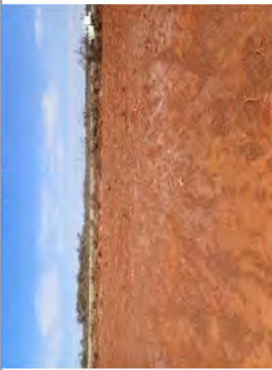
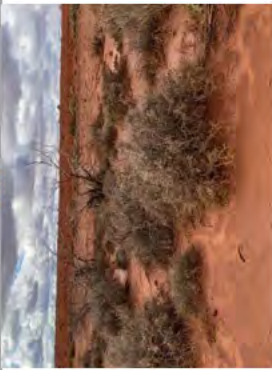
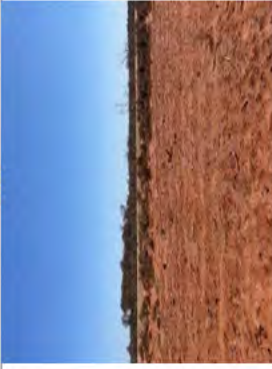
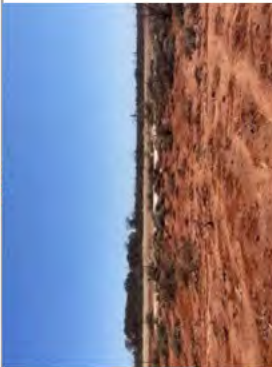
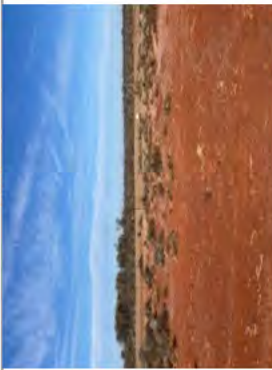
PP09: Facing away from CTD TSF. Overall vegetation condition rated as 'degraded' due to moderate vegetation death & the health of individual plants being 'poor'. Some pockets of small shrubs appear in better health. Extensive salt crusting on soil surface near boundary present, with evidence of ponding also in the area.

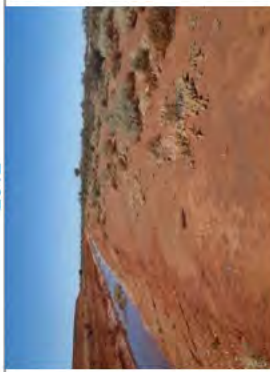
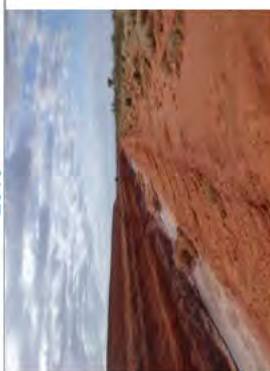
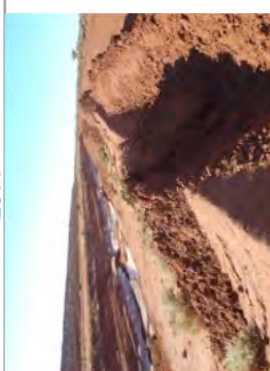
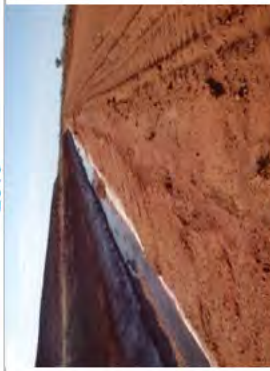
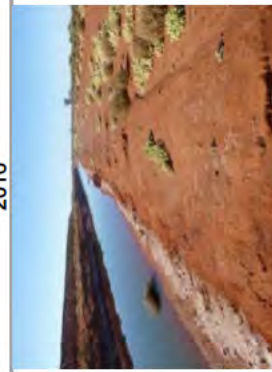
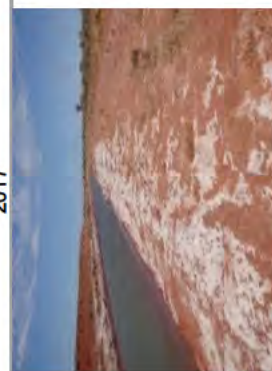
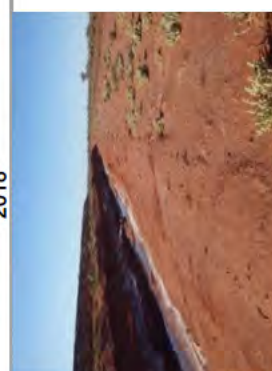
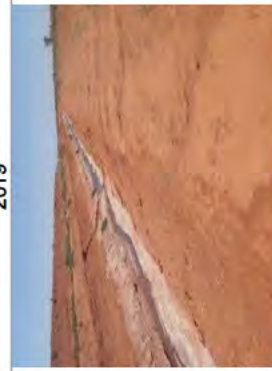
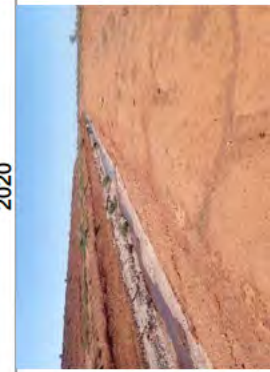
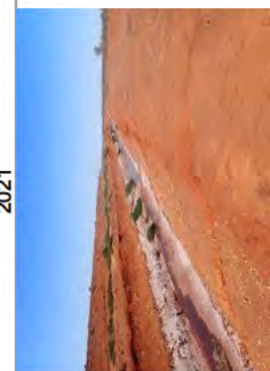
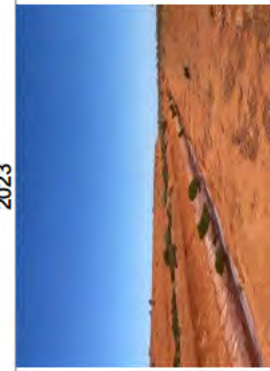
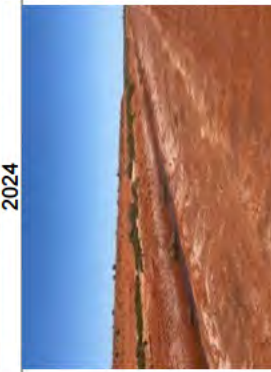
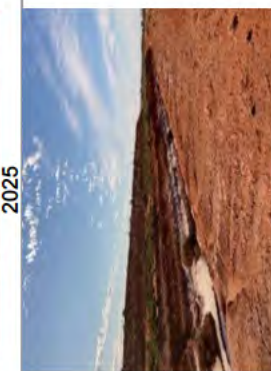
PP10: Facing CTD TSF along drain. Salt crusting on soil surface remains steady. Overall vegetation condition rated as 'degraded' & individual plant health rated as 'poor'. Plants in drain remain very few.

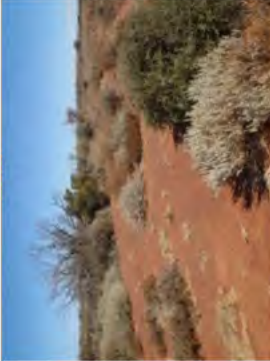
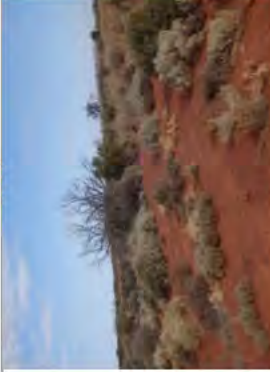
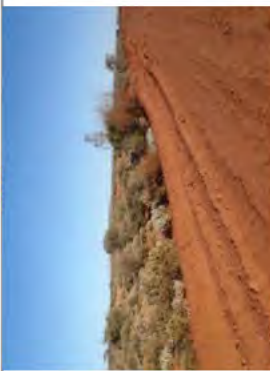
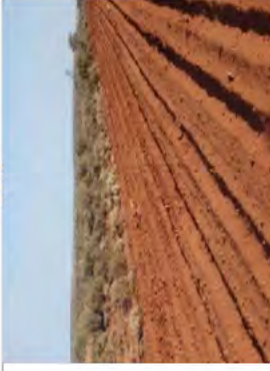
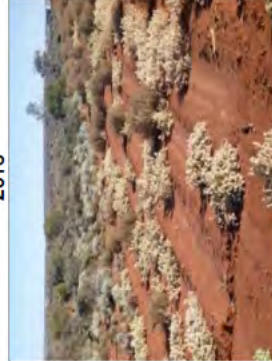
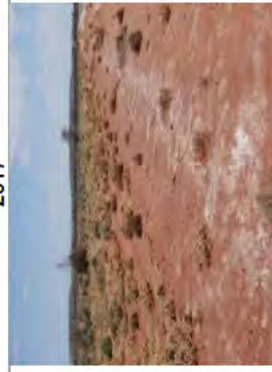
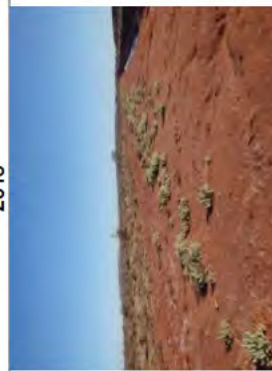
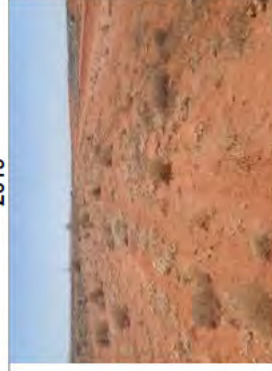
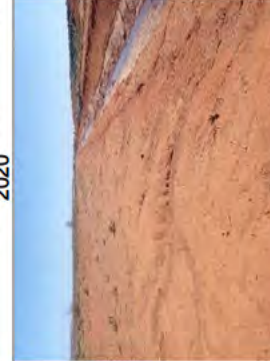
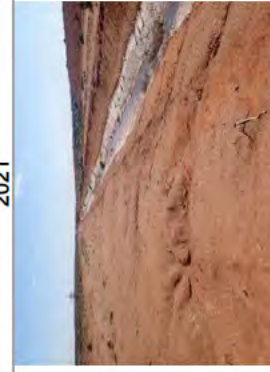
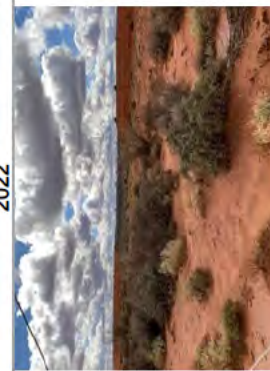
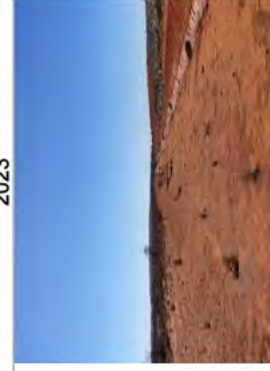
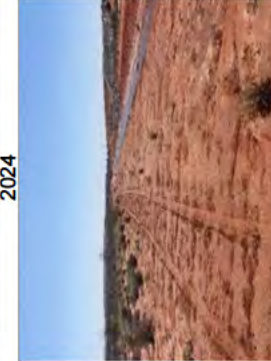
PP10-1: Facing away from CTD TSF along drain. Individual plant health is poor with plant deaths observed. Since 2024, vegetation close to fence line had declined & was rated 'very poor' health, overall condition of area is 'completely degraded'. Area has seen regression in plant health since 2024. Visible salt crusting on soil surface.

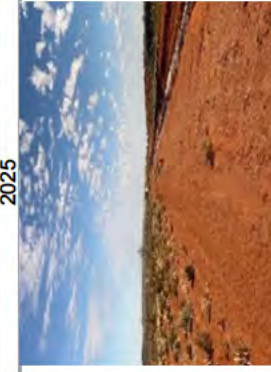
<p>2025</p>

PP11: Facing CTD TSF along drain. Water level in drain lower than 2024 with significantly increased salt crusting on soil surface. Individual plant health rated as 'poor' but looks to have seen improvements since 2024. Overall vegetation condition rated as 'degraded'.

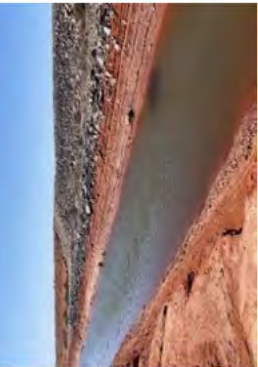
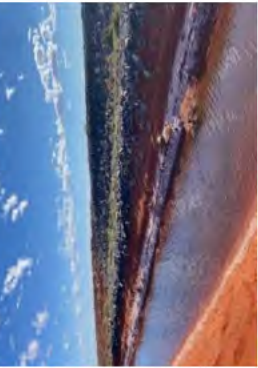
<p>2025</p>

PP12: Facing away from CTD TSF along drain. Overall condition of area remains at a rating of 'degraded' with individual plant health rated as 'poor'. Little change from 2024, pockets of recruitment for some annual species.

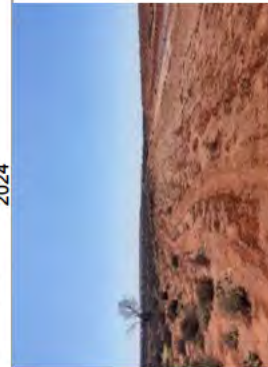
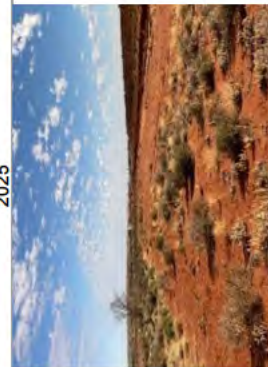
<p>2025</p>

PP13: Facing away from CTD TSF. Overall area rated as 'degraded' vegetation condition, & individual plant health rated as 'poor'. Vegetation appears to have made subtle improvements in cover and health. Visible salt crusting.

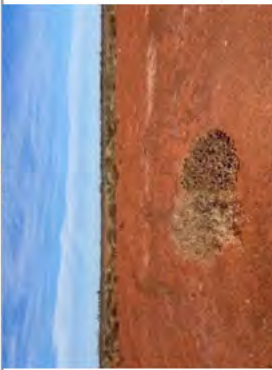
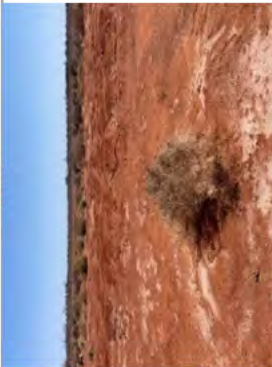
<p>2025</p>

PP13-1: Facing away from CTD TSF. Overall area in 'completely degraded' condition, with individual plant health rated as 'poor'. Extensive recent vegetation deaths in area. Less salt crusting in area than 2024, soil boggy with moisture.

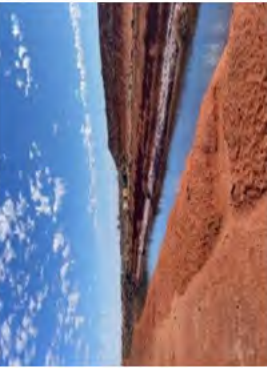
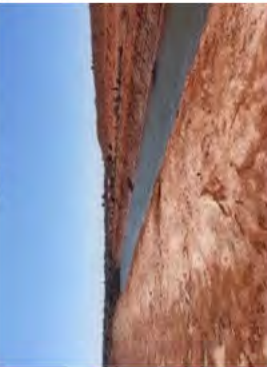
<p>2025</p>

PP14: Facing CTD TSF along drain. Drain water level lower than in 2024. Visible salt crusting on soil surface. Most plants observed dead, with few remaining in 'poor' health, therefore overall vegetation condition is 'completely degraded'. Appeared to be some minor improvement in density & colour on the TSF side of the drain.

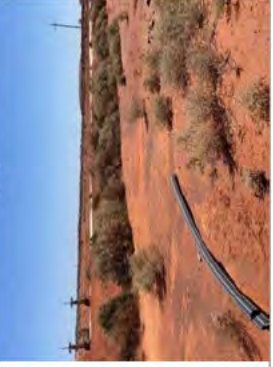
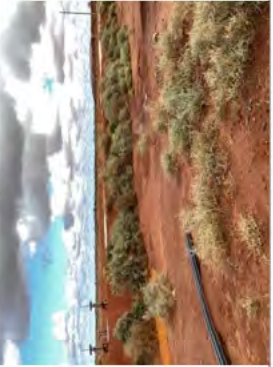
<p>2023</p>

PP18: Facing away from CTD TSF, toward pipe bunding. Overall vegetation condition of area was 'degraded'. No mid or upper storey present, *Maireana* dominant lower storey in 'good' health. Area is adjacent to a heavy vehicle & lay down area.

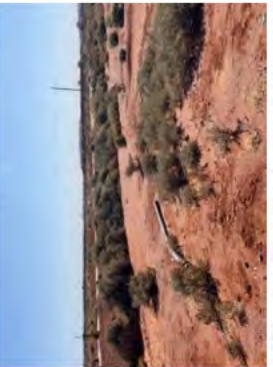
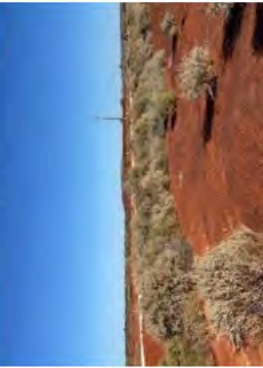
PP21-2: Facing CTD TSF. Erosion on batter appears unchanged since 2024. No visible salt crusting. Individual plant health rated 'moderate' with some deaths of *Acacia* shrubs. TSF slope over the drain, seeing improved recruitment of low-lying shrubs since 2024. Overall vegetation condition of area rated as 'degraded'.

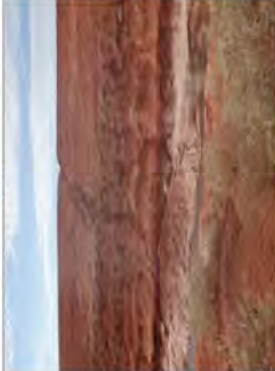
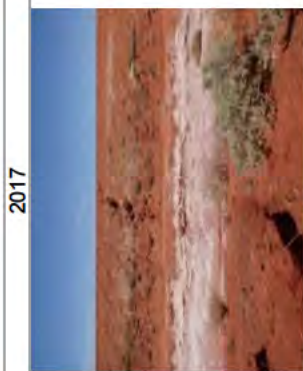
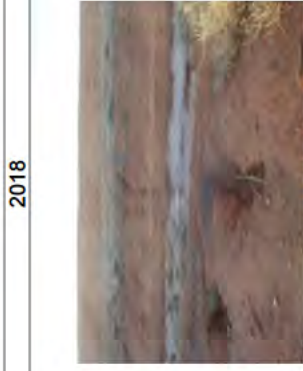
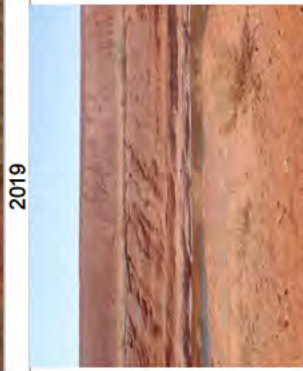
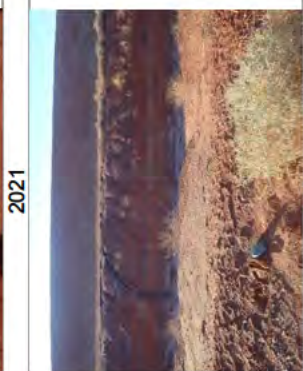
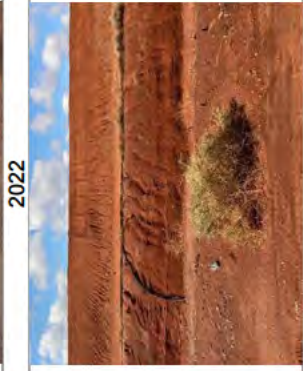
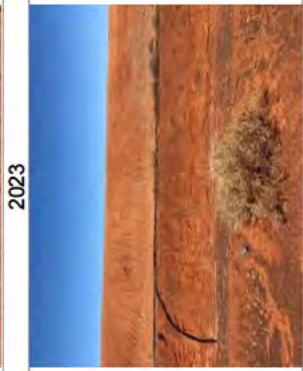
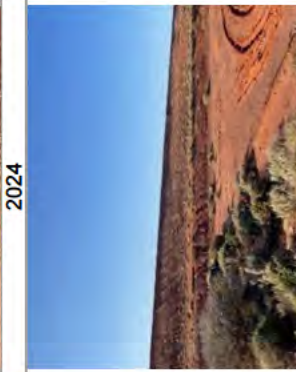
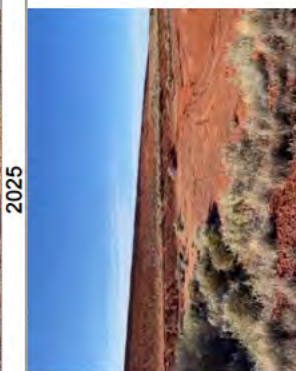
PP22: Facing CTD TSF between fence line & drain. Individual plant health of annual species inside the boundary are rated as 'poor', while individual plant health of salt tolerant shrubs & Acacia trees outside of boundary is 'good'. Overall vegetation condition of area rated as 'degraded' although has seen a decline in health across the batter.

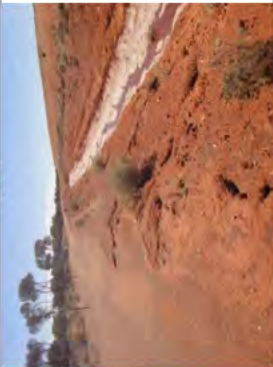
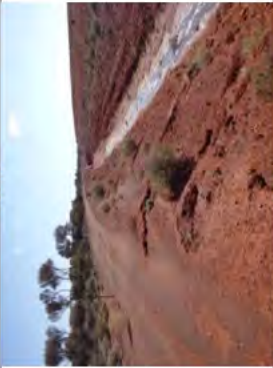
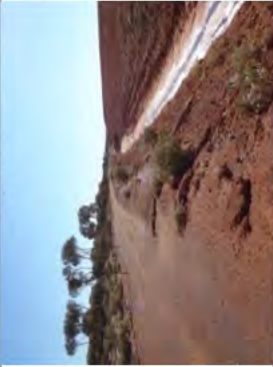
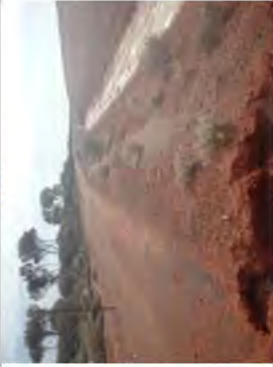
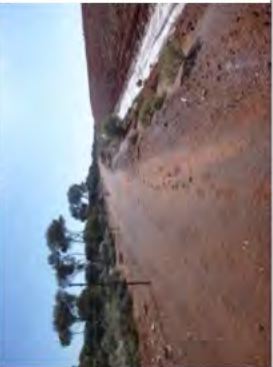
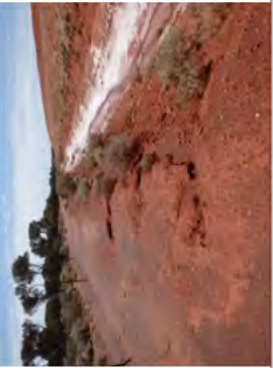
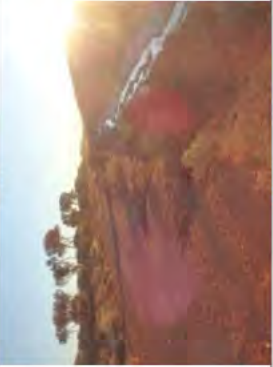
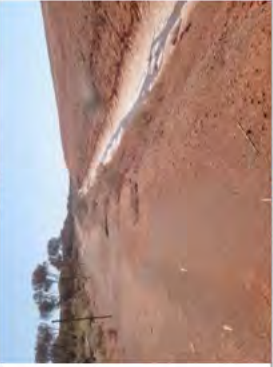
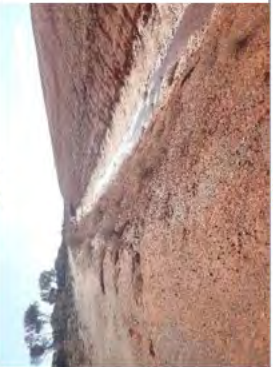
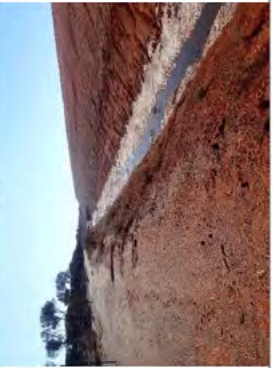
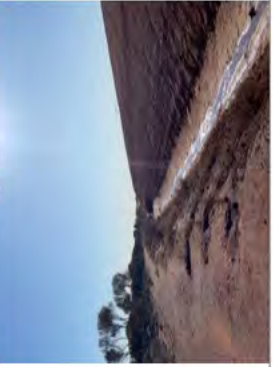
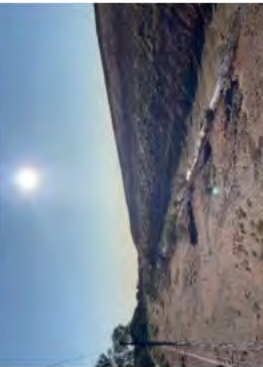
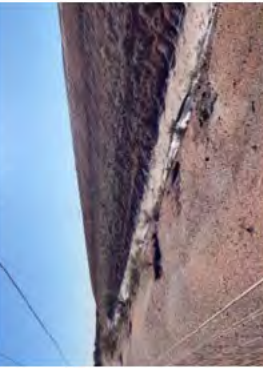
PP22-1: Facing away from CTD TSF between fence line & drain. Lower storey shrub cover in 'poor' health, although showing signs of regeneration. Upper storey Acacias in 'excellent' health. Layer of deposited silt with salt crusting within toe drain. No change in erosion. Vegetation on TSF batter is mostly annuals. Overall condition rated as 'degraded'.

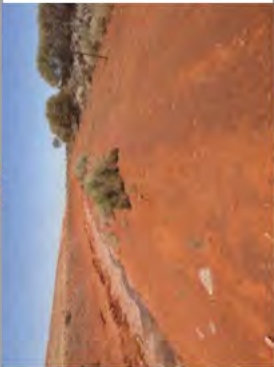
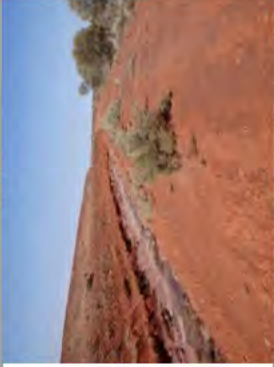
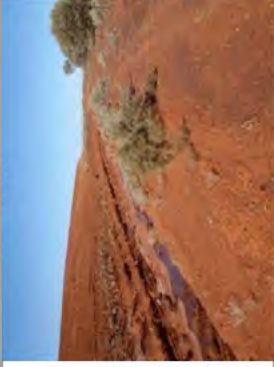
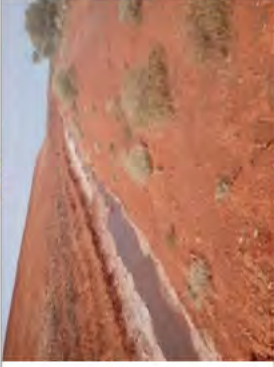
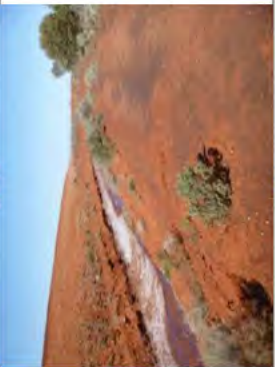
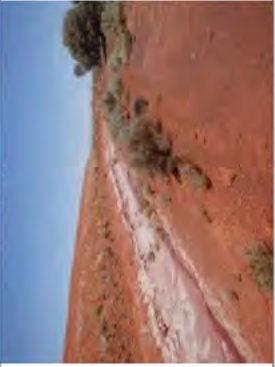
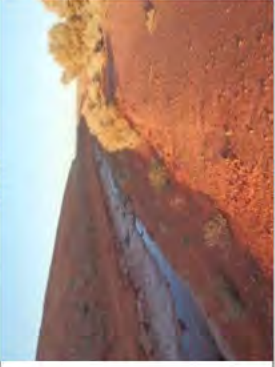
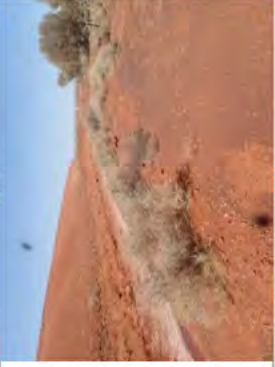
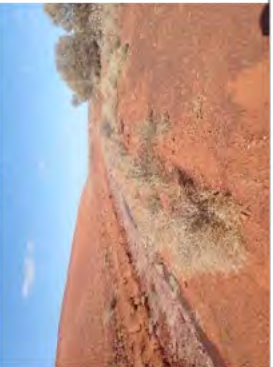
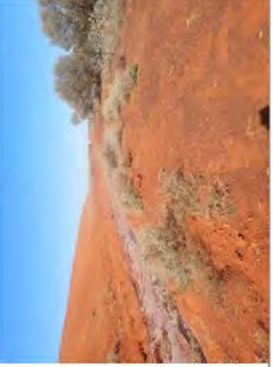
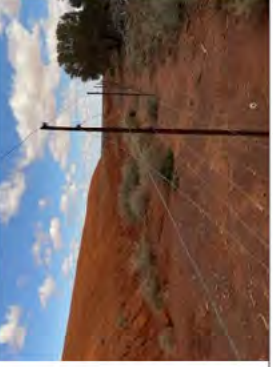
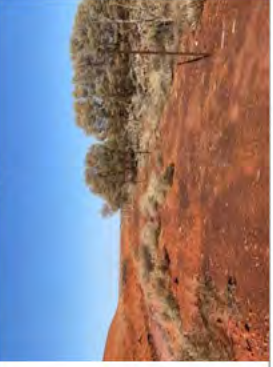
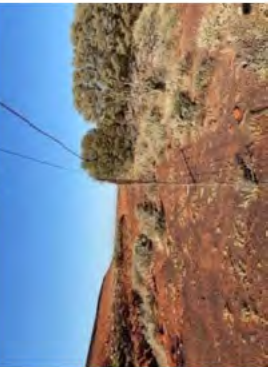
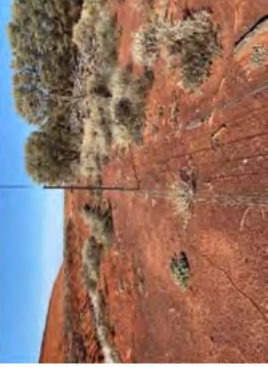
PP23: Facing CTD TSF across end of drain. No change in erosion. Almost all perennial shrubs have died, with few remaining in 'moderate' health. Cover mostly annual in 2025. Overall condition of area rated as 'completely degraded'. Layer of deposited silt with salt crusting within toe drain.

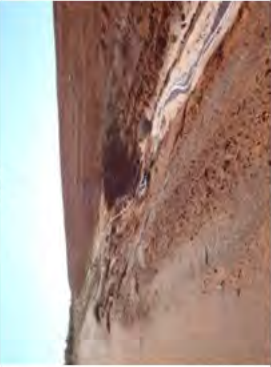
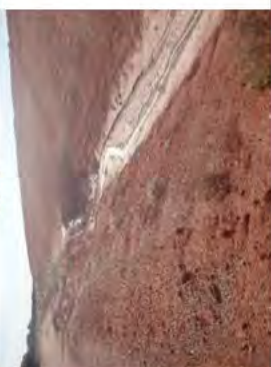
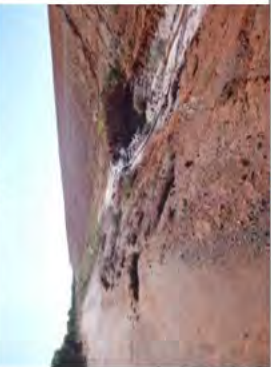
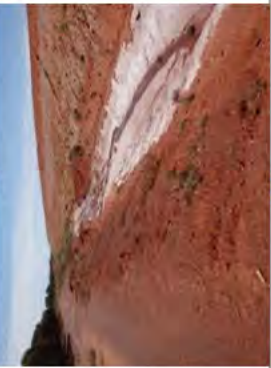
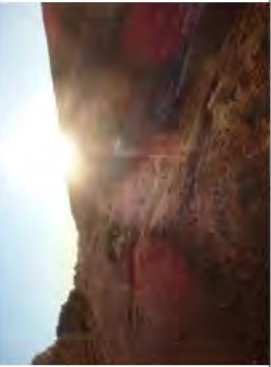
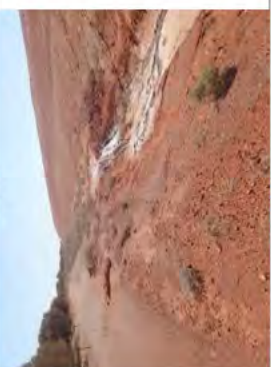
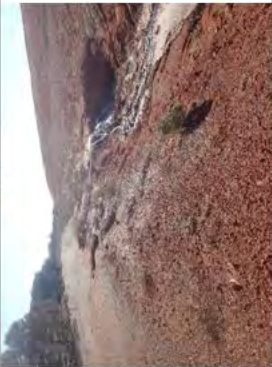
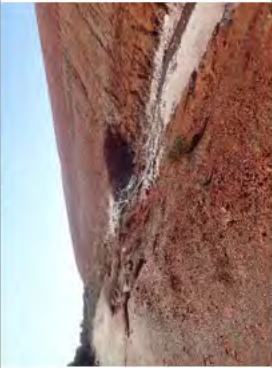
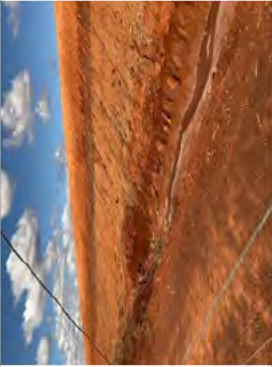
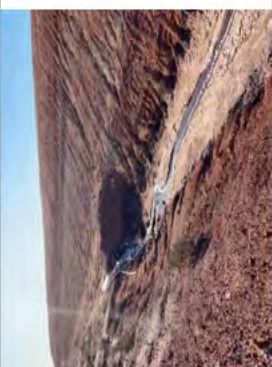
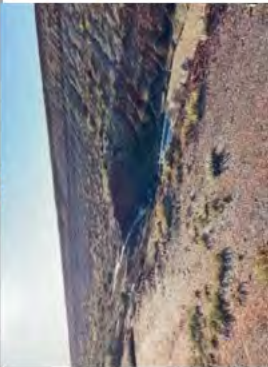
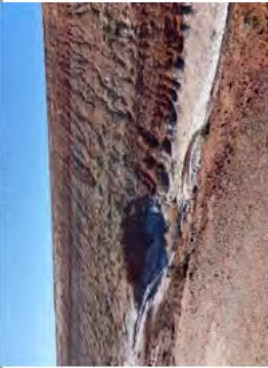
PP24: Facing away from CTD TSF along fence line. Vegetation around rocks in 'poor' health with evidence of water ponding and sheeting along the boundary line. Cover of annuals higher than perennials. Plants looking very dry. Overall condition of area within boundary fence rated as 'degraded'.

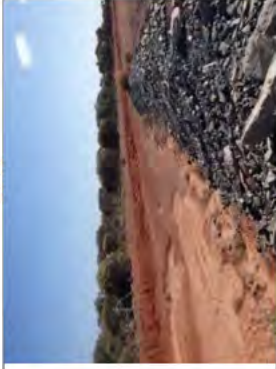
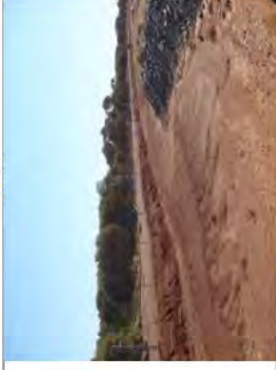
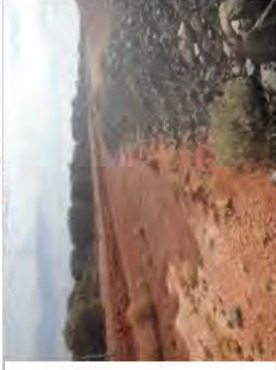
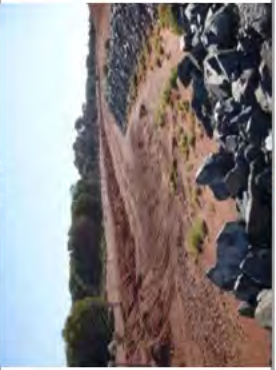
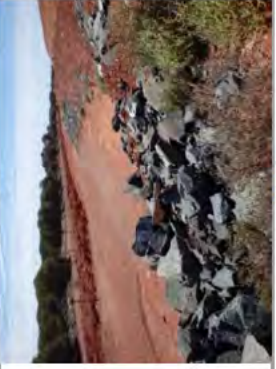
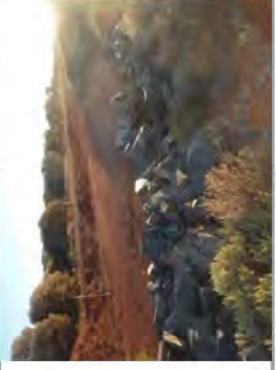
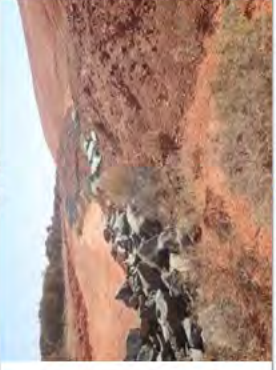
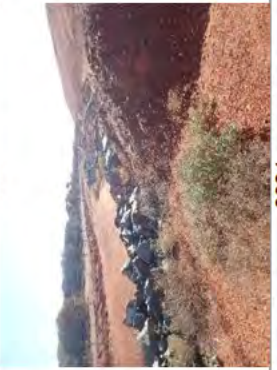
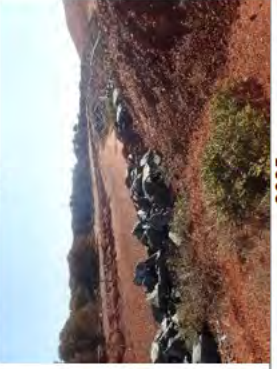
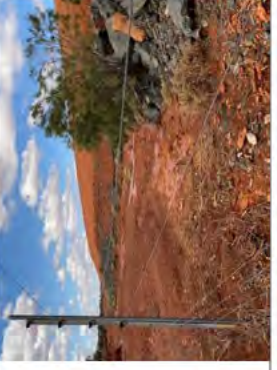
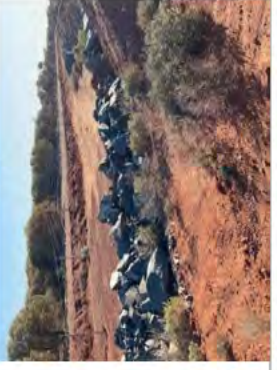
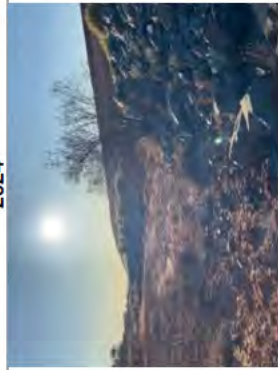
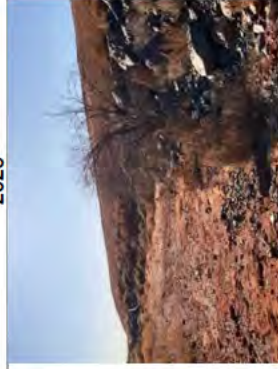
PP24-1: Facing away from CTD TSF toward start of drain. Acacia on the outside of the CTD TSF boundary in 'good-excellent' health. Perennial shrubs on the inside of the boundary in 'poor' health with signs of recent deaths. Cover of annuals higher than perennials. Evidence of water ponding & sheeting along the boundary line. Overall vegetation condition rating of 'degraded'.

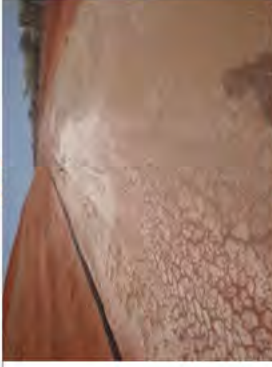
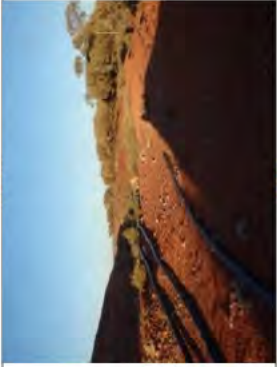
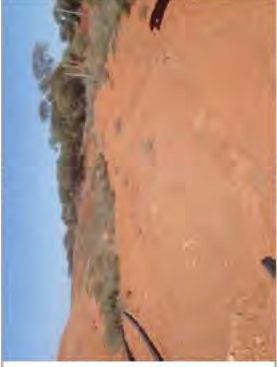
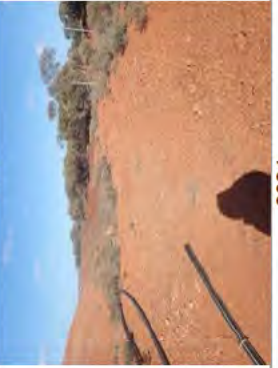
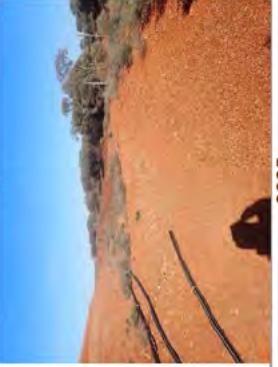
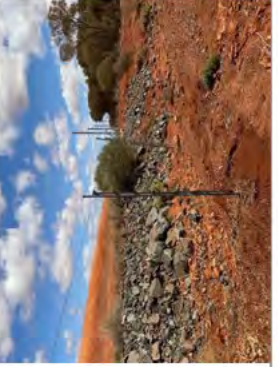
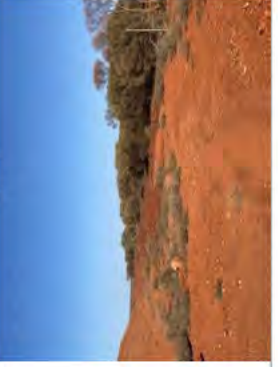
2012	2013	2014	2015
Photo not taken	Photo not taken	Photo not taken

PP25: Facing along fence line. Within boundary overall vegetation condition is 'degraded' with most perennials in 'good' health. Vegetation outside of boundary in 'good' health with minimal individual deaths. No change in run off drain.

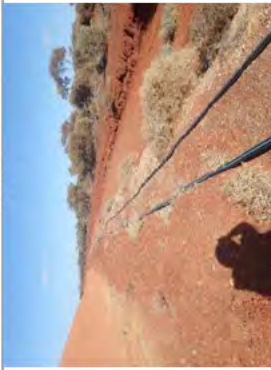
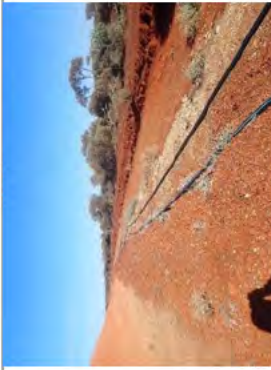
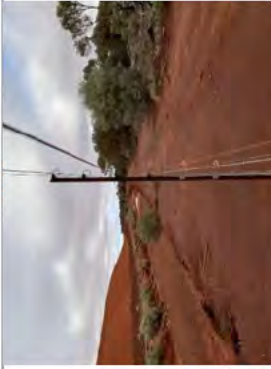
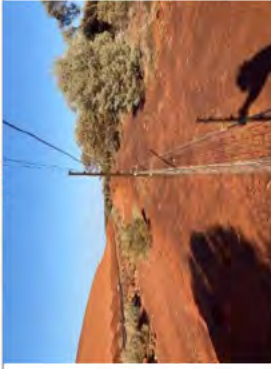
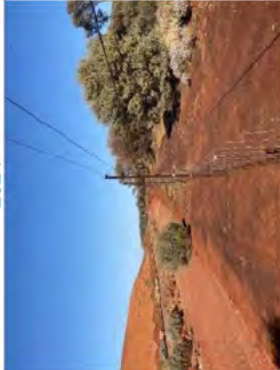
PP26: Facing away from CTD TSF toward topsoil pile. No salt crusting. Individual plant health rated as 'excellent' for all vegetation storeys. Overall vegetation condition of area rated as 'very good'.

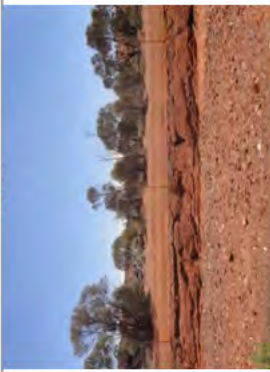
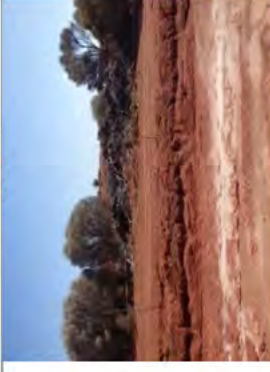
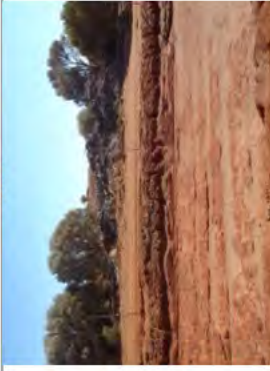
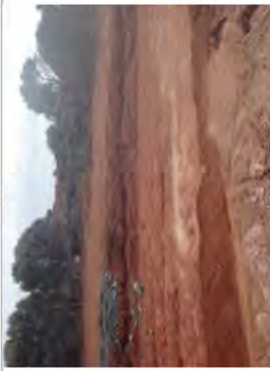
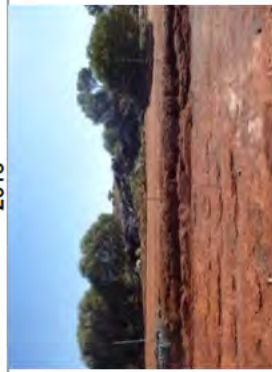
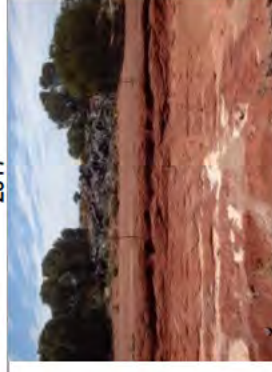
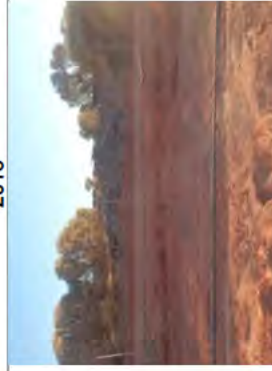
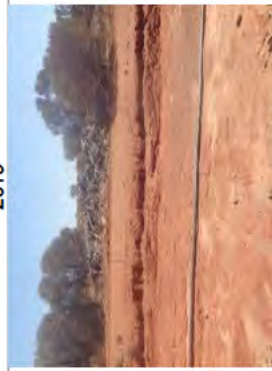
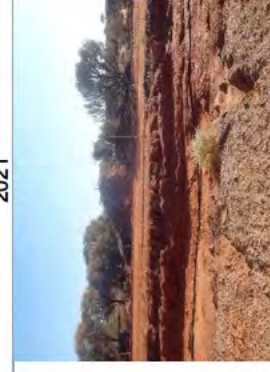
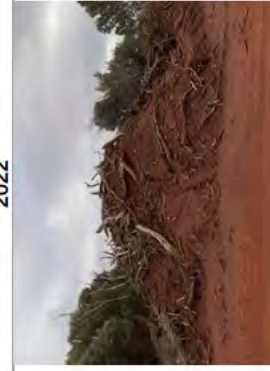
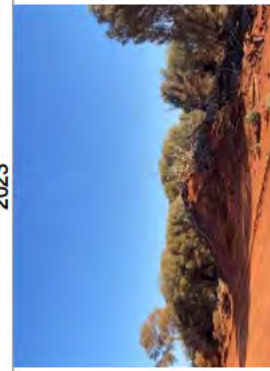
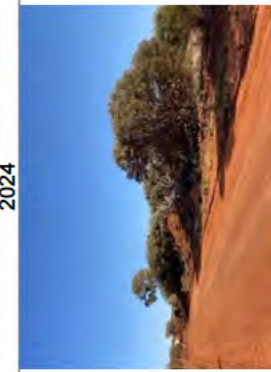
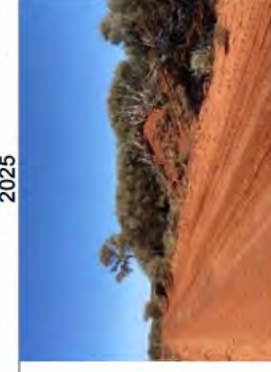
PP26-1: Facing CTD TSF along fence line. Individual plant health inside boundary in 'moderate' health. Signs of recent plant deaths & dust related decline, vegetation condition of area rated 'degraded'. Increase in sediment loss within runoff/overflow drain with potential for erosion & sheeting to increase with rainfall events.

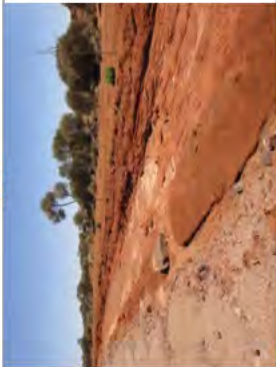
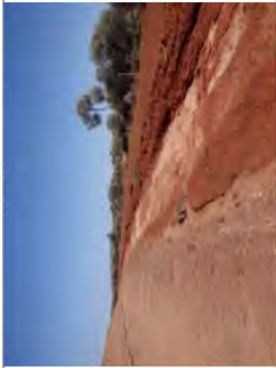
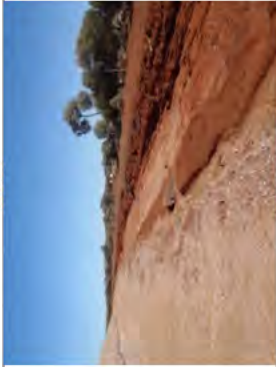
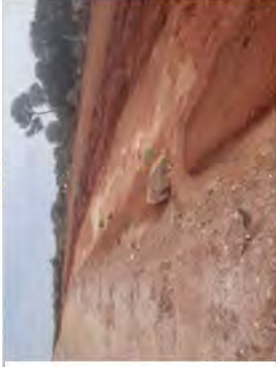
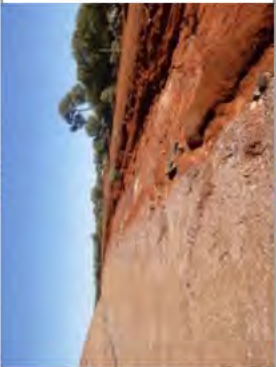
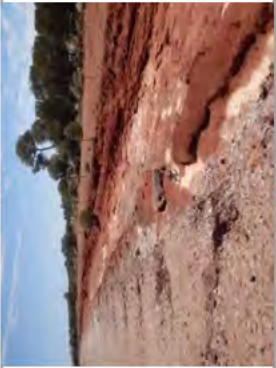
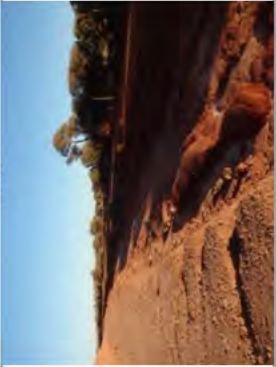
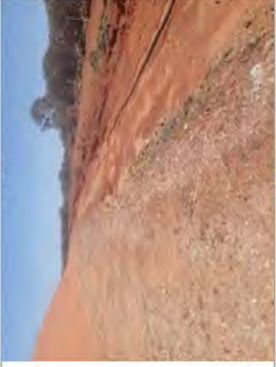
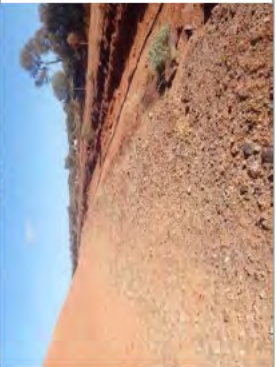
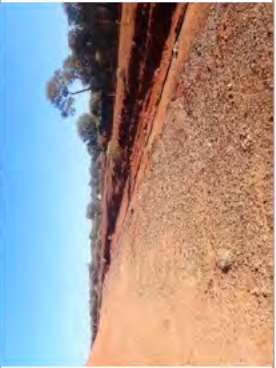
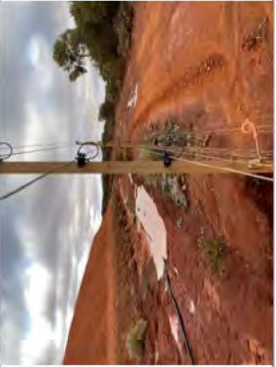
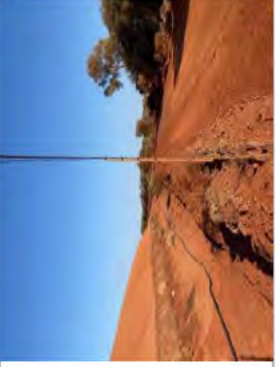
PP27: Facing CTD TSF from fence line. No water in drain. Vegetation on drain batters in 'degraded' condition, with individual plant health rated as 'moderate'.

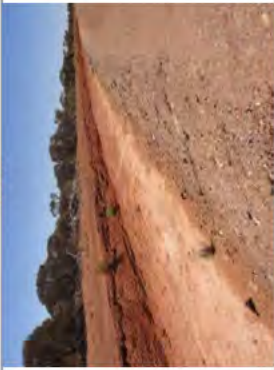
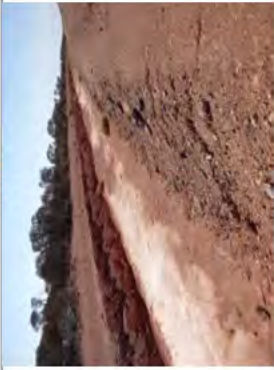
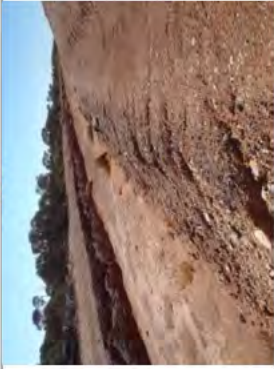
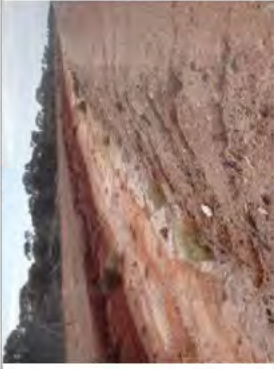
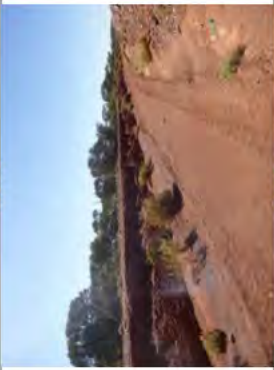
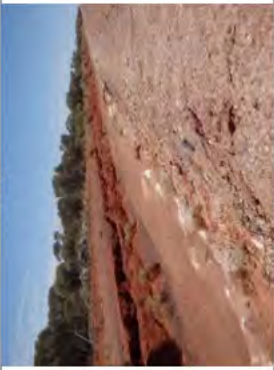
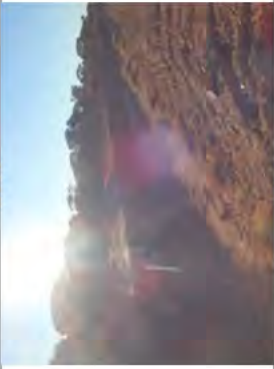
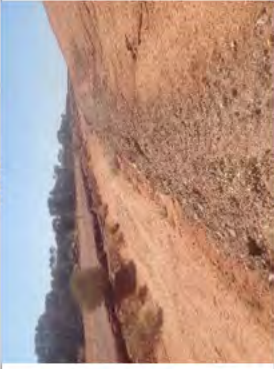
PP27-1: Facing away from CTD TSF along fence line. No salt crusting. Individual plant health rated as 'good' for mid-upper storeys. Some vegetation along road edge showing potential dust impacts. Recent signs of vegetation clearing present around site infrastructure. Overall vegetation condition of area rated as 'good'.

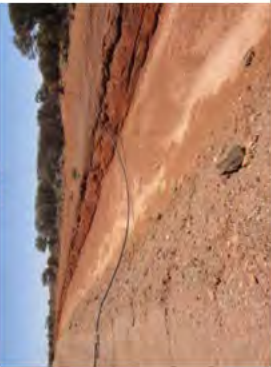
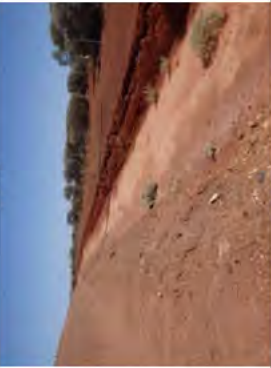
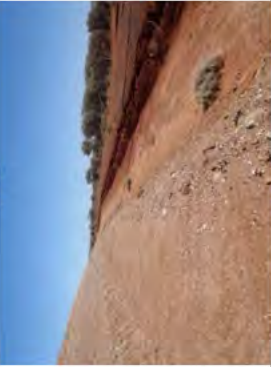
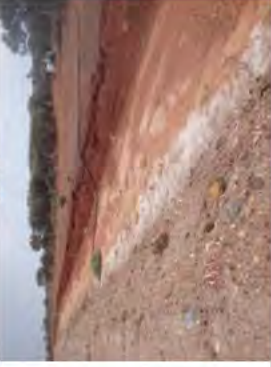
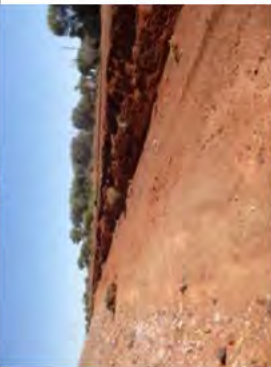
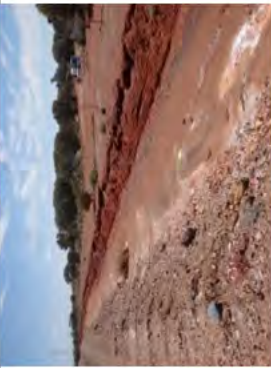
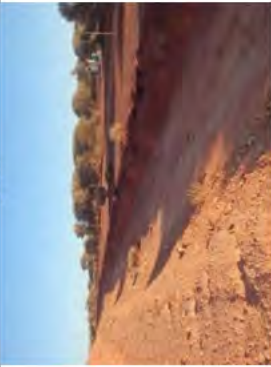
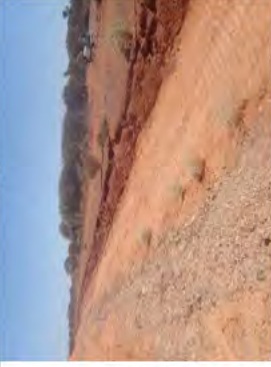
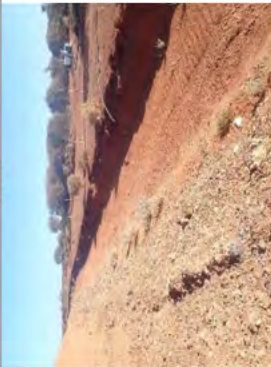
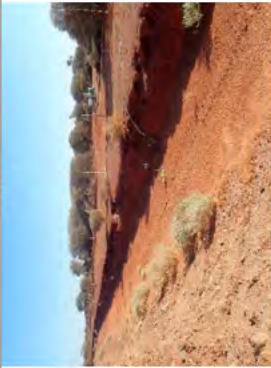
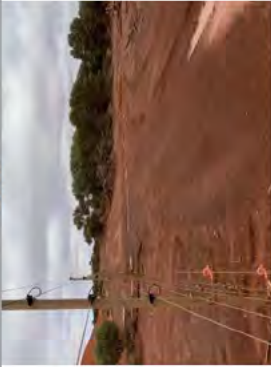
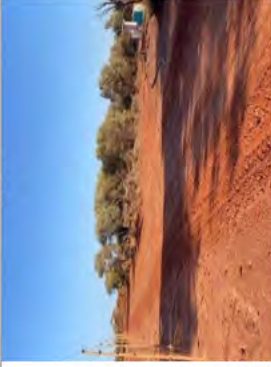
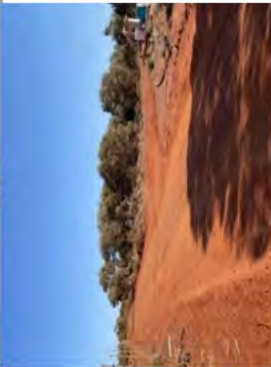
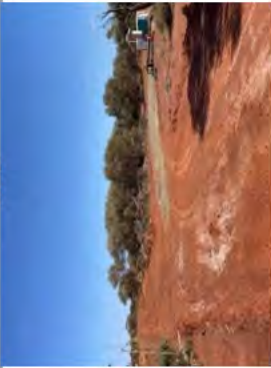
PP28: Facing CTD TSF along inside of fence line. Vegetation cover increased inside fence line, & individual plants in 'good' health. Vegetation outside of fence recently cleared & earthworks have taken place. Despite additional vegetation clearing, the overall condition of the area remains 'good'.

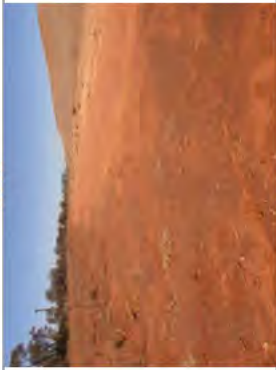
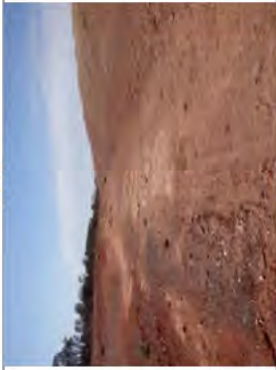
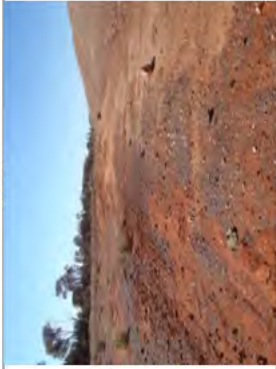
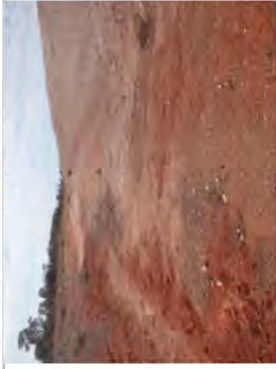
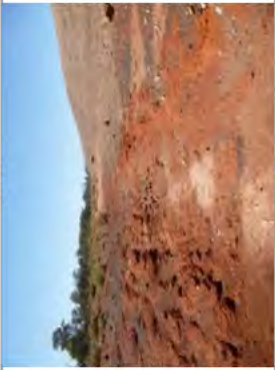
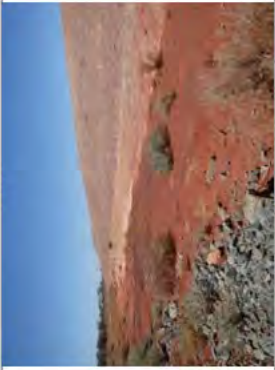
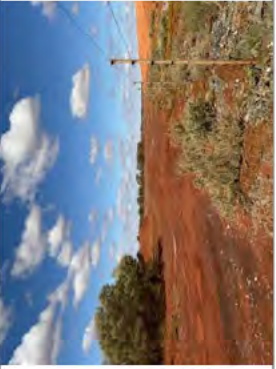
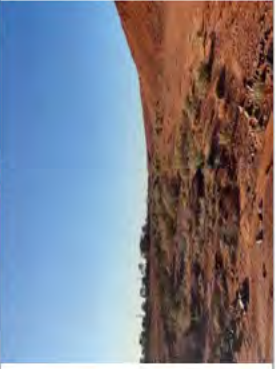
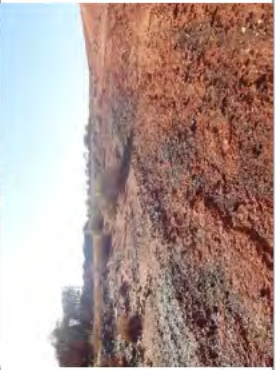
PP28-1: Facing away from CTD TSF toward fence line. Vegetation in 'good' health and condition, showing signs of dust impacts, showing signs of sheet erosion from large rainfall events. Very little change.

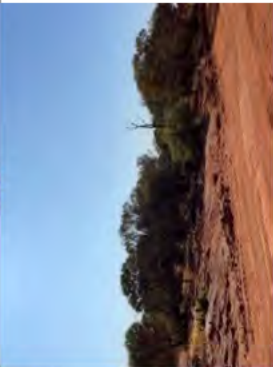
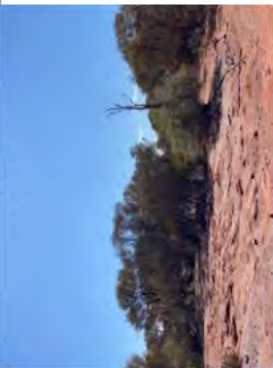
<p>PP38: Facing away from CTD TSF. Vegetation outside of boundary showing decline with extensive deaths & health decline in mid & upper storey plants. Vegetation in overall 'very poor' health & 'degraded' condition. Significant increase in salt crusting on surface. Soil very wet, slippery clay.</p>

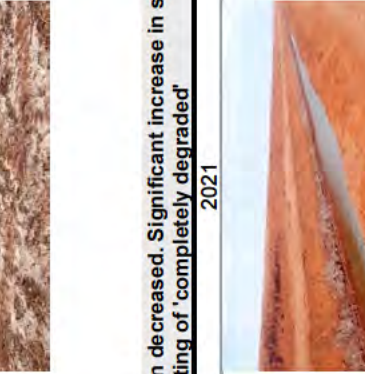
<p>PP38-1: Facing CTD TSF along drain. Water level in drain decreased. Significant increase in soil surface salt crusting. Active clearing in area due to pump and toe drain access. Very little vegetation present and little to no healthy vegetation therefore a rating of 'completely degraded'</p>

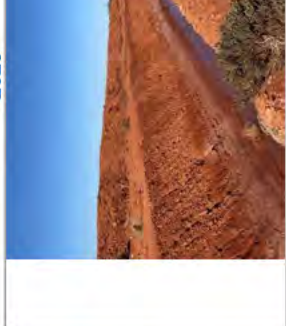
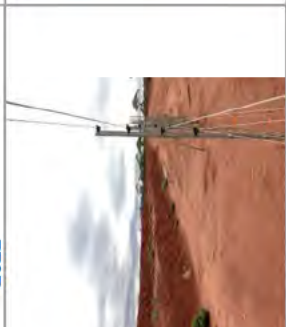
2020	2021	2022	2023

PP40-2: Facing CTD TSF across cleared area. Vegetation in 'good' health. With some mid storey shrub deaths. Slight increase in individual perennial plant cover. Increase in *Maireana* spp. growth on the mound. Decrease in annual cover around base of cleared vegetation pile. No salt crusting. Overall vegetation condition rating is 'degraded'.
