SUNRISE DAM GOLD MINE PRESCRIBED PREMISES LICENCE – L8579/2011/2 ANNUAL ENVIRONMENTAL REPORT 2025

REPORTING PERIOD 1 JANUARY 2025 – 31 DECEMBER 2025

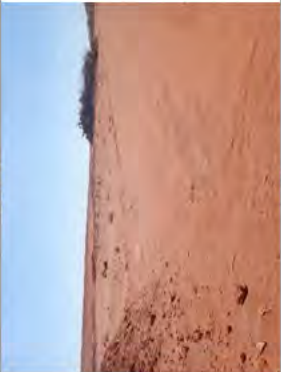
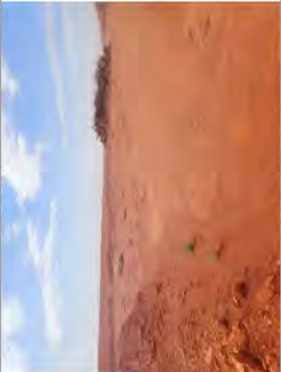
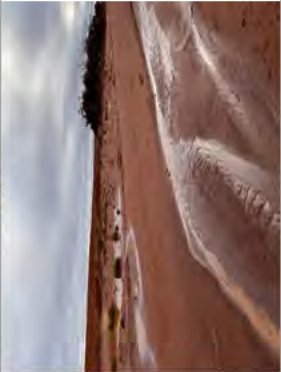
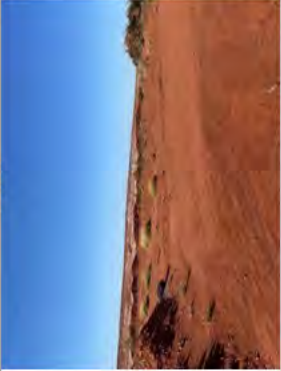
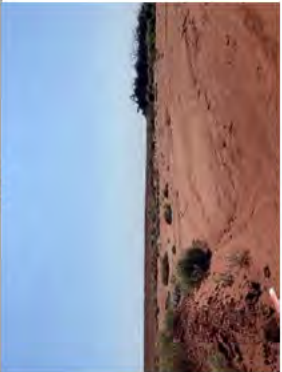
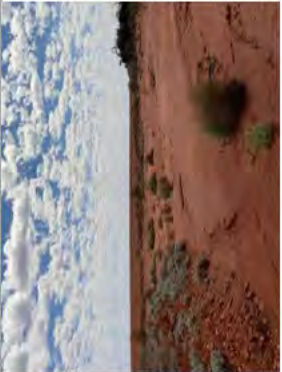
2020	2021	2022	2023

PP41-1: Facing CTD TSF along fence line and cleared area. Vegetation in 'very good' health and increasing in cover with moderate annual cover. No visible salt crusting. Evidence of moist soils in the area. Overall vegetation condition rating is 'good'.

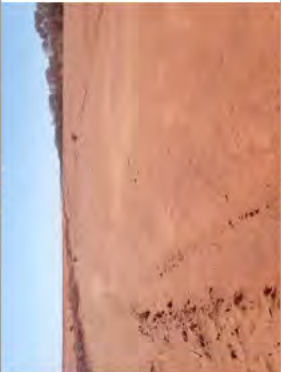
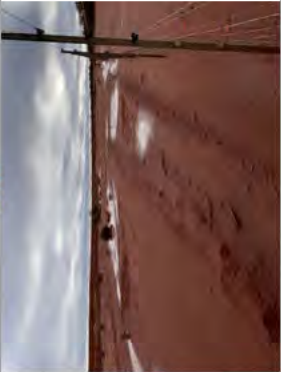
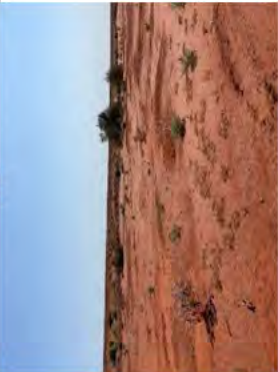
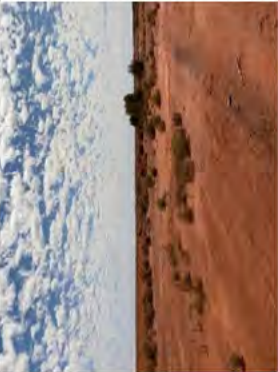
2020	2021	2022	2023

PP42: Facing CTD TSF from fence line. No increase in vegetation cover, mostly annuals, in 'good' health. Showing signs of regeneration post clearing. No salt crusting. Overall vegetation condition rating is 'completely degraded'.
