# SECOND FORTUNE GOLD MINE

Prescribed Premises Licence: L9012/2016/1

Annual Audit Compliance Report

1 July 2024 – 30 June 2025

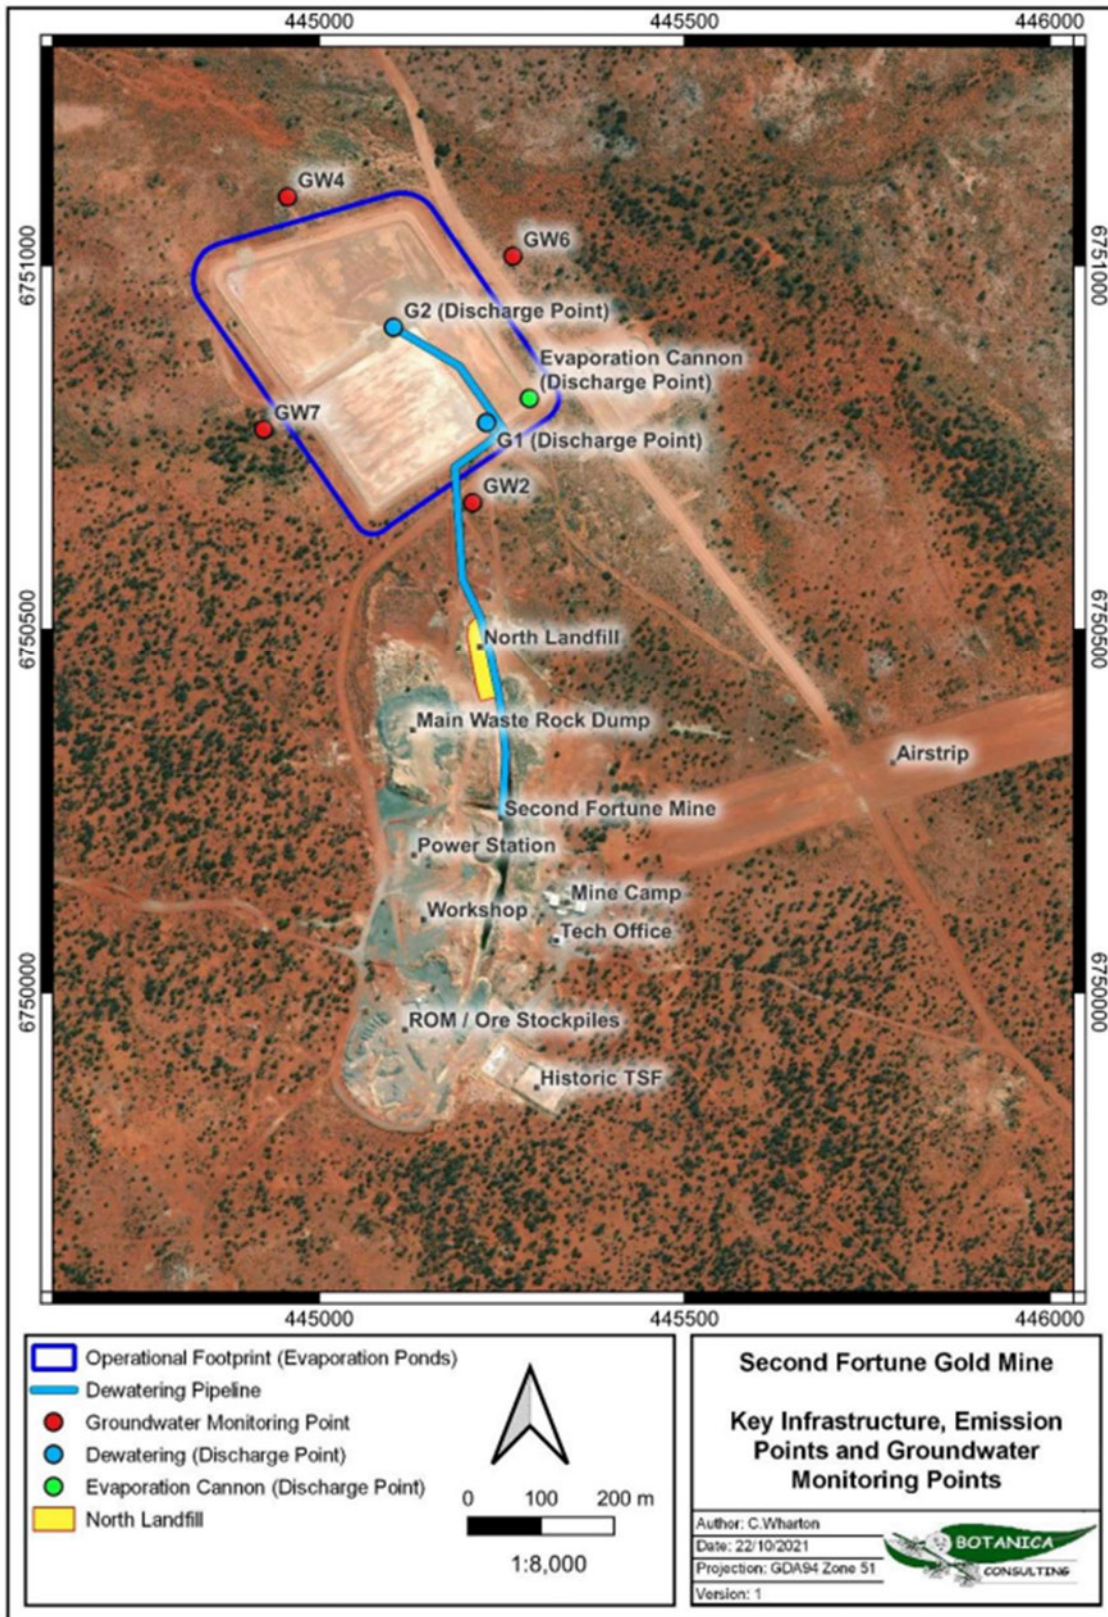
Figure 2: Map of Emission and Monitoring Points

Mine dewater effluent from the underground is currently discharged into a two celled evaporation pond located to the north of the main open pit (Figure 2).
