Annual Audit Compliance Report Form

Section A – Licence Details			
Licence number:	L9246/2020/1	Licence file number:	DER2020/000086
Licence holder:	Donald Pty Ltd		
Trading as:	Westerndale Farm		
ACN:	121 909 108		
Registered address:	36 Milton Street, Yokine, WA, 6060		
Reporting period:	1/07/2022 to 30/06/2023

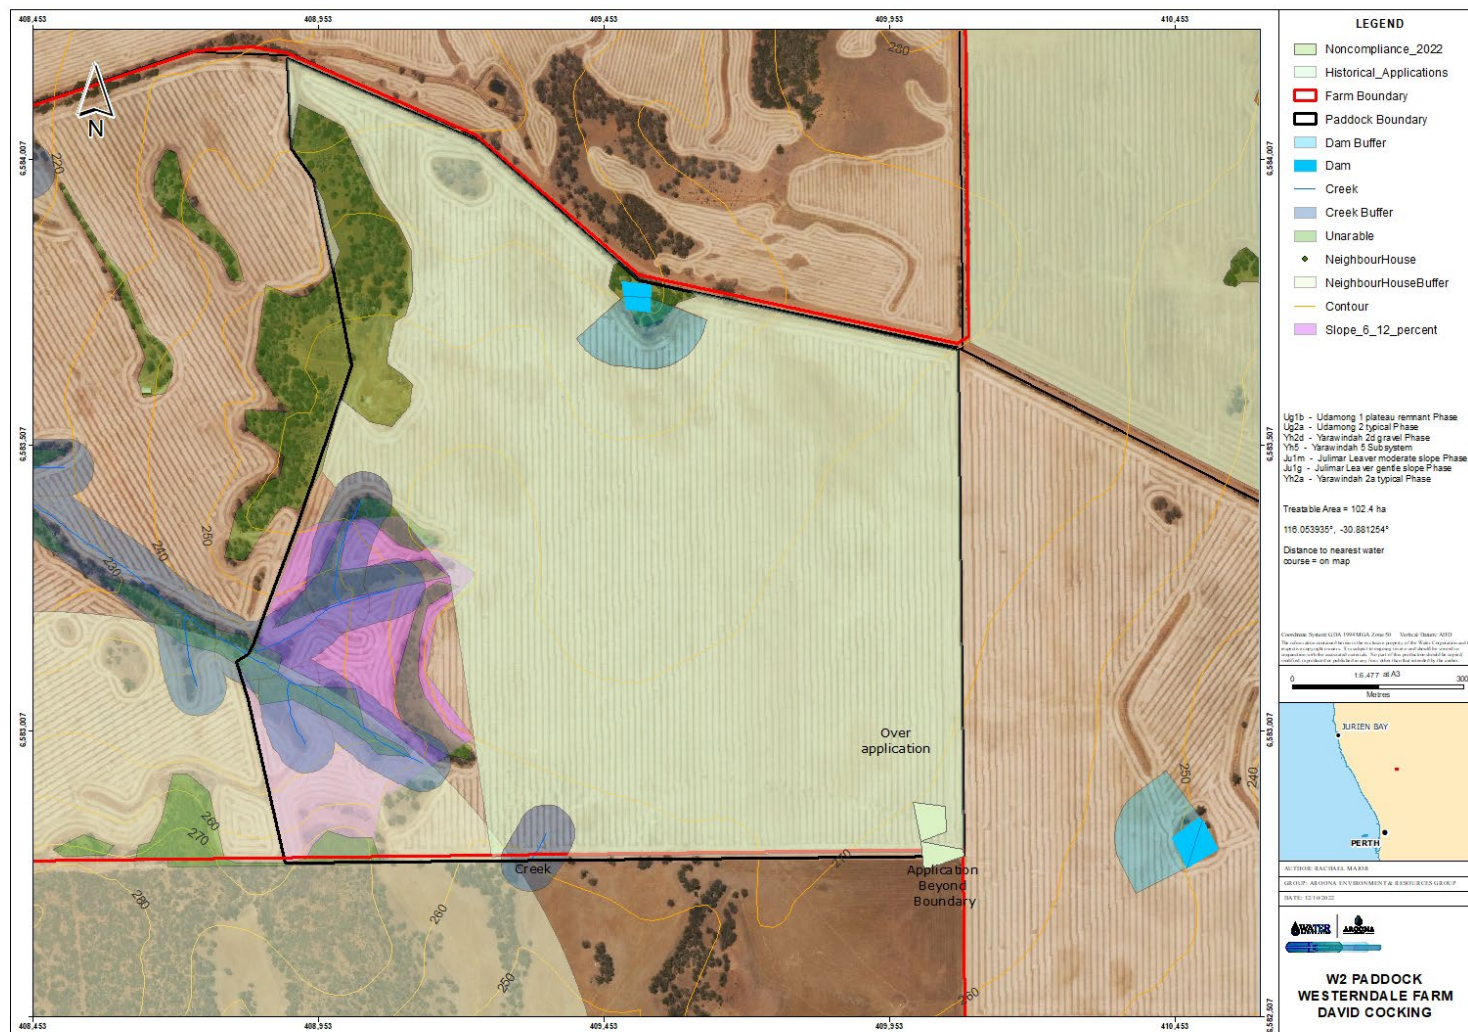
Map 1. W2 Non-compliance

Condition no:	Condition 2 Table 2 Waste processing s) Ensure that the quantity of biosolids per hectare directly applied to land does not exceed the Limiting Factor for that particular paddock, crop type and biosolids composition;	Date(s) of non-compliance:	16/08/2023
Details of non-compliance:			
<p>This Non-compliance relates to what would appear to be over application, particularly at one point within the W2 paddock, the start of the spreader run on 16/08/2023 Water corporation observed heavy application of LAB in SW corner which occurred during the initial calibration of the spreader. This is where a 'slug' of biosolids discharges before 'spreading' commences properly. Otherwise, the spreader is routinely calibrated to meet approved application rates.</p>			
What was the actual (or suspected) environmental impact of the non-compliance?			
<p>NOTE – please attach maps or diagrams to provide insight into the precise location of where the non-compliance took place.</p>

No Environmental Impact. Map1 for location			
Cause (or suspected cause) of non-compliance:			
This occurred at the beginning of a spreader run where a 'slug' of biosolids discharges before 'spreading' commences properly			
Action taken to mitigate any adverse effects of non-compliance and prevent recurrence of the non-compliance:			
<ul style="list-style-type: none"> The Water Corporation consulted the license holder (farmer) regarding the requirement to comply with the regulatory obligations of the DWER licence and DoH approvals Incorporation of biosolids with Kelly chain

Condition no:	Condition 2:Table 2 Waste processing u) Biosolids are not to be applied pending or during inclement weather	Date(s) of non- compliance:	19/07/2023
Details of non-compliance:			
This non-compliance relates to the biosolids cake being spread in W2 on 19 July there was rainfall on 21 July (18ml) and 23 July (22ml).			
What was the actual (or suspected) environmental impact of the non-compliance?			
<p>NOTE – please attach maps or diagrams to provide insight into the precise location of where the non-compliance took place.</p> <p>No environmental impact- The paddock was observed to have been heavily pastured and, the areas spread were no greater than 6% slope so runoff of biosolids because of these spreading activities is unlikely. See Map1 for location</p>			
Cause (or suspected cause) of non-compliance:			
An operational decision to spread during a light rainfall event prior to a forecasted heavier rainfall event. The risk of runoff was deemed to be low due to the paddock being well-covered in vegetation.

Condition no:	2. Table 2: Waste processing q) vii. 5 m surrounding farm driveways, access roads and fence lines.	Date(s) of non-compliance:	28 June 2022 to 30 September 2022
Details of non-compliance:			
There was evidence of biosolids spread in the adjacent farm in the SW Corner W2 Paddock, which had been raked and removed with a shovel, approximately 3 shovels were removed			
What was the actual (or suspected) environmental impact of the non-compliance?			
<p>NOTE – please attach maps or diagrams to provide insight into the precise location of where the non-compliance took place.</p> <p>No environmental impact. See Map1 for location</p>			
Cause (or suspected cause) of non-compliance:

Lack of awareness by machinery operator of the potential to spread “flick” excess biosolids as the spreader turned a corner which caused a small amount of biosolids cake to be deposited over the fence into the neighboring property	
Action taken to mitigate any adverse effects of non-compliance and prevent recurrence of the non-compliance:	
<ul style="list-style-type: none"> • The Biosolids cake was raked and removed with a shovel by the license holder as soon as he became aware of the non-compliance on 16/08/2023, approximately 3 shovels were removed. • The external Boundary of W2 was driven to ensure there was no further incursion of biosolids beyond the farm boundary. • The License holder has committed to ensuring turning the spreader occurs not less than 20m from the boundary with all future applications 	
Was this non-compliance previously reported to DWER?	
<input checked="" type="checkbox"/> Yes, and

<ul style="list-style-type: none"> The Water Corporation consulted the license holder (farmer) regarding the requirement to comply with the regulatory obligations of the DWER licence and DoH approvals Incorporation of biosolids with Kelly chain 	
Was this non-compliance previously reported to DWER?	
<input checked="" type="checkbox"/> Yes, and	
<input type="checkbox"/> Reported to DWER verbally	Date: / /
<input checked="" type="checkbox"/> Reported to DWER in writing	Date: 25/08/23

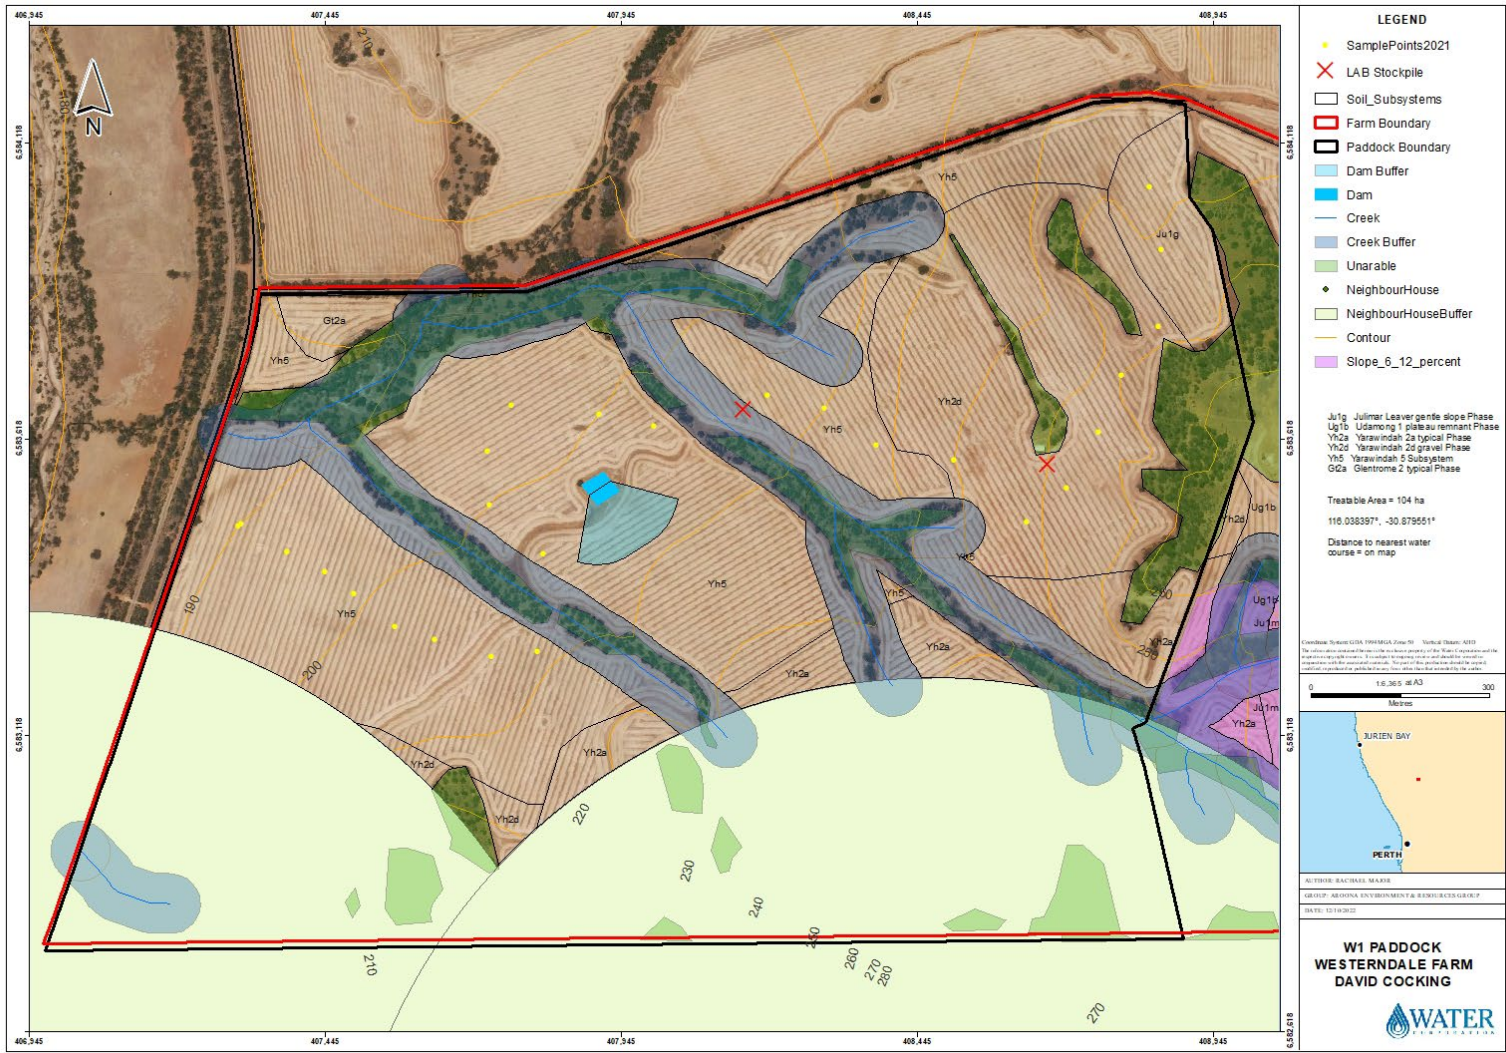
Map 2. W1 Non-compliance

Section E – Details of Non-Compliance with Licence Condition			
Please use a separate page for each condition with which the licence holder was non-compliant at a time during the reporting period.			
Condition no:	2. Table 2: Waste processing j) Storage sites are 100 m away from surface water bodies including dams.	Date(s) of non-compliance:	28 June 2022 to 30 September 2022
Details of non-compliance:			
This non-compliance relates to biosolids storage within 30m of an ephemeral creek line, contravening the 100m buffer distance.			
What was the actual (or suspected) environmental impact of the non-compliance?			
NOTE – please attach maps or diagrams to provide insight into the precise location of where the non-compliance took place.			
No environmental impact, as this stockpile was strategically located within a depression in the landscape, with surface flow running away from the creek. See Map 2 for location.

Cause (or suspected cause) of non-compliance:			
This was a result of a change to the storage location originally identified in the REF, as multiple high rainfall events resulted in the paddock conditions restricting vehicle access. The stockpile location was chosen to maximize truck delivery distances given the access issues resulting from wet paddocks.			
Action taken to mitigate any adverse effects of non-compliance and prevent recurrence of the non-compliance:			
<ul style="list-style-type: none"> • The Water Corporation consulted the license holder (farmer) regarding the requirement to comply with the regulatory obligations of the DWER licence and DoH approvals. • Bunding installed around the stockpile to prevent runoff from the stockpile onto downslope areas • Lime amended Biosolids were spread and incorporated as soon as paddock access improved • Inspect adjacent watercourse for runoff and if biosolids or changes in water conditions are observed, determine an action plan in consultation with The Water Corporation. • Biosolids signage was located at the entrance to the farm
