# Annual Audit Compliance Report Form

Environmental Protection Act 1986, Part V Division 3

Section A – Licence details			
Licence number:	L9335/2022/1	Licence file number:	DER2022/000219
Licence holder name:	Thunderbird Operations Pty Ltd		
Trading as:			
ACN:	611 251 743		
Registered business address:	264 Port Drive   PO Box 1876, Broome WA 6725		
Reporting period:	14 / 12 / 2024 to 13 / 12 / 2025

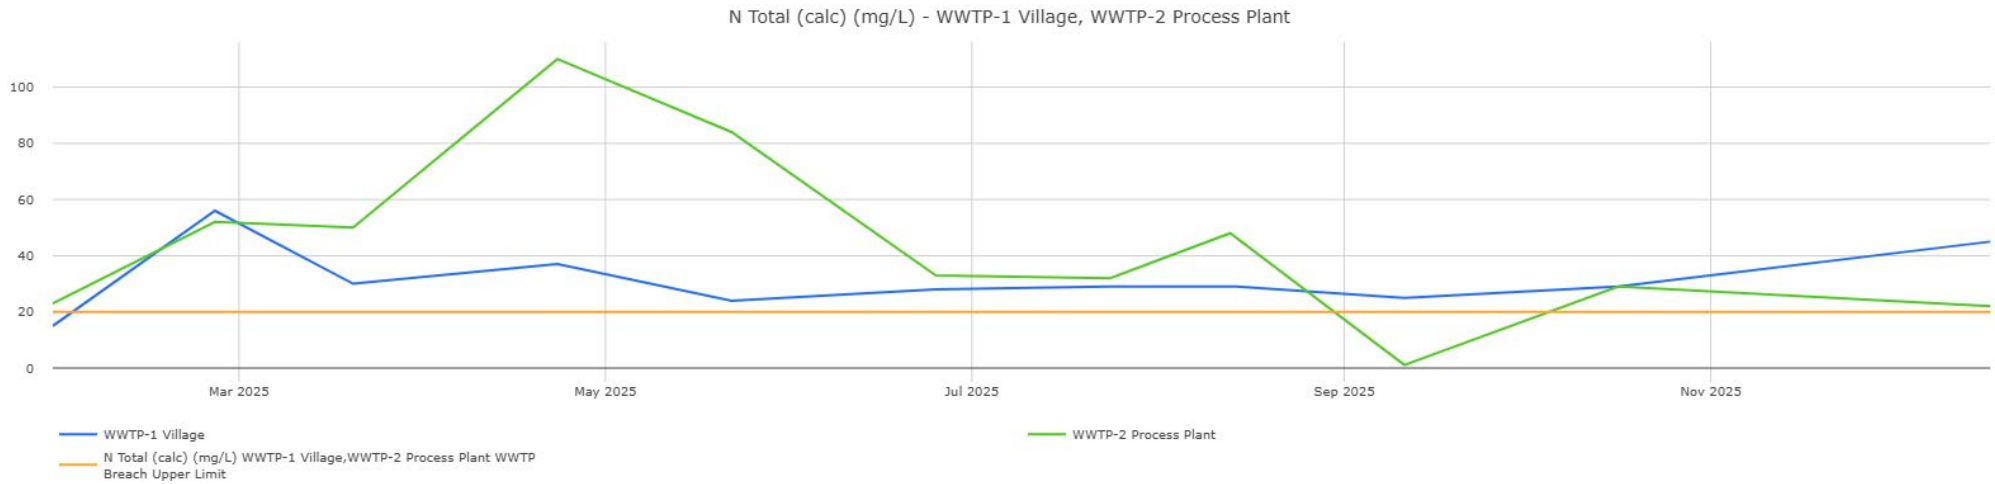
Figure B1. Total Nitrogen at WWTP1 and WWTP2

The 2023-2024 AACR reported on multiple exceedances of the concentration limit listed for total nitrogen and total phosphorus during monthly effluent sampling for WWTP1 and WWTP2. Continued sampling of WWTP1 and WWTP2 has shown ongoing exceedance levels results over the current reporting period, although WWTP1 continues to demonstrate better performance overall and nitrogen levels appeared to trend closure towards compliance levels particularly towards the end of the reporting period. (*Appendix B; Figures B1 and B2*).

The elevated nitrogen and phosphorus levels have been attributed to both a high concentration of urea and a low availability of Mixed Liquor Suspended Solids (MLSS) within the wastewater system. Elevated urea levels within wastewater systems are a common issue across the industry contributing to elevated nutrient levels. MLSS concentrations are important during the aeration process of the waste stream as this accounts for the availability of micro-organisms to consume the organic waste. If the ratio of micro-organisms to waste is not right, unacceptable amounts of waste will continue to move through the wastewater system resulting in the current elevated emission concentrations being discharged. This can be seen with the lower nutrient levels experienced at WWTP1-Village compared to WWTP2-Processing Plant which has had greater variability in its servicing population due to work group locations around site. While works have been ongoing to make improvements to the system, success has been restricted due to interface accessibility of the pump controller restricted by the manufacturer.

Daily monitoring and adjustments of plant performance continue to be improved with regards to consistency knowledge of the system. Adjustments to the ratio of solids as well as oxygenation levels are consistently made in order to increase microbiological activity and subsequently bring nutrient levels down. As population numbers across site continue to stabilize this will assist in creating a sufficient baseline of system requirements with regards to solids ratios and oxygenation levels.

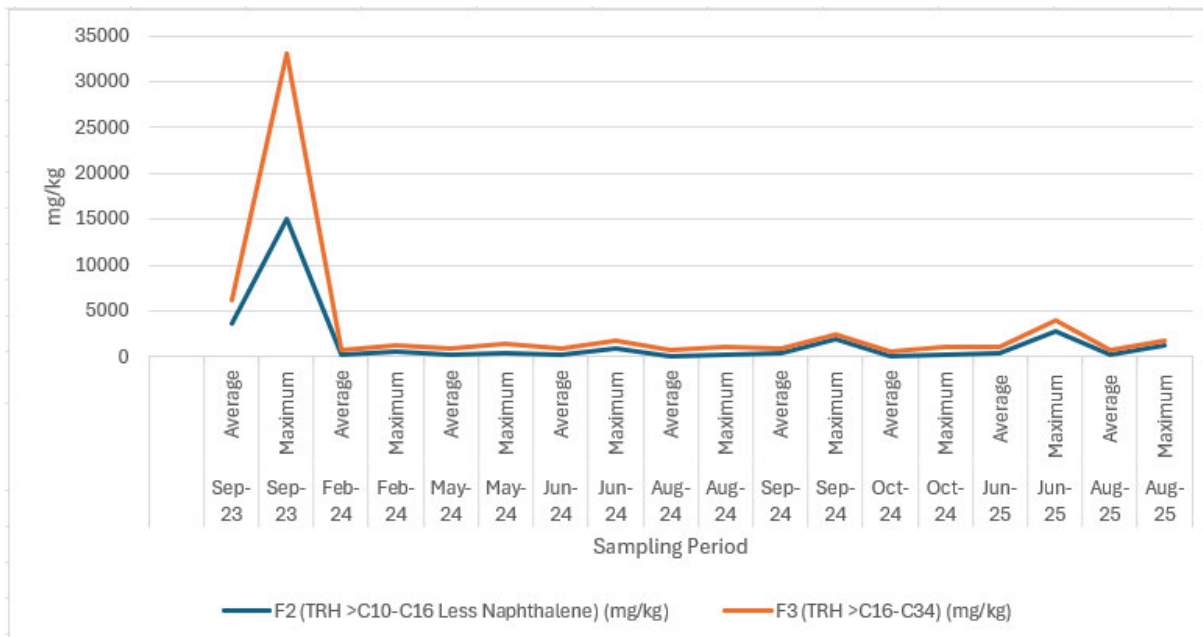
**Figure B3: Remediation Rate of TRH-F2 and TRH-F3 Hydrocarbon Fractions**

Regular treatment and sampling has been conducted since Cell 1 reached capacity and was closed for further deposition. Samples are analysed for hydrocarbon contaminants of concern including BTEX, Naphthalene, Total PAH's and TRH's (including TRH-F1, TRH-F2, TRH-F3 and TRH-F4). The predominant contaminants were identified to be within hydrocarbon fractions TRH>C10-C34 (TRH-F2 and TRH-F3), consistent with expectations for non-combusted diesel compounds.

Analytical results from sampling conducted on material in Bio-Remediation Cell 1 indicate that volatile hydrocarbons (BTEX) and Poly-Aromatic Hydrocarbons (PAHs) have been consistently below laboratory reporting limits confirming effective treatment of the more mobile and toxic hydrocarbon fractions. Total petroleum hydrocarbons are dominated by the heavier aliphatic and aromatic fractions (C16–C35), with measured concentrations generally well below applicable landfill acceptance criteria. Of the ten validation samples collected in August 2025, only one sample recorded a C16–C35 aromatic concentration of 580 mg/kg, marginally exceeding the Landfill Class II guideline value of 450 mg/kg. All remaining samples were below this criterion, with an average C16–C35 aromatic concentration of approximately 322 mg/kg. Statistical assessment using the WA Landfill Waste Classification Guidelines approach shows the 95% Upper Confidence Limit (UCL) for C16–C35 aromatics to be 390 mg/kg, which is below the Landfill Class II threshold.

The material treated in Bio-Remediation Cell 1 was excavated in September 2025 and deposited into the sites Class II landfill cell as backfill, thus bringing the capacity of the bio-remediation cells back within compliance limits.

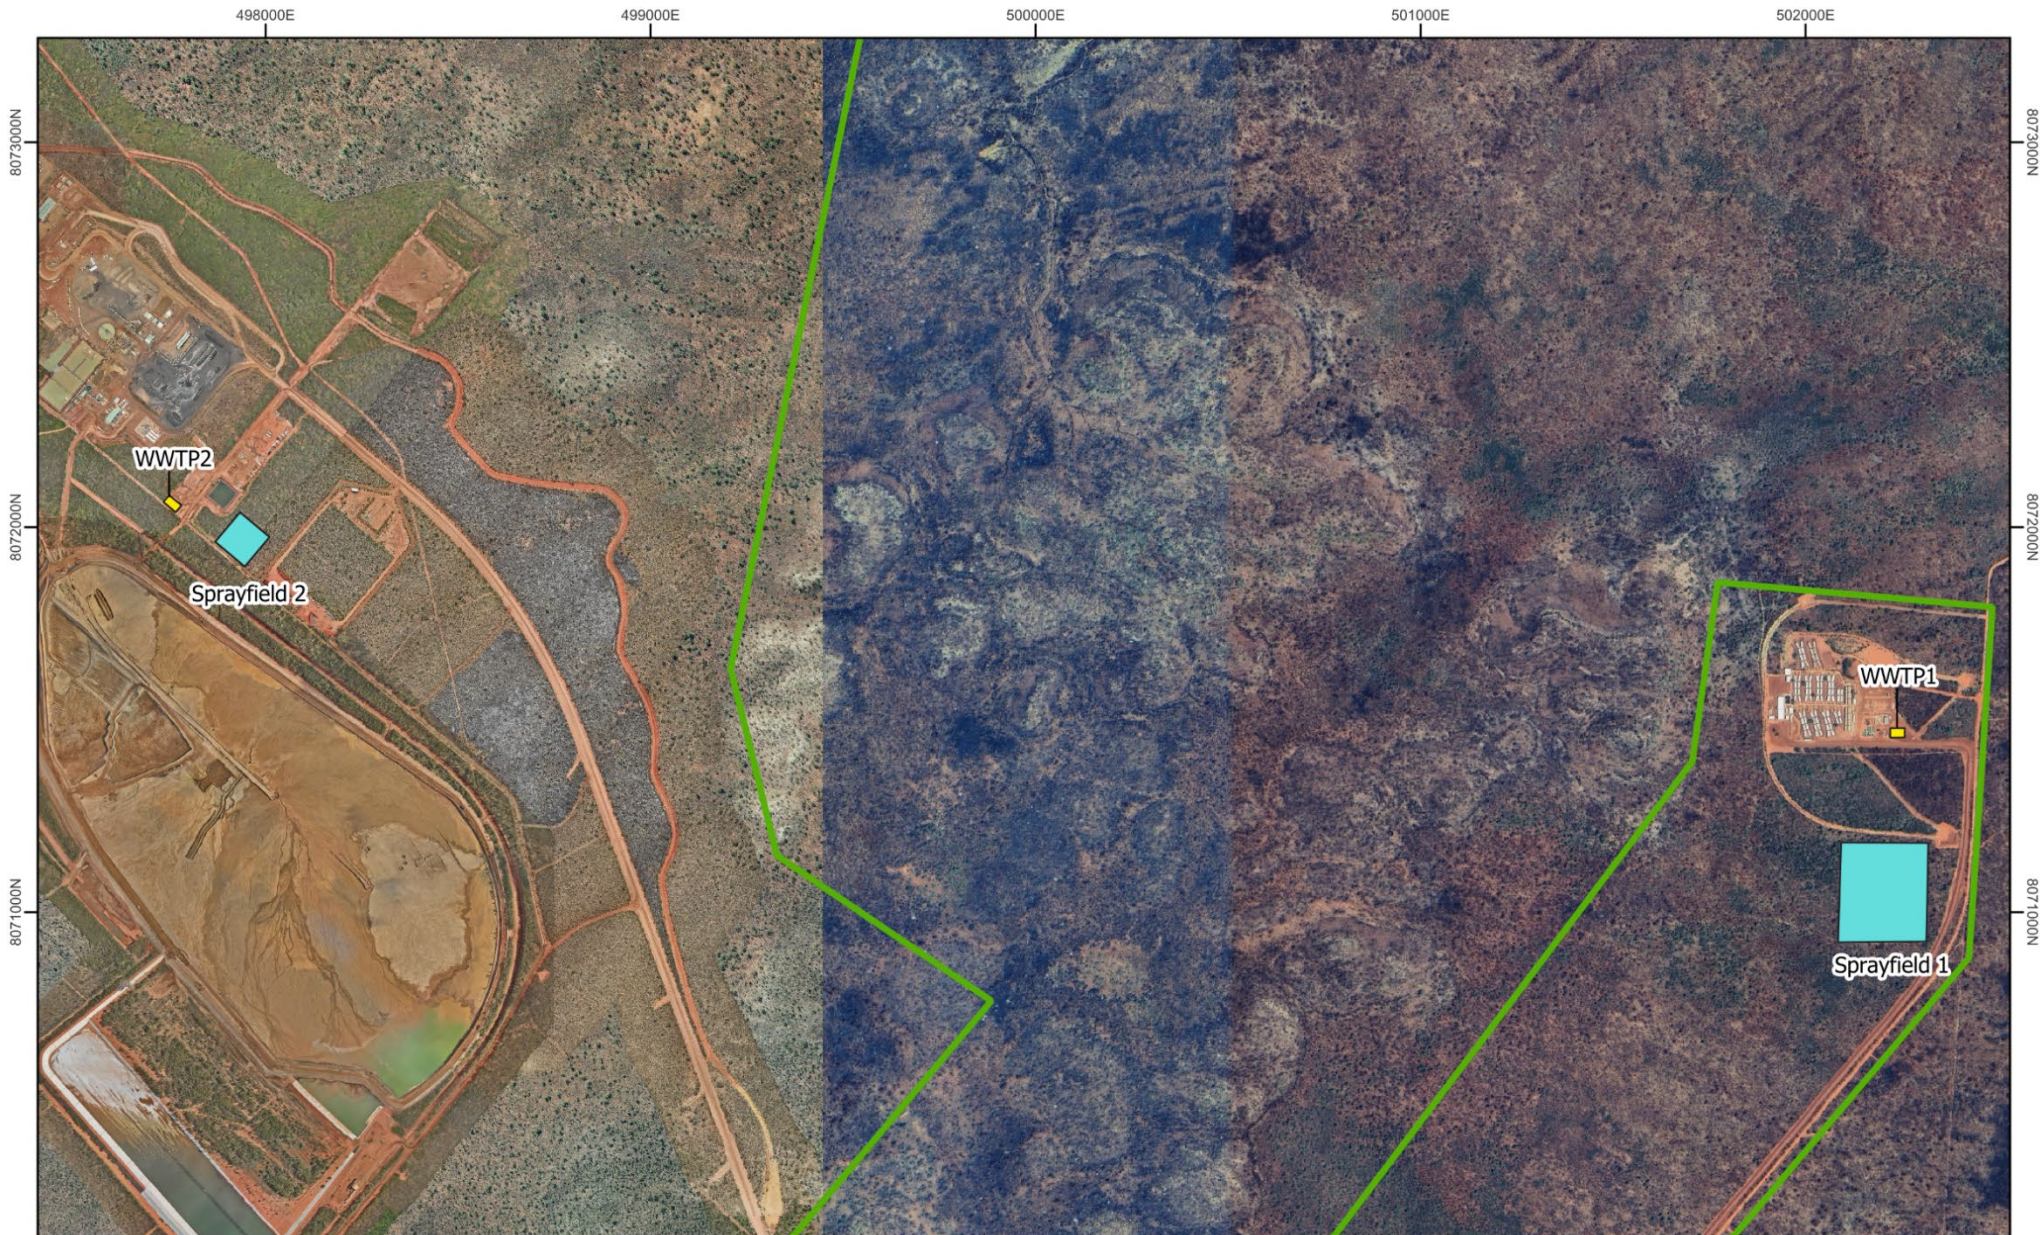
**Figure B5**

The discharge volumes continue to be well below the licenced production capacity of each facility. As a result, despite exceeding concentration limits the total loading over the course of the licence period has not exceeded approved limits. Therefore, the actual environmental impact of concentration exceedances is deemed to be negligible. Location of incident is shown in Appendix B; Figure B5.

Figure B5. Aerial view showing the location and extent of the WWTP1 and WWTP2 sewage sprayfields within the Thunderbird Development Envelope, including associated irrigation areas and infrastructure.

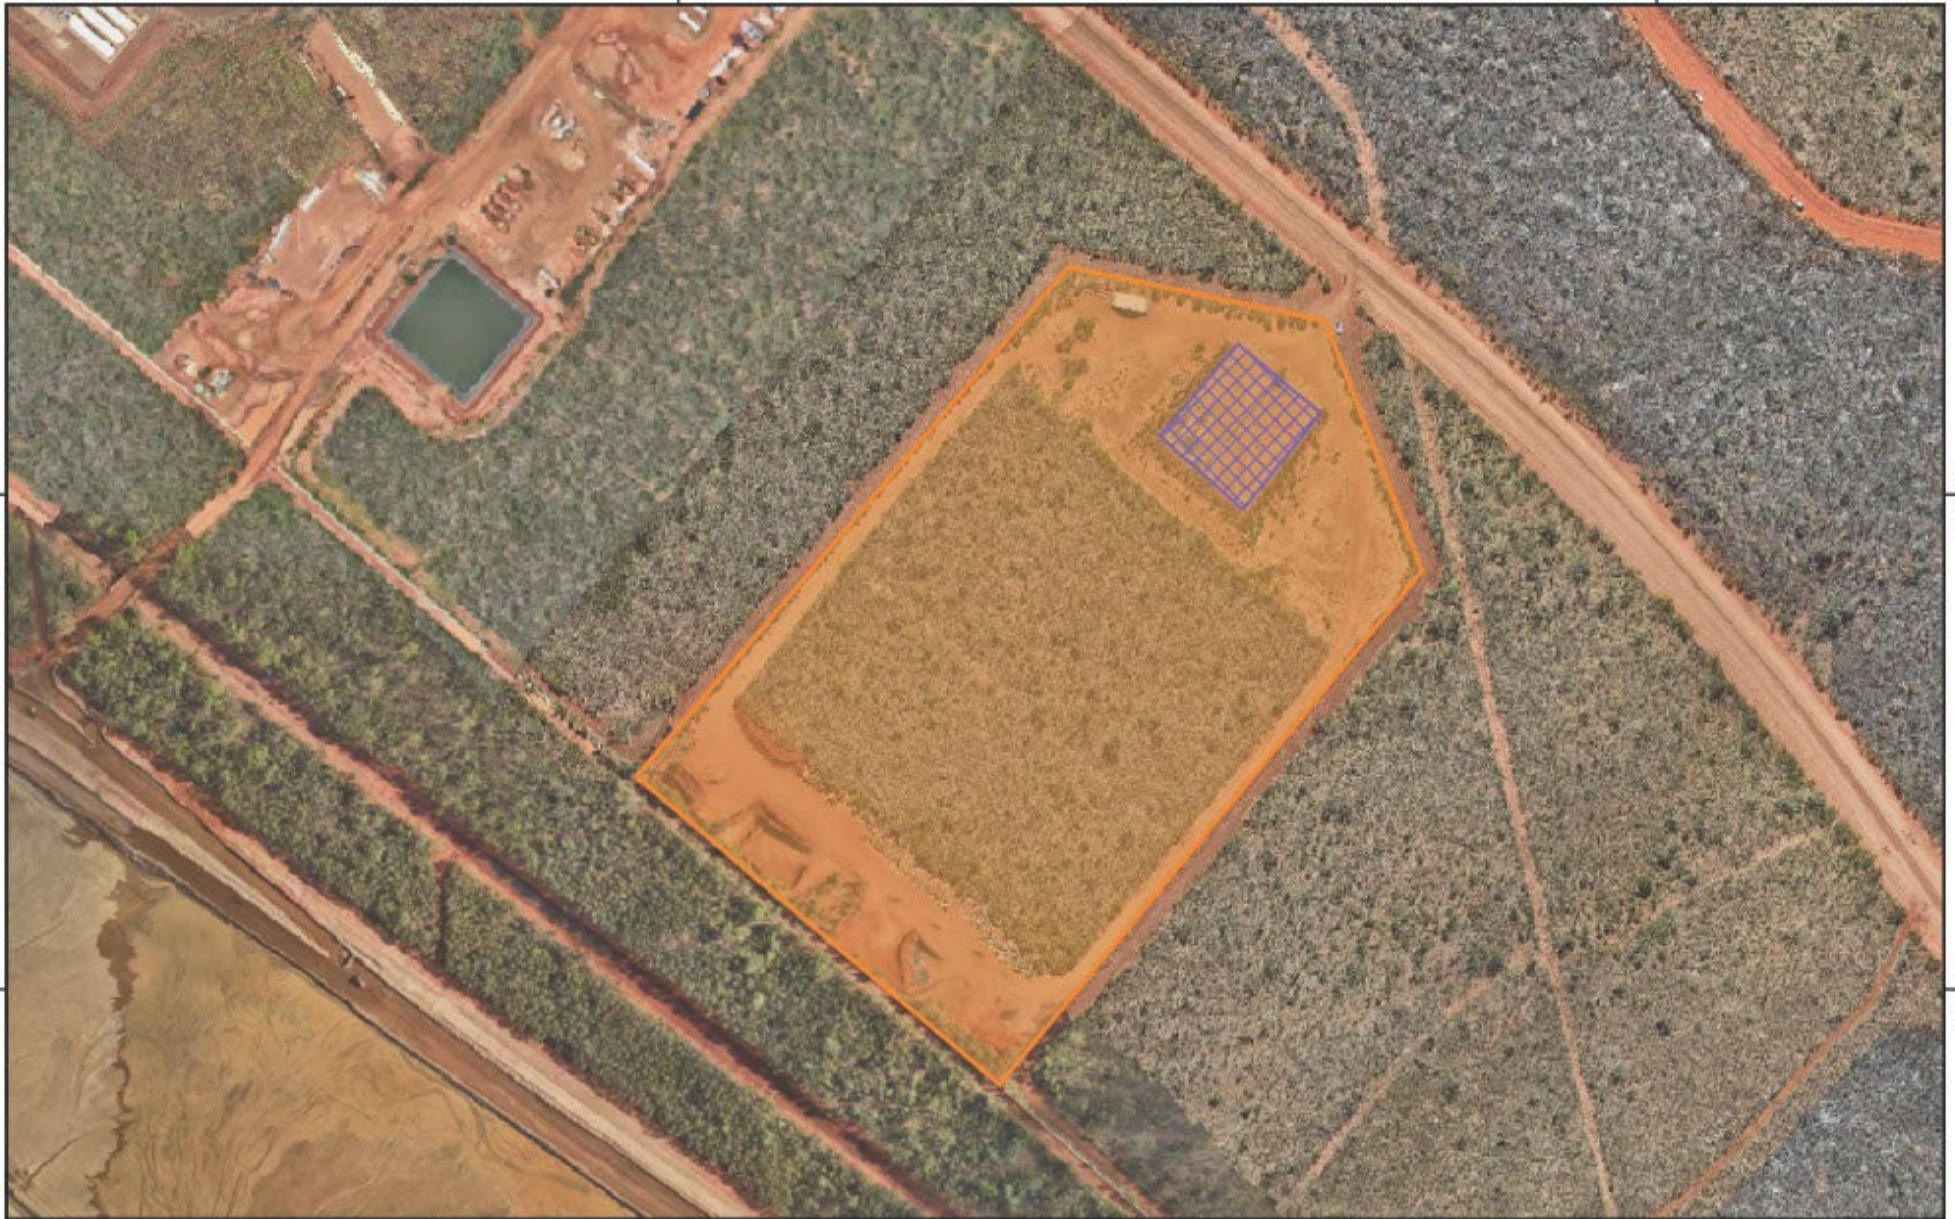
### Figure B6

Landfill & Bioremediation Pad
