**Re: Annual Environmental Report and Annual Audit Compliance Report 2024 for Carnegie Gold Pty Ltd, Riverina Gold Operation – Prescribed Premises Licence L4902/2023/1.**

**Annual Environmental Report**

**Licence Number: L9402/2023/1**

**Premises: Riverina Gold Operations**

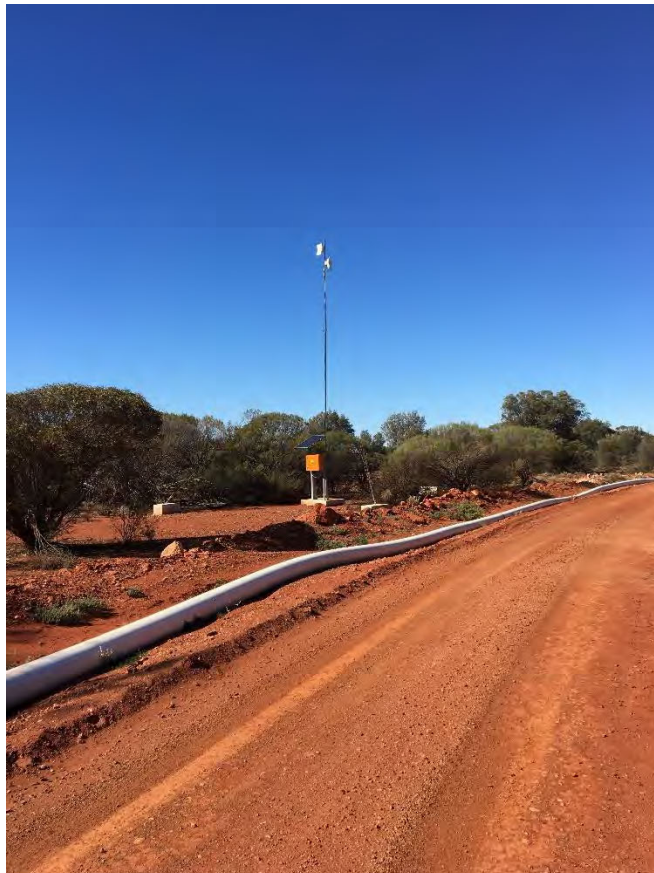
- Telemetry and pressure systems to detect pipeline leaks and failures were installed by a hydrological engineering contractor during construction and were operational during the reporting period (Figure 1). The system was inspected and maintained by site maintenance personnel and during visits by the contractor.

**Figure 1: Telemetry receiver tower linked to leak detection system**

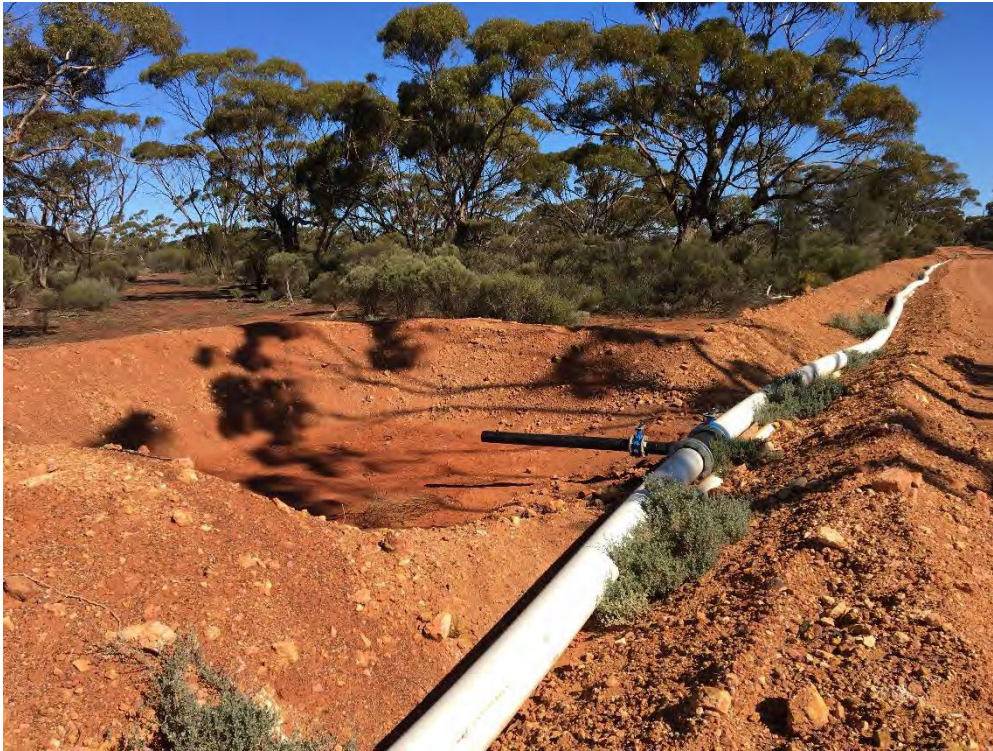
- Dewatering pipelines were located within V notch drains and maintained in bunded corridors (Figure 2).

**Figure 2: Pipeline maintained within a v-notch drain and catch sump / scour pit**

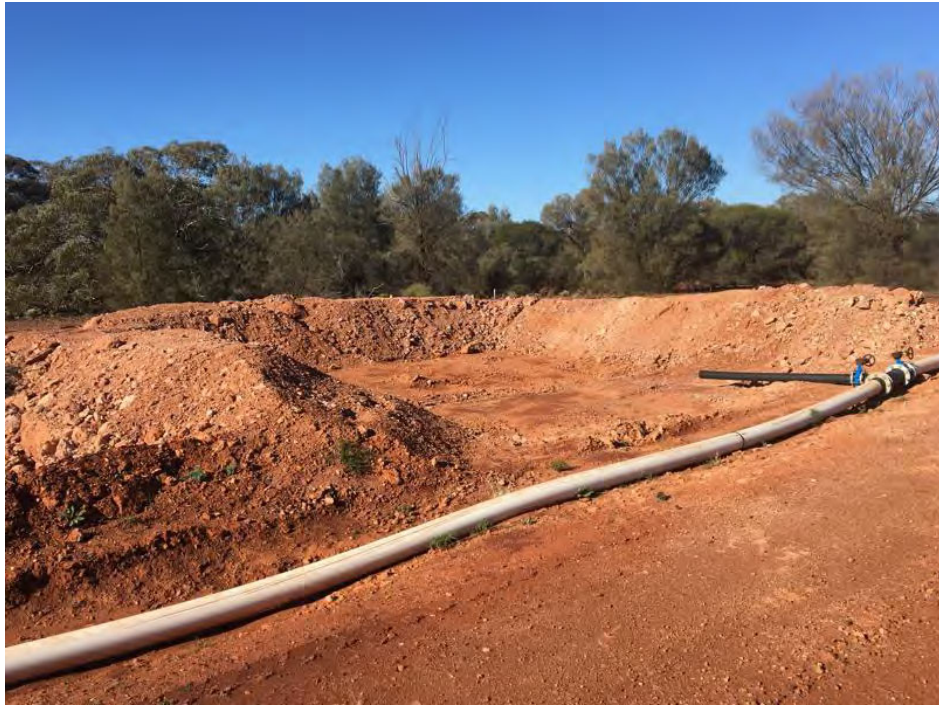
- Standpipes and tanks were in the mine disturbed area. Drainage from the facilities was directed to the pit or to sumps.
- V drains were and overflow pipes were maintained in Schedule 1: Maps Figure 1 “Enlargement NTS”.
- Shutoff valves at standpipes were installed and operational. Water cart operators were trained in the operations of the standpipe facility. Operating procedures require the operator to be present during water cart refill.
- Secondary containment including catch sumps and bunds were maintained along the pipeline corridor to contain spills (Figure 3).

**Figure 3: Example of a catch sump located on the Riverina to Lady Gladys dewatering line**

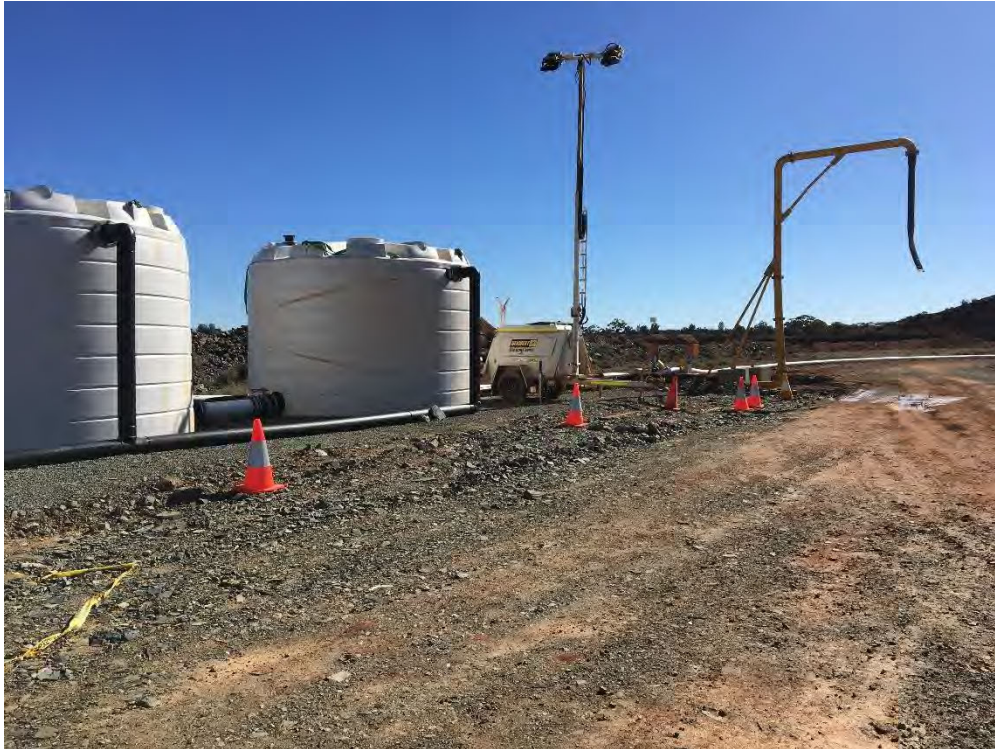
- Dewater was discharged into Lady Gladys pit from the discharge point designated in Schedule 1: Maps, Figure 1.
- Dewater was directed to Lady Gladys. The infrastructure was inspected daily. A standpipe located adjacent to the break tanks for charging water trucks for dust suppression was utilised during the reporting period.
- There was no discharge into catch sumps during the year.

**Figure 4: Infrastructure at the Lady Gladys Open Pit and Standpipe**

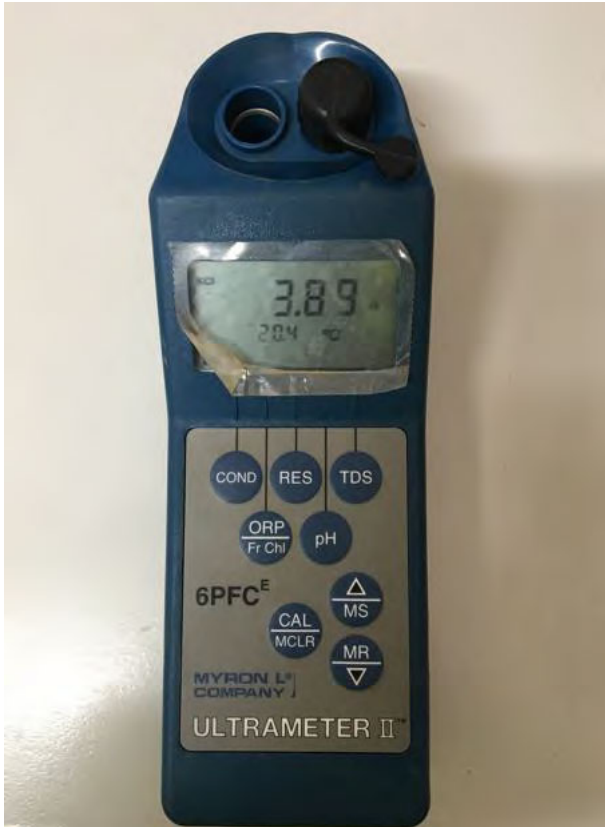
- Water samples collected for offsite analysis at a NATA accredited laboratory were sampled and stored in accordance with applicable standards.
- Annual and quarterly samples were submitted to NATA accredited laboratory MPL (Envirolab Services (WA) Pty Ltd) ABN 53 140 099 207 located in Myaree WA 6154. Certificate of Analysis for the samples taken are provided as an attachment to this AER and AACR.
- Field measurements of pH, conductivity and salinity were obtained using a Myron Ultrameter II (S/N 52333). The unit was calibrated by the company Eco Environmental on 02/04/2025. Field checks were conducted using calibration fluid supplied with the unit (Figure 5).

**Figure 5: Myron Ultrameter II used for field water quality testing**

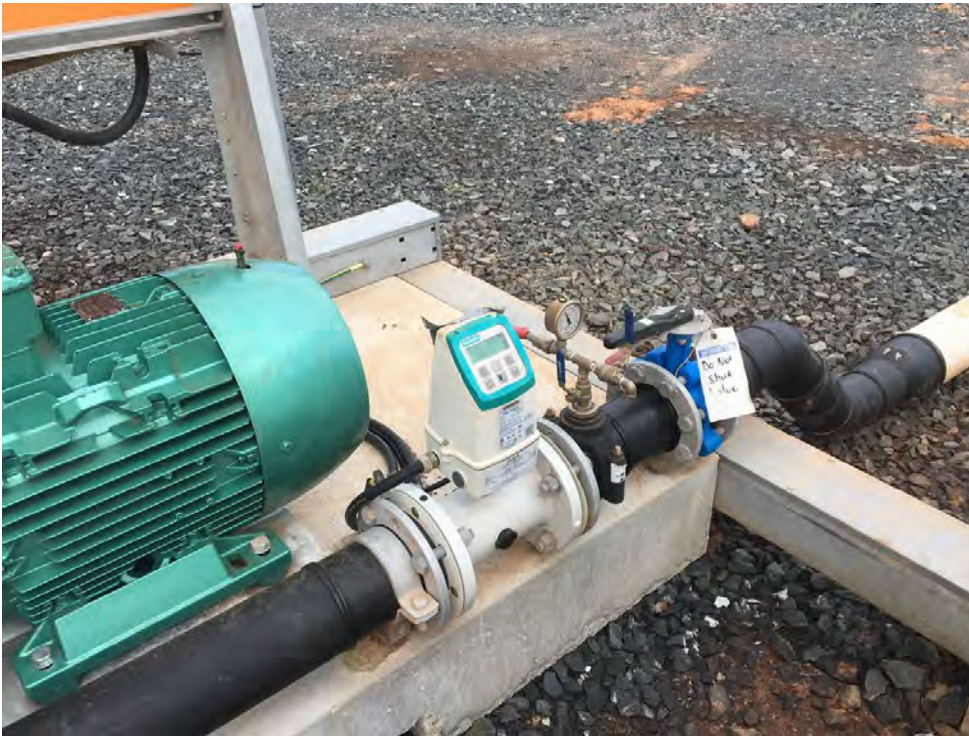
Daily meter readings were obtained from the flow meters located at the Riverina Pit South Staging Tank and the Lady Gladys discharge point during line inspections (Figure 6 and 7).

**Figure 6: Staging Tank Meter**

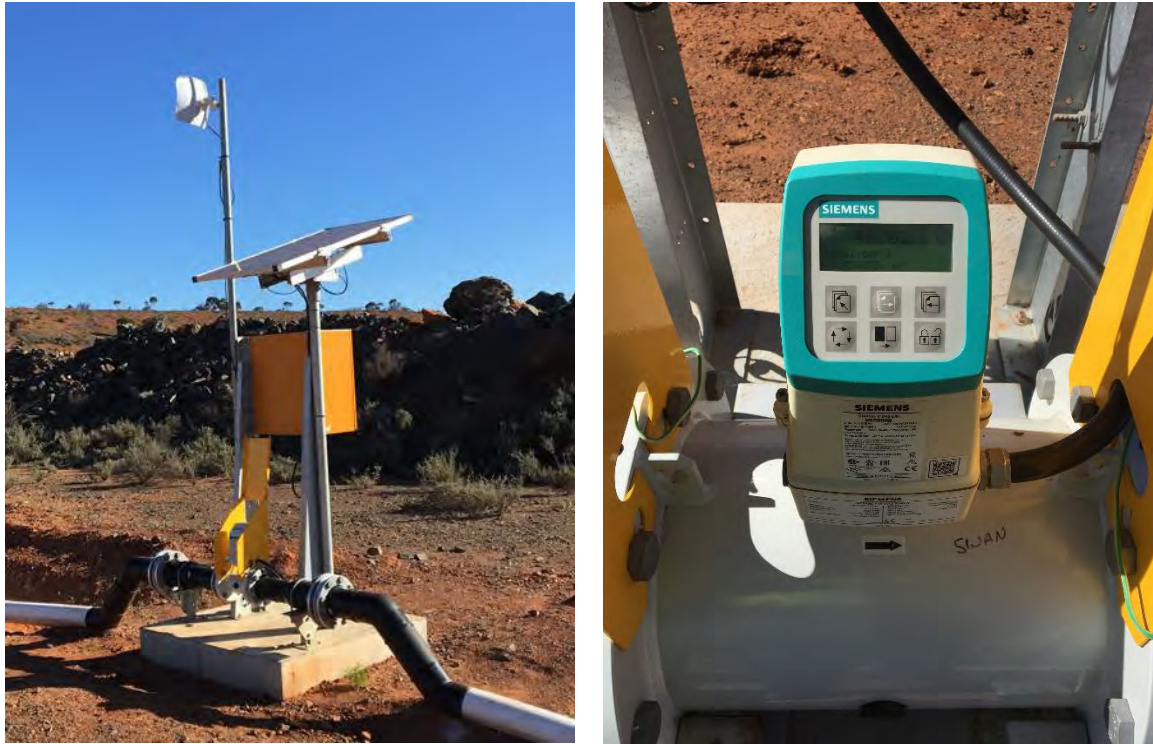
**Figure 7: Lady Gladys Meter with telemetry installed.**

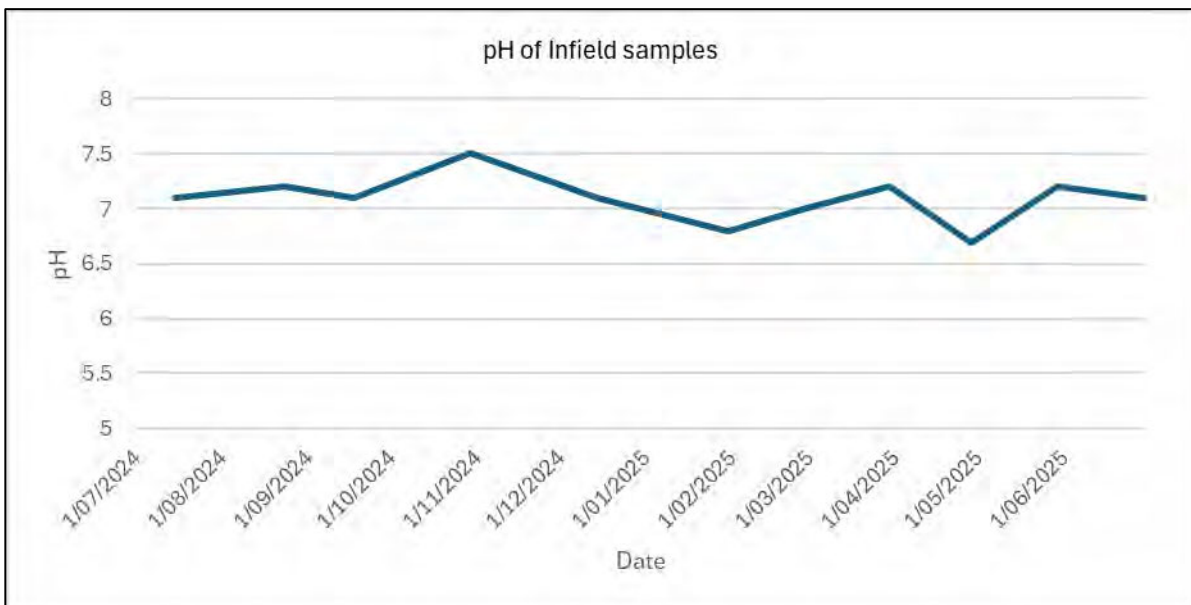
There were no set limits for parameters. During the reporting period the electrical conductivity ( $\mu\text{S}/\text{cm}$ ) and TDS ( $\text{mg}/\text{L}$ ) increased in December 2024 from 43000  $\mu\text{S}/\text{cm}$  and 3100  $\text{mg}/\text{L}$  TDS respectively to 89500  $\mu\text{S}/\text{cm}$  Ec and 62685  $\text{mg}/\text{L}$  TDS. The increase in salinity of the water is likely due to the progressive nature of underground dewatering and characteristic of the underlying hydrology. pH remained relatively neutral and did not fluctuate significantly.

Figure 8: pH from monthly water samples taken from Riverina South staging tanks during the reporting period.

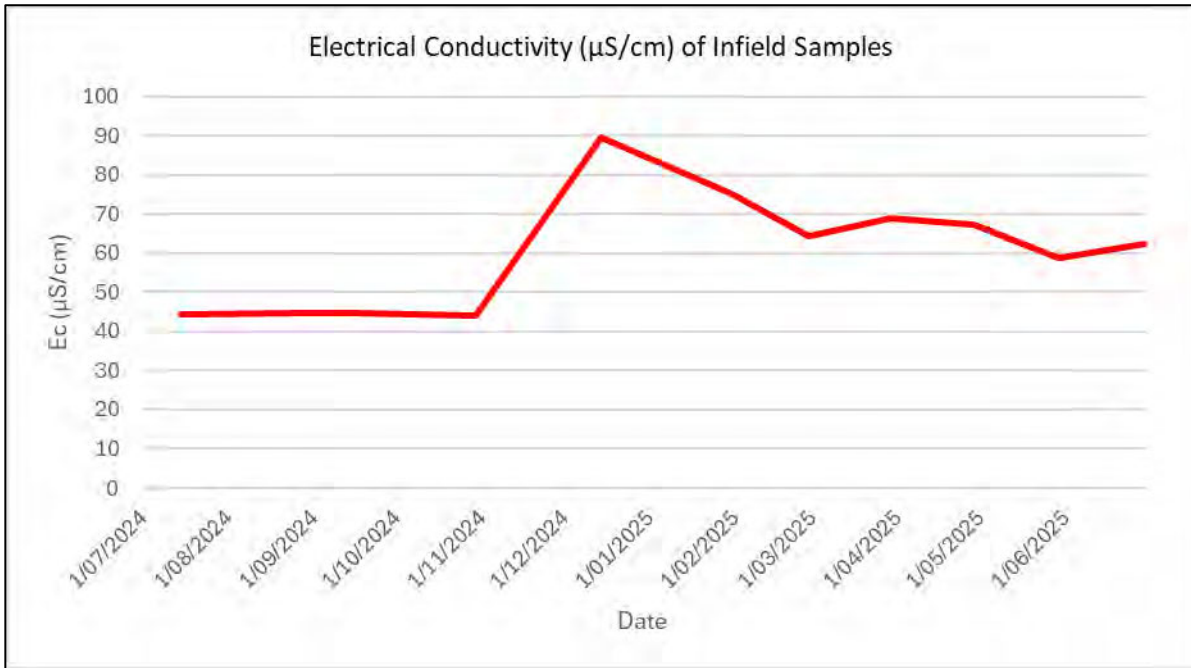
**Figure 9: Electrical conductivity from monthly water samples taken from Riverina South staging tanks during the reporting period.**

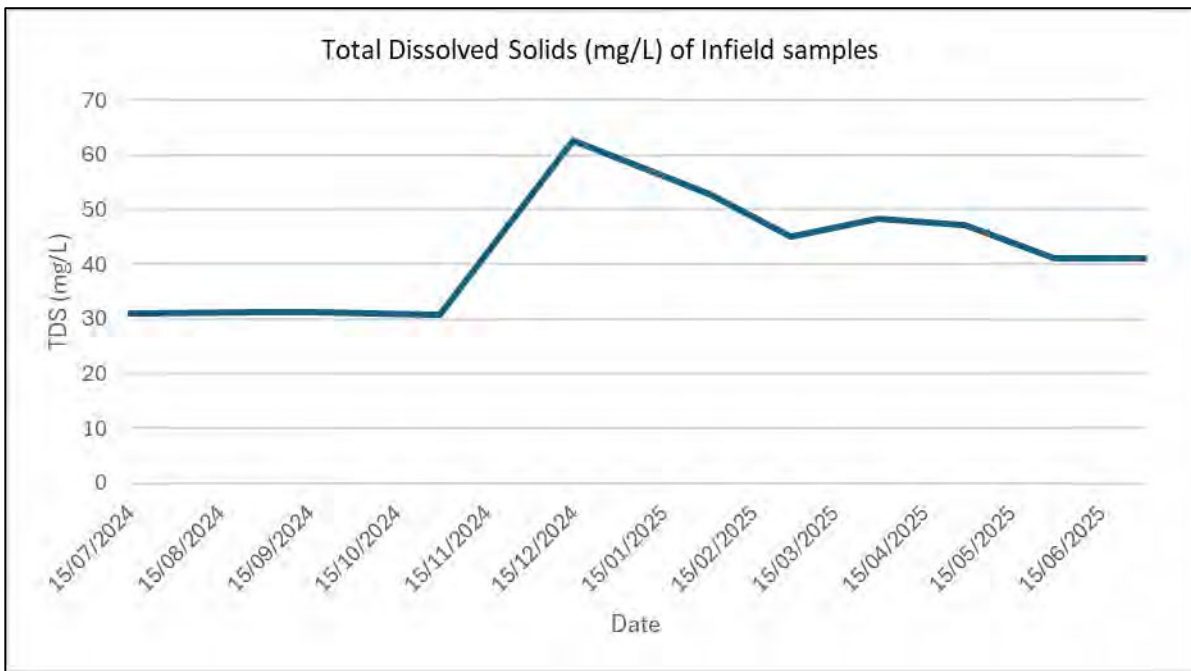
**Figure 10: Total dissolved solids (mg/L) from monthly water samples taken from Riverina South staging tanks during the reporting period.**

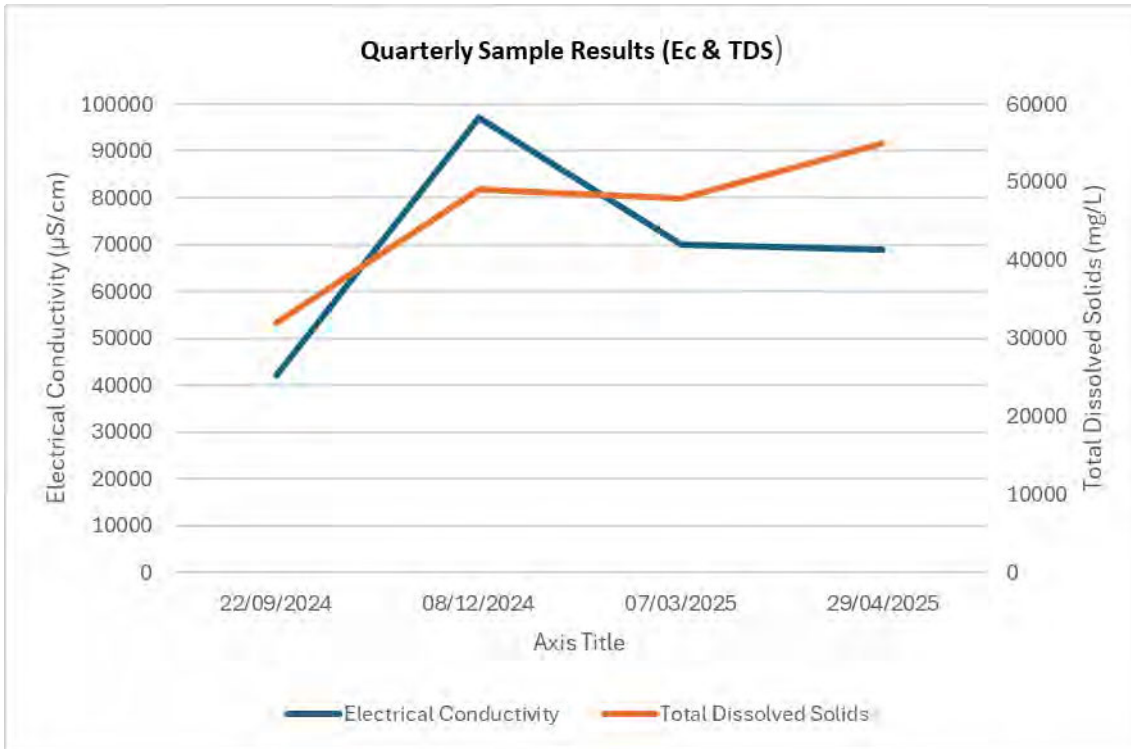
There were no set limits to water quality parameters. During the reporting year there was a gradual increase in the level of parameters such as electrical conductivity, total dissolved solids, hardness and sodium. Water discharged to Lady Gladys can be considered hypersaline. The electrical conductivity in dewater from Riverina is consistently over 45,000µS/cm and 35,000 mg/L TDS increasing gradually over time as dewatering progressed. Chloride also increased steadily during the year. Results for quarterly sampling are presented in Table 7 and Annual Environmental Report 2024-2025

Figure 11: Electrical conductivity and total dissolved solids for quarterly samples taken from Riverina South staging tanks during the reporting period.

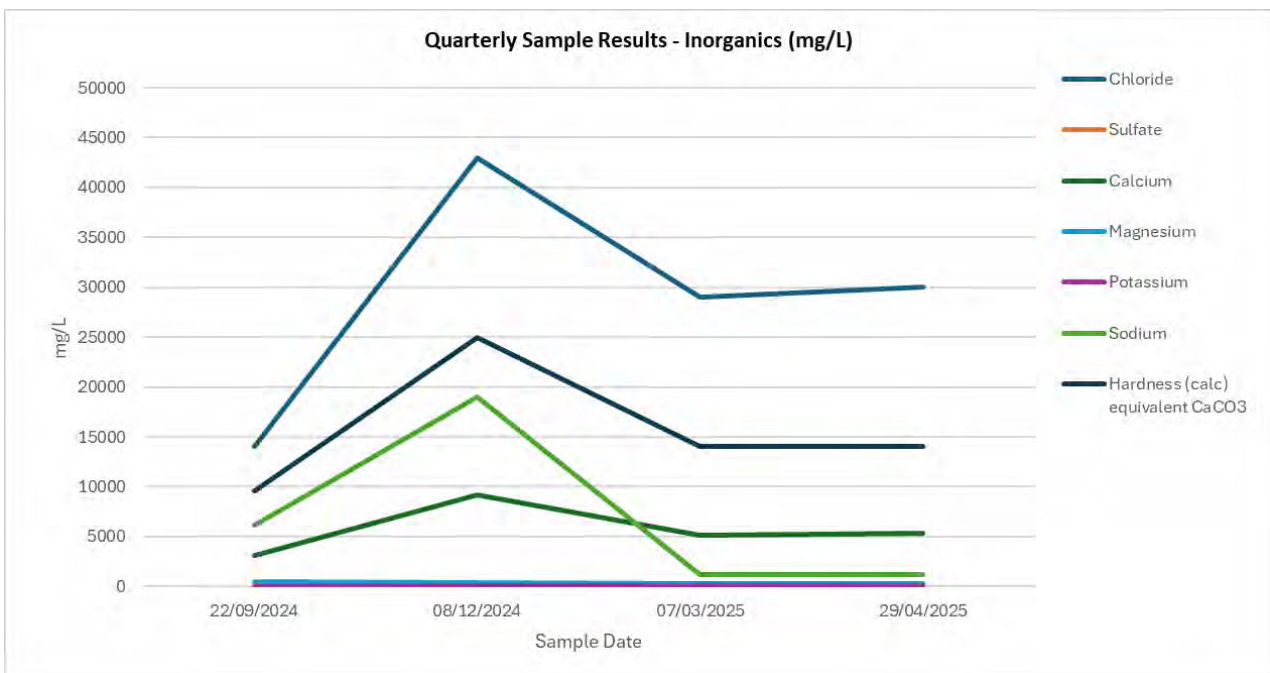
Figure 12: Inorganic parameters in mg/L for quarterly samples taken from Riverina South staging tanks during the reporting period.

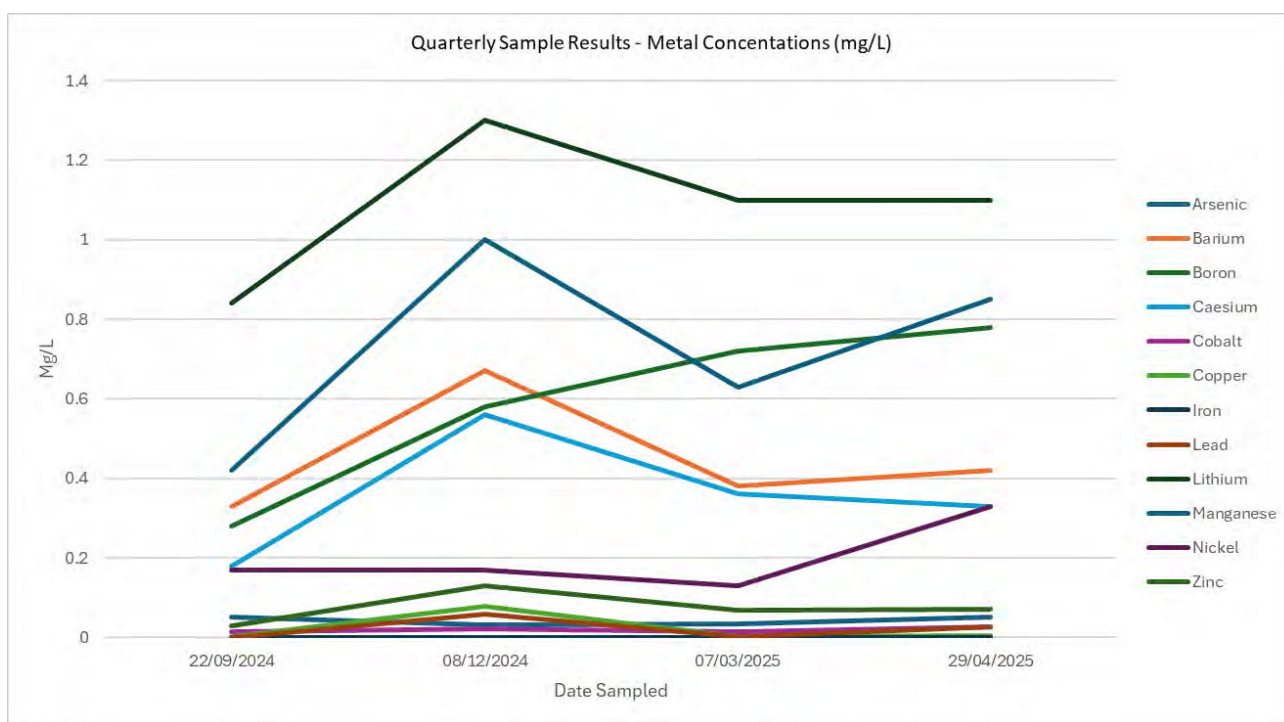
**Figure 13: Metals parameters in mg/L for quarterly samples taken from Riverina South staging tanks during the reporting period.**

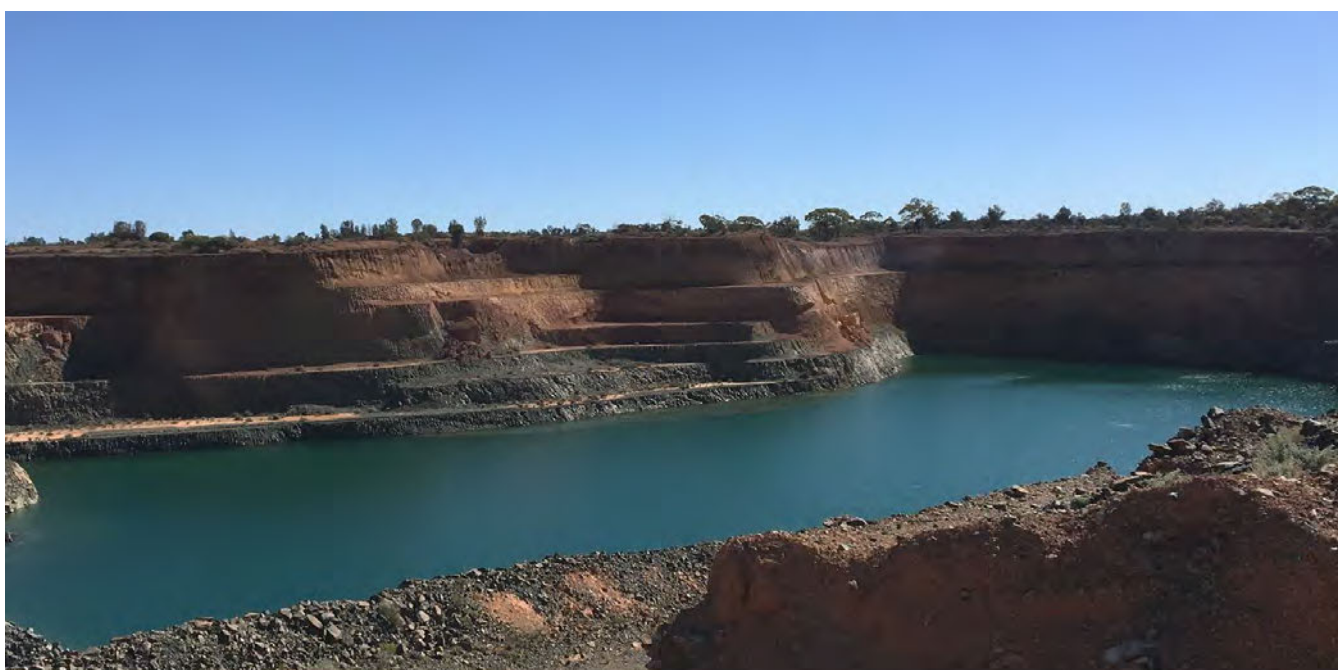
An annual water sample was obtained from Lady Gladys Pit Lake (Figure 14) on 22/09/2024 and 13/12/2024. Samples were sent offsite for analysis at MPL Laboratories. Compared to the previous year there was an increase in electrical conductivity noted. A resample is expected to occur in December 2025. Table 8 presents results for this reporting period.

**Figure 14: Lady Gladys pit lake 30/06/2025.**

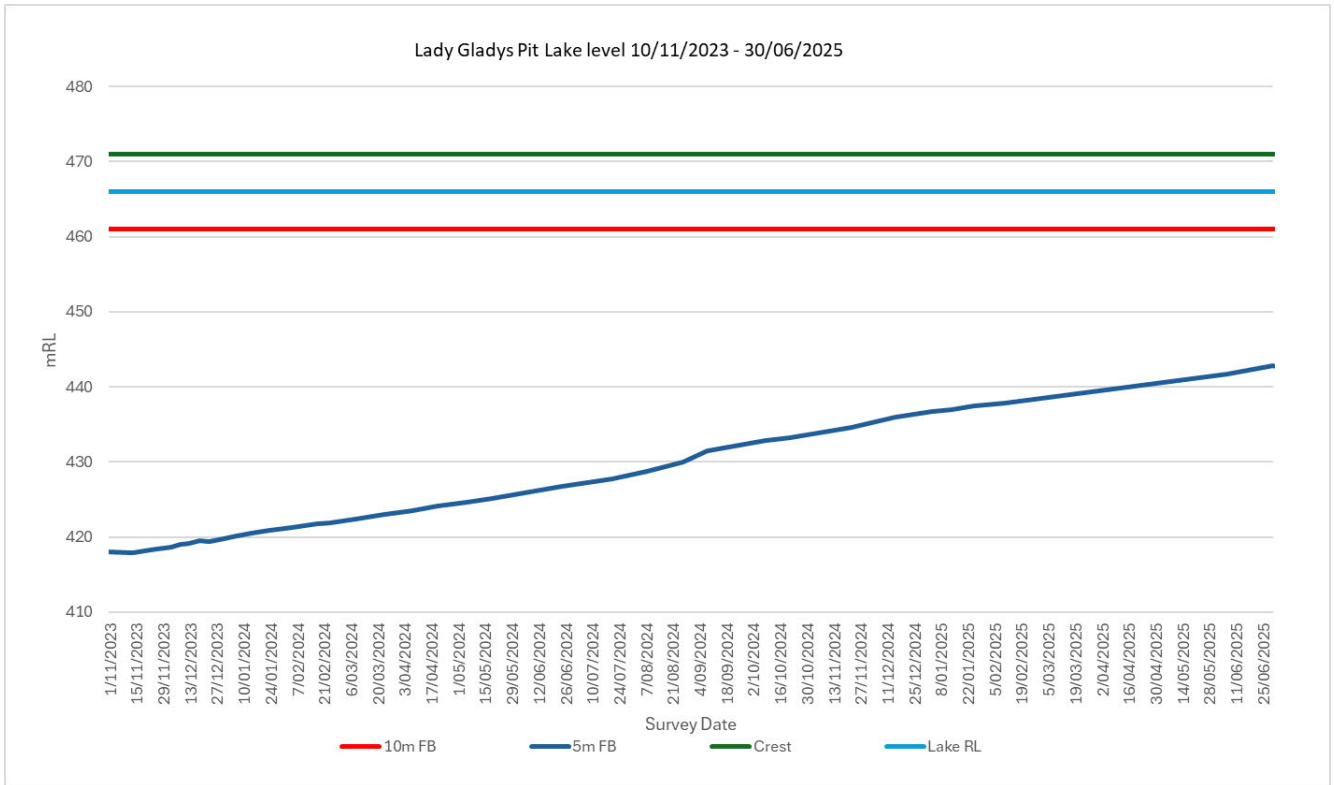
During the reporting period Lady Gladys water levels were checked visually daily. A survey pick-up of the water pit lake water level was conducted monthly. At the commencement of the reporting period on 1 July 2024 the pit lake was at 426.75mRL and at the end of the reporting period on 30 June 2025 it was 442.64. During the reporting period the water level rose 16 meters. In total since discharge commenced the level has risen 24m. The freeboard limit is 461mRL which is 18 meters above the water level on the 30 June 2025 and 28m below the Pit crest at 471mRL. A graph showing the rate of increase of the pit lake level against the freeboard limit is presented in Figure 15.

At current discharge rates the pit lake is expected to arrive at the freeboard level in 2027 without any stochastic events occurring such as a 1 in 200-year flood event.

Figure 15: Lady Gladys pit lake water level (mRL) 10/11/23 – 30/06/2025. The capacity of the Lady Gladys Pit to freeboard level was 43% at the end of the reporting period.

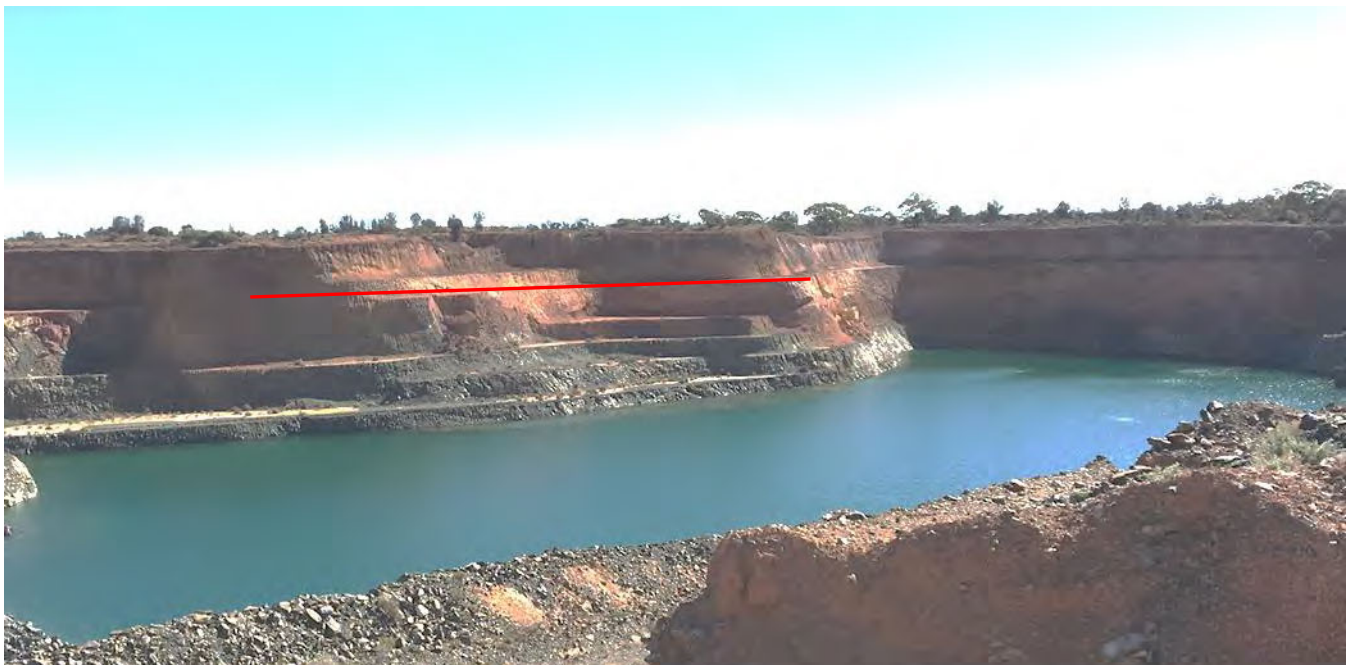
An image that represents the freeboard line against the water level on 20 June 2025 is presented in Figure 16. At the end of the reporting period the percentage of total volume taken up by water in the Lady Gladys pit was 43%.

Figure 16: Lady Gladys Pit Lake on 20 June 2025. The 10m freeboard limit is indicated with the red line.
