## BROOKTON HIGHWAY UPGRADE 2006

### **Project Rehabilitation Plan**

**For Gorge Rock and Hartley to Bartlett Rd Sections**

**Appendix A: Site Photographs Prior to Works**

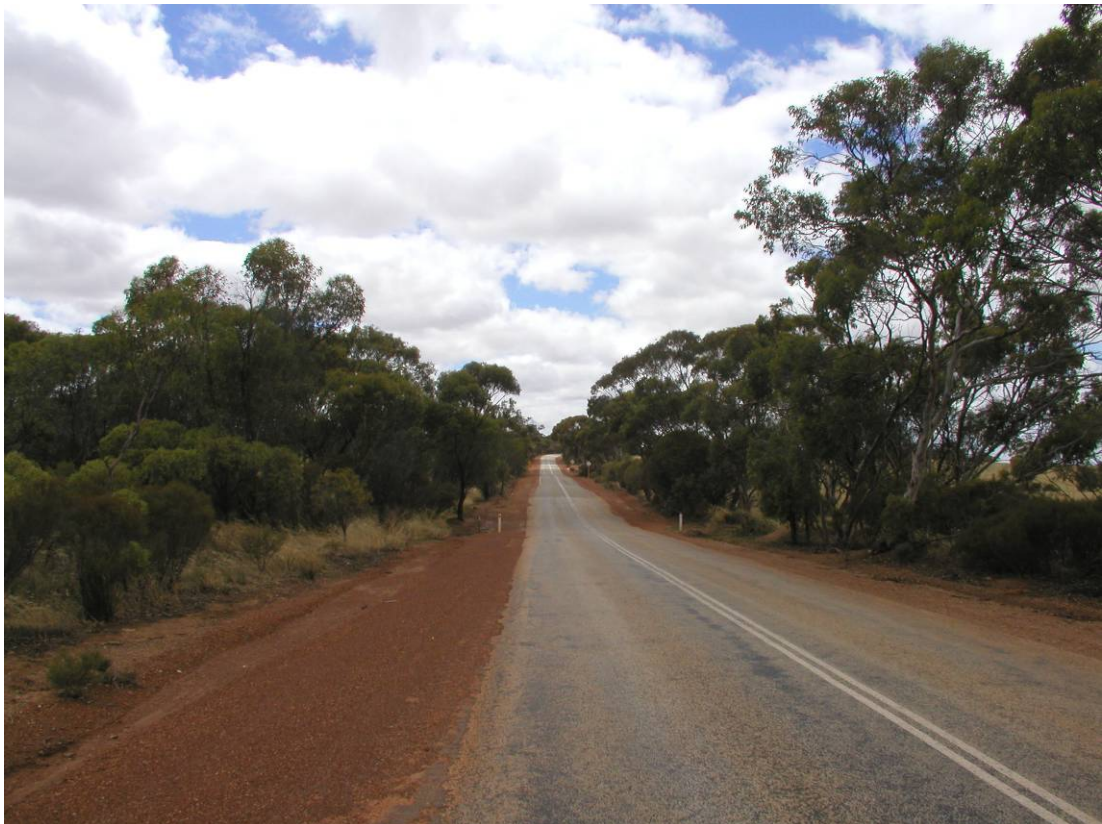
**Figure 1: Hartley – Bartlett road section (taken at 216.1 SLK facing east).**

The existing highway between the bend after Hartley Road and the intersection with Bartlett Road will be closed. There will be 3.75 Ha of land available for rehabilitation after this closure.

The sealed surface will be ripped and then graded to each side to fill in drains. The remaining soil and gravel underneath is to be ripped to 300 mm deep. Every 100 metres, for a distance of 20 metres, the ripping is to be undertaken across the profile to reduce erosion.

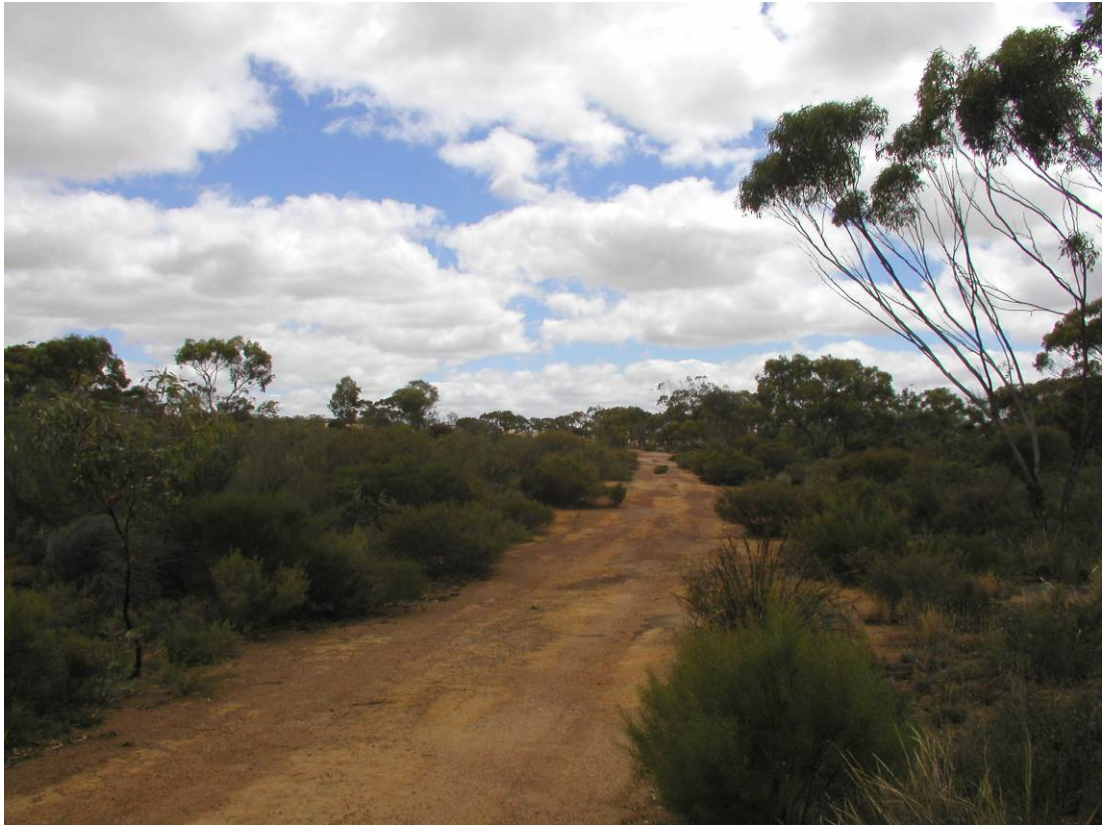
**Figure 2: Farmer's access track (216.1 SLK facing north).**

All other access tracks identified during the site visit (of which there are 4, totalling 1.16 Ha in area) are to be ripped, closed off and direct seeded. Additional brush seeding cut from adjoining trees and shrubs can then be spread intermittently over the whole area.

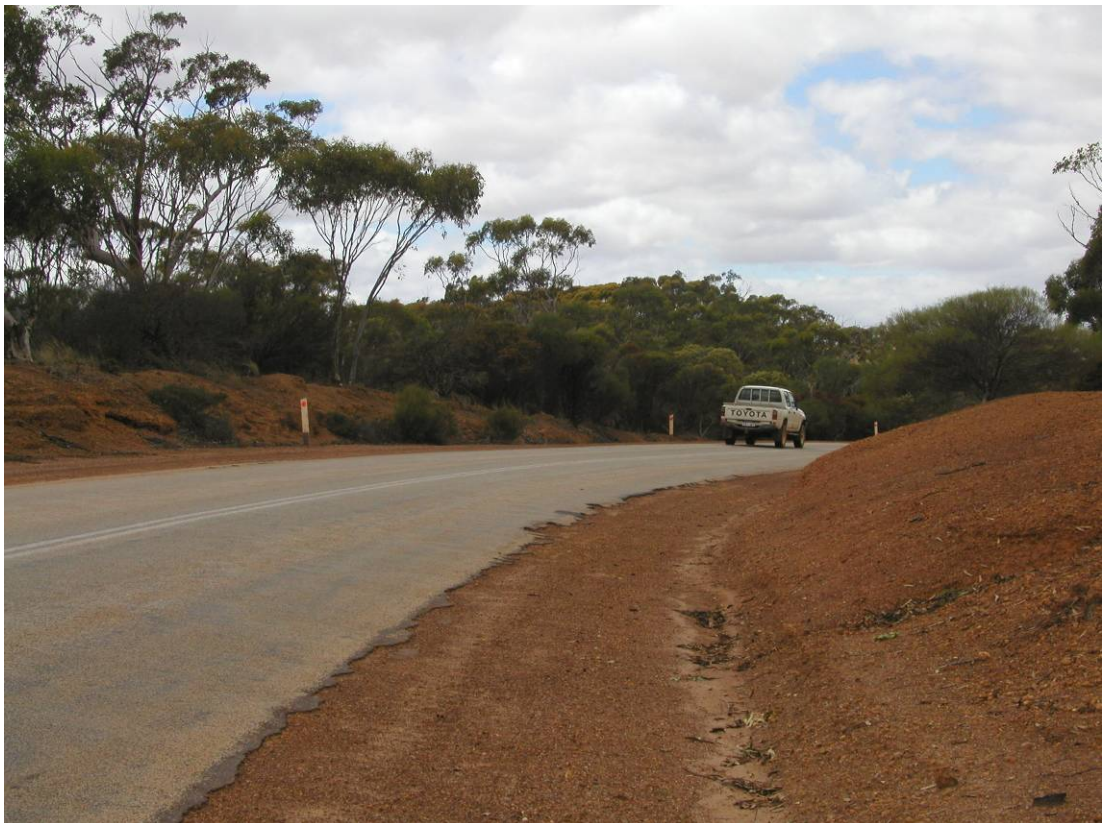
**Figure 3: Embankment near gravel pit (216.72 SLK facing south-east).**

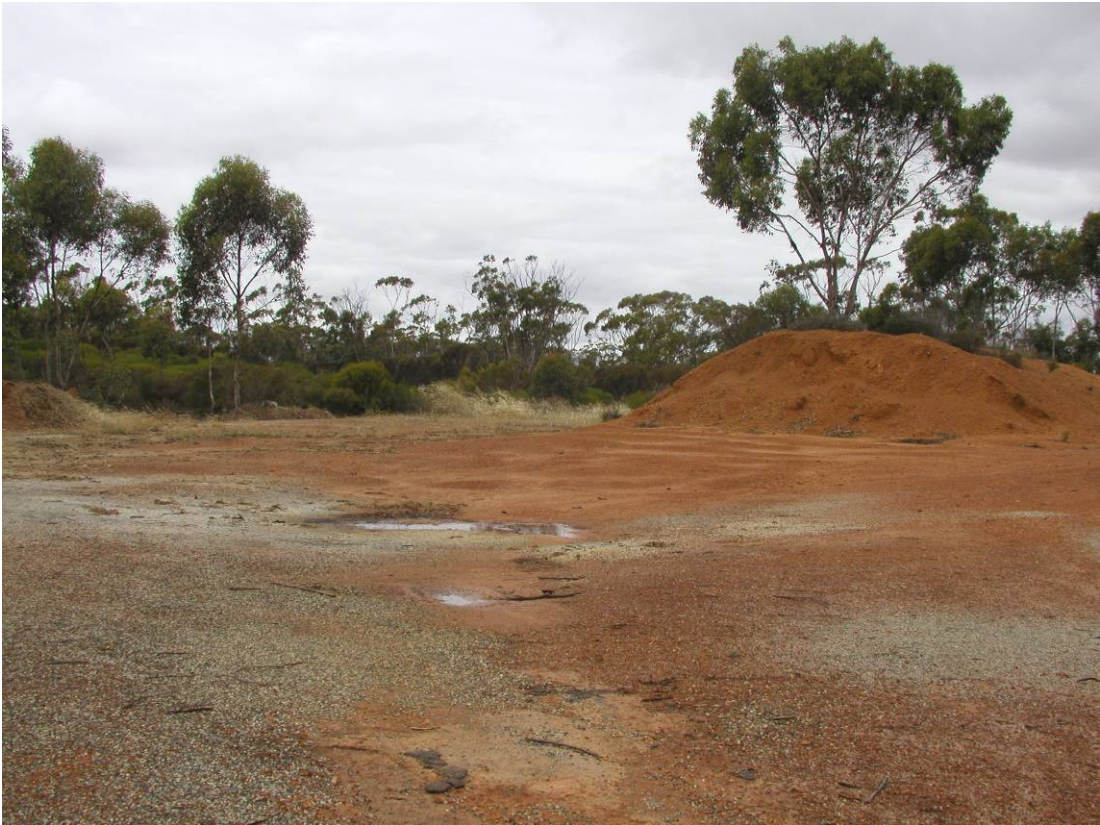
**Figure 4: Gravel pit at 216.72 SLK, showing old gravel pile.**

The pit at 217.62 SLK is approximately 0.4 Ha in area and contains one gravel pile of approximately 1000 m<sup>3</sup> in volume. Most of this stockpile will be used on the closed section of highway from Hartley to Bartlett Road. All remaining gravel is to be spread evenly over the pit and blue metal hardstand areas, and then ripped on the contour with rip lines 300mm deep. The area can then be direct seeded as per Hartley-Bartlett Road.

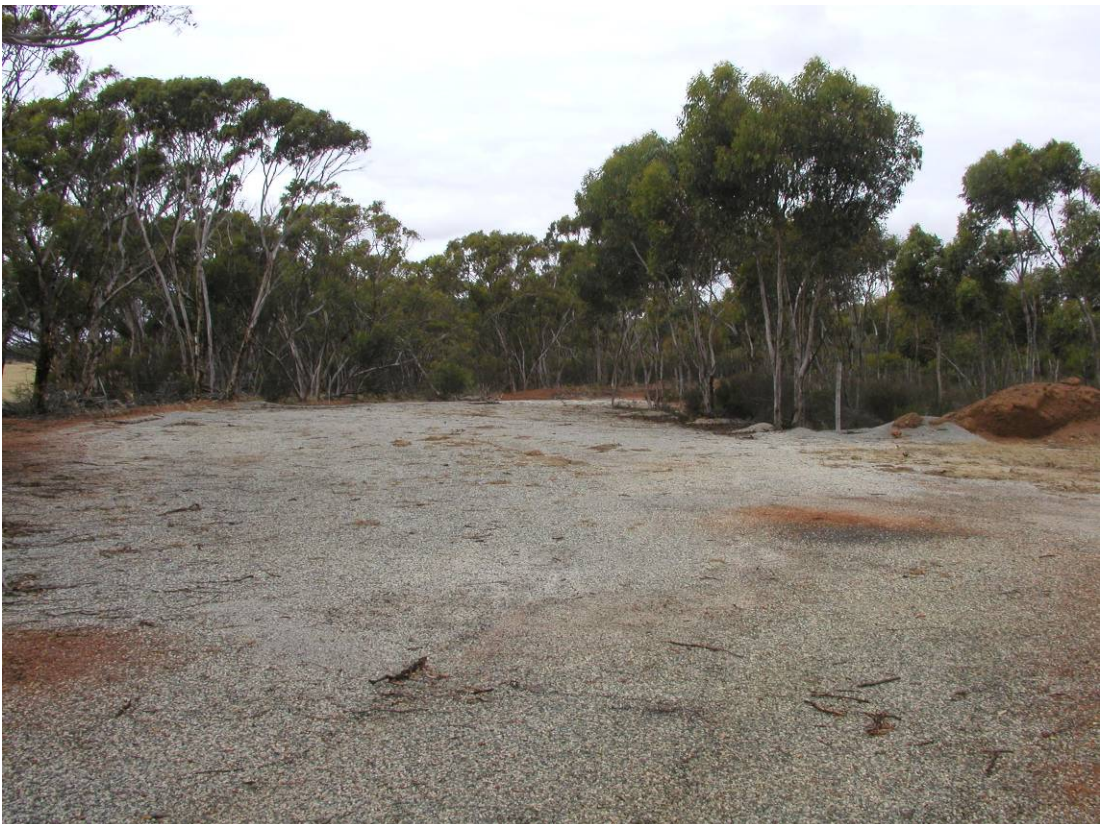
**Figure 5: Gravel pit at 216.72 SLK, showing blue metal hardstand.**

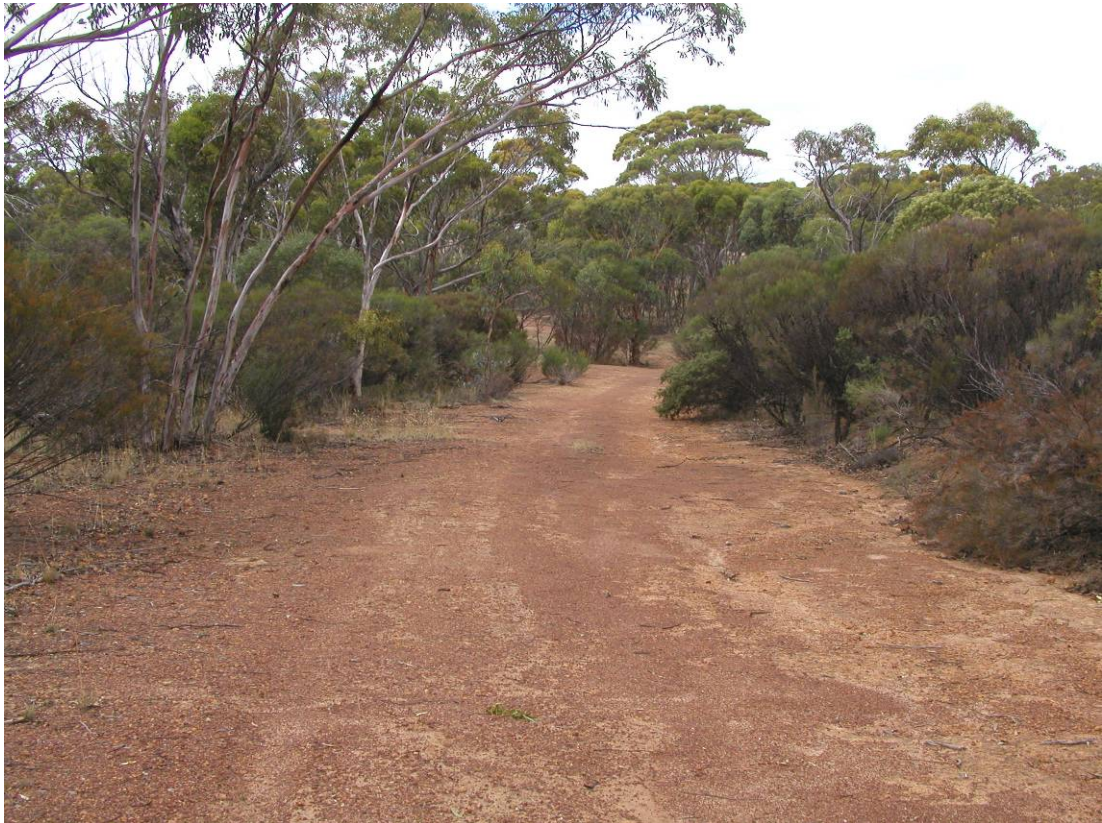
**Figure 6: Access road from gravel pit (216.72 SLK facing east).**

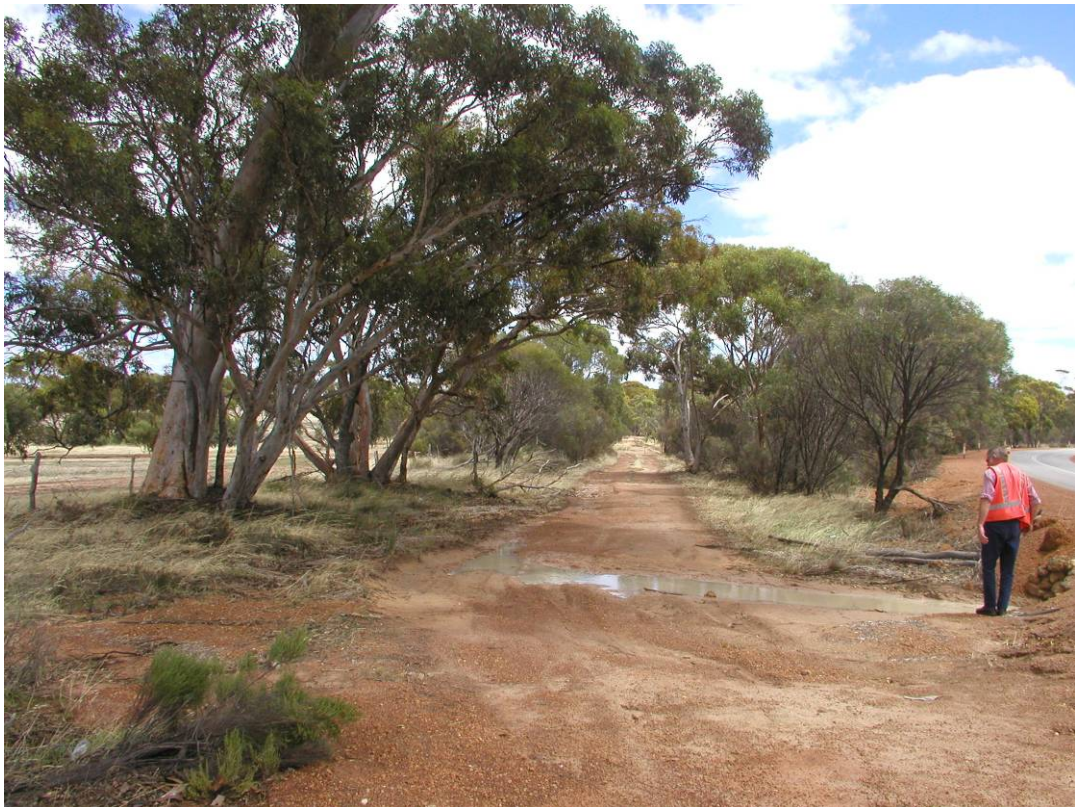
**Figure 7: Access track to Lewis's resumption (215.8 SLK facing west).**

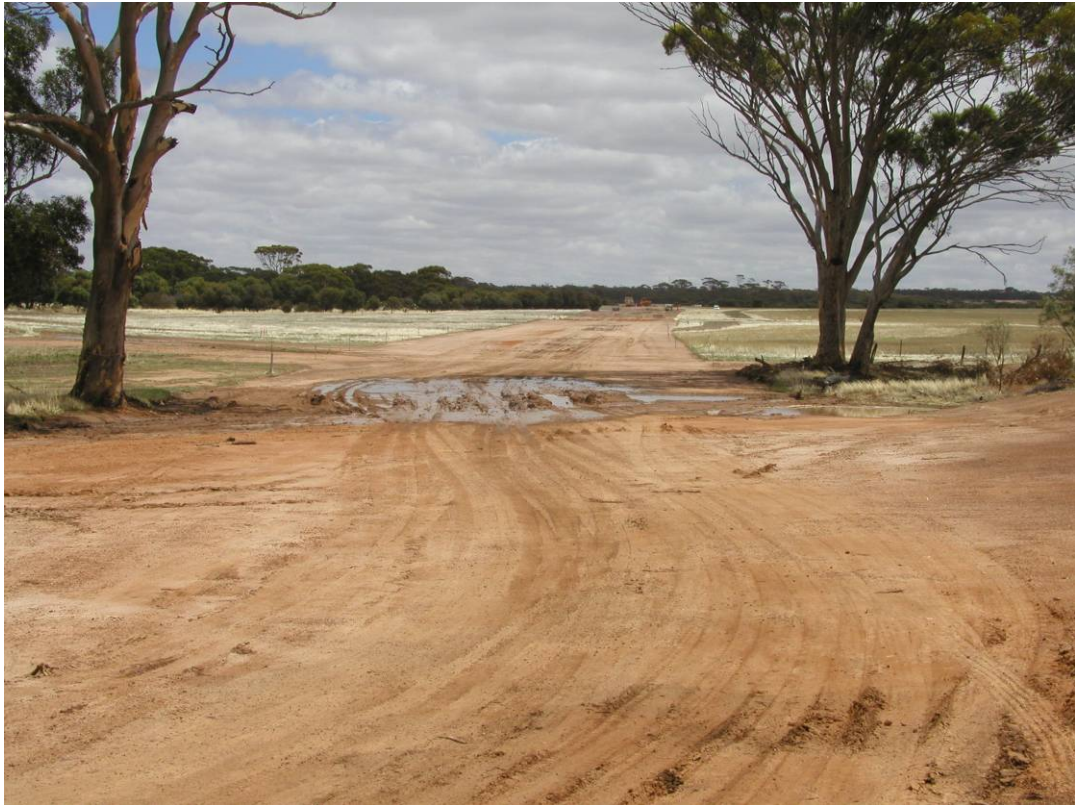
**Figure 8: New alignment across resumed farmland, Lewis's resumption (218.1 SLK facing west).**

The new Hartley-Bartlett Road highway will cross resumed land for 1800 m. Land resumption width is 60 m in this section, so after construction 5.6 Ha of farmland will be rehabilitated. 0.36 Ha of clearing is required prior to construction, 0.12 Ha of which is previously cleared land.

The reserves will be planted with seedlings, as in the "Kondinin end" area, since weeds and clay soils would cause direct seeding to be ineffective. Lines will be ripped at 2 m apart, and planting will occur at 2 m intervals. Weed control will be implemented in the same way as in the "Kondinin end" section (see above).

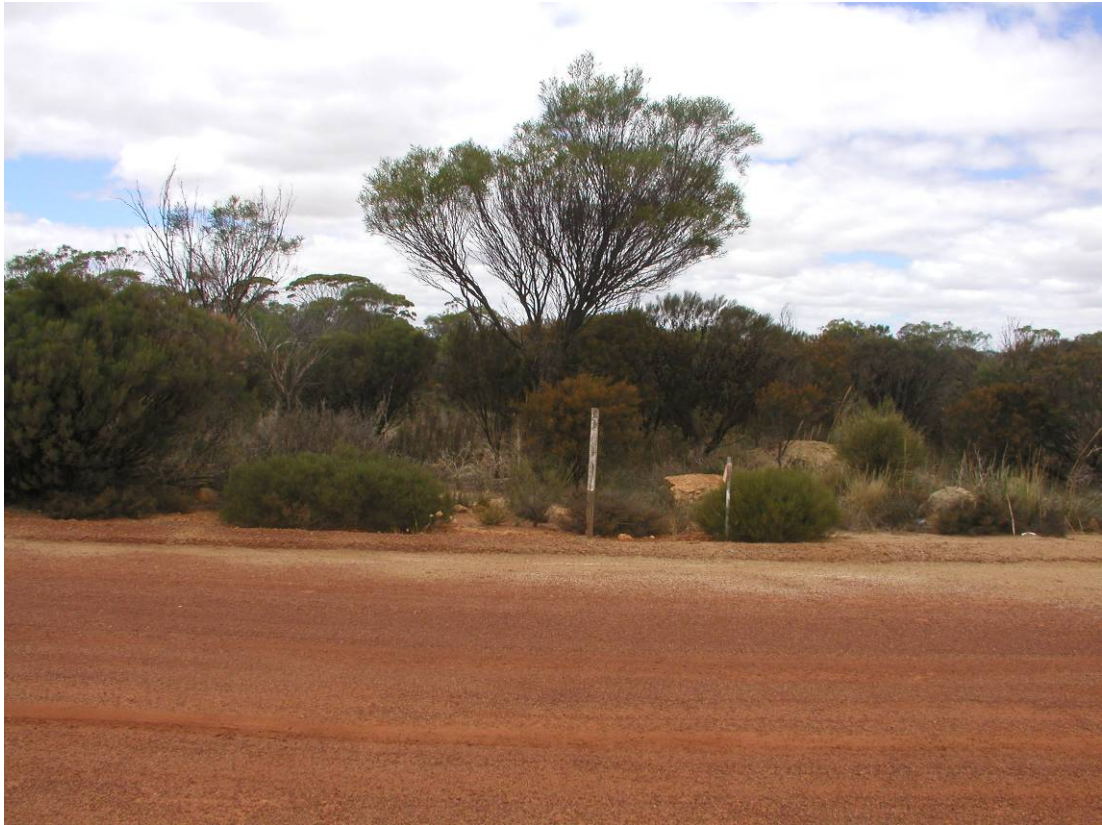
**Figure 9: Proposed Gorge Rock alignment (facing east).**

The new truncation of the highway (which bypasses the current Gorge Rock highway section as described above) requires the clearing of .82 Ha of native vegetation, of which approximately 0.45 Ha will be revegetated.

All vegetative and topsoil materials (deemed weed free and pristine) resulting from clearing and construction of the new truncation are to be stockpiled at the worksite. At the end of the project, the batters and embankments of the new truncation are to be ripped and treated with this material as a mulch and seed base, eliminating the need to conduct a direct seeding process.

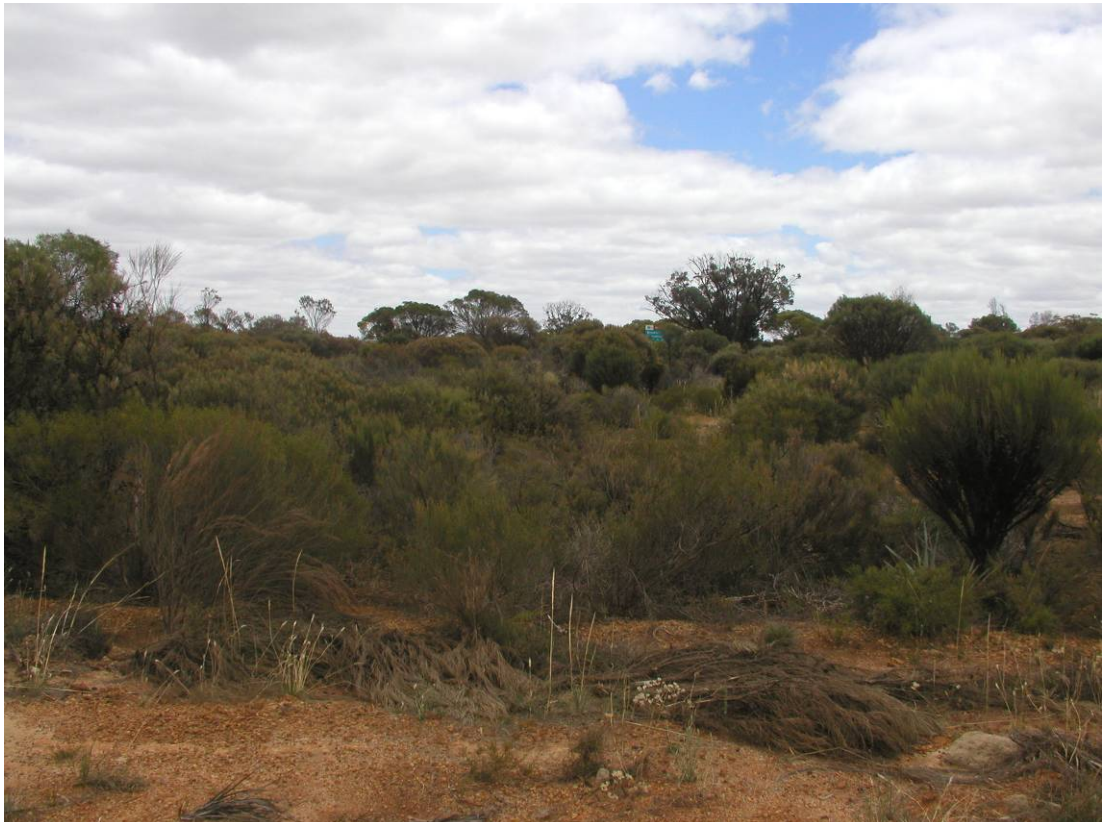
**Figure 10: Proposed Gorge Rock alignment (facing west).**

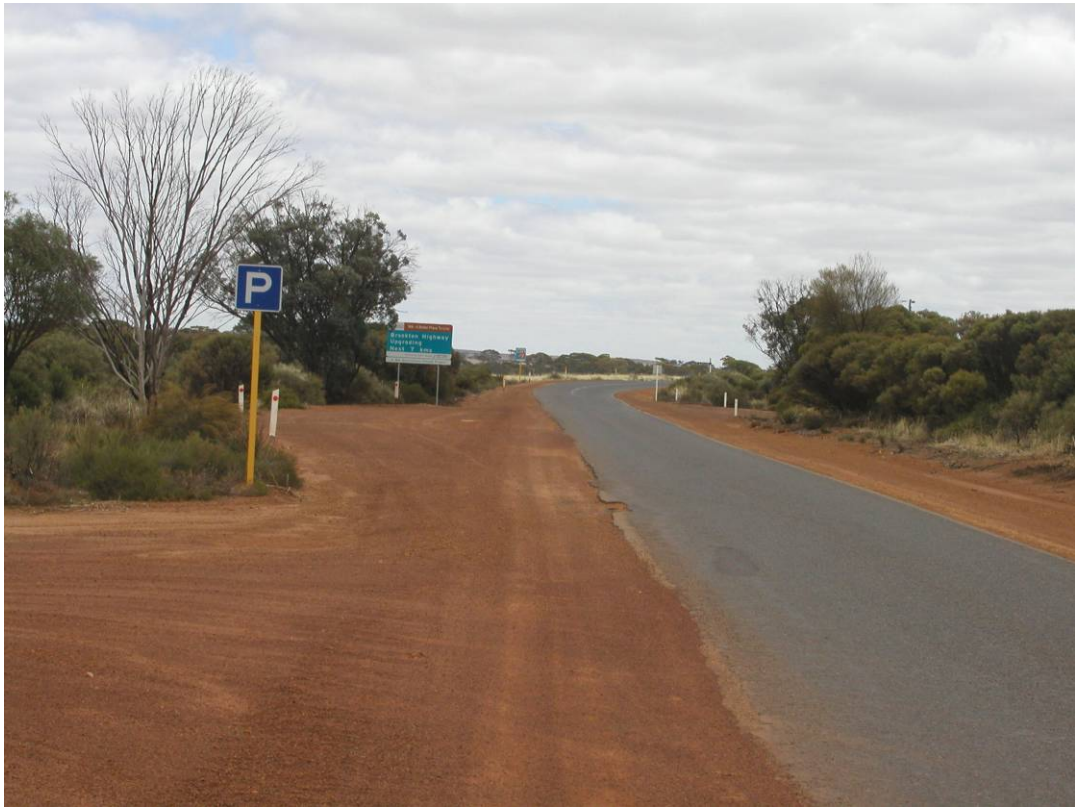
**Figure 11: Existing Gorge rock alignment, to be closed (221.9 SLK facing west).**

An 800 metre section of highway (from 221.7 to 222.7 SLK) alongside Gorge Rock will also be closed as part of this project, and a new truncation set to the south (see below). After this closure, there will be approximately 1.2 Ha available for rehabilitation (including two rest areas). This road will be rehabilitated in the same method as for the Hartley Road to Bartlett Road section (see above).

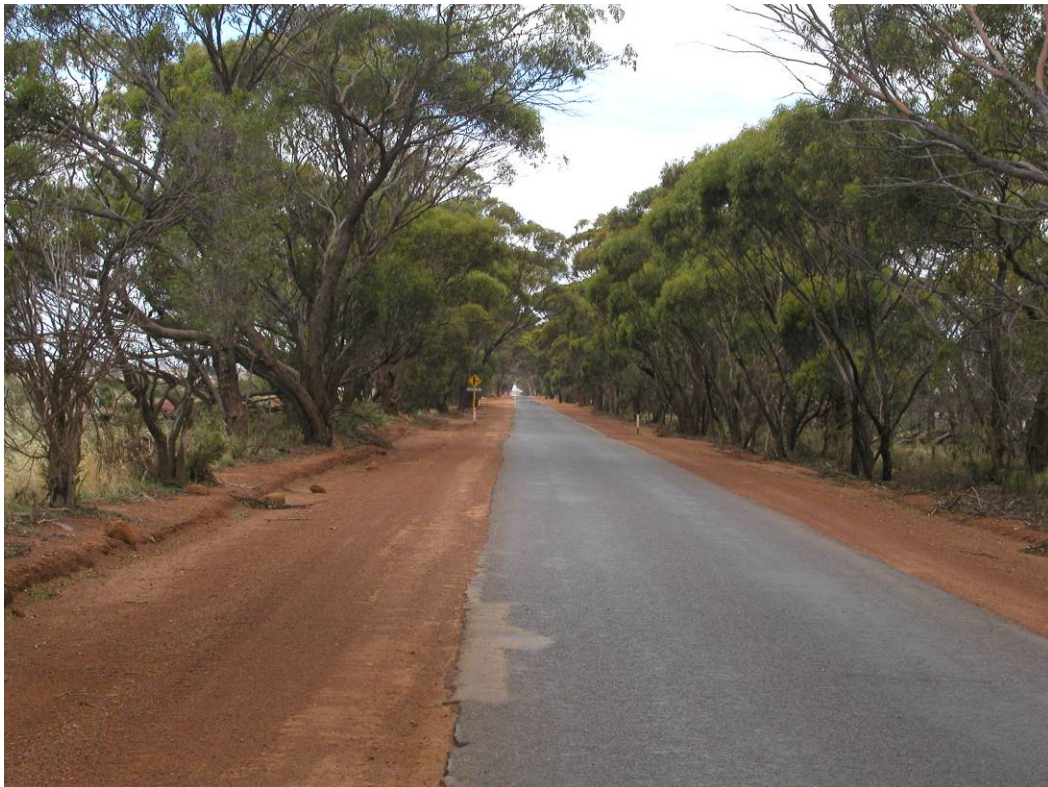
**Figure 12: Existing road exiting Gorge Rock, to be widened (222.8 SLK facing east). Left side only to be cleared.**

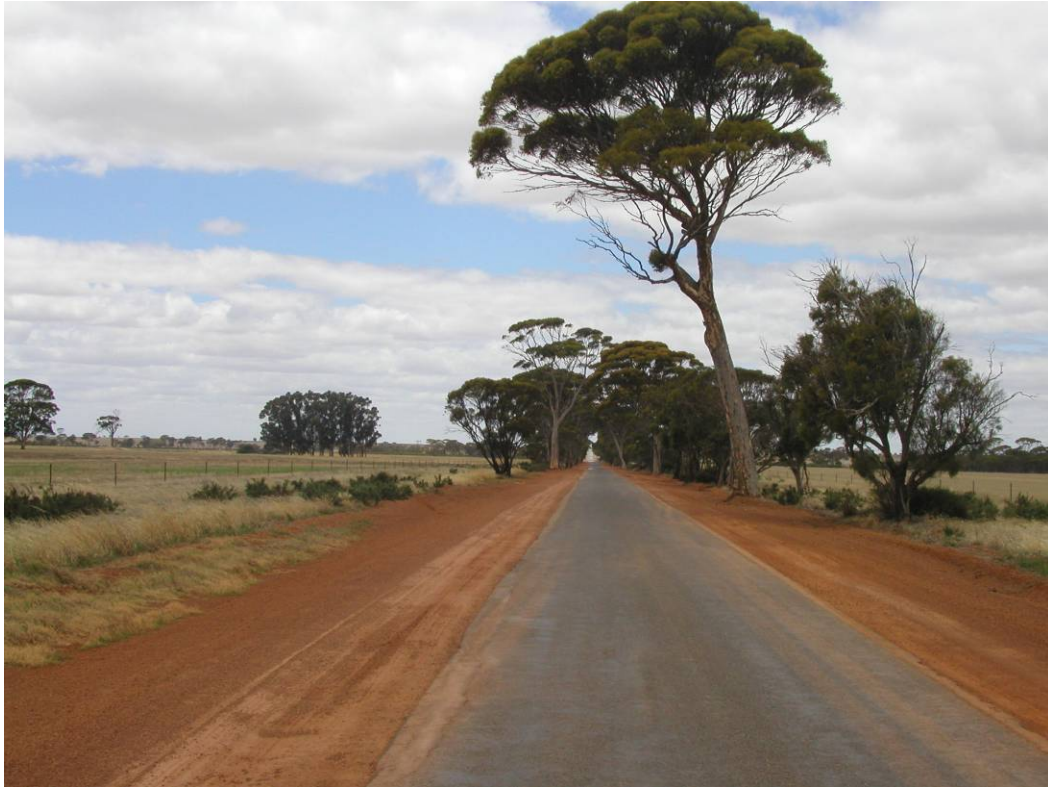
**Figure 13: Existing road, Kondinin end, to be widened (224.8 SLK facing east). Left hand side only to be cleared.**

From 222.7 to 226 SLK, land has been resumed which expands the road reserve to 40 m width. Prior to construction, existing vegetation on the northern side of the road will be

cleared (total area approximately 1.6 Ha). After construction, 2.6 Ha will be rehabilitated.

Planting lines will be ripped prior to winter. These lines are to be no more than 300mm deep and spaced at 2.5 metres apart, with a 3 metre gap between the new farm fence and the first tree rip line. Trees and shrubs are to be planted at 2 metre spacing.
